## Inspection Report, Colowyo, C-1981-019

<b>Permit Number:</b> C-1981-019 <b>Mine Name:</b> Colowyo Coal Mine <b>Operator:</b> Colowyo Coal Company L.P. <b>Operator Address:</b> Mr Tony Tennyson 5731 State Highway 13 Meeker, CO 81641	<b>County:</b> Moffat, Rio Blanco <b>Operation Type:</b> Surface <b>Permit Status:</b> Active <b>Ownership:</b> Private
	<b>Operator Representative Present:</b>  Tony Tennyson
<b>Operator Representative Signature: (Field Issuance Only)</b>

<b>Inspection Start Date:</b> March 19, 2025 <b>Inspection Start Time:</b> 12:00 <b>Inspection End Date:</b> March 20, 2025 <b>Inspection End Time:</b> 10:00		<b>Inspection Type:</b> Coal Complete Inspection <b>Inspection Reason:</b> Normal I&E Program <b>Weather:</b> Cloudy	
<b>Joint Inspection Agency:</b>  None		<b>Joint Inspection Contacts:</b>	
<b>Post Inspection Agency:</b>  None		<b>Post Inspection Contacts:</b>	
<b>Inspector(s):</b>  Hunter Ridley	<b>Inspector's Signature:</b>  <i>Hunter Ridley</i>		<b>Signature Date:</b>  March 27, 2025

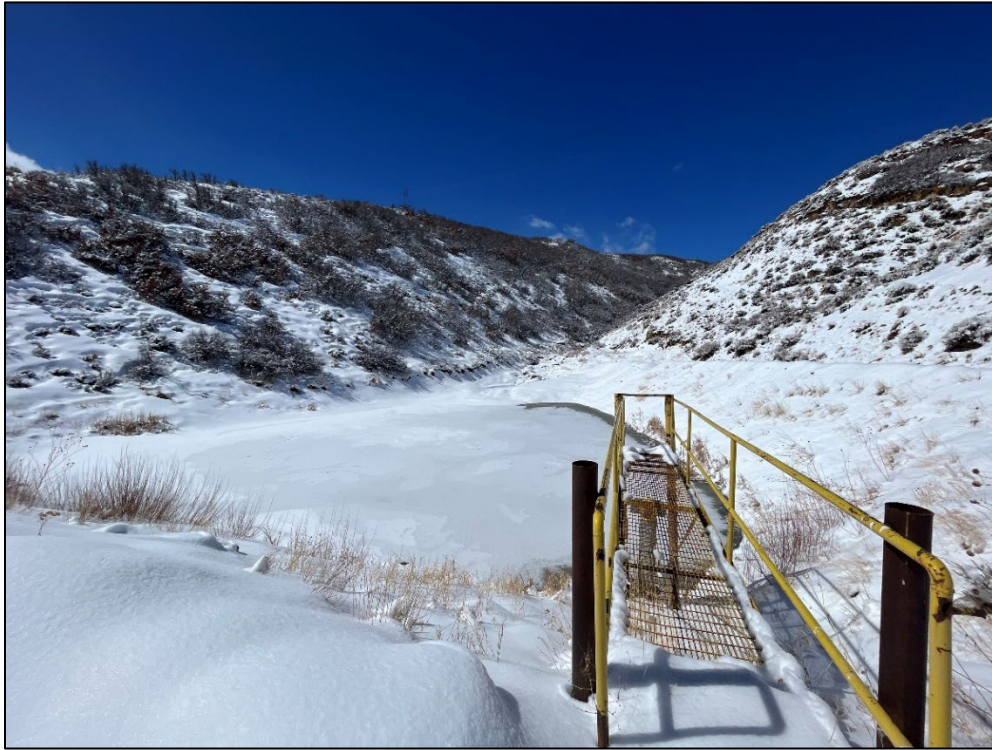
The Prospect Pond, accessible via Hwy 13, was inspected. Section 28 pond was inaccessible at the time of inspection. Prospect Pond (Photo 1) held water at the time of inspection and was mostly frozen over. All embankments appeared stable and vegetated under snow cover. No issues were noted.

*Photo 1: View west of Prospect Pond.*

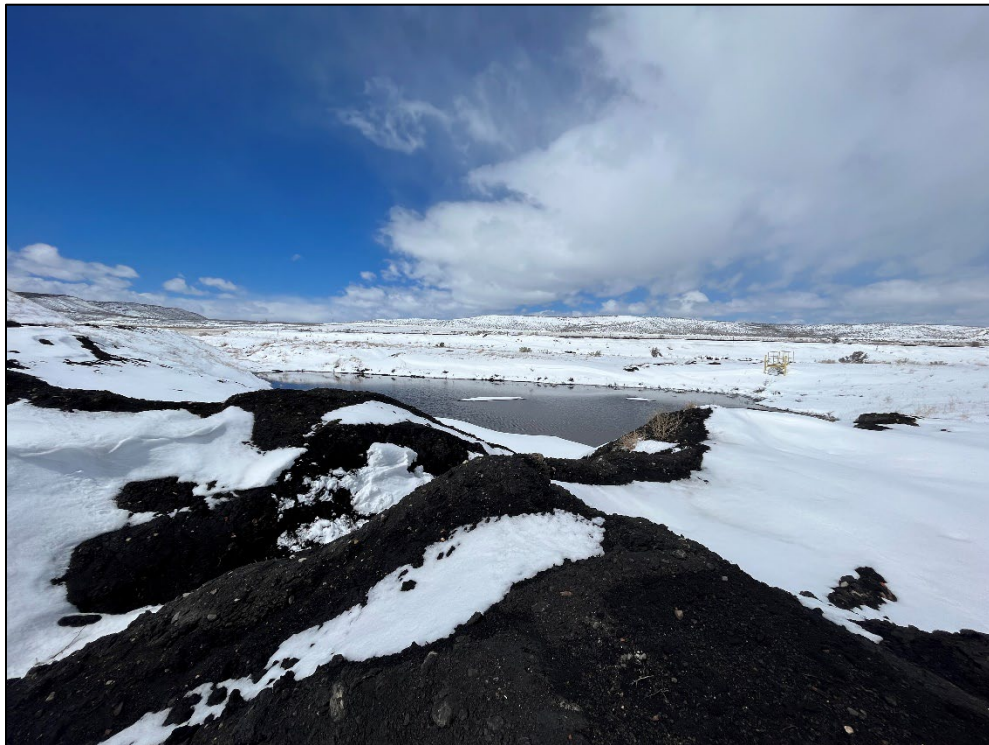
The Rail Loop, Stoker Siding and Gossard Ponds were inspected in the Gossard Loadout area (Photos 2-4). All ponds were holding water but were not frozen over. Embankments appeared stable and vegetated under snow cover. Discharge points were free of blockages. Stoker Siding Pond had a small but steady discharge flow.

*Photo 2: View northwest of Rail Loop Pond near Gossard Loadout.*

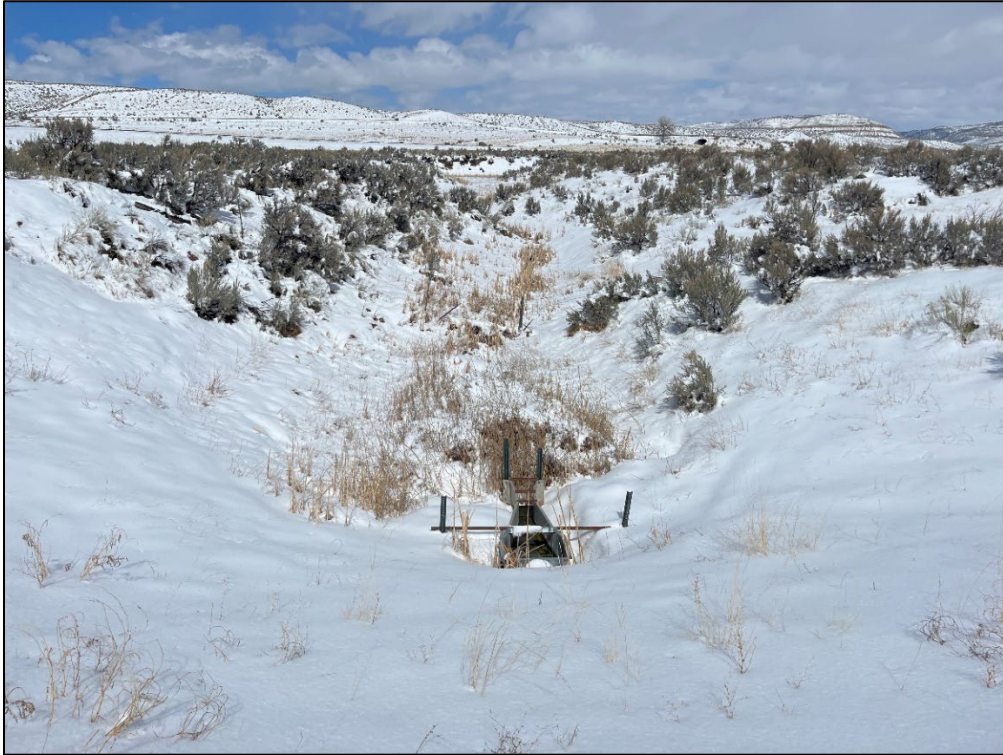
*Photo 3: View north of the discharge point for the Stoker Siding Pond.*

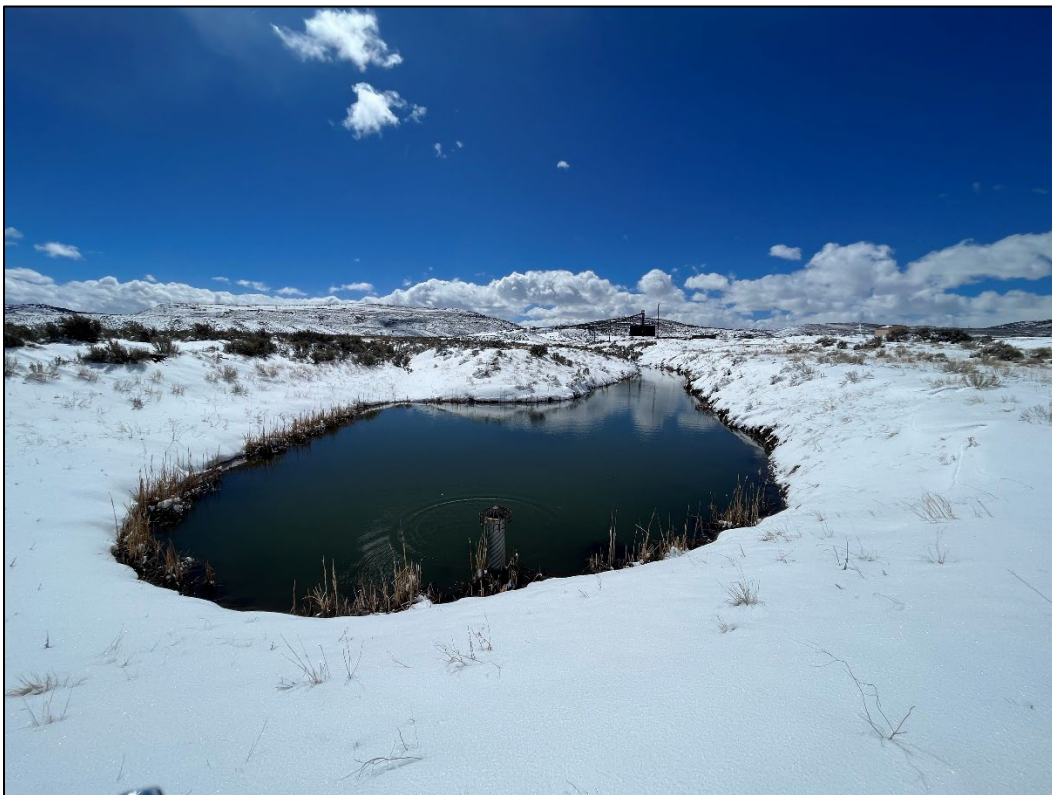
*Photo 4: View south of the Stoker Siding Pond.*

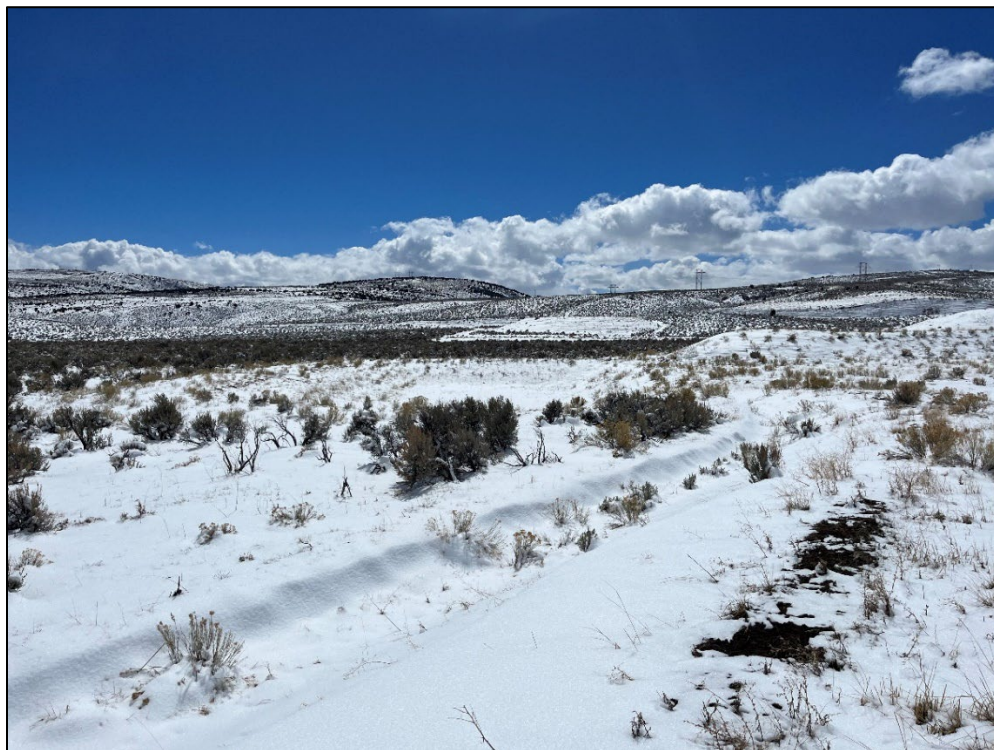
Ponds in the Temporary Storage Facilities area, just west of the Gossard Loadout were inspected and found to be snow-covered, but mostly dry (Photo 5). This area serves as a temporary shop and equipment storage area for the highwall mining company currently working at Colowyo.

*Photo 5: View southeast of the Wilson Storage Pond in the Temporary Facilities Area.*

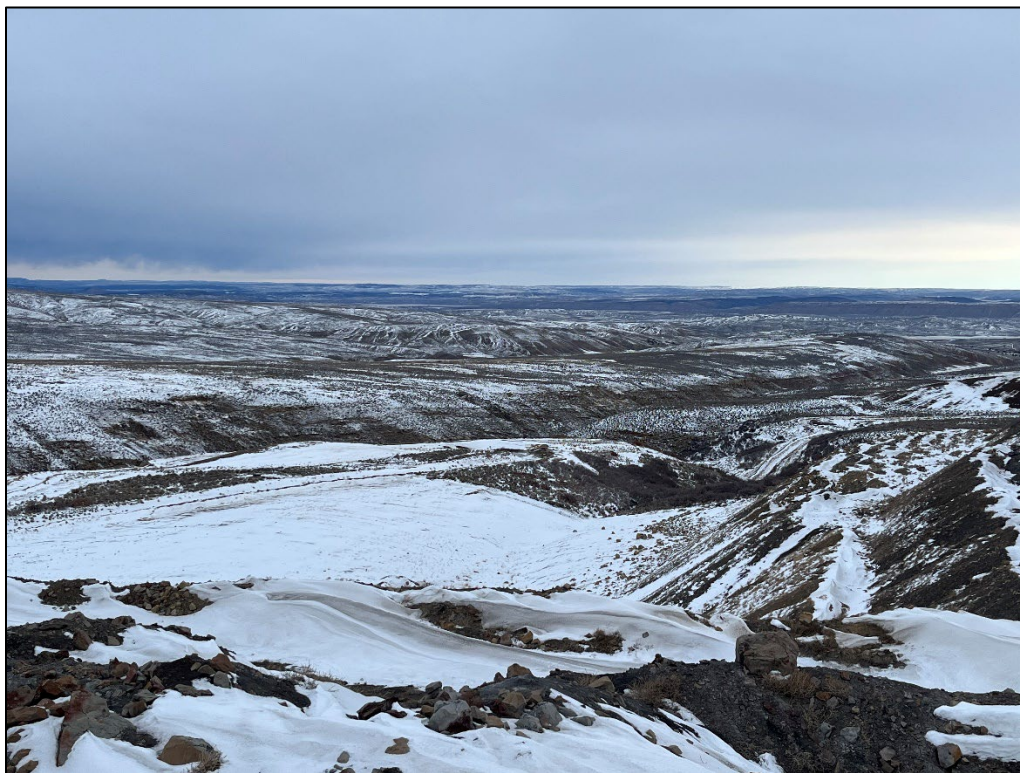
All ponds in the Collom Pit area (Sidehill, Section 26, Section 36, Middle, and Section 25) were unable to be inspected at the Division's inspection this month. Roads to the ponds were either too difficult to navigate due to snowy and wet conditions, or cable laying operations blocked the paths needed to access these ponds. Sidehill Pond and a small portion of Section 26 Pond were able to be viewed from afar this month, from atop a lookout point on the western side of the Colom Spoil Pile (Photo 6). From what the Division could see from this vantage point, the ponds appeared free of issues.

The following ditches in the Collom Pit area were inspected this month from afar: D-1 and D-4 (Photo 6). All channels appeared to be stable with no signs of erosion or undercutting.

Topsoil piles across the site contained appropriate markers (e.g. Photo 8). Markers have been maintained throughout the winter season thus far. Topsoil Pile 26A, north of the Collom temporary spoil pile, was observed from afar during this inspection (Photo 6) and was in stable condition.

*Photo 6: View north from atop the western side of the Collom Spoil Pile. Sidehill Pond and ditches D4 and D1 are partially visible.*

- Monitor the slump area at Section 26 Pond
- Monitor the small erosional feature in D4, repairs will be necessary if conditions worsen

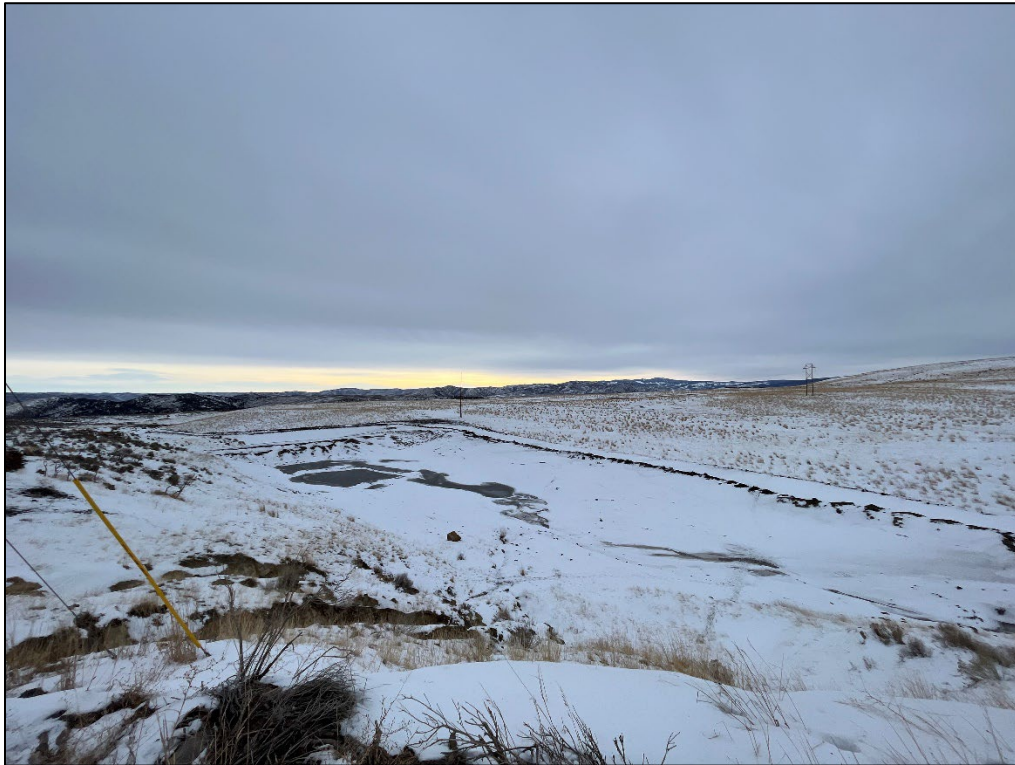
Stock ponds and ditches in the East Pit were inaccessible during this inspection. The side-by-side vehicle usually used to access these in snowy conditions was also not available for use during the inspection, limiting access. Access to Section 15 and 16 Ponds was attempted, but a deep puddle ultimately restricted access to the ditch and pond (Photo 10). The Division was able to access and inspect the Section 3 Ponds, which were holding a small pool of frozen water. All embankments appeared stable and free of any other issues (Photo 7).

*Photo 7: View southeast of Section 3 Ponds.*

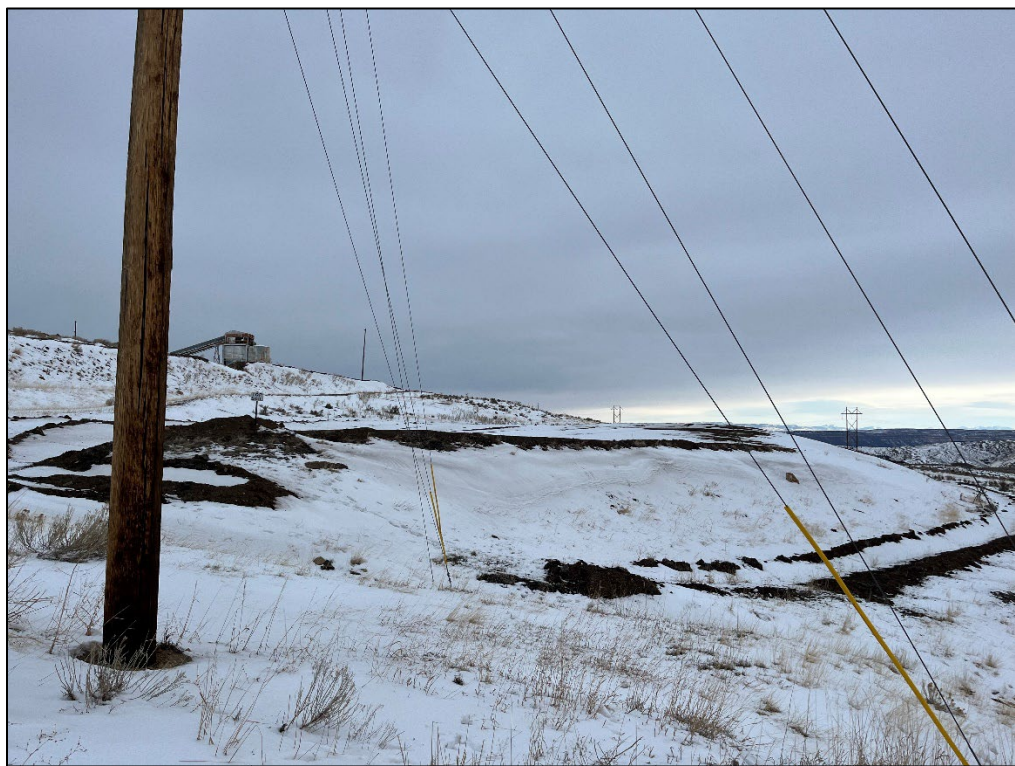
*Photo 8: View north of a topsoil pile adjacent the Section 3 Ponds, the pile is appropriately marked.*

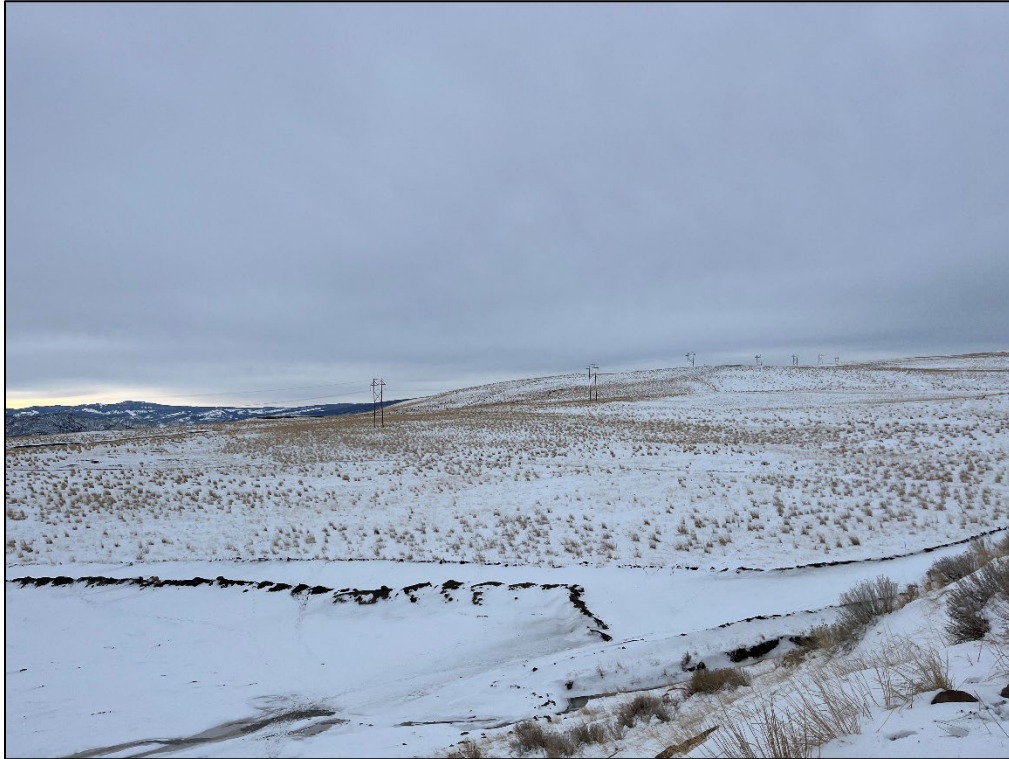
No negative impact to wildlife was observed. A large herd of elk were observed just south of Section 3 Ponds, in the reclaimed East Pit (Photo 9).

*Photo 9: View south of a large heard of elk seen from the Section 3 Ponds.*

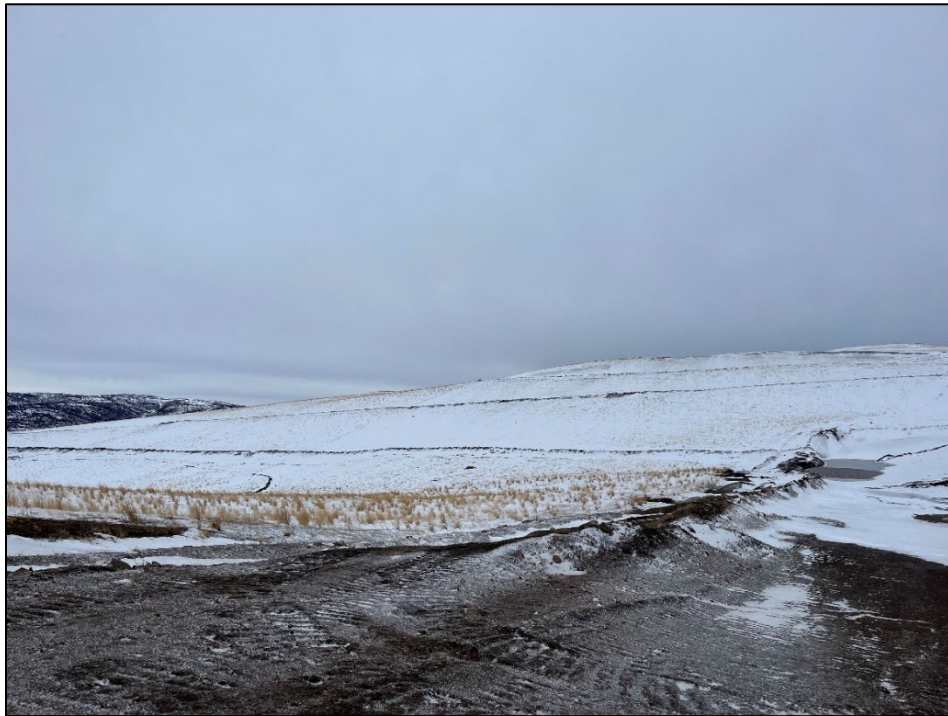
*Photo 10: View south towards Section 15 Pond, the site was inaccessible due to deep snowmelt and mud.*

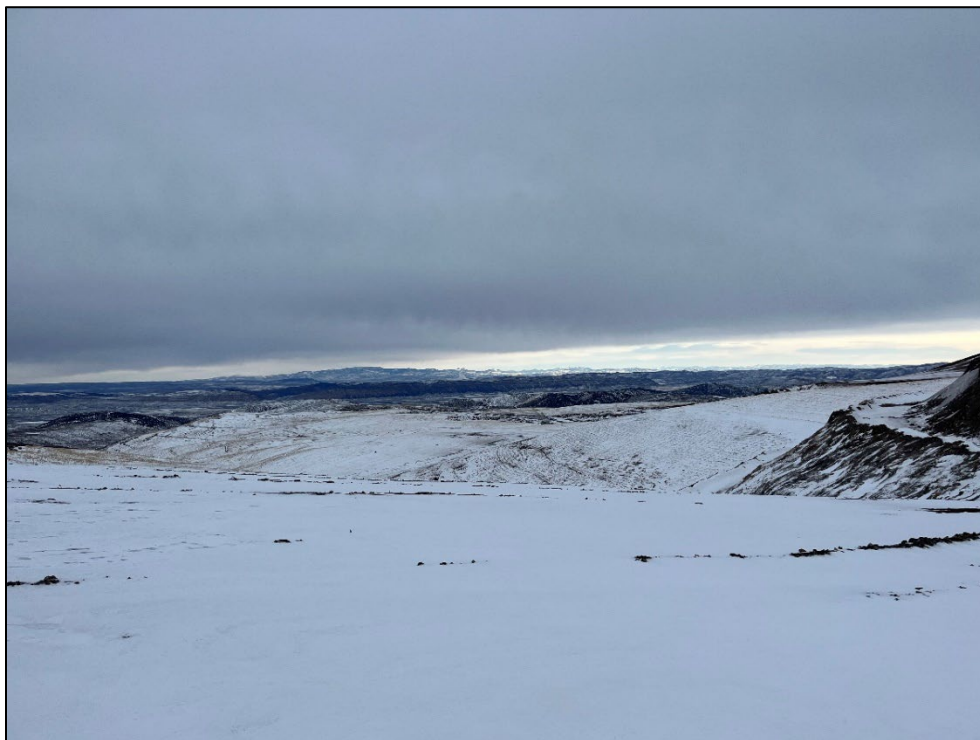
West Pit was inspected from above via an overlook point on the western side of the South Taylor temporary spoil pile. West Pit has been almost entirely backfilled and is in its revegetation phase (Photo 11). A large portion of this West Pit area has been proposed for Phase I Bond Release under SL24.

*Photo 11: View into the West Pit from atop a lookout point on the western side of the South Taylor temporary spoil pile.*

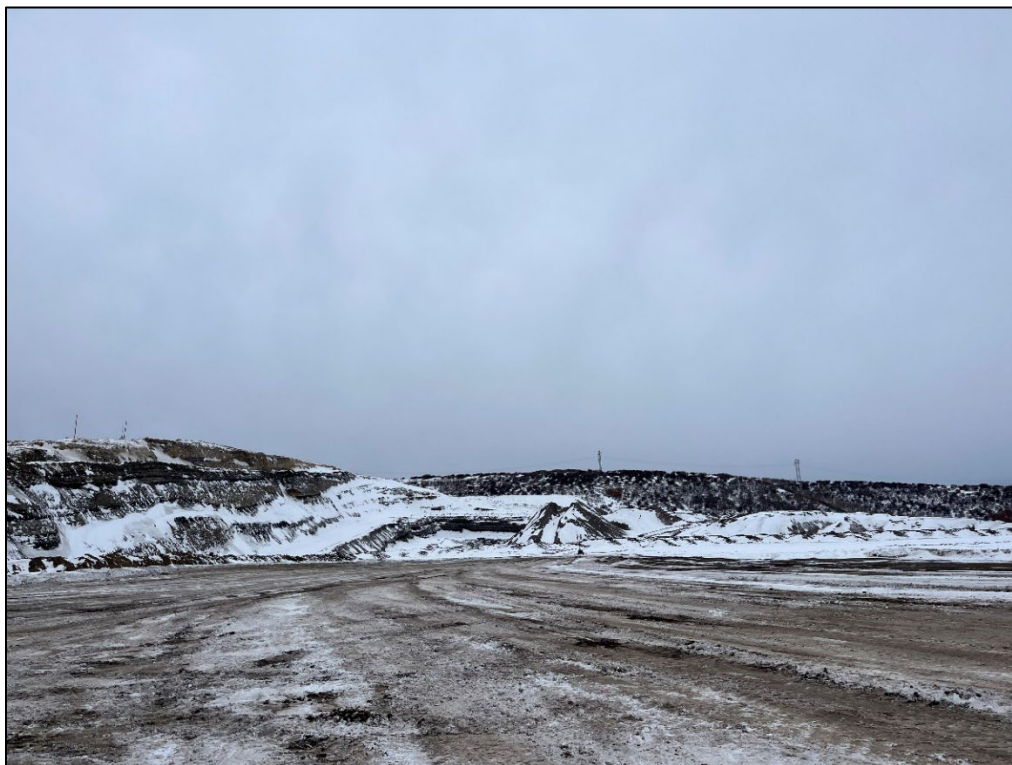
Active backfill operations were not observed during this inspection of the South Taylor Pit. However, backfill activities appeared to have progressed since the Division's last inspection (Photo 12). Spoil material is still mainly being deposited towards the southeast corner of the South Taylor pit.

*Photo 12: View west into the recently active backfilled area of South Taylor Pit.*

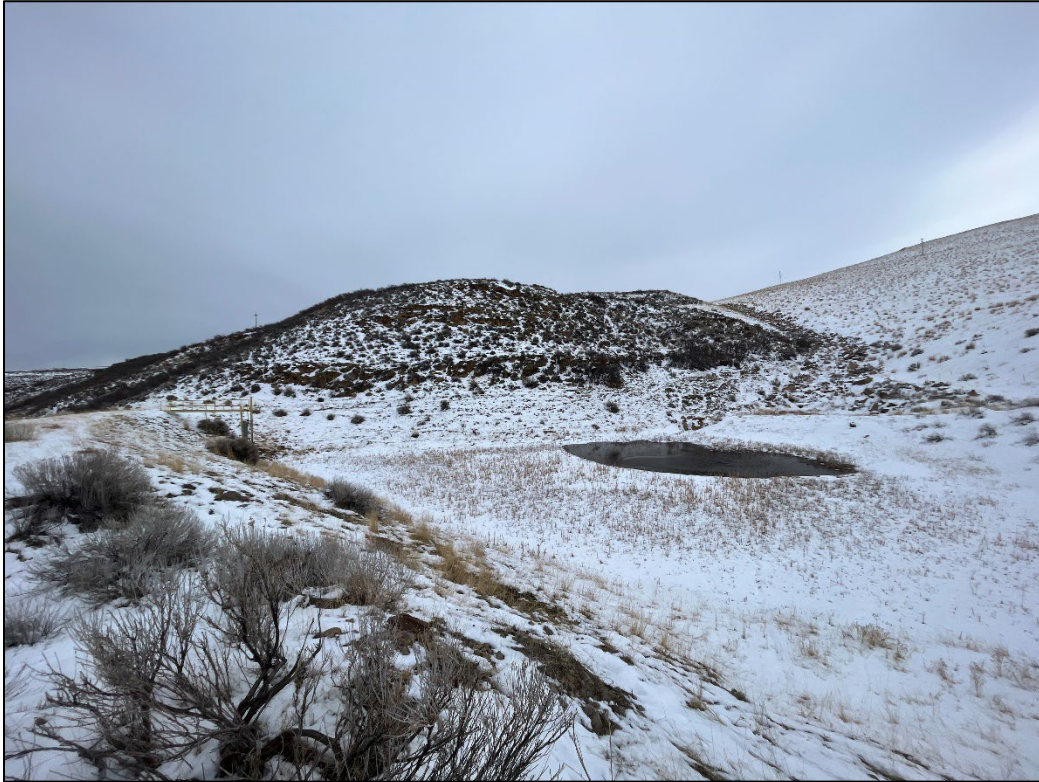
short portion of the access road. West Pit Pond was accessed on foot from the limitation point of the access road. The pond was holding a small amount of water and had stable embankments (Photo 13). No issues were noted.

*Photo 13: View east of West Pit Pond.*
