**MINERALS PROGRAM INSPECTION REPORT**  
**PHONE: (303) 866-3567**

<b>MINE NAME:</b> Jarnagin Pit	<b>MINE/PROSPECTING ID#:</b> M-2018-022	<b>MINERAL:</b> Clay (general) and sand gravel	<b>COUNTY:</b> Kit Carson
<b>INSPECTION TYPE:</b> Monitoring	<b>WEATHER:</b> Windy	<b>INSP. DATE:</b> March 18, 2025	<b>INSP. TIME:</b> 11:00
<b>OPERATOR:</b> Kit Carson County	<b>OPERATOR REPRESENTATIVE:</b> Dave Hornung	<b>TYPE OF OPERATION:</b> 110c - Construction Limited Impact	
<b>REASON FOR INSPECTION:</b> Normal I&E Program	<b>BOND CALCULATION TYPE:</b>	<b>BOND AMOUNT:</b> \$0.00	
<b>DATE OF COMPLAINT:</b> NA	<b>POST INSP. CONTACTS:</b> None	<b>JOINT INSP. AGENCY:</b> None	
<b>INSPECTOR(S):</b> Ben Hammar	<b>INSPECTOR'S SIGNATURE:</b>

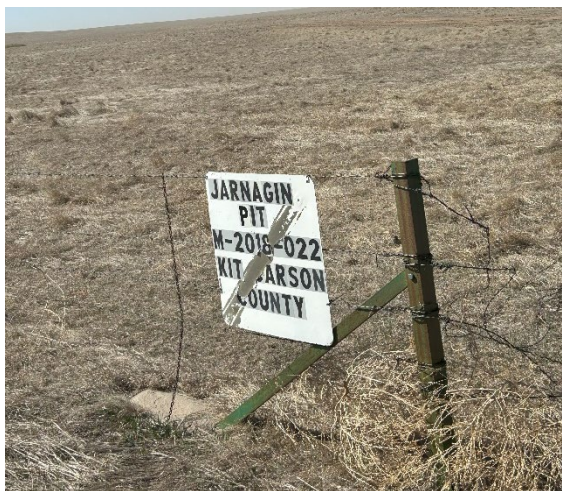
All boundary markers and required signage were adequately intact and located in the correct locations. No other significant issues were found, and the site generally appeared to be in compliance with the Act and the Rules and in good condition.

Photo 1: Posted mine sign.

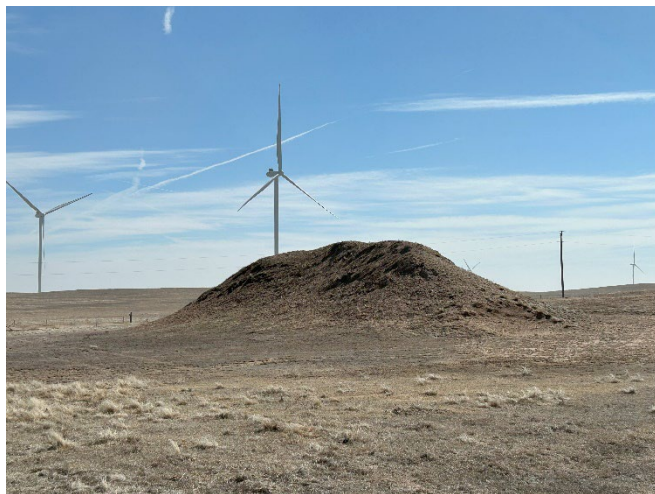
The referenced topsoil pile appeared to be seeded and stable, and no significant signs of erosion were visible during the inspection. The stockpiled topsoil appears adequate to successfully reclaim the site. No standing water was visible, and other signs of impacts to the surrounding hydrologic balance were not present.

Photo 2: Topsoil stockpile, located northwest of the pit.

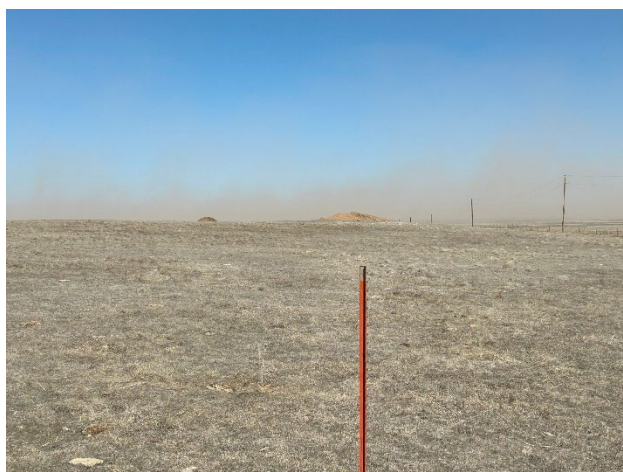
Photo 3: Southeast site boundary marker, facing north.  
Note that all boundary markers were present.

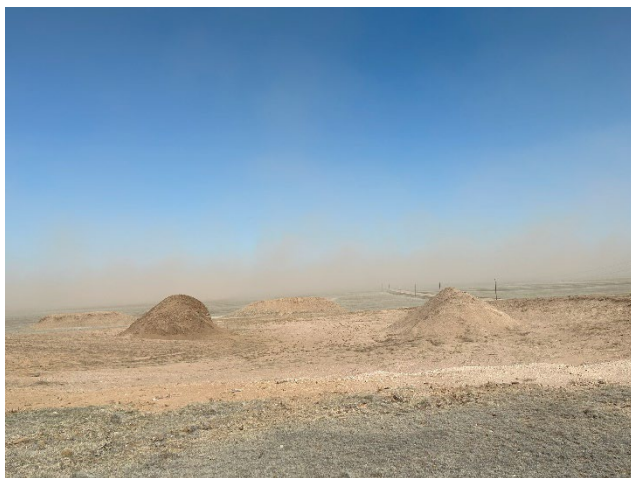
The current post-mining land use is pastureland, and the site is used relatively regularly based on conversations with the operator and the site conditions at the time of inspection. Product stockpiles were present within and northeast of the pit, and a single topsoil pile was present northwest of the pit. Pit slopes were shallow, and mining generally appears to proceed by stripping and stockpiling shallow surface deposits. No significant highwall was present.

Photo 4: Pit area and product stockpiles.
