**MINERALS PROGRAM INSPECTION REPORT**  
**PHONE: (303) 866-3567**

<b>MINE NAME:</b> Dorsch Pit	<b>MINE/PROSPECTING ID#:</b> M-1998-060	<b>MINERAL:</b> Sand and gravel	<b>COUNTY:</b> Kit Carson
<b>INSPECTION TYPE:</b> Monitoring	<b>WEATHER:</b> Windy	<b>INSP. DATE:</b> March 18, 2025	<b>INSP. TIME:</b> 12:00
<b>OPERATOR:</b> Kit Carson County	<b>OPERATOR REPRESENTATIVE:</b> Dave Hornung	<b>TYPE OF OPERATION:</b> 112c - Construction Regular Operation	
<b>REASON FOR INSPECTION:</b> Normal I&E Program	<b>BOND CALCULATION TYPE:</b>	<b>BOND AMOUNT:</b> \$0.00	
<b>DATE OF COMPLAINT:</b> NA	<b>POST INSP. CONTACTS:</b> None	<b>JOINT INSP. AGENCY:</b> None	
<b>INSPECTOR(S):</b> Ben Hammar	<b>INSPECTOR'S SIGNATURE:</b>

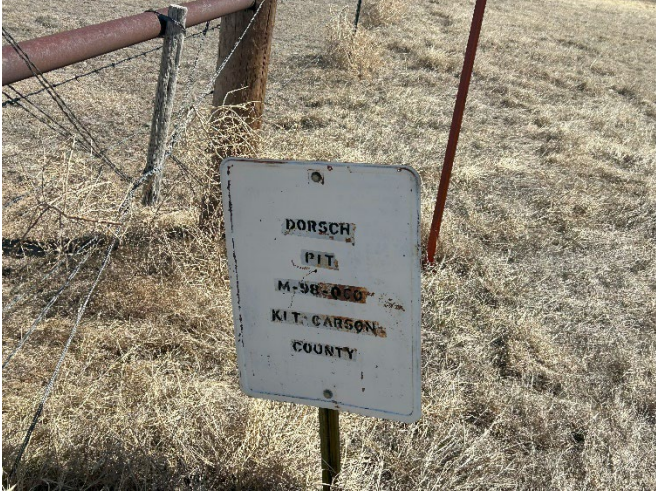
Photo 1: Posted mine ID sign.

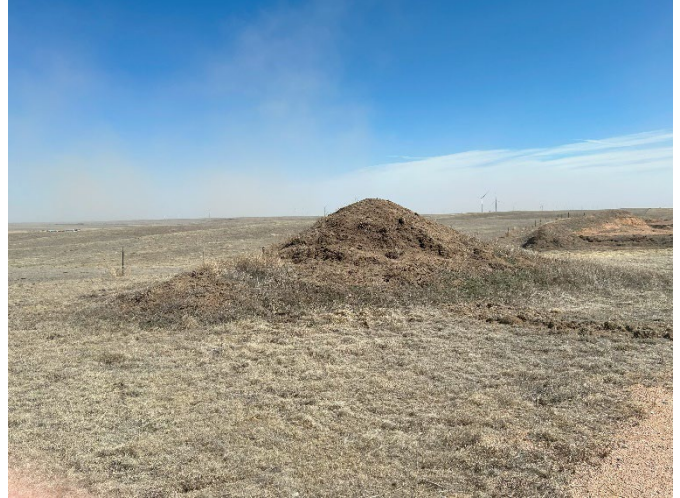
No significant erosional issues were observed, and all signs and markers were present and in place. Topsoil berms were constructed around the perimeter of the site to the north, east and south, and appeared to be stable at the time of inspection.

Photo 2: Example topsoil stockpile. Note all stockpiles were seeded and stable.

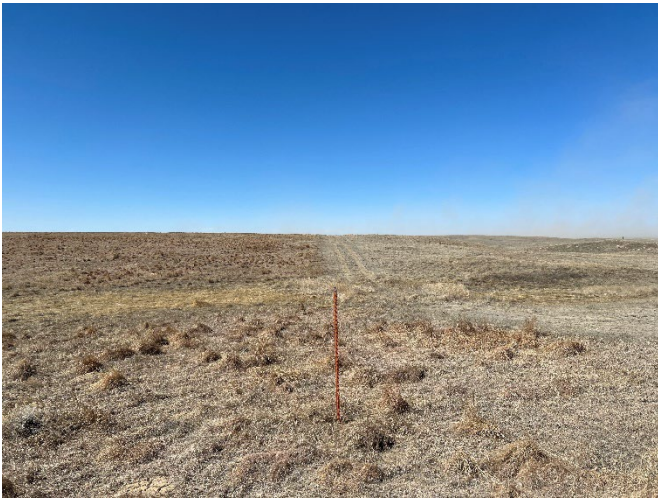
Photo 3: Example boundary marker. All boundary markers were present and in good condition.

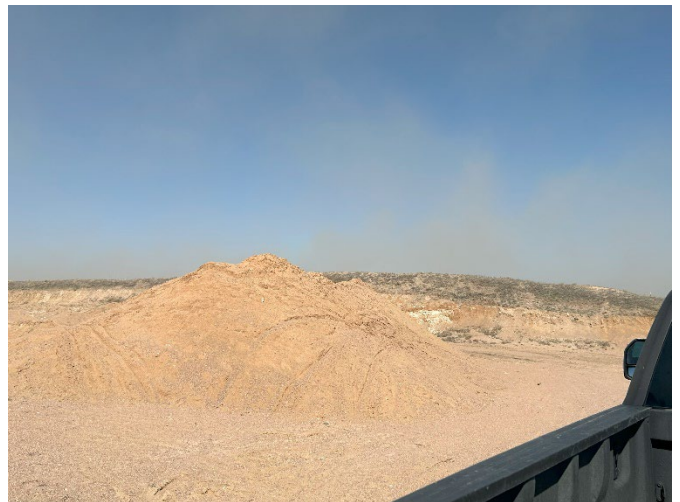
Current mining takes place in the western portion of the pit, and the eastern pit area is nearly completely reclaimed. Per statements from the operator, the site sees frequent use. A small highwall was present along the north site boundary, and the site appears to be approximately 5 feet deep. Product stockpiles were stored within the pit floor.

Photo 4: Pit floor and product stockpiles. Pit highwall is also shown.
