**MINERALS PROGRAM INSPECTION REPORT**  
**PHONE: (303) 866-3567**

<b>MINE NAME:</b> Strode Pit	<b>MINE/PROSPECTING ID#:</b> M-2021-002	<b>MINERAL:</b> Sand	<b>COUNTY:</b> Kit Carson
<b>INSPECTION TYPE:</b> Monitoring	<b>WEATHER:</b> Windy	<b>INSP. DATE:</b> March 18, 2025	<b>INSP. TIME:</b> 12:30
<b>OPERATOR:</b> Castle Rock Construction Company of Colorado	<b>OPERATOR REPRESENTATIVE:</b>	<b>TYPE OF OPERATION:</b> 112c - Construction Regular Operation	
<b>REASON FOR INSPECTION:</b> Normal I&E Program	<b>BOND CALCULATION TYPE:</b>	<b>BOND AMOUNT:</b> \$74,825.00	
<b>DATE OF COMPLAINT:</b> NA	<b>POST INSP. CONTACTS:</b> None	<b>JOINT INSP. AGENCY:</b> None	
<b>INSPECTOR(S):</b> Ben Hammar	<b>INSPECTOR'S SIGNATURE:</b>

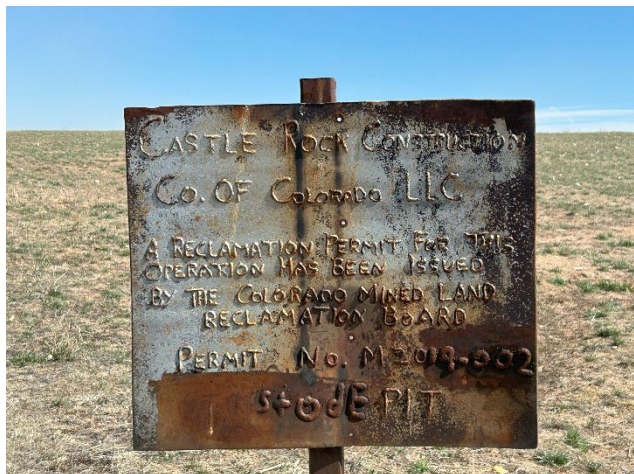
All signs and markers were present and in adequate condition at the time of inspection. Boundaries were clearly marked at each corner with T-posts, and a steel sign was posted at the former site entrance.

Photo 1: Posted mine ID sign.

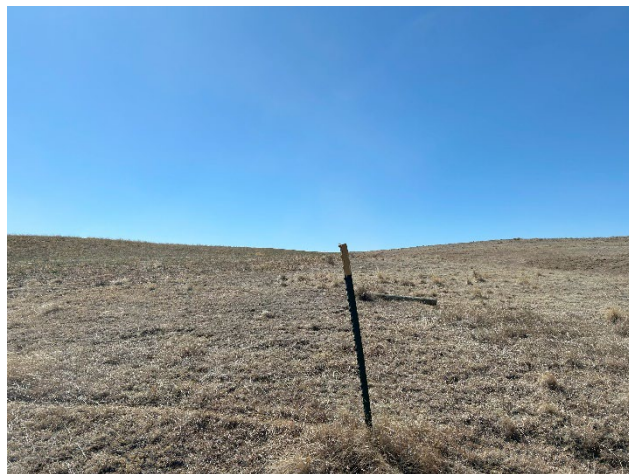
Photo 2: Example boundary marker.

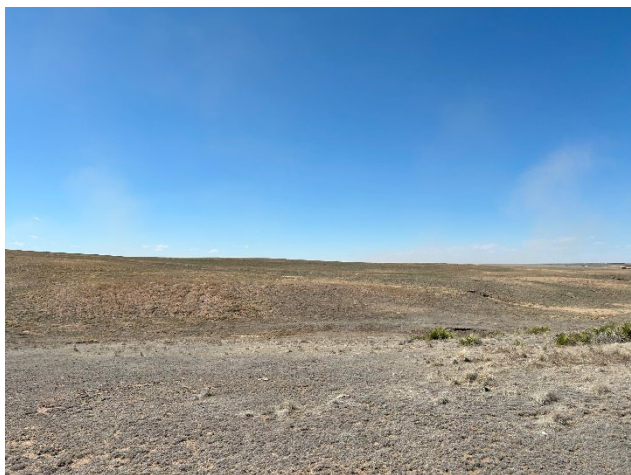
At the time of inspection, the reseeded sections of the site hadn't experienced a recent growing season, and so no significant observations related to reclamation success could be made. Based on the ground cover present during this inspection the site does appear to be in active reclamation and a reasonable effort has been made by the operator to control noxious weeds. The operator should take care to continue to monitor noxious weeds.

The site had been completely regraded at the time of inspection, and all slopes are shallow and within compliance of being 3:1 slopes or flatter as required by a rangeland post-mining land use.

Photo 3: Current reclamation progress.
