**MINERALS PROGRAM INSPECTION REPORT**  
**PHONE: (303) 866-3567**

<b>MINE NAME:</b> Morrison Quarry	<b>MINE/PROSPECTING ID#:</b> M-1973-021	<b>MINERAL:</b> Granite, granite gneiss	<b>COUNTY:</b> Jefferson
<b>INSPECTION TYPE:</b> Monitoring	<b>WEATHER:</b> Cloudy	<b>INSP. DATE:</b> March 20, 2025	<b>INSP. TIME:</b> 01:00
<b>OPERATOR:</b> Holcim - WCR, Inc.	<b>OPERATOR REPRESENTATIVE:</b> Kurt Thurmann	<b>TYPE OF OPERATION:</b> 112c - Construction Regular Operation	
<b>REASON FOR INSPECTION:</b> Normal I&E Program	<b>BOND CALCULATION TYPE:</b> Complete Bond	<b>BOND AMOUNT:</b> \$30,733,935.00	
<b>DATE OF COMPLAINT:</b> NA	<b>POST INSP. CONTACTS:</b> None	<b>JOINT INSP. AGENCY:</b> None	
<b>INSPECTOR(S):</b> Ben Hammar	<b>INSPECTOR'S SIGNATURE:</b>

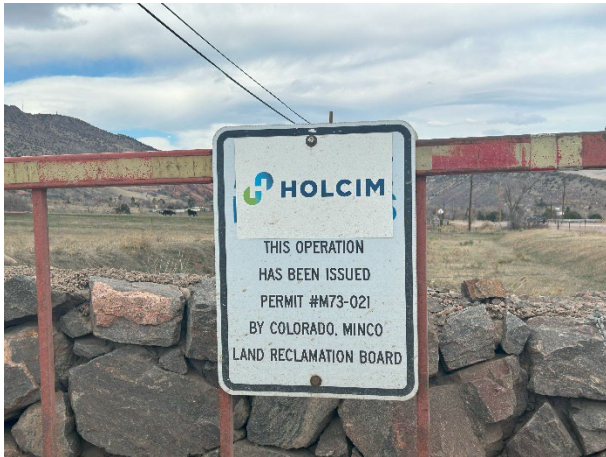
Per conversations with the operator, all boundary fences are currently in good condition. Due to the size of the site a full inspection of the site boundary was beyond the scope of this inspection, however the boundary fences that were incidentally observed appeared to be in good condition and the mine ID sign was in place.

Photo 1: Posted mine sign.

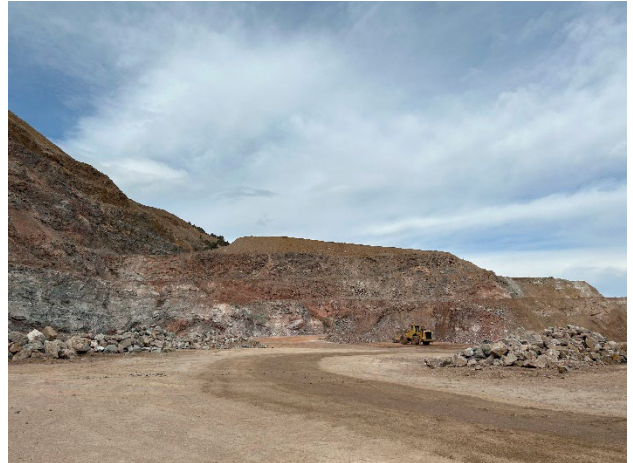
No issues related to erosion or sediment control were observed, and most site activity was contained within the active south quarry area during this inspection. The on-site fuel storage facility was inspected and was found to be adequate in containing potential spills.

Photo 2: Active south pit area.

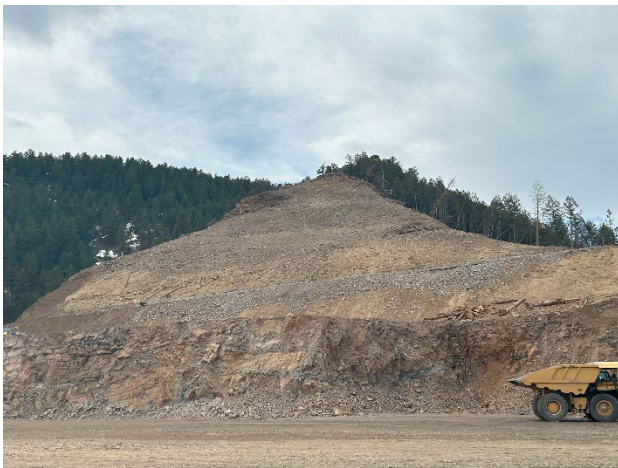
Regarding adherence to the approved mining plan, no significant deviations were observed. Mining has progressed into the west quarry and continues to occur within the approved sections of the south quarry, and concurrent reclamation was underway during this inspection. The upper benches within the south and west quarries have been backfilled and reseeded.

Photo 3: West quarry reclamation and regrade.

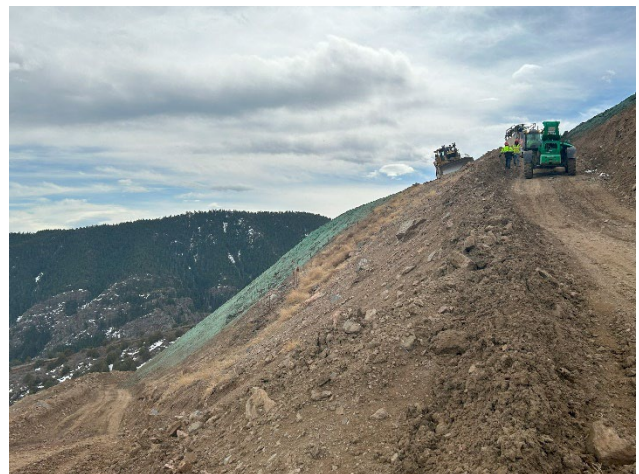
Photo 4: Most recent south quarry reclamation work, shown in progress.

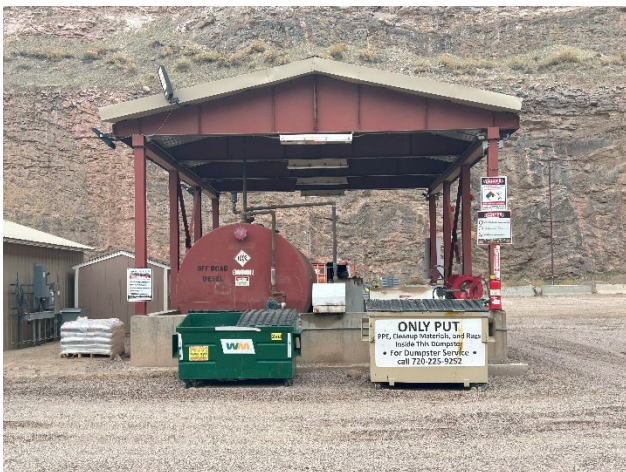
Photo 5: Fuel storage area. Note the double lined containment area.

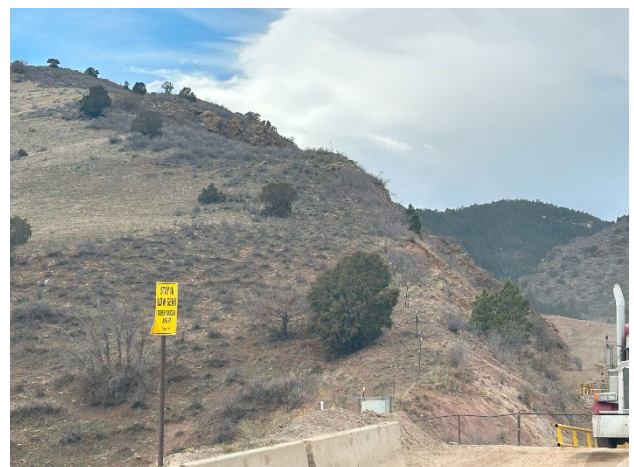
Photo 6: Boundary fenceline located near the site entrance.
