Roadside Portals Mine, C-1981-041, March Complete Inspection Report

Permit Number: C-1981-041 Mine Name: Roadside Portals Operator: Snowcap Coal Company, Inc Operator Address: Ms. Tonya Hammond P. O. Box 443 Grand Junction, CO 81502	County: Mesa Operation Type: Underground Permit Status: Active Ownership: Private
	Operator Representative Present: Tonya Hammond
Operator Representative Signature: (Field Issuance Only)

Inspection Start Date: March 20, 2025 Inspection Start Time: 10:15 Inspection End Date: March 20, 2025 Inspection End Time: 11:30		Inspection Type: Coal Complete Inspection Inspection Reason: Normal I&E Program Weather: Cloudy	
Joint Inspection Agency: None		Joint Inspection Contacts: None	
Post Inspection Agency: None		Post Inspection Contacts: None	
Inspector(s): Clayton Wein	Inspector's Signature: <i>Clayton Wein</i>		Signature Date: 3/31/2025

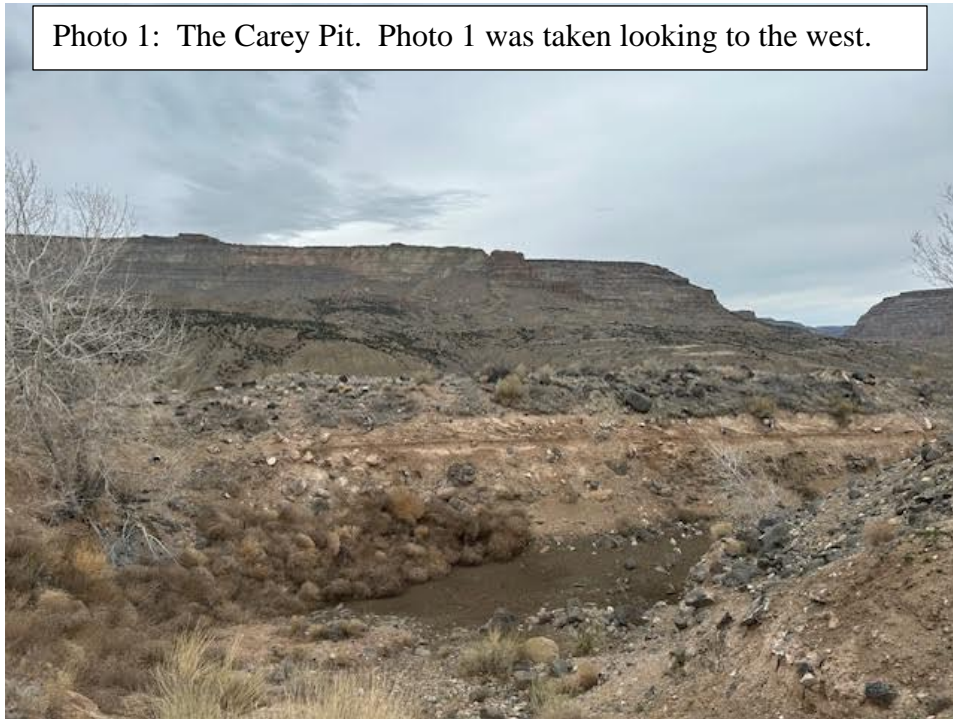
The Carey pit is located within the southwest corner of Tract 71. The pit is adjacent to the permit boundary. From the edge of the permit boundary, the pit was observed to have no evidence of water application from the landowner's buried pipeline (Photo 1). The bottom of the pit was muddy from recent precipitation events.

Photo 1: The Carey Pit. Photo 1 was taken looking to the west.

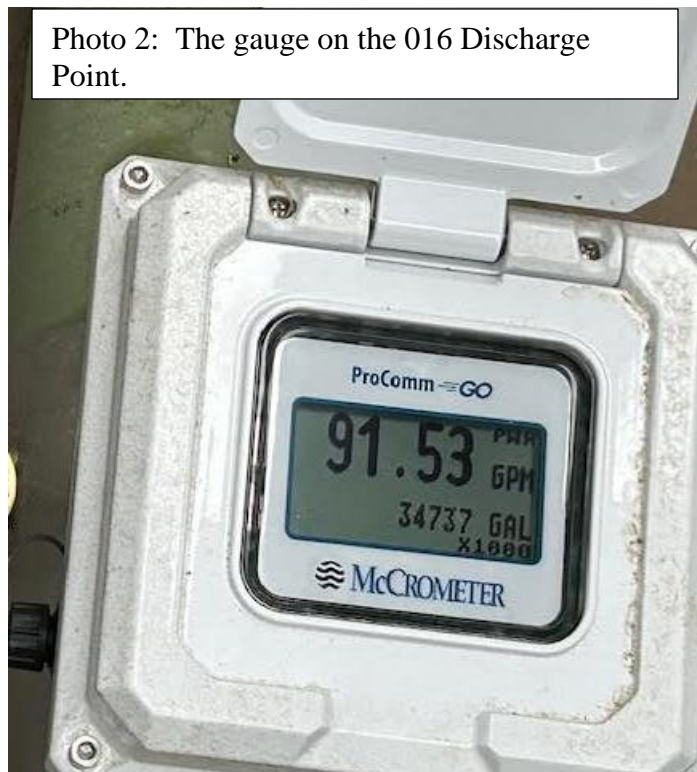
The Discharge Point 016 was discharging at the time of the inspection. Point 016 discharges water from the mine workings. The electronic meter gave a reading of 91.53 gpm (Photo 2). This rate of flow is within seasonal historical ranges for point 016. The outlet for the discharge pipe was unobstructed.

Photo 2: The gauge on the 016 Discharge Point.

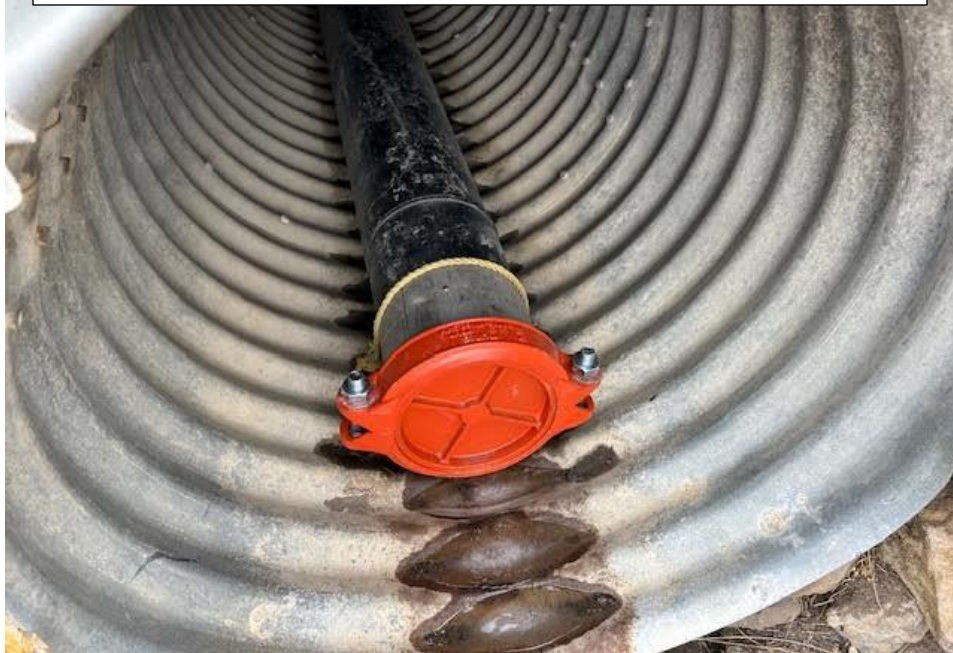
Discharge Point 002 was capped recently. Point 002 was used as a backup discharge point to 016. 002 would discharge water siphoned from the lower mine workings. No discharge was occurring at the time of the inspection (Photo 3).

Photo 3: Discharge Point 002 with cap.

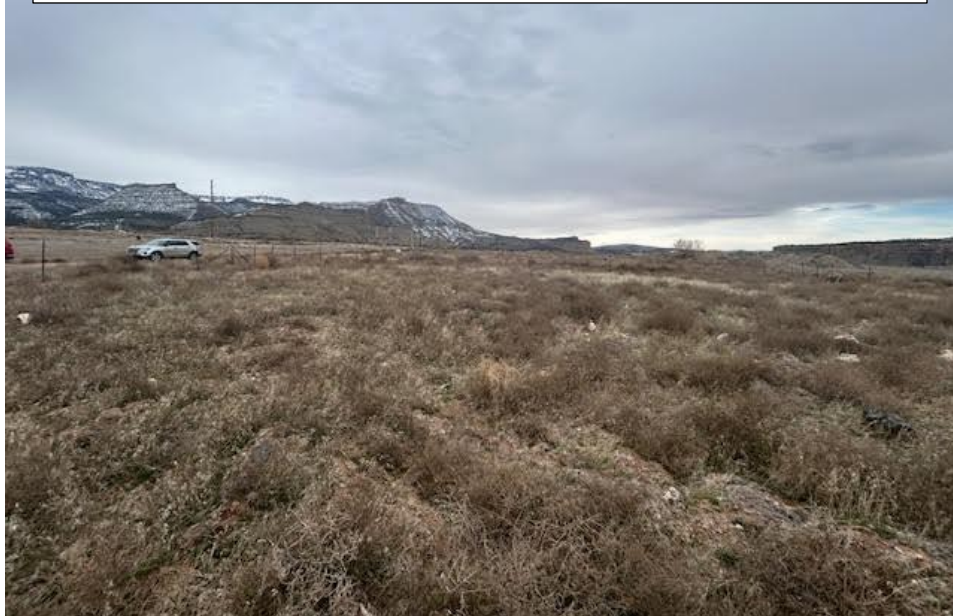
The TR-69 Repair Area is located within the northern portion of Tract 71. The disturbance for the TR-69 Repair area is approximately 0.4 acres in size and is the only permitted disturbance left in the permit area. The TR-69 Repair Area was observed to be stable with vegetative cover (Photos 4, 5 and 6). Vegetation was beginning to green for the season. There were no indications of differential settling or erosion. The straw waddles placed on the downgradient boundary of the disturbance were in good condition (Photo 7). There was no indication of off-site impacts. The perimeter fence was intact and the mine identification sign on the southeast post was legible and posted in a location easily visible (Photo 8).

Photo 4: The eastern portion of the TR-69 Repair Area. The photo is looking to the southeast.

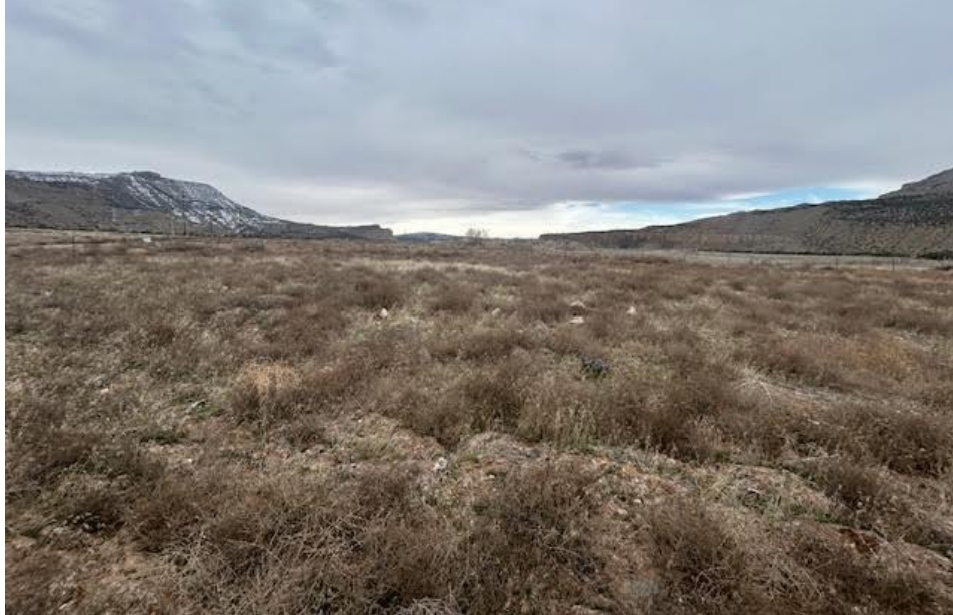
Photo 5: The middle section of the TR-60 Repair Area. Photo 5 is looking to the south.

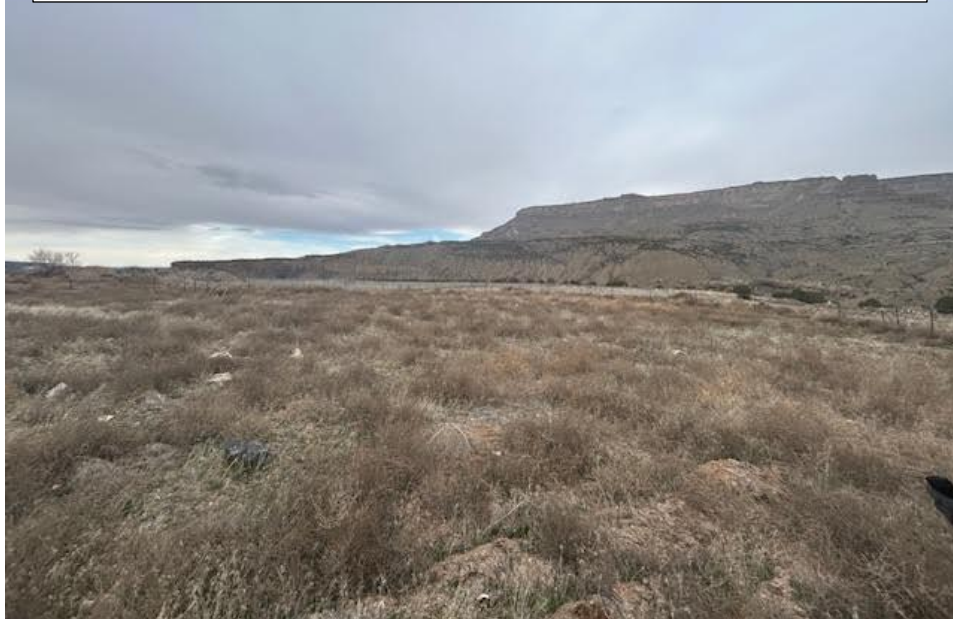
Photo 6: The western section of the TR-69 Repair Area. Photo 6 is looking to the southwest.

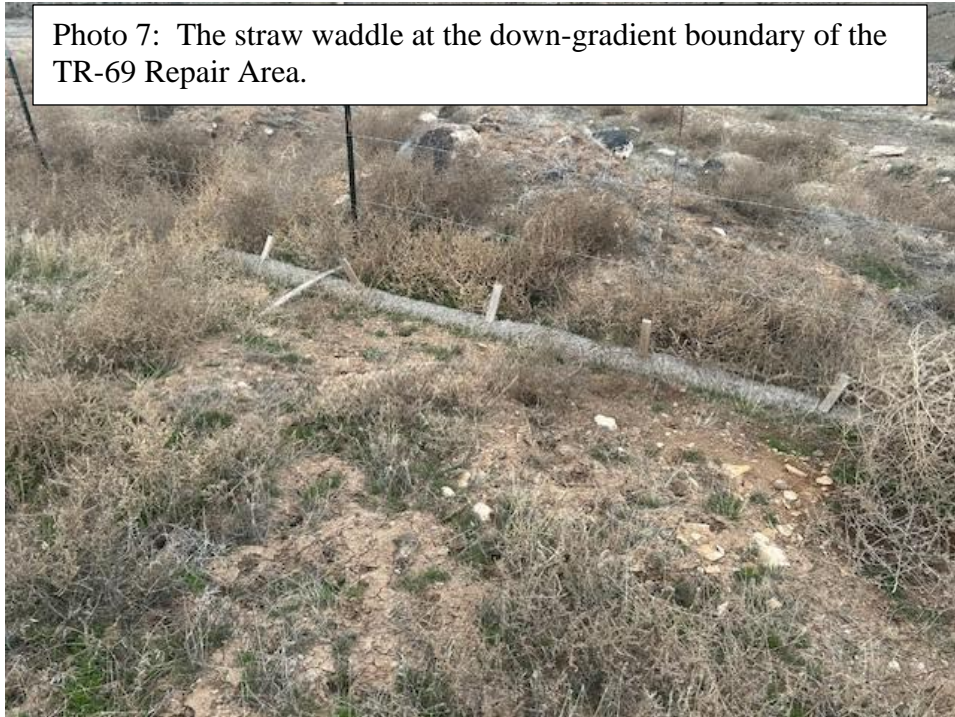
Photo 7: The straw waddle at the down-gradient boundary of the TR-69 Repair Area.

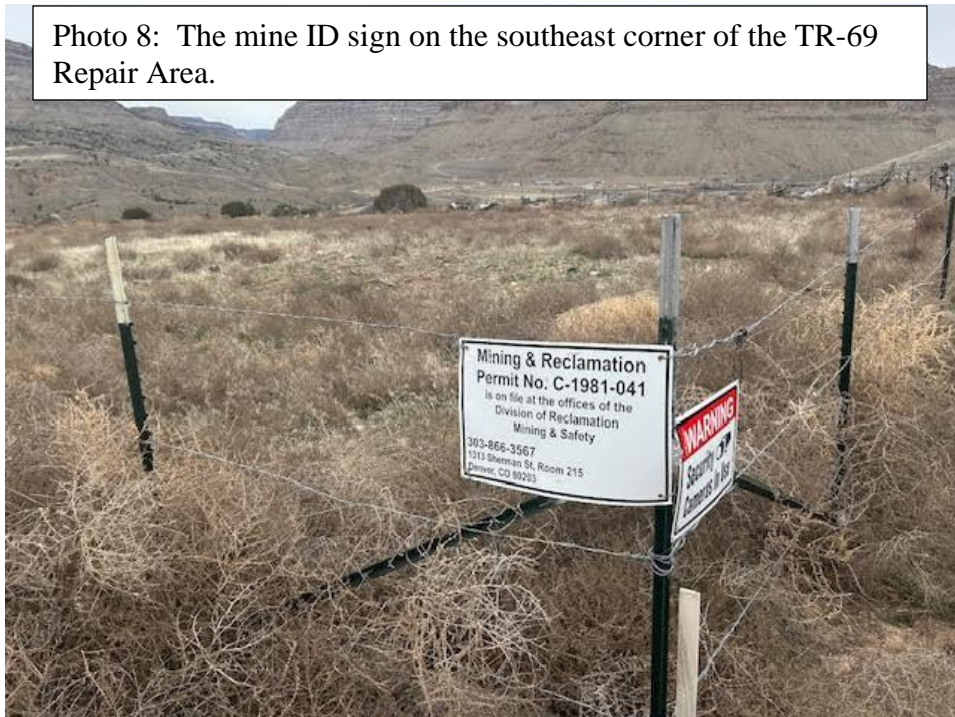
Photo 8: The mine ID sign on the southeast corner of the TR-69 Repair Area.

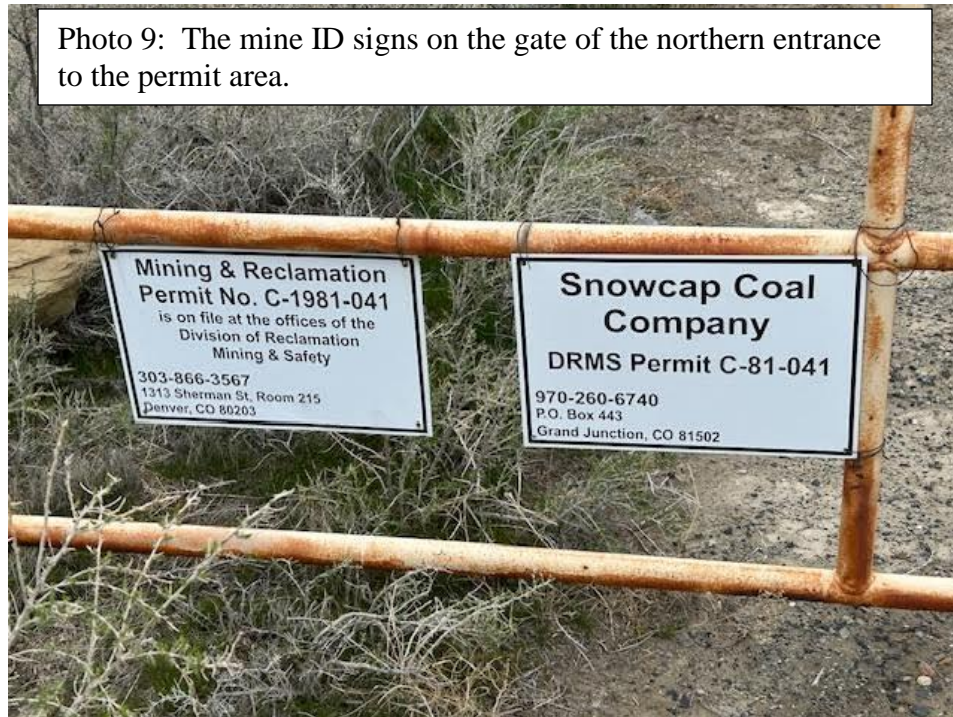
Mine identification signs were posted in unobstructed locations. The signs were clearly legible with the required information regarding the Permittee, the CRDMS permit number and contact information (Photo 9).

Photo 9: The mine ID signs on the gate of the northern entrance to the permit area.
