**MINERALS PROGRAM INSPECTION REPORT**  
**PHONE: (303) 866-3567**

<b>MINE NAME:</b> Cross Gold Mine	<b>MINE/PROSPECTING ID#:</b> M-1977-410	<b>MINERAL:</b> Gold, copper, silver, zinc and lead	<b>COUNTY:</b> Boulder
<b>INSPECTION TYPE:</b> Monitoring	<b>WEATHER:</b> Cloudy	<b>INSP. DATE:</b> March 27, 2025	<b>INSP. TIME:</b> 09:30
<b>OPERATOR:</b> Grand Island Resources LLC	<b>OPERATOR REPRESENTATIVE:</b> Richard Mittasch	<b>TYPE OF OPERATION:</b> 110(2) - Hard Rock Limited Impact	
<b>REASON FOR INSPECTION:</b> Priority	<b>BOND CALCULATION TYPE:</b> None	<b>BOND AMOUNT:</b> \$546,751.00	
<b>DATE OF COMPLAINT:</b> NA	<b>POST INSP. CONTACTS:</b> None	<b>JOINT INSP. AGENCY:</b> None	
<b>INSPECTOR(S):</b> Patrick Lennberg	<b>INSPECTOR'S SIGNATURE:</b>

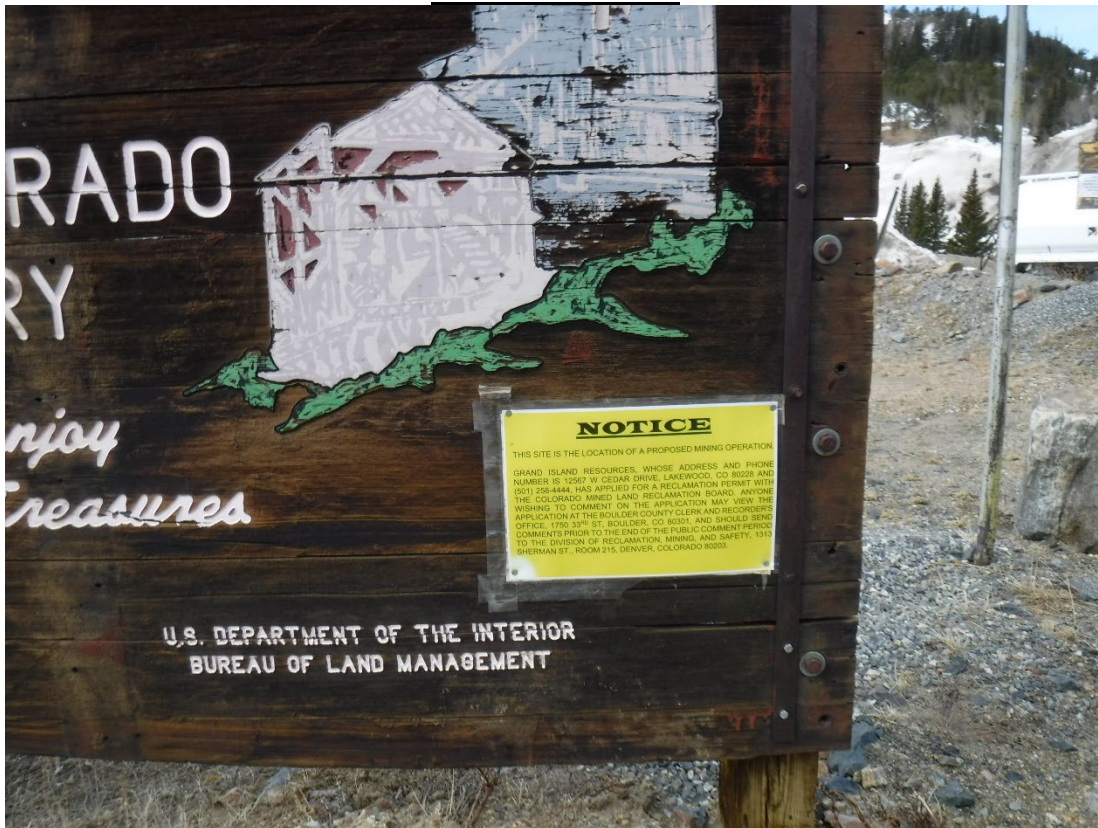
Photo 1: Notice sign for CN-1 at the primary mine entrance

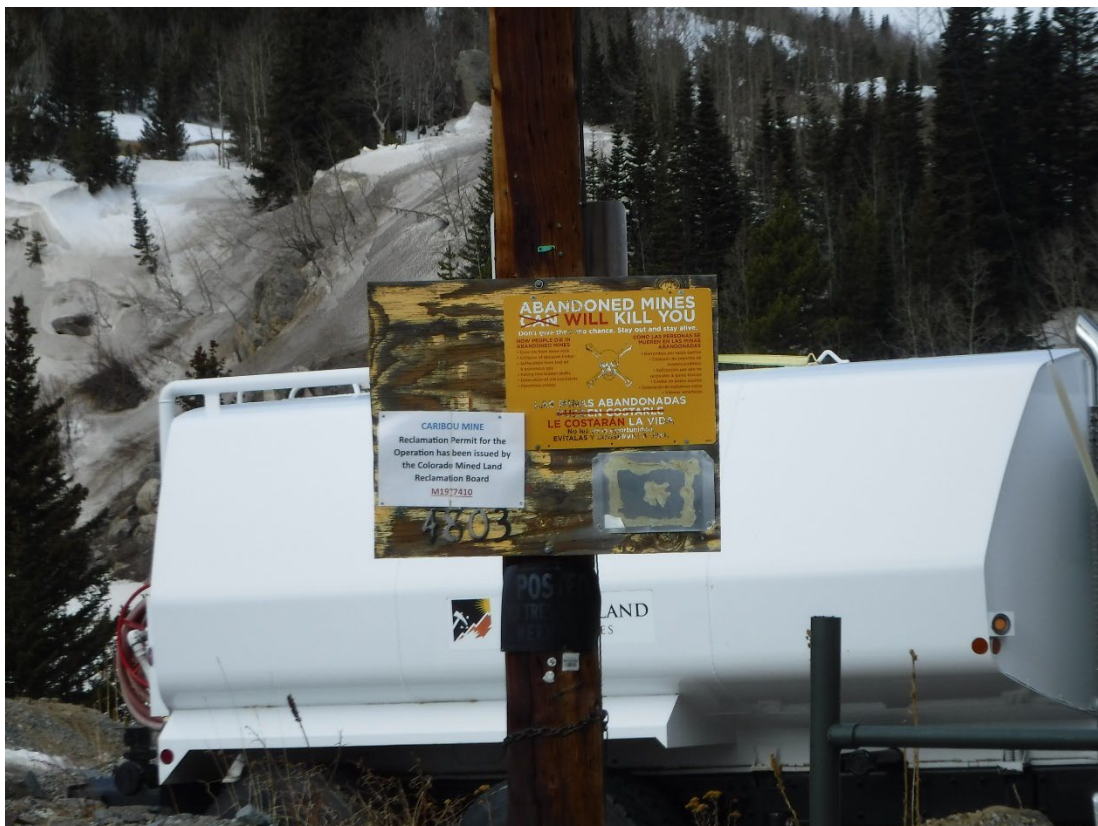
Photo 2: Mine sign at the primary mine entrance

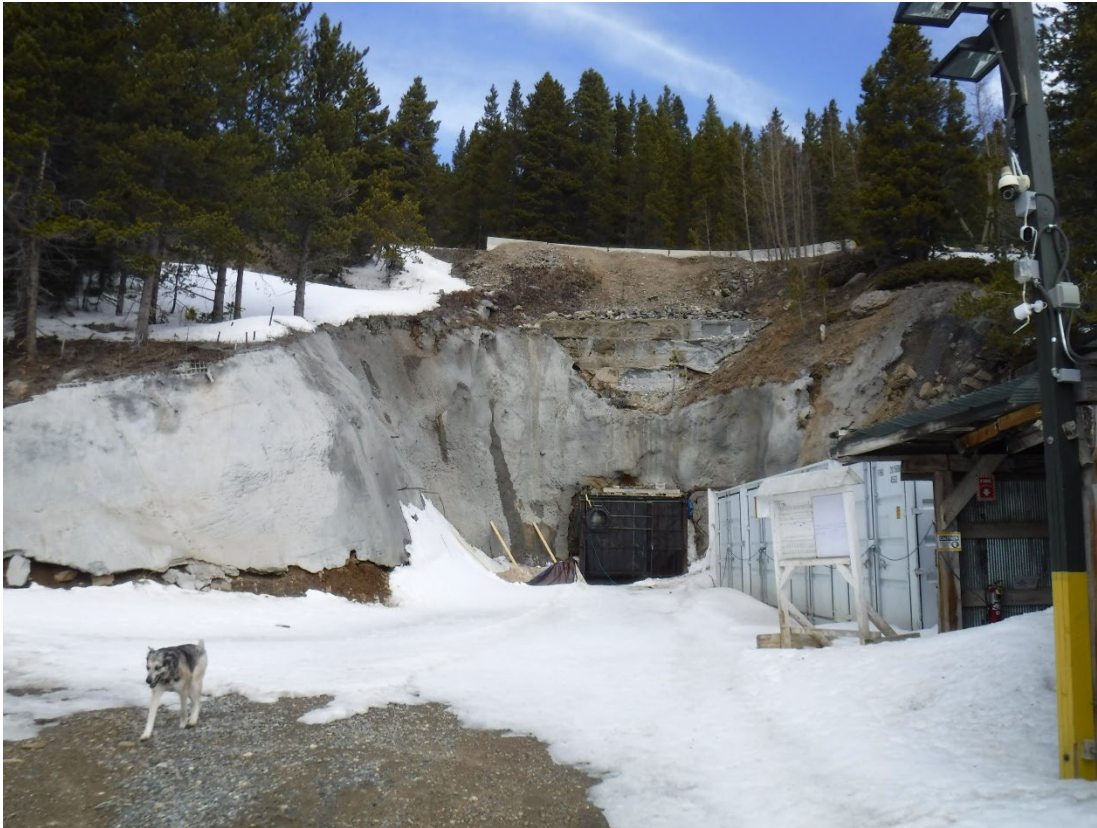
At the Idaho Tunnel, GIR indicated that over the winter and during recent thaws the shotcrete that was installed to stabilize the hillside is cracking and small seeps have developed. GIR stated they are monitoring the seeps and have plans to reapply another layer of shotcrete when weather conditions allow.

**Photo 3:** Idaho Tunnel entrance

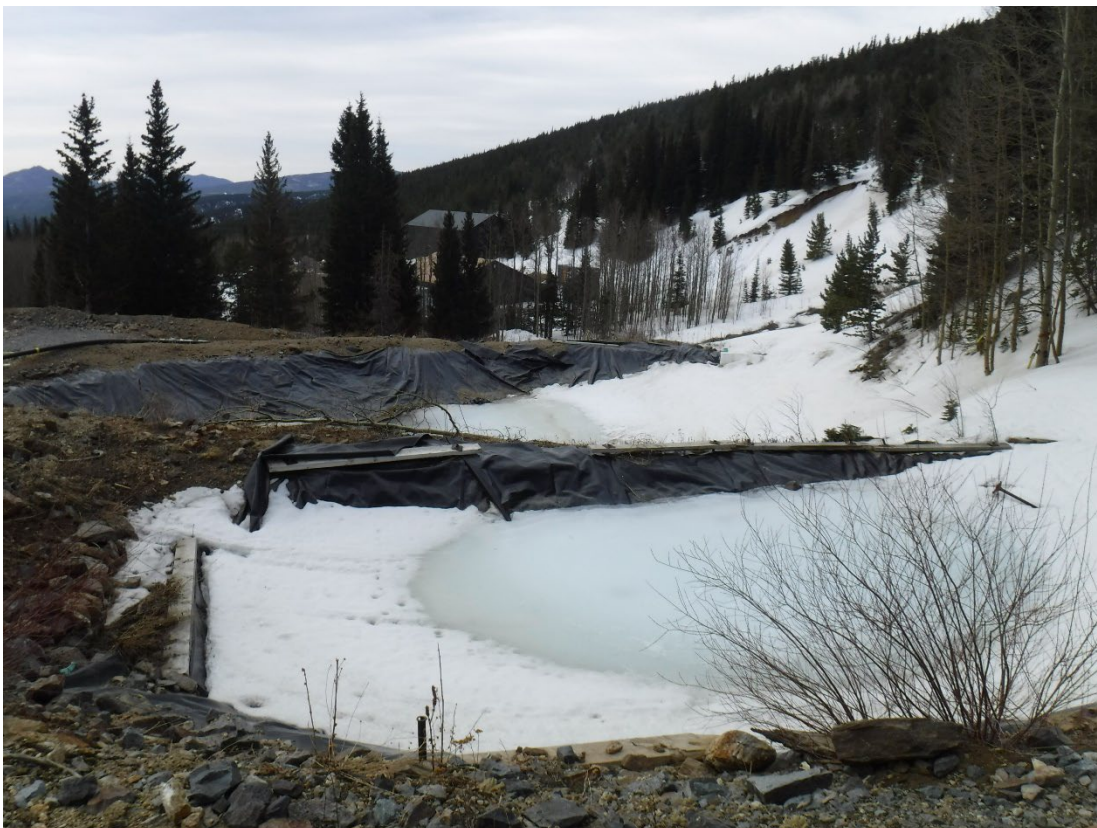
**Photo 4:** 3-Series ponds filled with snow and melt water

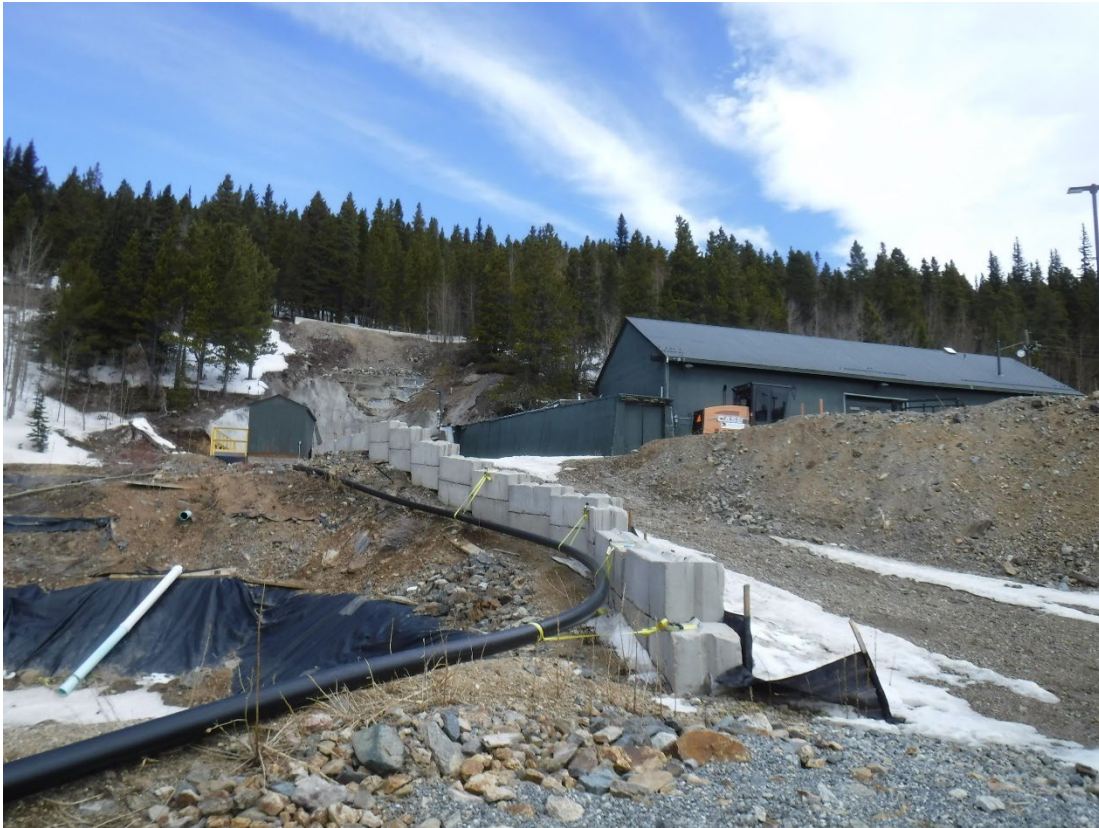
At the time of inspection, the Caribou effluent was being discharged at ~20 gpm to Pond 1 through a pipeline that bypasses the 3-series ponds. Pond 1 was also receiving water from Joliet Raise to create storage capacity in anticipation of runoff beginning. Pond 1 water was being run through the water treatment plant and discharged at the CDPHE discharge location at ~60 gpm.

**Photo 5:** Pipeline conveying effluent water to Pond 1. Heat tape in the pipeline prevent freezing.

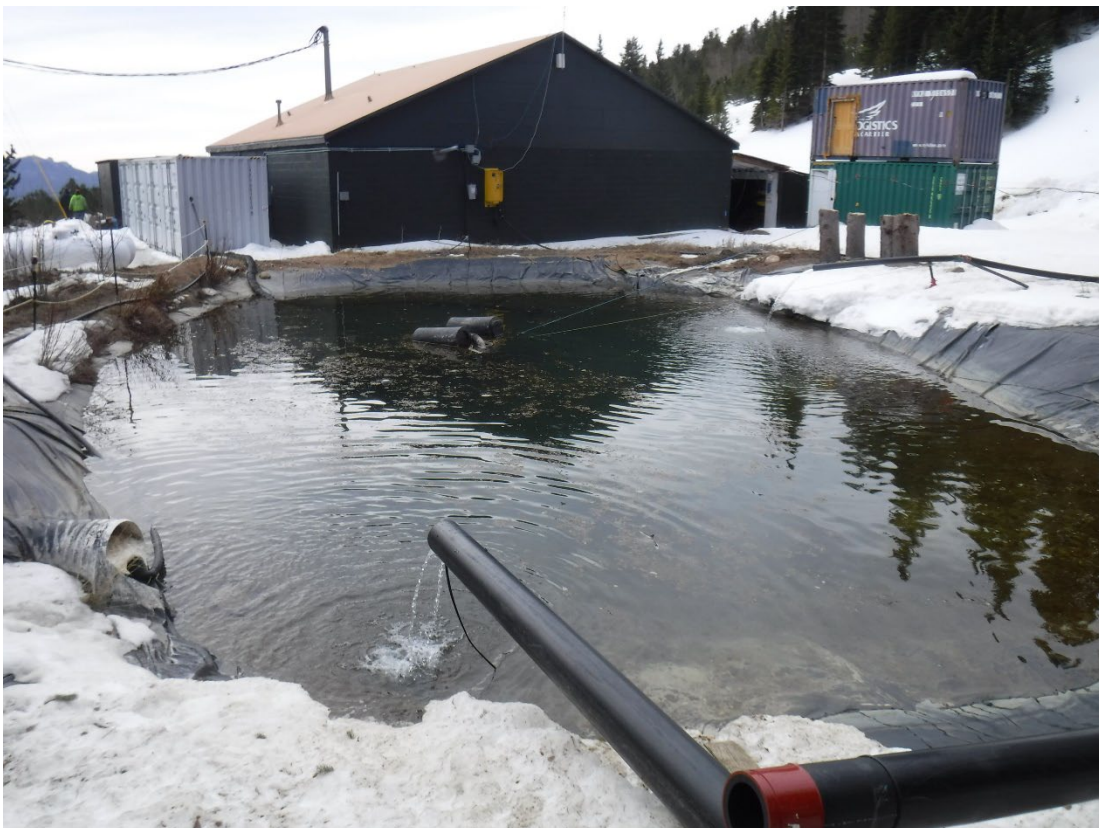
**Photo 6:** Pond 1.

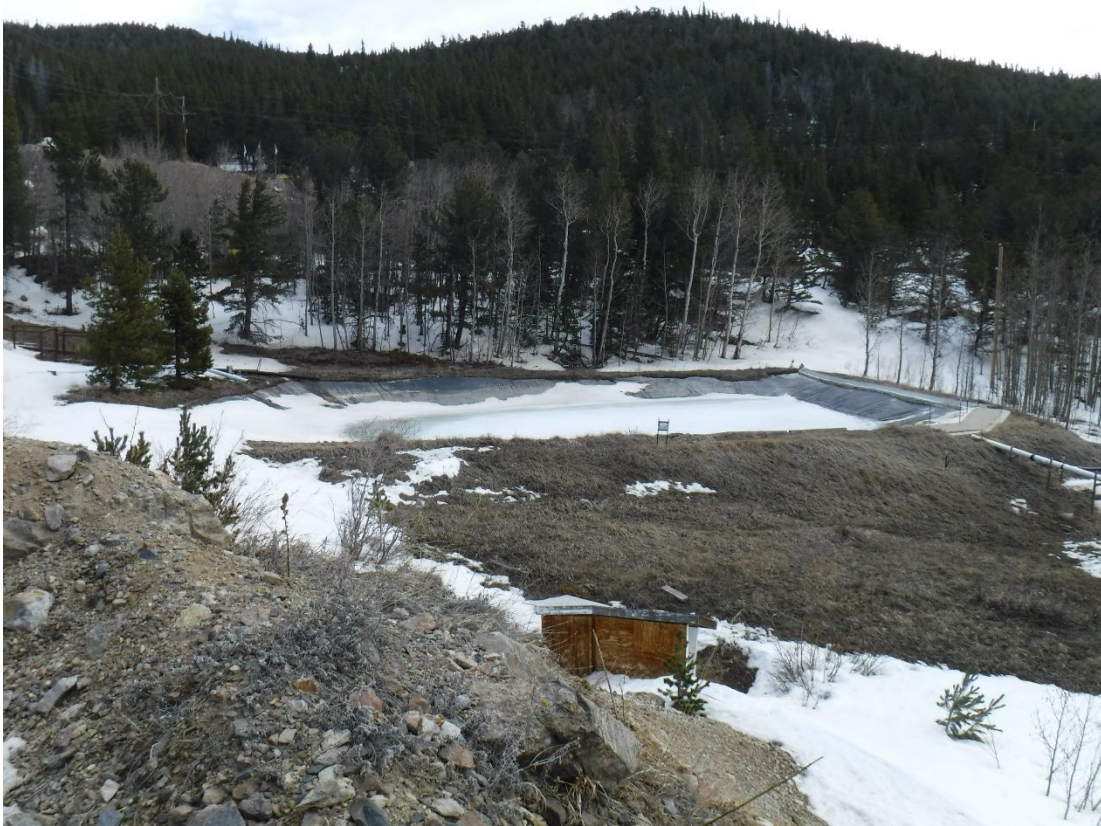
**Photo 7:** Pond 2.

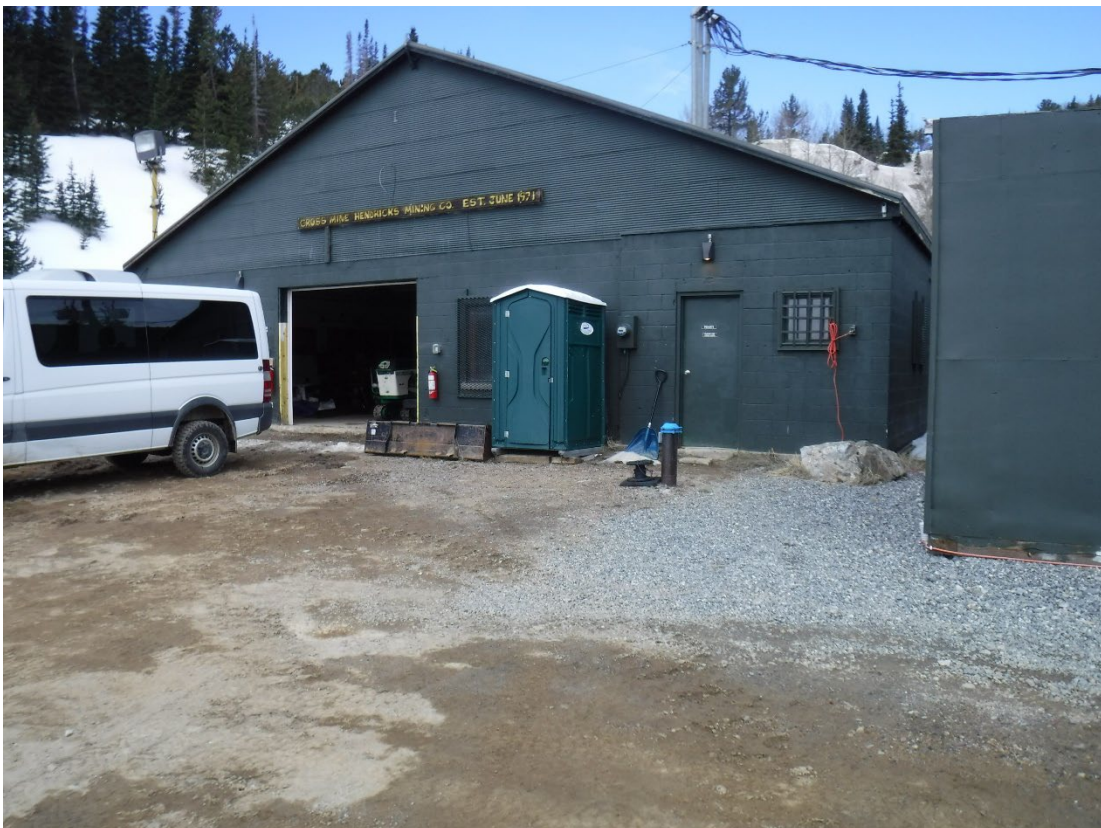
**Photo 8:** Cross Well
