Aerial inspection of Bowie #1

Permit Number: C-1981-038 Mine Name: Bowie No. 1 Mine Operator: Bowie Resources, LLC Operator Address: Mr. Art Etter P.O. Box 1488 Paonia, CO 81428	County: Delta Operation Type: Underground Permit Status: Active Ownership: Private Operator Representative Present:		
Operator Representative Signature: (Field Issuance Only)

INSPECTION INFORMATION

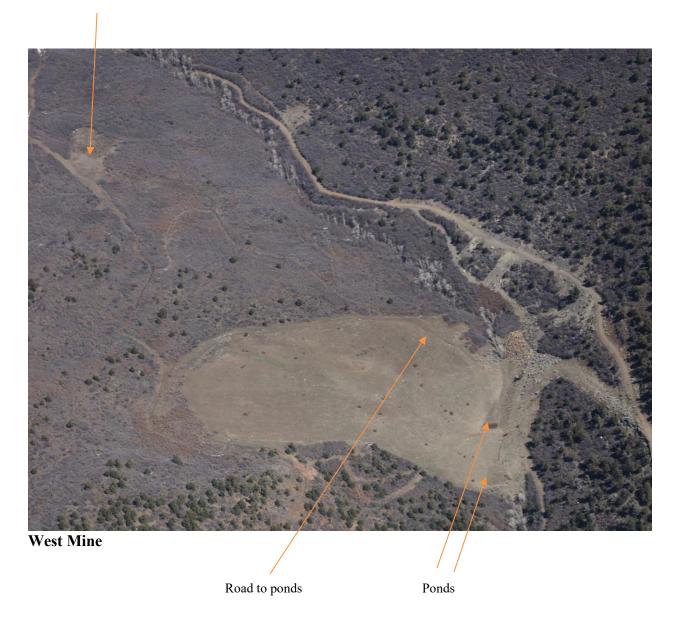
The West Mine was inspected, including the area near the creek, the road to the creek, and the West Mine Fan area. No erosion or other problems were identified.

Reclaimed West Mine Fan area
