## Bowie #2 report

**INSP-REPORTC\_C1996083\_RDZ\_04022025.pdf**

<b>Permit Number:</b> C-1996-083 <b>Mine Name:</b> Bowie No. 2 Mine <b>Operator:</b> Bowie Resources, LLC <b>Operator Address:</b> Mr. Art Etter P.O. Box 1488 Paonia, CO 81428	<b>County:</b> Delta <b>Operation Type:</b> Underground <b>Permit Status:</b> Active <b>Ownership:</b> Private
	<b>Operator Representative Present:</b>  None
<b>Operator Representative Signature: (Field Issuance Only)</b>

<b>Inspection Start Date:</b> March 26, 2025 <b>Inspection Start Time:</b> 12:00 <b>Inspection End Date:</b> March 26, 2025 <b>Inspection End Time:</b> 12:15	<b>Inspection Type:</b> Aerial Inspection <b>Inspection Reason:</b> Normal I&E Program <b>Weather:</b> Clear	
<b>Joint Inspection Agency:</b>  None	<b>Joint Inspection Contacts:</b>	
<b>Post Inspection Agency:</b>  None	<b>Post Inspection Contacts:</b>	
<b>Inspector(s):</b>  Robert Zuber, P.E.  Hunter Ridley	<b>Inspector's Signature:</b>

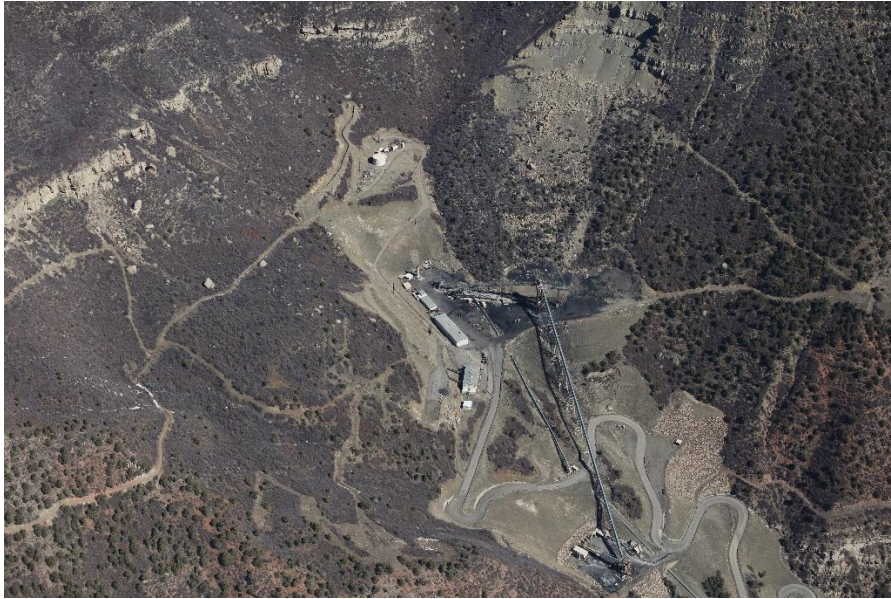
**Utility Bench and portal benches**

The slumps above the B Portal Bench, at Curve 11, and above the road to the Utility Bench have not worsened in recent months. Also, the large slide at Curve 11 appears to have stabilized.

No problems were identified with any facility areas, including the following: the Utility Bench, the D Portal Bench, the B Portal Bench, the Material Storage Area by TSS A, the Conveyor Corridor, the Coal Stockpile Pad, the office, the Preparation Plant area, the storage area and buildings near Pond D, the old power plant, the Pump House and Filter Building, the train loadout area, and the tracks near the train loadout.

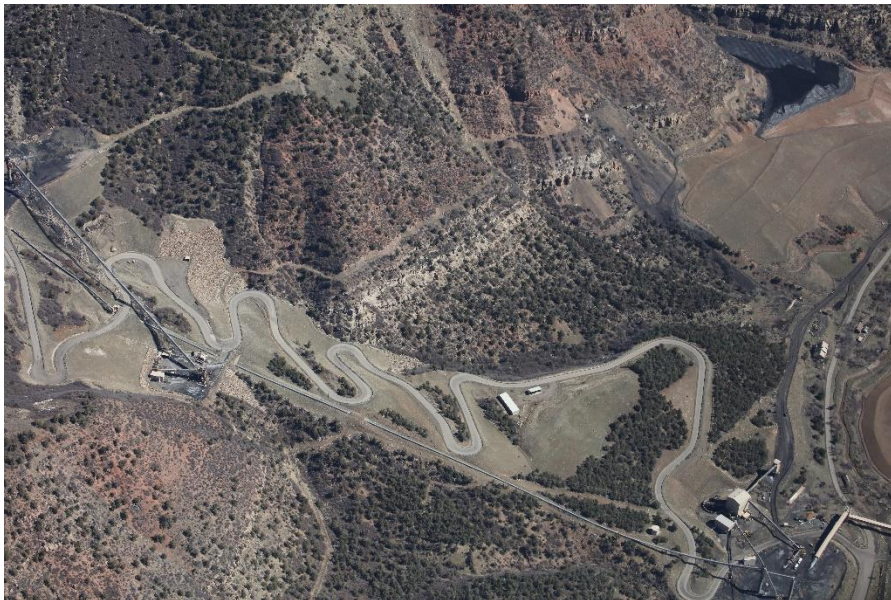
**Haul Road and Prep Plant**

No problems were seen with any haul roads or access roads.

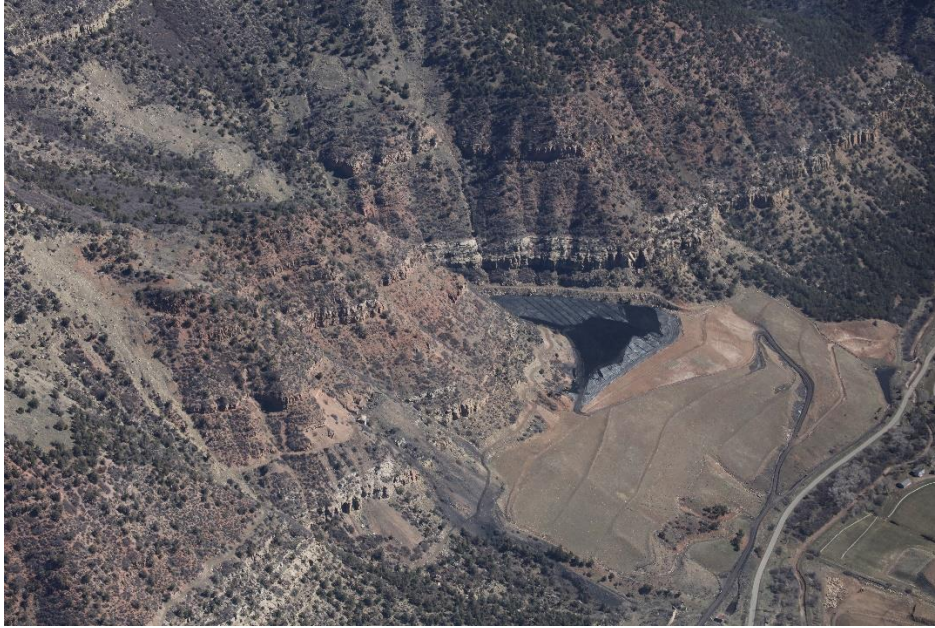
**Gob Piles 1, 2, and 4**

It appeared that BRL staff had been working on the upper portion of Gob Pile #2, prior to the inspection. This may have entailed the placement of material and grading. No erosion, areas with ponded water, or other problems were identified on any of the gob piles.

The repair of the blowout that occurred on Gob Pile #4 in the spring of 2023 appears stable.

Gob Pile #1, Gob Pile #4, and the reclaimed portion of Gob Pile #2 all appear to be in stable condition. In general, there is no erosion on the hillsides along the access road to the mine portals and Utility Bench, with exceptions noted in the Slides and Other Damage section of this report.

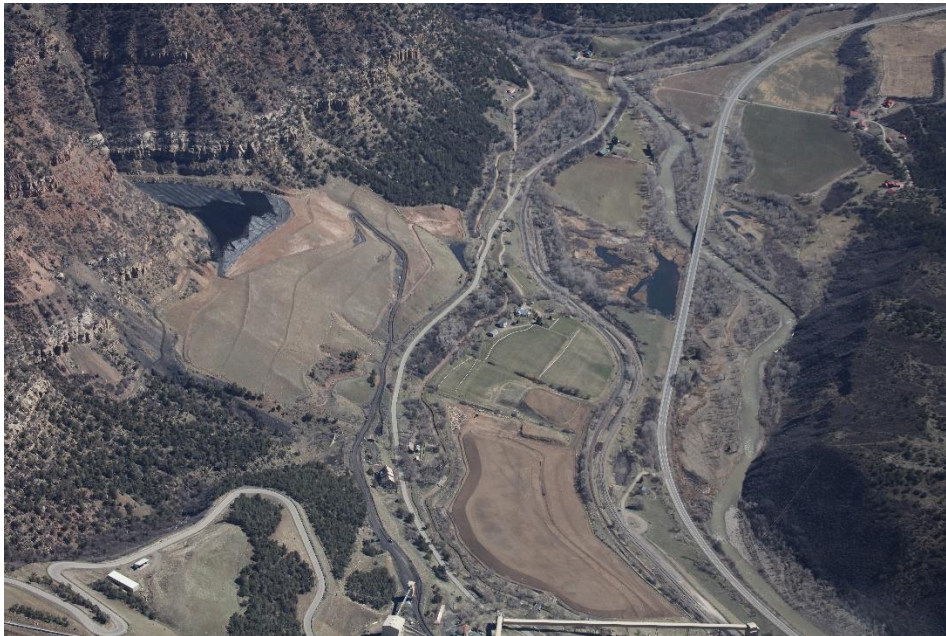
**Gob Pile 3 and river below the mine**

The photographs revealed no signs of pollutant loading from the mine into the North Fork of the Gunnison River or adjacent lands.

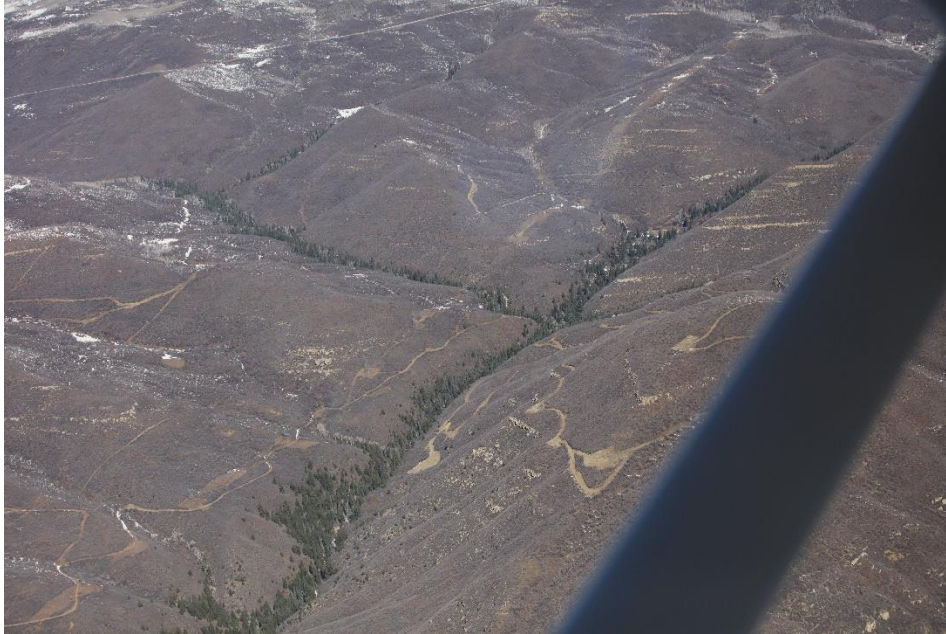
**Pads and roads near the Terror Creak Vent Shaft area**

No problems were identified with the Terror Creek Access Road or the associated pads. Several other pads and roads were inspected in Sections 7 and 8 (T13 South, R91 West), west of Terror Creek, and no problems were identified.
