Aerial Inspections 2025 March Sage Creek, Williams Fork

PERMIT INFORMATION

Permit Number: C2009087 Mine Name: Sage Creek

Inspection Start Date: 26 March 25 Inspection Type: Aerial Inspection

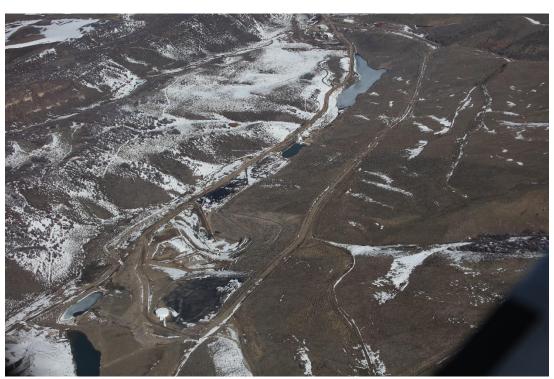
Photo 1: Overview of the north section of the site with Pond 003 in the foreground and Pond 002 in the distance.

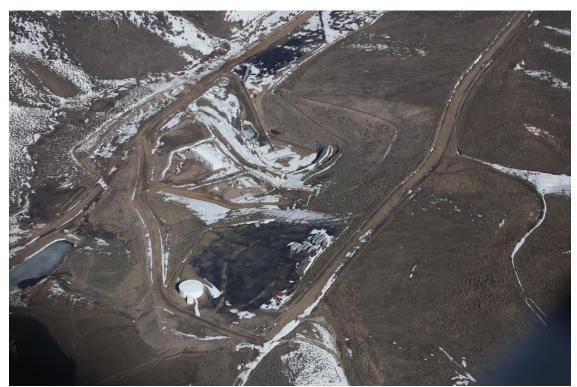
Photo 2: Facilities area comprised of the vehicle maintenance shop, a pad for equipment storage and the one million gallon water tank.

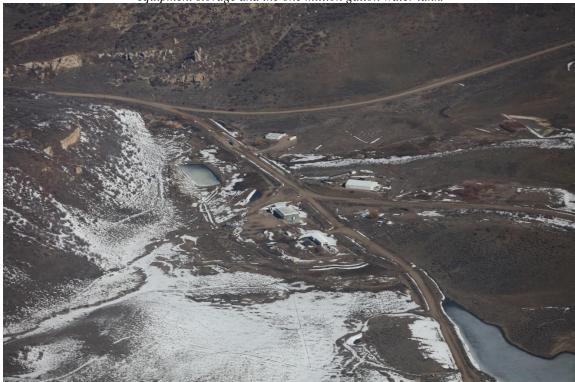
Photo 2: Facilities area looking west comprised of the vehicle maintenance shop, a pad for equipment storage and the million gallon water tank.

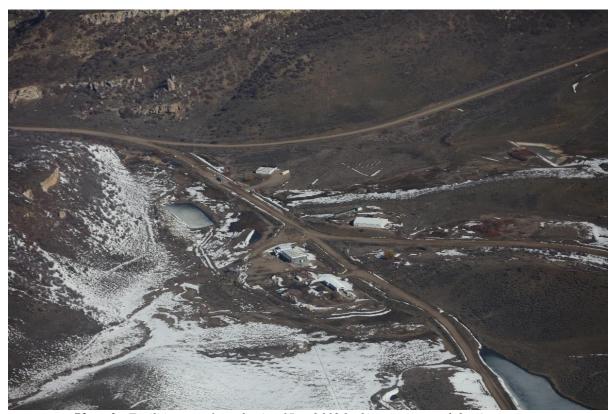
Photo 3: Facilities area from the tip of Pond 002 looking west toward the site entrance

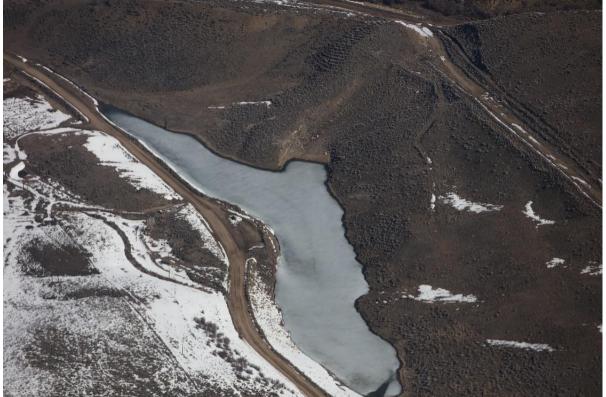
Photo 4: Pond 002, with ice cover.

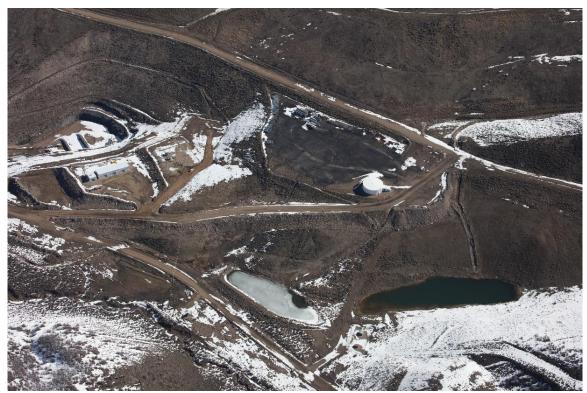
Photo 5: Portal area with facilities and Pecoco Pond, and Pond with ice cover.
