Partial Inspection March 2025

COLORADO
 Division of Reclamation,
 Mining and Safety
 Department of Natural Resources

11 March 2025

Permit Number: C1981010 Mine Name: Trapper Mine Operator: Trapper Mining, Inc. Operator Address: Mr. Graham Roberts P.O. Box 187 Craig, CO 81626	County: Moffat Operation Type: Surface Permit Status: Active Ownership: Federal
	Operator Representative Present: Graham Roberts
This report was issued electronically from the Divisions' Denver Office.

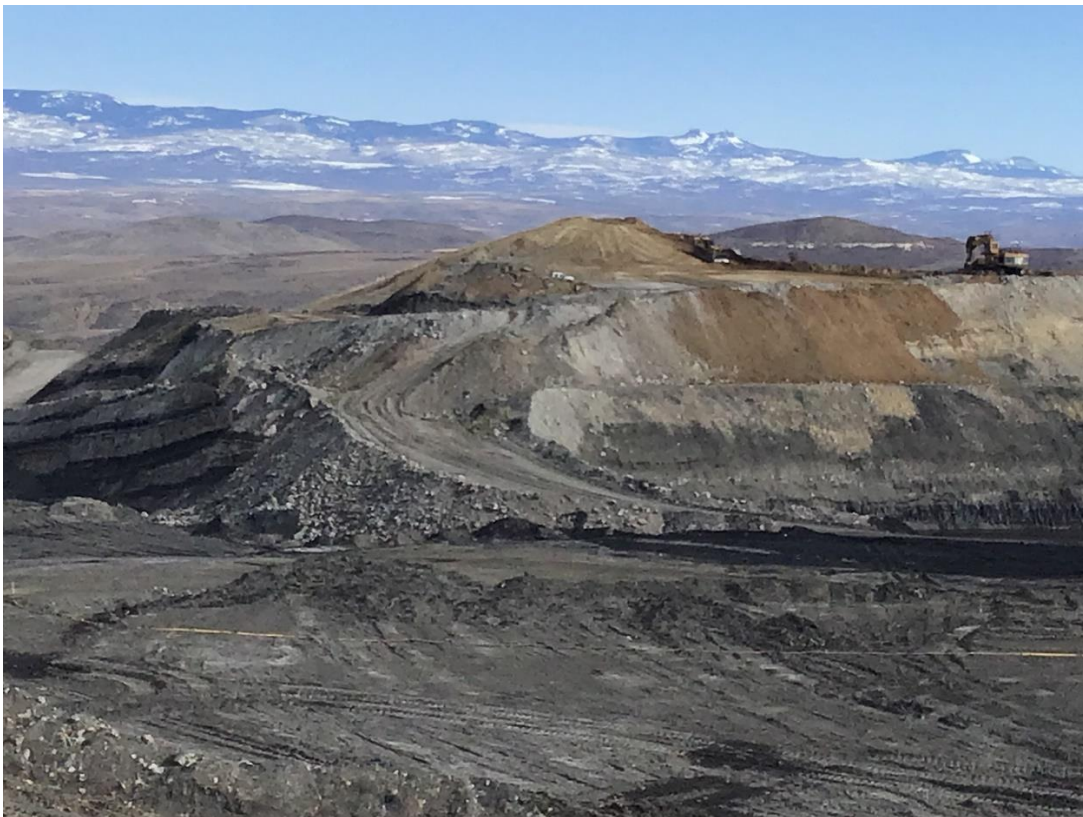
Photo 1: View of L Pit K Knob looking east.

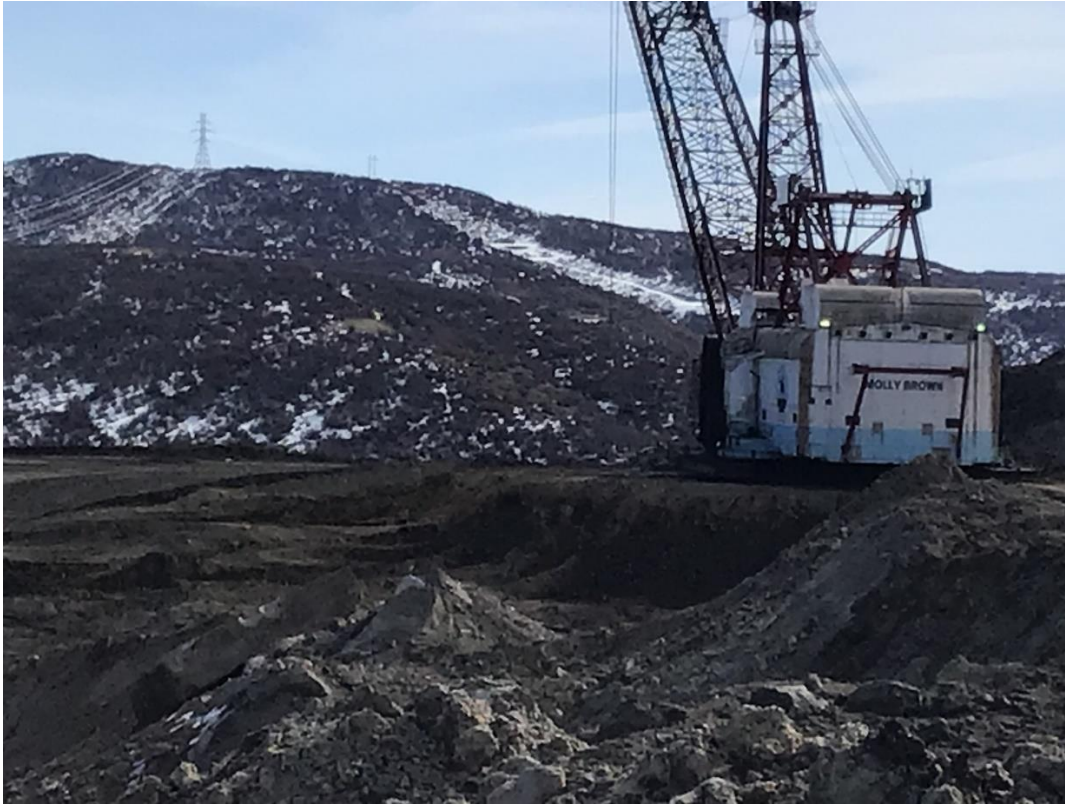
L Pit: The Baby Doe was idle in north end of the pit and Molly Brown at the south end of the pit. Mining is occurring in the K and L seams.

Photo 2: Dragline activities at the south end of L Pit.

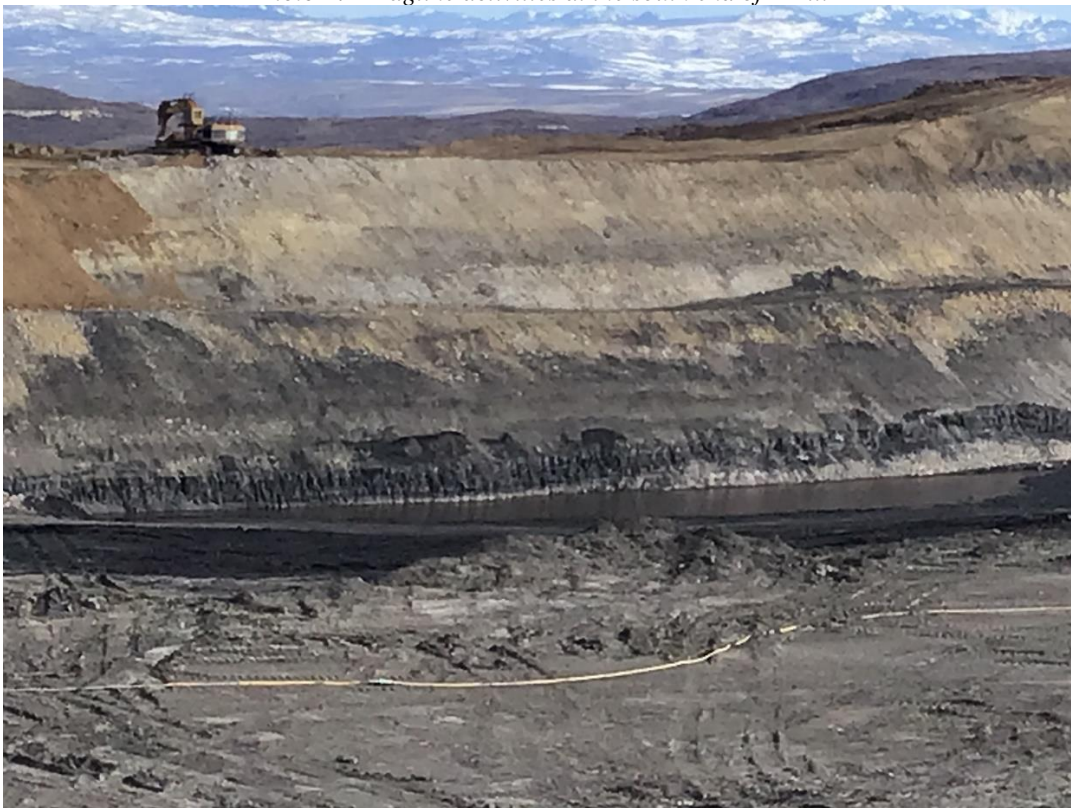
Photo 3: L Pit looking east. Water lying against the highwall.

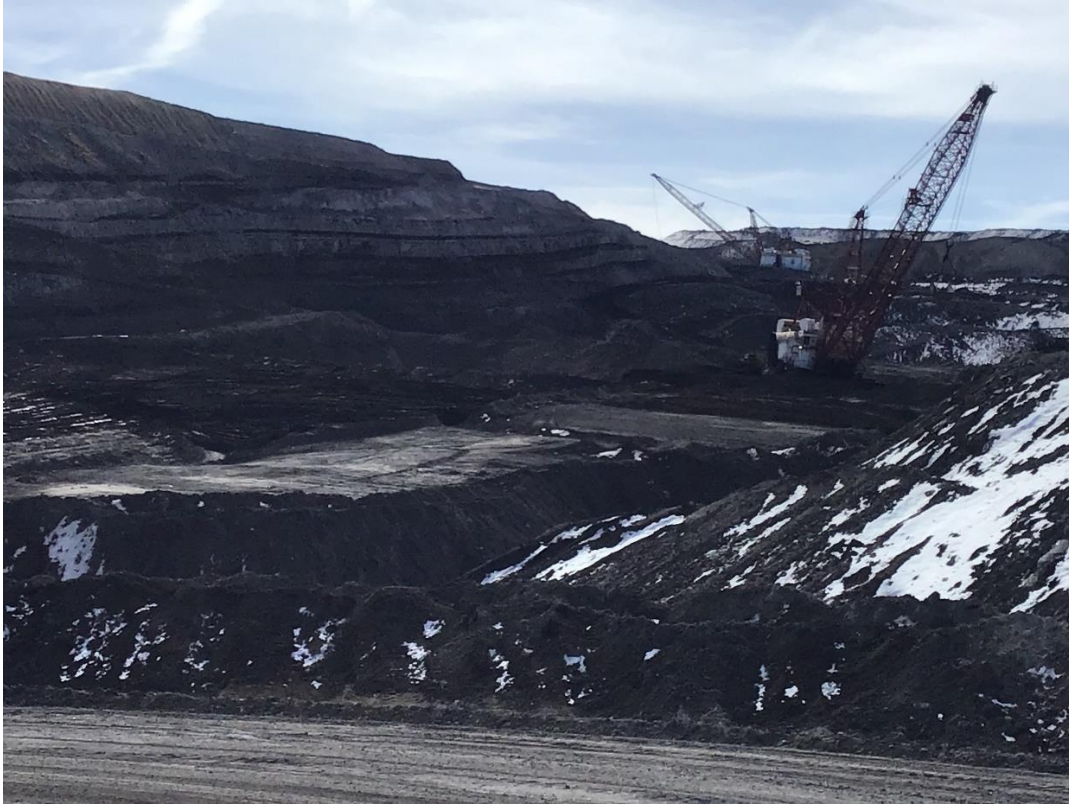
Photo 4: L Pit looking up to the south.

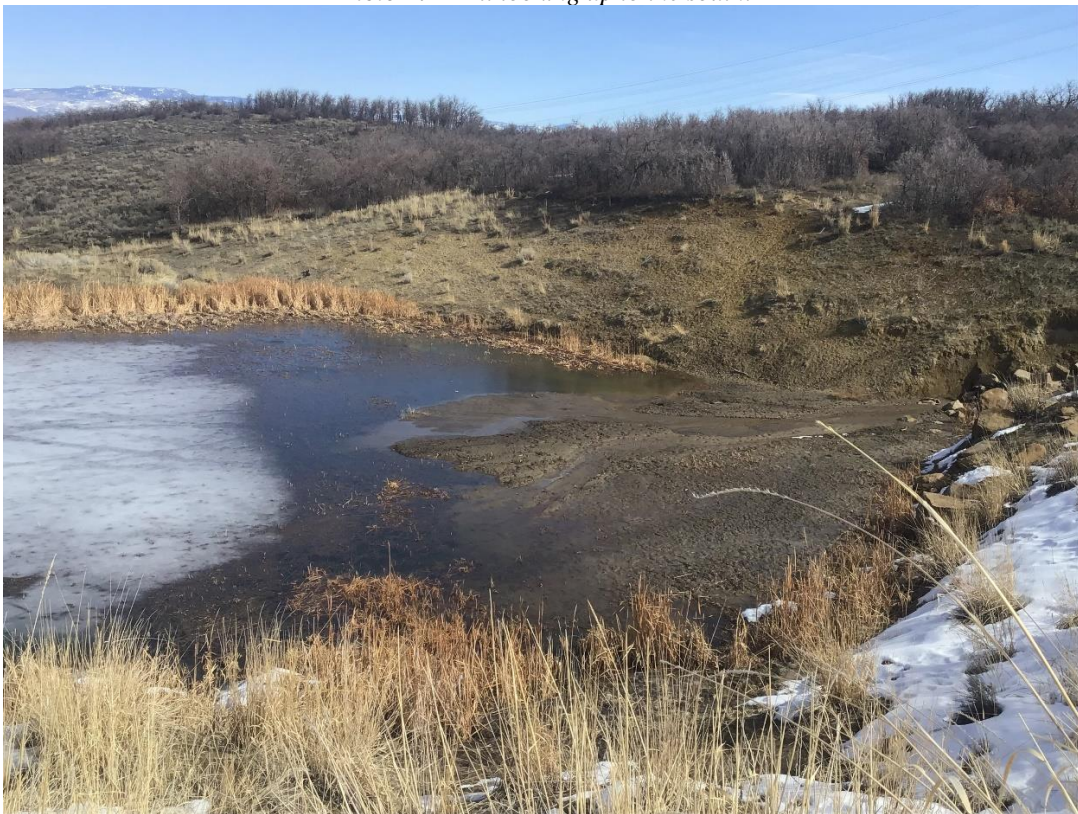
- East Middle Flume #1 is ice covered and beginning to melt out. No apparent discharge. The pond is on the on list to dredge in 2025. The inlet is being eroded by clear pit water that is pumped at head of inlet.
- Middle Flume #1 holding water and ice covered.
- East Pyeatt#1, #2, #3 Full and ice covered at the time of inspection.
- Middle Pyeatt #1 has a delta at the inlet.
- No Name #4 and #5 holding water and iced over.
- No Name #2 shows significant sedimentation and will be dredged this summer.

Photo 5: Inlet sediment fan in East Middle Flume #1 Pond.

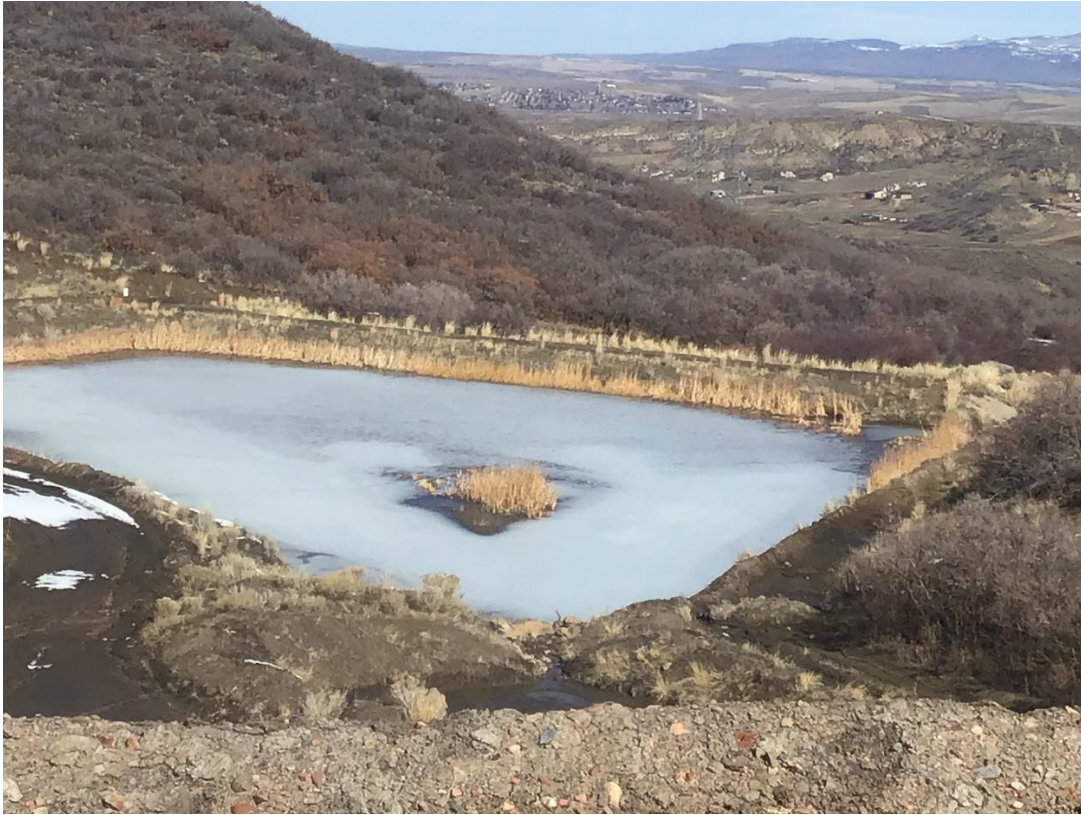
Photo 6: Ice covered Middle Flume #1 Pond.

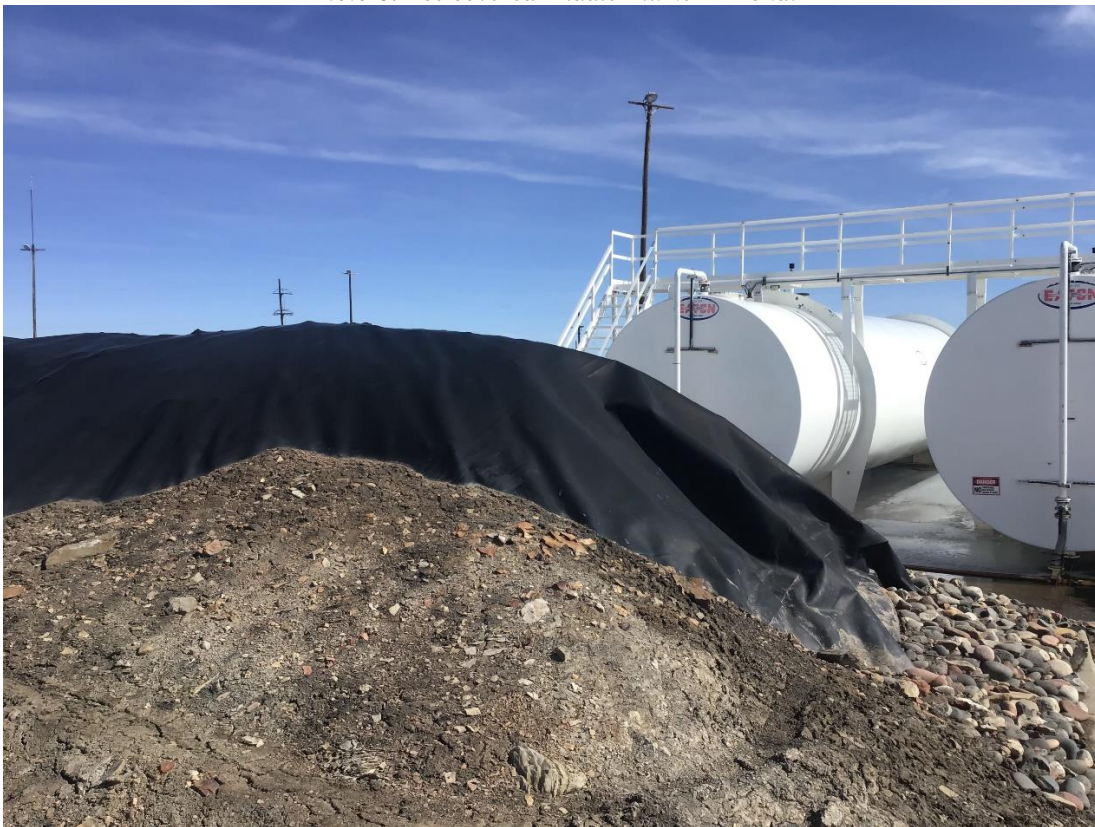
Photo 7: Three 50,000 gallon diesel fuel tanks showing lined containment berm.

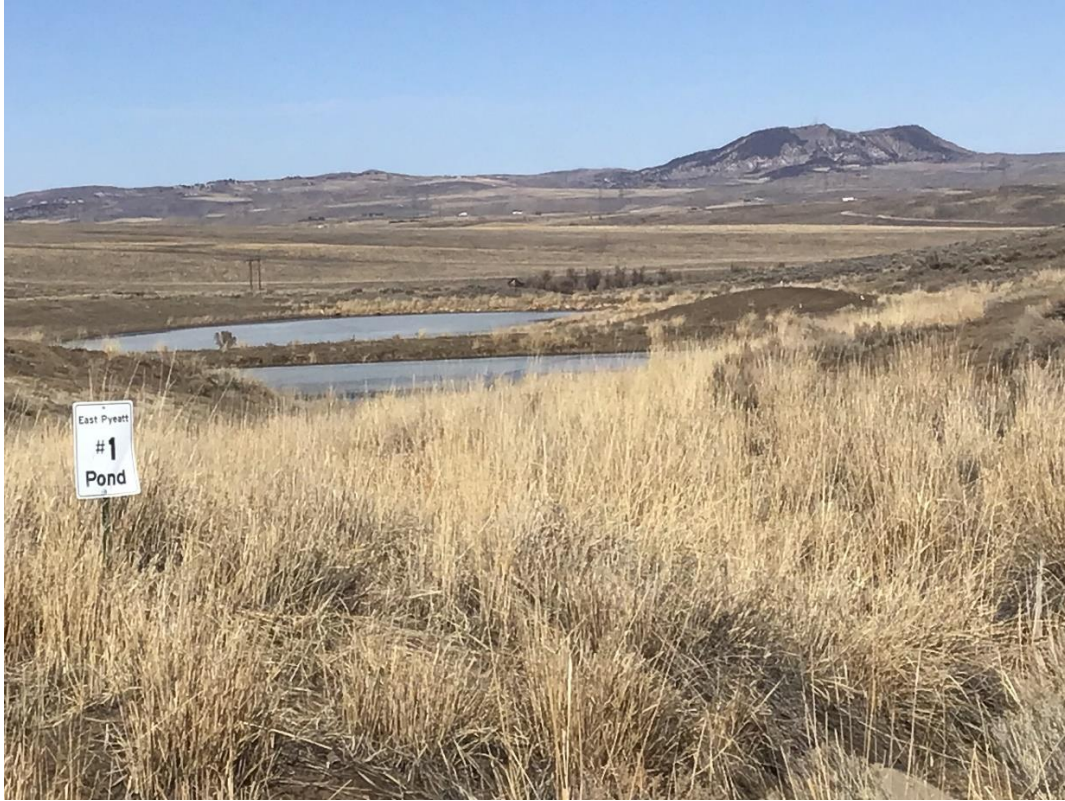
Photo8: Looking north to the East Pyeatt Ponds #2 and #3.

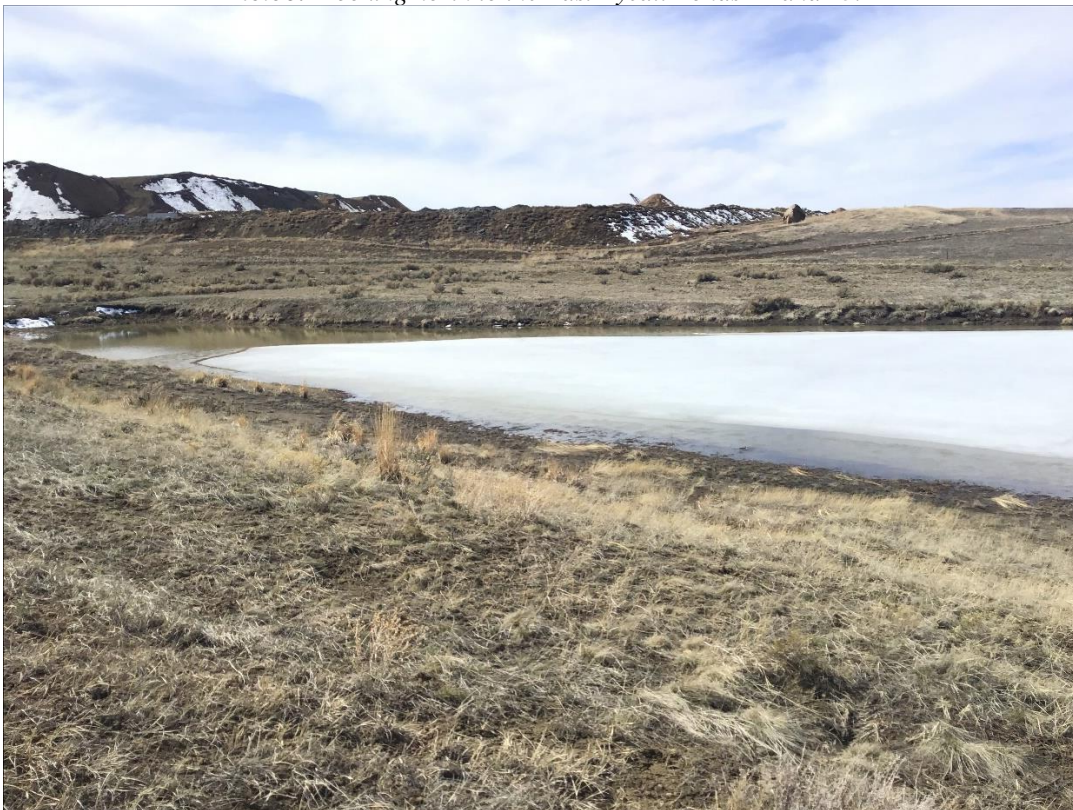
Photo 9: Looking southeast along East Pyeatt Pond #1.

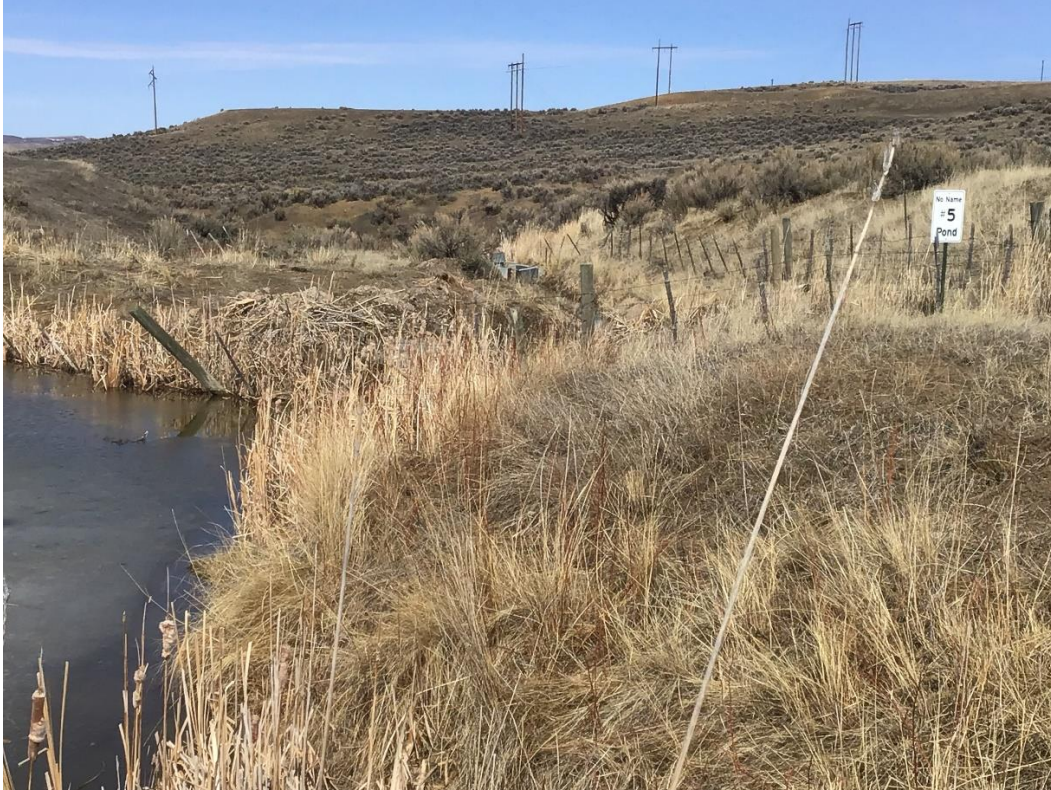
Photo 10: Looking north at No Name Pond #5 discharge flume, that was carrying water.

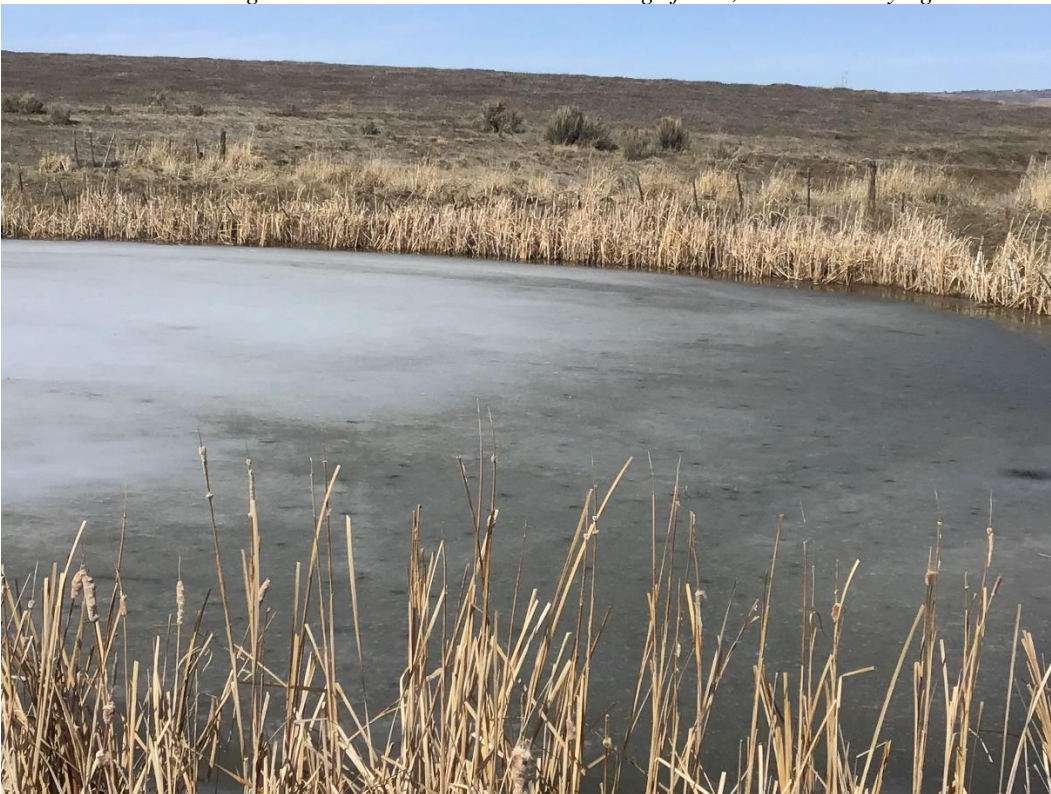
Photo 11: No Name Pond #5 looking west. Ice is beginning to melt out.

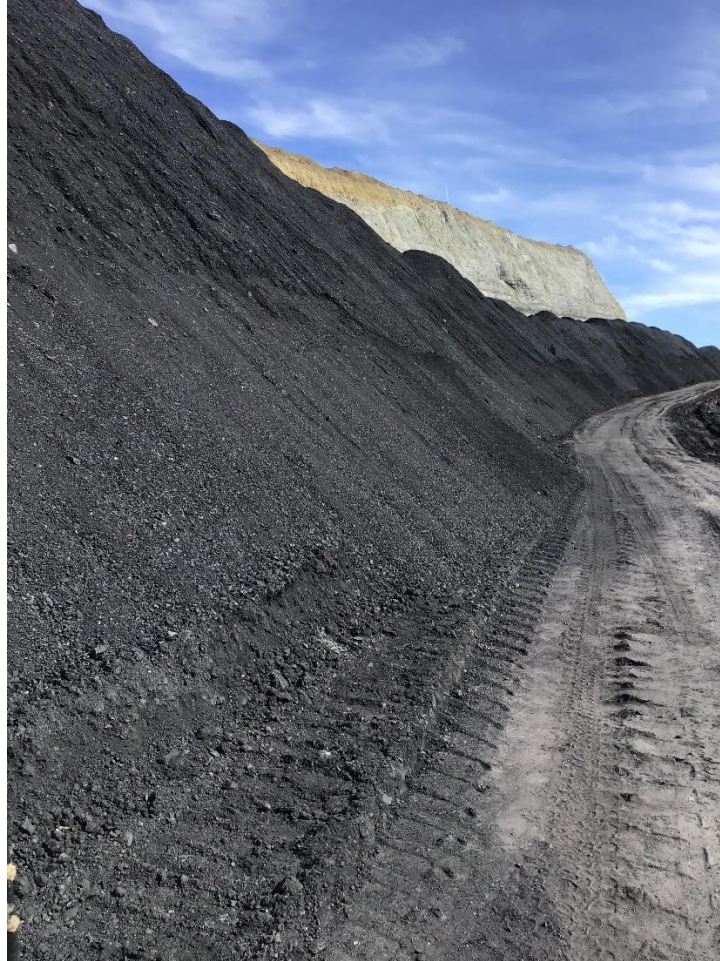
Photo 12: N Pit coal pile along north highwall, looking east.
