**MINERALS PROGRAM INSPECTION REPORT**  
**PHONE: (303) 866-3567**

| <b>MINE NAME:</b><br>Burton Pit | <b>MINE/PROSPECTING ID#:</b><br>M-1987-013 | <b>MINERAL:</b><br>Sand and gravel | <b>COUNTY:</b><br>Rio Grande |
| <b>INSPECTION TYPE:</b><br>Monitoring | <b>WEATHER:</b> Clear | <b>INSP. DATE:</b><br>March 25, 2025 | <b>INSP. TIME:</b><br>14:00 |

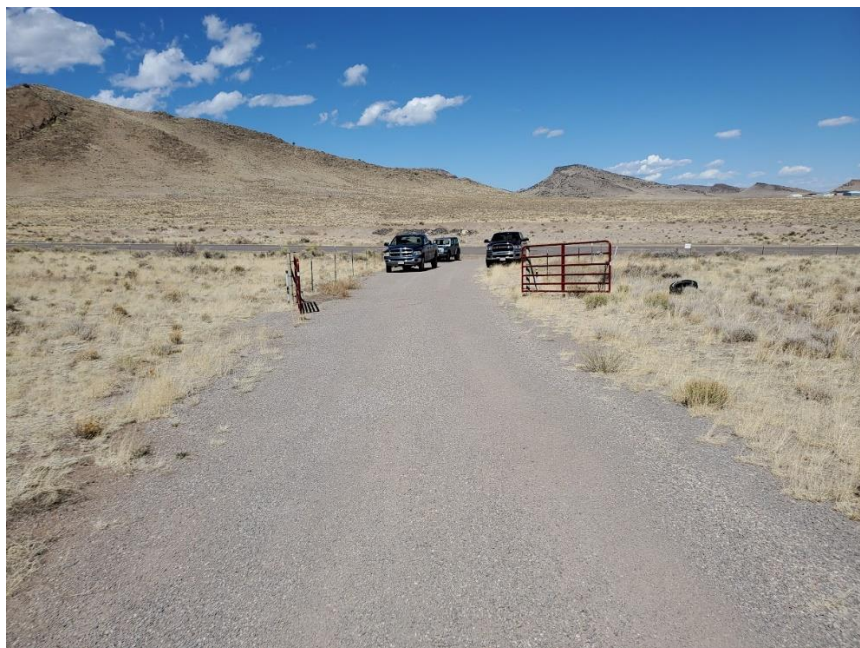
The access road is in good condition and will remain post reclamation for the landowner. No signs of excessive erosion or displacement were noted along the road during the inspection.

Photo 1: View to the north of the gate at the pit entrance on Burton Property. Road will remain post reclamation.

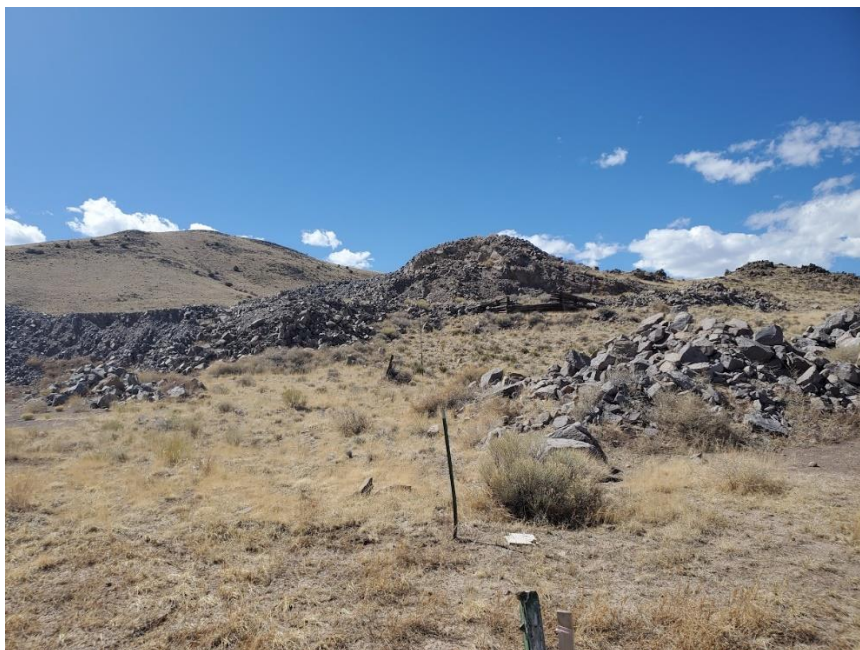
Permit boundaries and property lines are marked by fence lines and posts. No sign was present, but this will be addressed during the SO process with the new permit holder.

Photo 2: View to the west of property markers between Burton property (left of fence) and canal company property (right of fence)

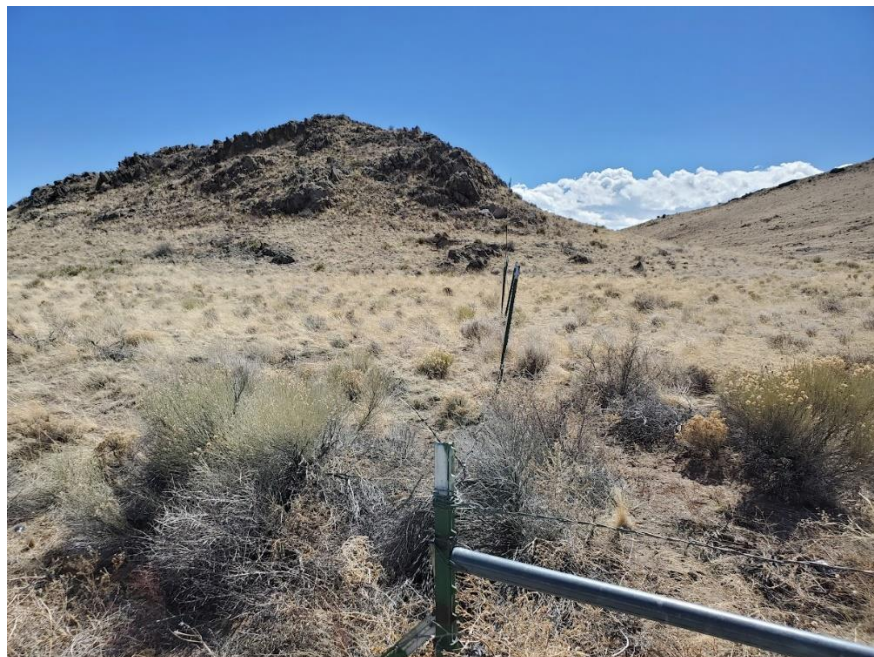
Photo 3: View to the south of undisturbed ground on north end of Burton property.  
Fence line is property line.

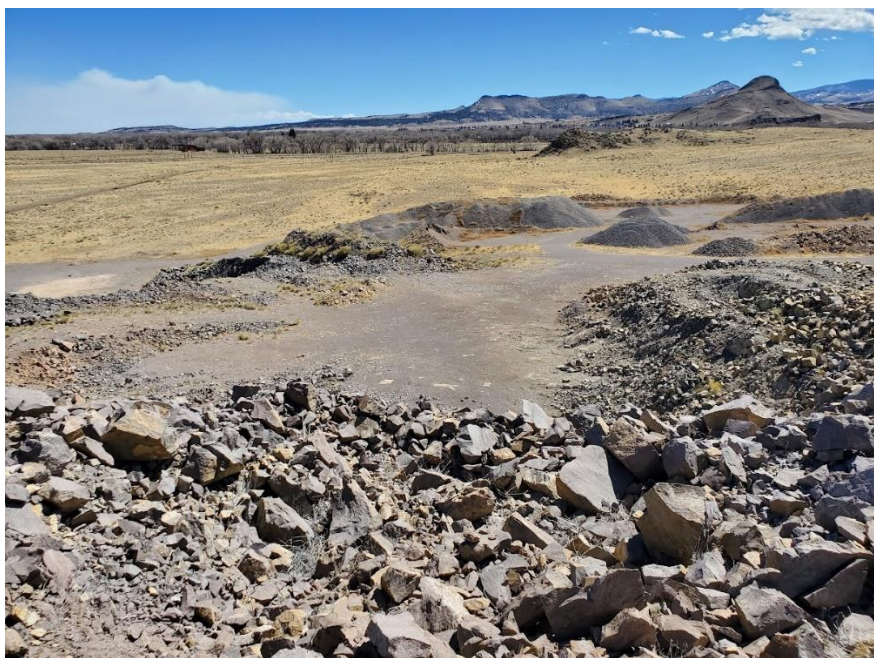
Southway Construction Company LLC has lost right of entry to the site from the land owners. As a result, the section of the permit area that are on the Burton property will be released and the remaining acreage will be transferred to the canal company. Mining has been conducted according to Slopes of the pit generally appear stable with minor erosional rills in the southwest corner of the pit.

Photo 4: View to the south of mining area on Burton property.

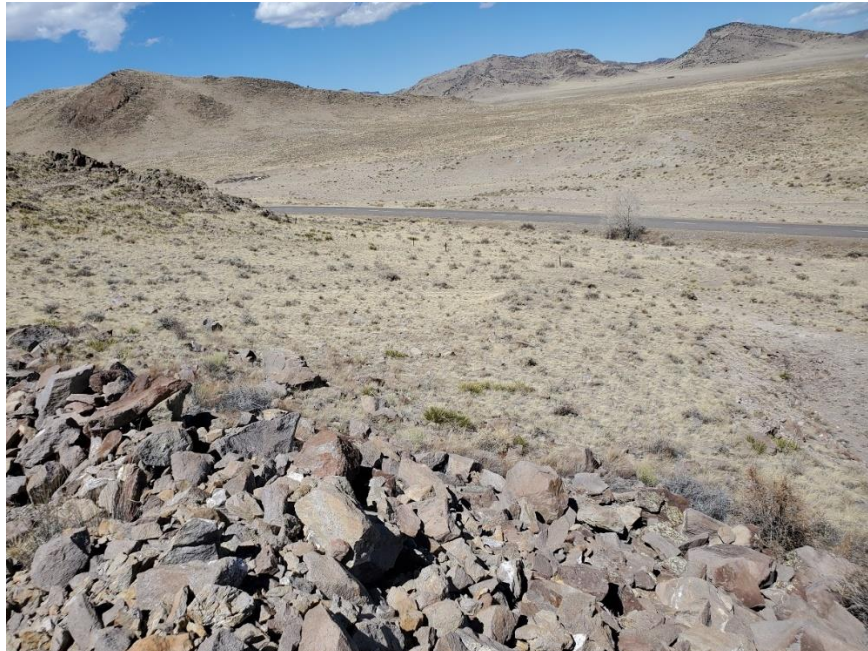
Photo 5: View to the north of the permit area on canal company property.

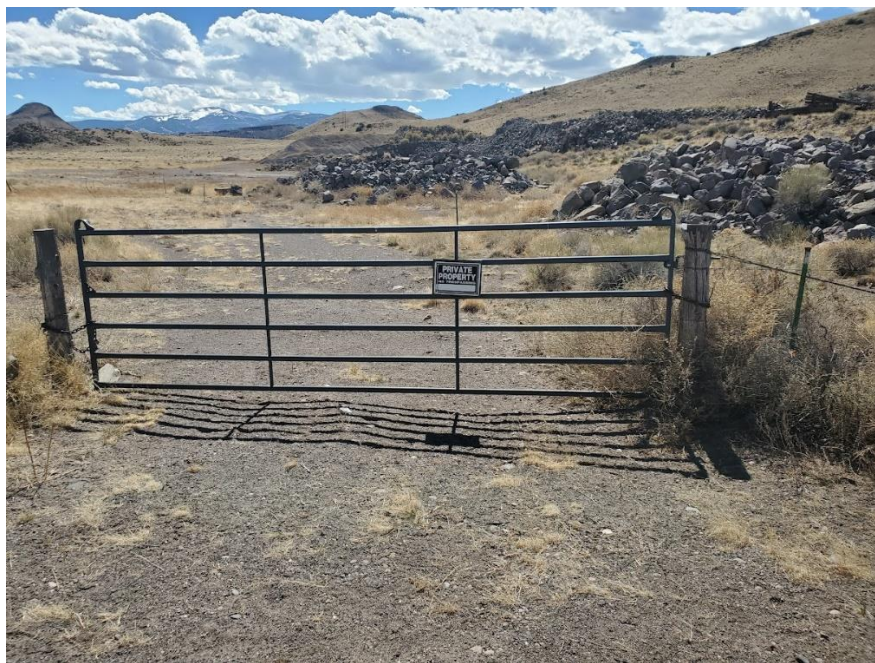
Photo 6: View to the south of gate to access the portion of the permit on the canal company property. Process area can be seen in the background.
