Inspection Report, March 26, 2025

MINERALS PROGRAM INSPECTION REPORT
PHONE: (303) 866-3567

MINE NAME: Cresson Project	MINE/PROSPECTING ID#: M-1980-244	MINERAL: Gold and silver	COUNTY: Teller
INSPECTION TYPE: Multi Person Inspection	WEATHER: Clear	INSP. DATE: March 26, 2025	INSP. TIME: 09:33
OPERATOR: Cripple Creek & Victor Gold Mining Company	OPERATOR REPRESENTATIVE: Brian Doering, Paulina Barela	TYPE OF OPERATION: 112d-3 - Designated Mining Operation	
REASON FOR INSPECTION: Normal I&E Program	BOND CALCULATION TYPE:	BOND AMOUNT: \$109,667,792.00	
DATE OF COMPLAINT: NA	POST INSP. CONTACTS: None	JOINT INSP. AGENCY: None	
INSPECTOR(S): Lucas West	INSPECTOR'S SIGNATURE:

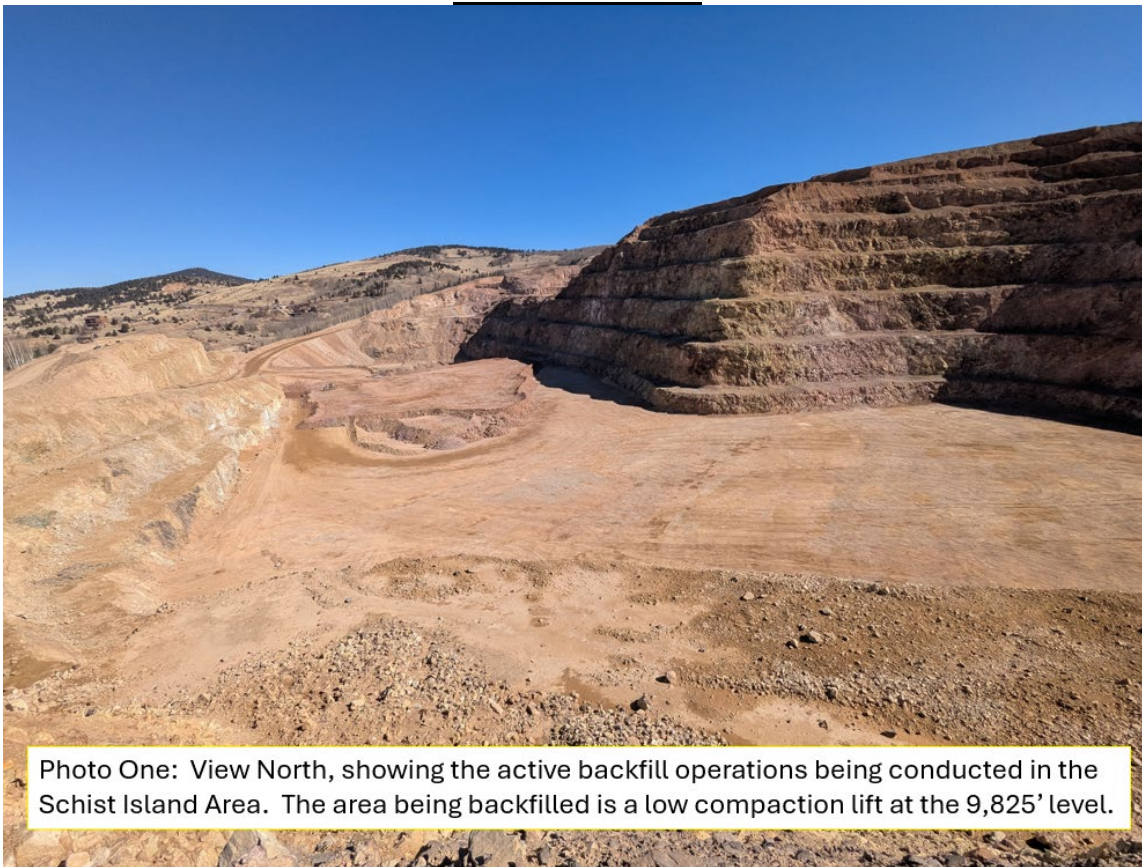
During this inspection the Shist Island Backfill was observed from multiple vantage points. Material was actively being deposited in the 9,825' low Compaction Area at the time of the inspection. Photo One shows an overview of the backfill area as seen from the overlook. On the face of the lift, as seen in Photo Two, both the lift height and material size appear to be consistent with the design specifications. The face of the lift was well compacted and no evidence of settling or slumping was observed. The rollover protection berm around the perimeter of the area was in good condition and the outslopes appeared stable at the time. An example of the outslopes can be seen in Photo Three. Most of the material being placed in the backfill area at the time of the inspection was being generated from exposing the liner near the 10,200' level. Additionally, on March 25, 2025 the Schist Island Phase 2 Backfill Weekly Report was submitted to the Division as required. The observed conditions of the backfill area appeared to be consistent with the findings of the report and no issues were identified.

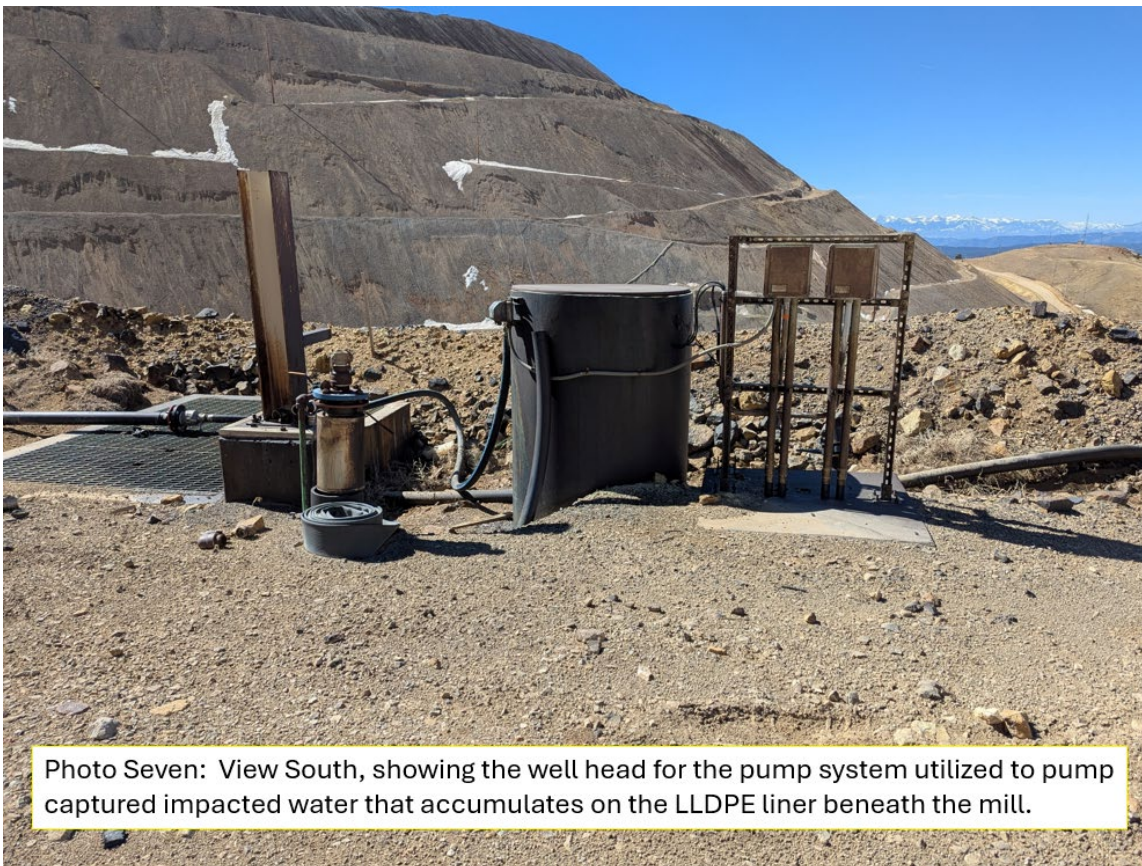
Photo Seven: View South, showing the well head for the pump system utilized to pump captured impacted water that accumulates on the LLDPE liner beneath the mill.

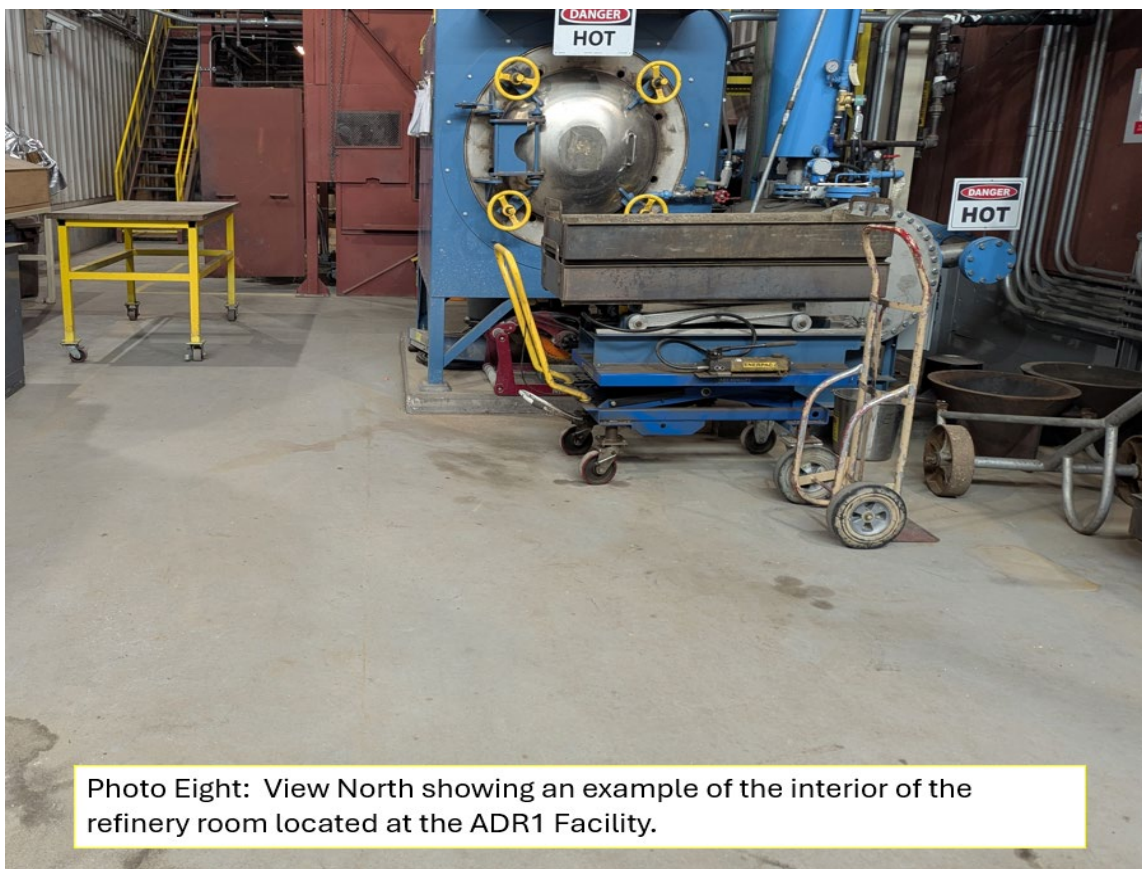
Photo Eight: View North showing an example of the interior of the refinery room located at the ADR1 Facility.
