## March inspection reports

<b>Permit Number:</b> C-1992-081 <b>Mine Name:</b> Hayden Gulch Loadout <b>Operator:</b> Hayden Gulch Terminal, LLC <b>Operator Address:</b> Ms. Miranda Kawcak 29515 Routt County Road 27 Oak Creek, CO 80467	<b>County:</b> Routt <b>Operation Type:</b> Loadout <b>Permit Status:</b> Active <b>Ownership:</b> Private
	<b>Operator Representative Present:</b>  N/a
<b>Operator Representative Signature: (Field Issuance Only)</b>

<b>Inspection Start Date:</b> March 25, 2025 <b>Inspection Start Time:</b> 15:00 <b>Inspection End Date:</b> March 25, 2025 <b>Inspection End Time:</b> 16:00		<b>Inspection Type:</b> Coal Partial Inspection <b>Inspection Reason:</b> Normal I&E Program <b>Weather:</b> Clear	
<b>Joint Inspection Agency:</b>  None		<b>Joint Inspection Contacts:</b>  	
<b>Post Inspection Agency:</b>  None		<b>Post Inspection Contacts:</b>  	
<b>Inspector(s):</b>  Brock Bowles	<b>Inspector's Signature:</b>

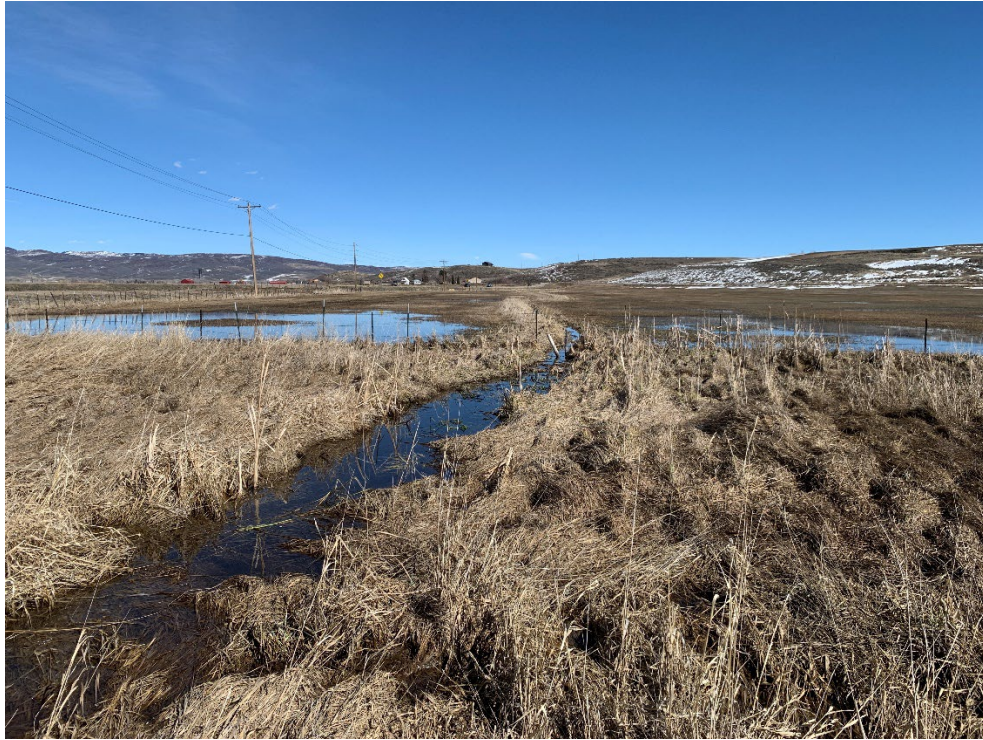
Water was flowing in the ditches from east to west across the reclamation on the south side of Hwy 40 (photo 1). The ditch on the north side of Hwy 40 was dry (photo 2). The ditch along the railroad main-line contained water.

Photo 1- Ditches flowing across the reclamation south of Hwy 40.

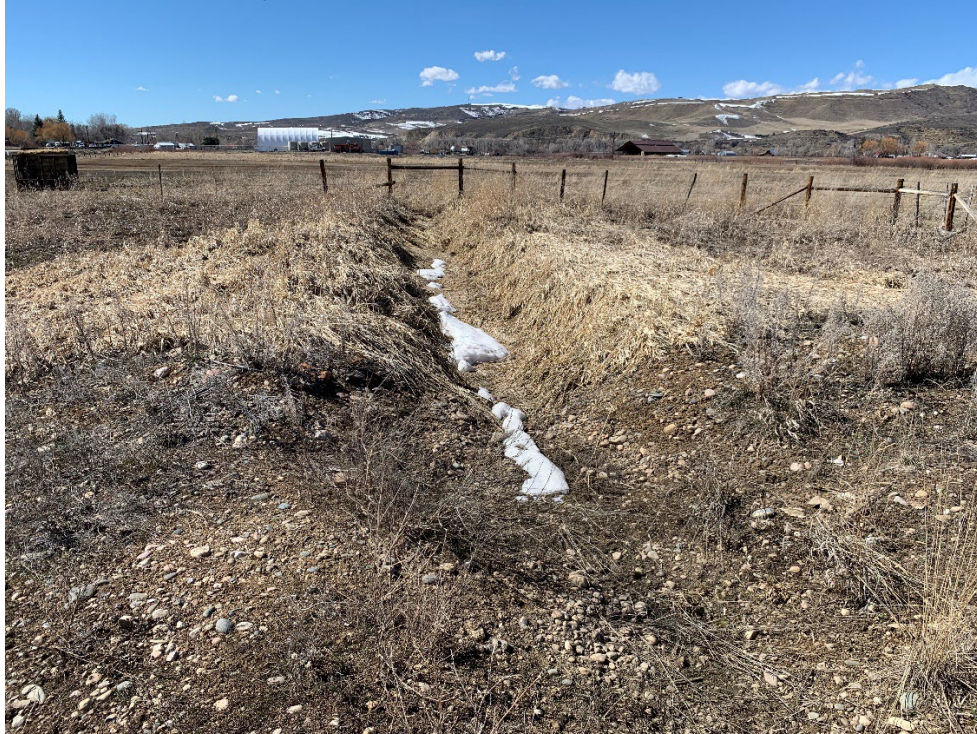
Photo 2- Ditch on north side of Hwy 40 is dry.

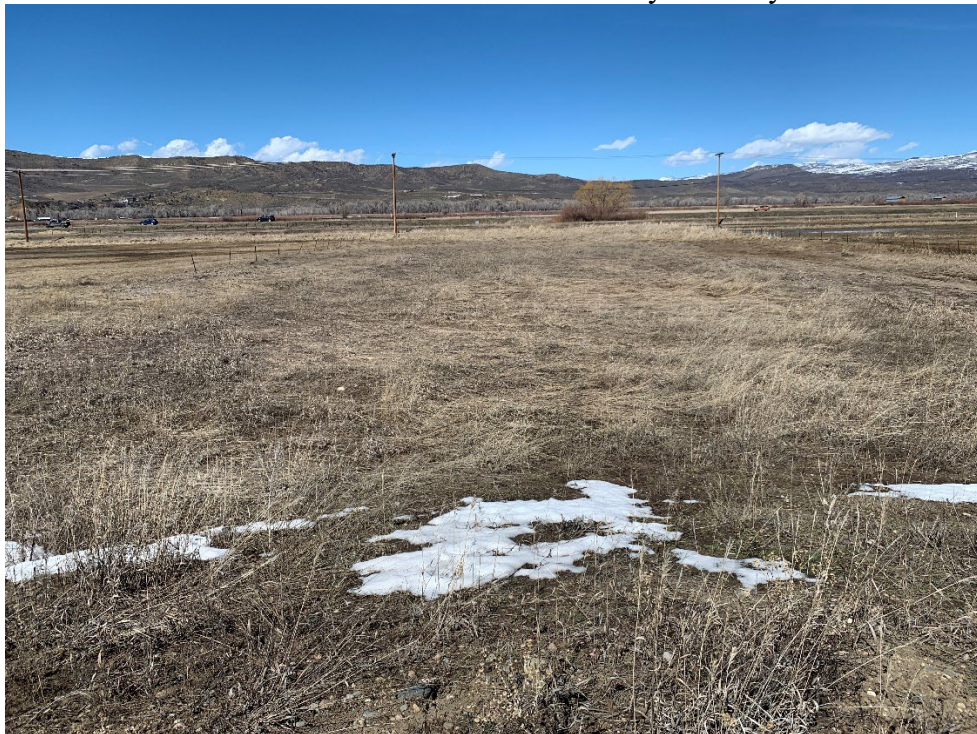
The snow had melted from most of the site except on the small slope leading up to the trailhead parking lot (photo 3).

Photo 3- Reclaimed area facing north from trail head parking lot
