March inspection reports

Permit Number: C-1982-056 Mine Name: Foidel Creek Mine Operator: Twentymile Coal, LLC Operator Address: Ms. Miranda Kawcak 29515 Routt County Road No. 27 Oak Creek, CO 80467	County: Routt Operation Type: Underground Permit Status: Active Ownership: Private
	Operator Representative Present: Miranda Kawcak
Operator Representative Signature: (Field Issuance Only)

Inspection Start Date: March 25, 2025 Inspection Start Time: 08:00 Inspection End Date: March 25, 2025 Inspection End Time: 14:00		Inspection Type: Coal Partial Inspection Inspection Reason: Normal I&E Program Weather: Clear	
Joint Inspection Agency: None		Joint Inspection Contacts: 	
Post Inspection Agency: None		Post Inspection Contacts: 	
Inspector(s): Brock Bowles	Inspector's Signature:

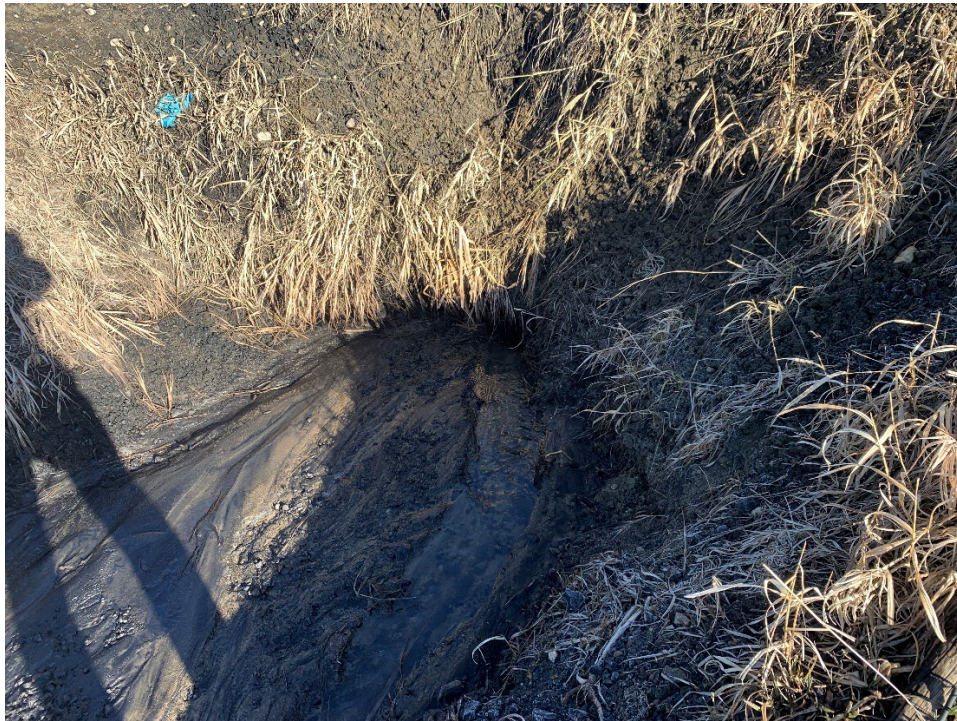
The sump above the B-ponds is nearly full and needs to be cleaned. The culvert between the sump and B-pond needs to be cleaned (photo 1). Water was discharging from the B-ponds.

Photo 1- Culvert from the B-pond sump to the first stage of B-pond

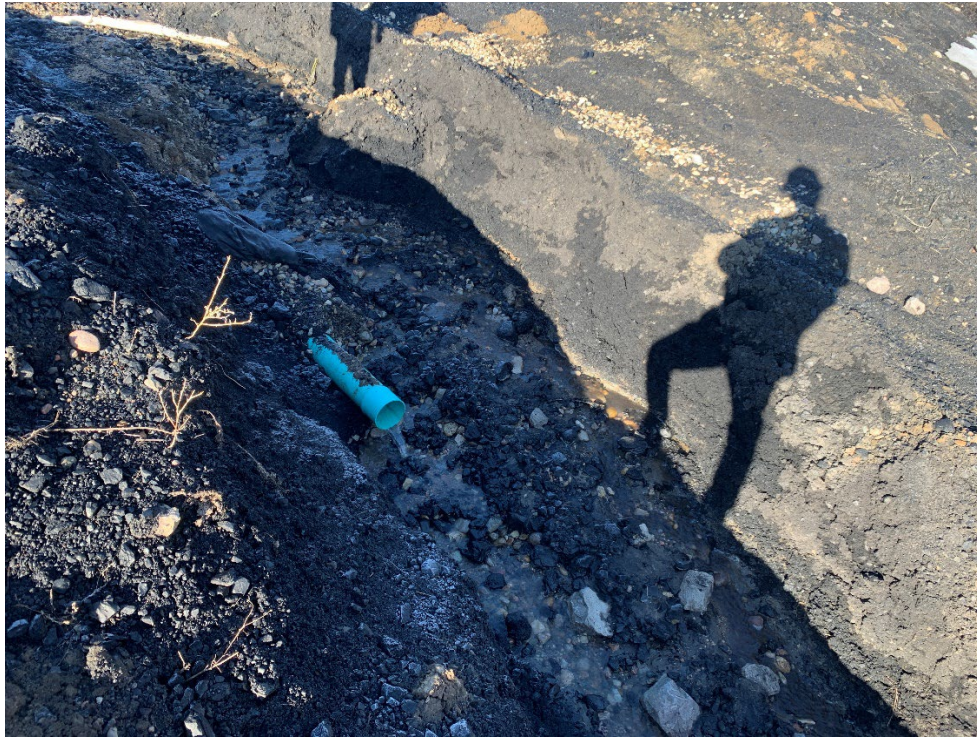
Water was discharging from the belt-out-back stockpile underdrain into the B-pond sump (photo 2). The underdrain was replaced the previous summer and appears to be working as designed.

Photo 2- Belt-out-back underdrain discharge

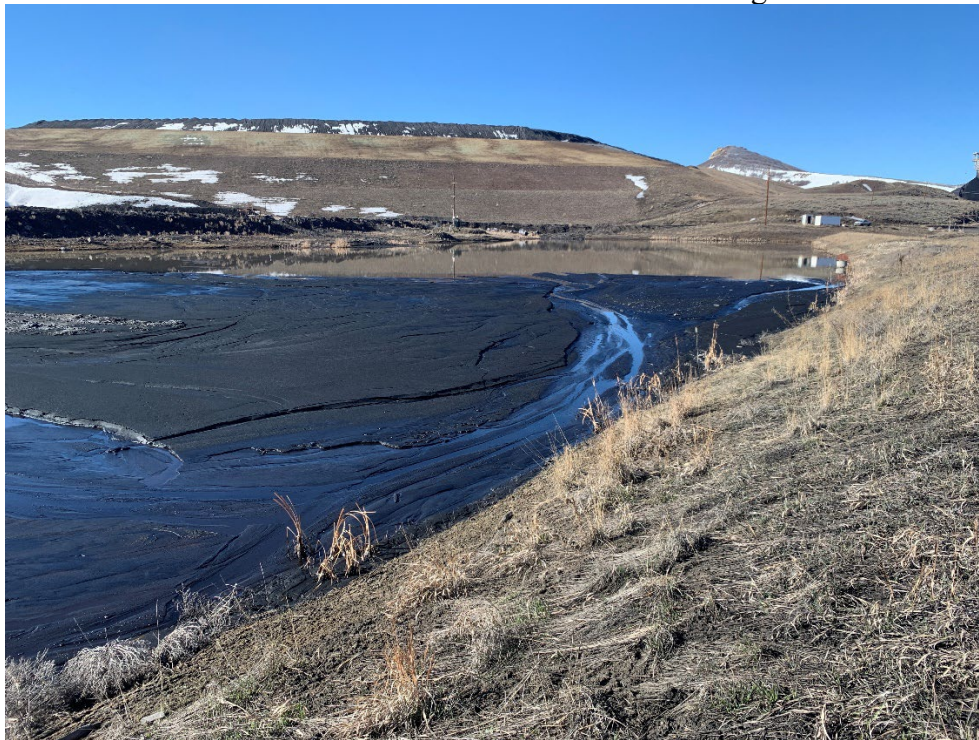
The D-pond primary and emergency spillways were clear of obstructions. The east side of D-pond contains a large amount of sediment and should be cleaned soon (photo 3).

Photo-3 Sediment build up in D-pond

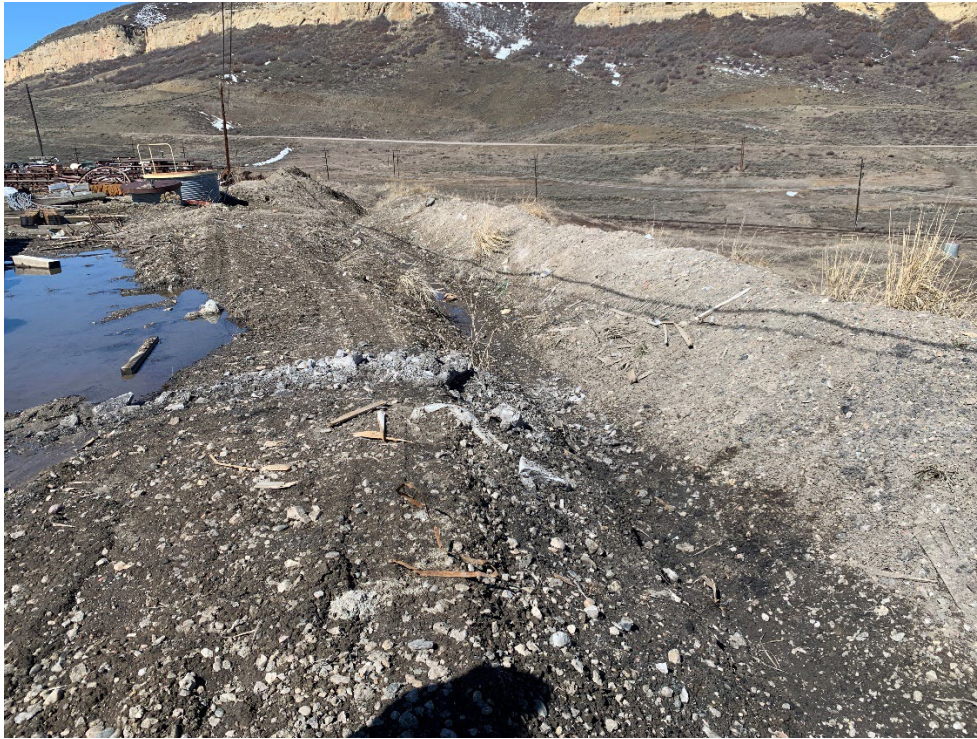
The E-pond contained water and was discharging. The primary and emergency spillways were free and clear of obstructions. Ditch E-1 behind the warehouse was clear of obstructions (photo 4).

Photo -4 Ditch E-1 behind the warehouse is free of obstructions

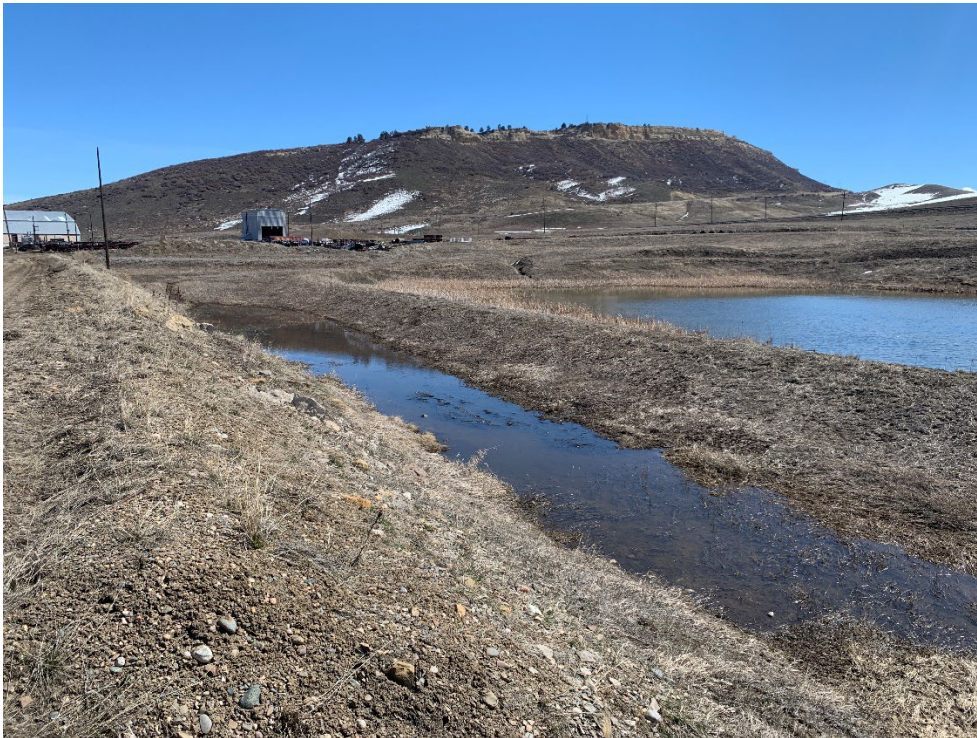
Pond F contained water and was discharging (photo 5).

Photo 5- Pond F, facing east

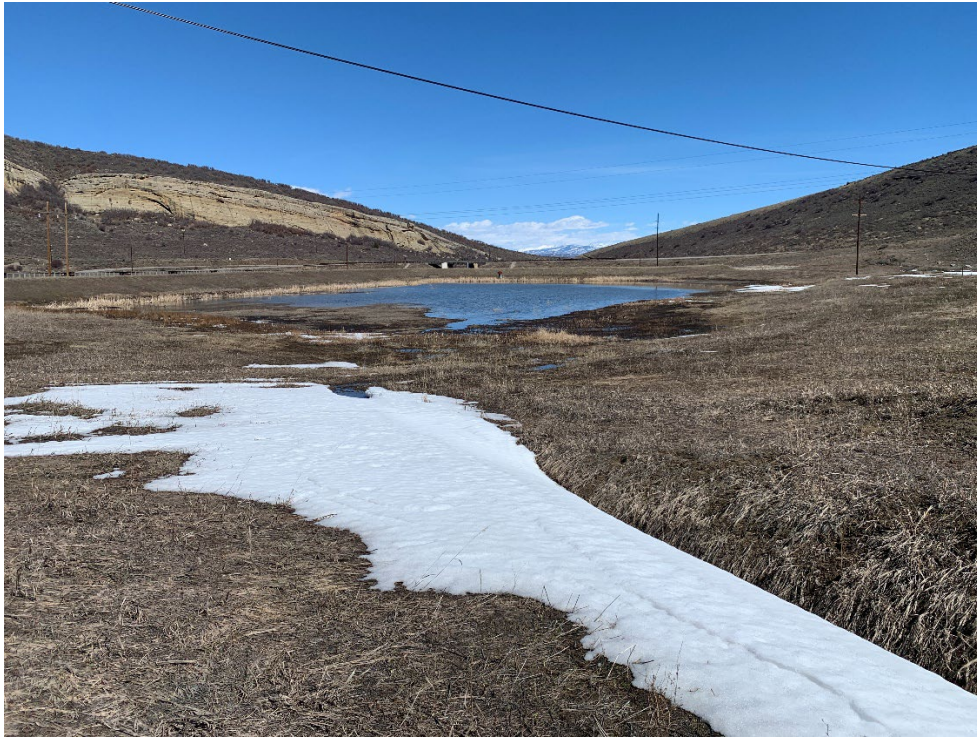
Pond G contained water (photo 6).

Photo 6- Pond G, facing east

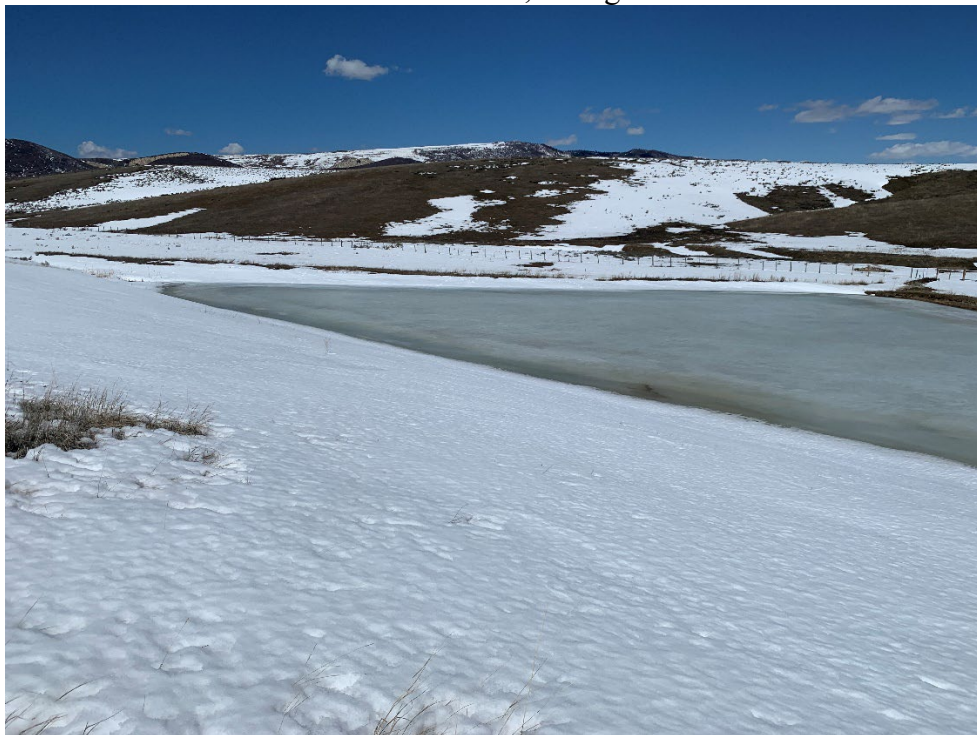
The 6 MN pond contained water and was frozen (photo 7).

Photo 7- Pond 6MN, frozen and not discharging
