PERMIT INFORMATION

Permit Number: C-1996-084 Mine Name: Lorencito Canyon Mine Operator: New Elk Coal Company, LLC Operator Address: 12250 Highway 12 Weston, CO 81091	County: Las Animas Operation Type: Surface Permit Status: Permanent Cessation Ownership: Private
	Operator Representative Present: None
Operator Representative Signature: (Field Issuance Only)

Inspection Start Date: March 25, 2025 Inspection Start Time: 12:20 Inspection End Date: March 25, 2025 Inspection End Time: 13:40	Inspection Type: Coal Partial Inspection Inspection Reason: Normal I&E Program Weather: Clear
Joint Inspection Agency: None	Joint Inspection Contacts:
Post Inspection Agency: None	Post Inspection Contacts:
Inspector(s): Amber M. Gibson	Inspector's Signature:

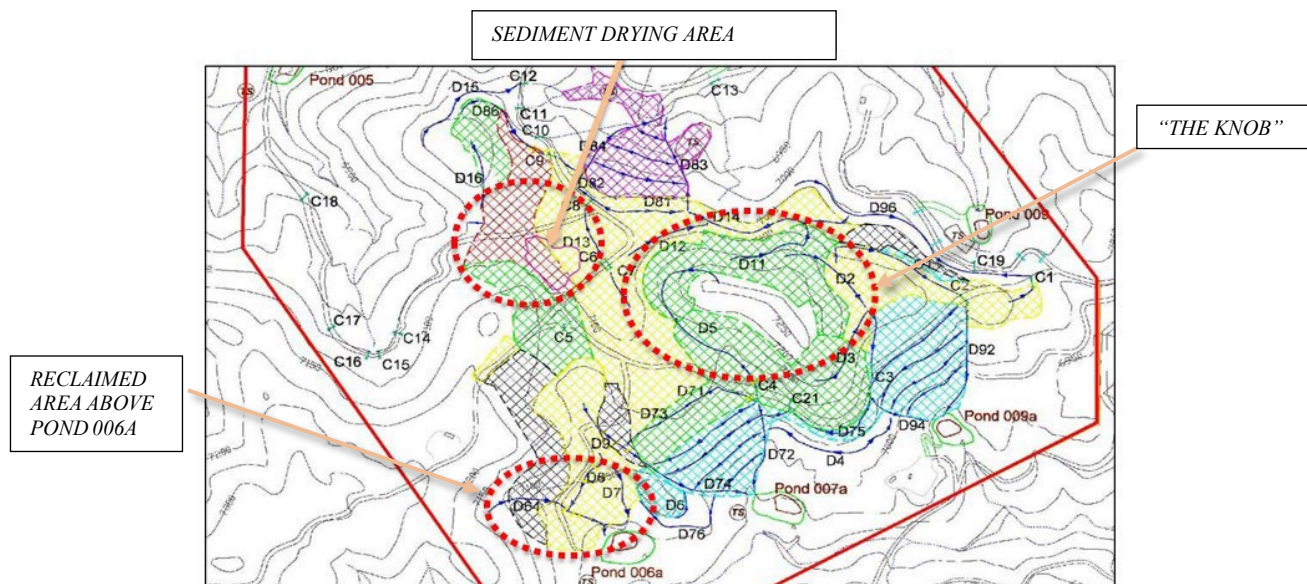
4. The following items pertain to ongoing erosional issues in the areas shown in Figure 1, that pursuant to Rule 4.14.6 need to be addressed. A Technical Revision will be required to expand on the current Rill and Gully plan in the PAP. **The Operator shall submit the technical revision, obtain approval, repair the erosion, and stabilize the slopes pursuant to the approved plan by December 31, 2024.**

FIGURE 1. AREAS WHERE RILLS, GULLIES AND SPARSE VEGETATION HAS BEEN FOUND TO BE A PERSISTENT PROBLEM AT THE SITE ARE WITHIN THE DOTTED CIRCLE AREAS. BACKGROUND IMAGE IS THE 2020 ANNUAL REPORT MAP.

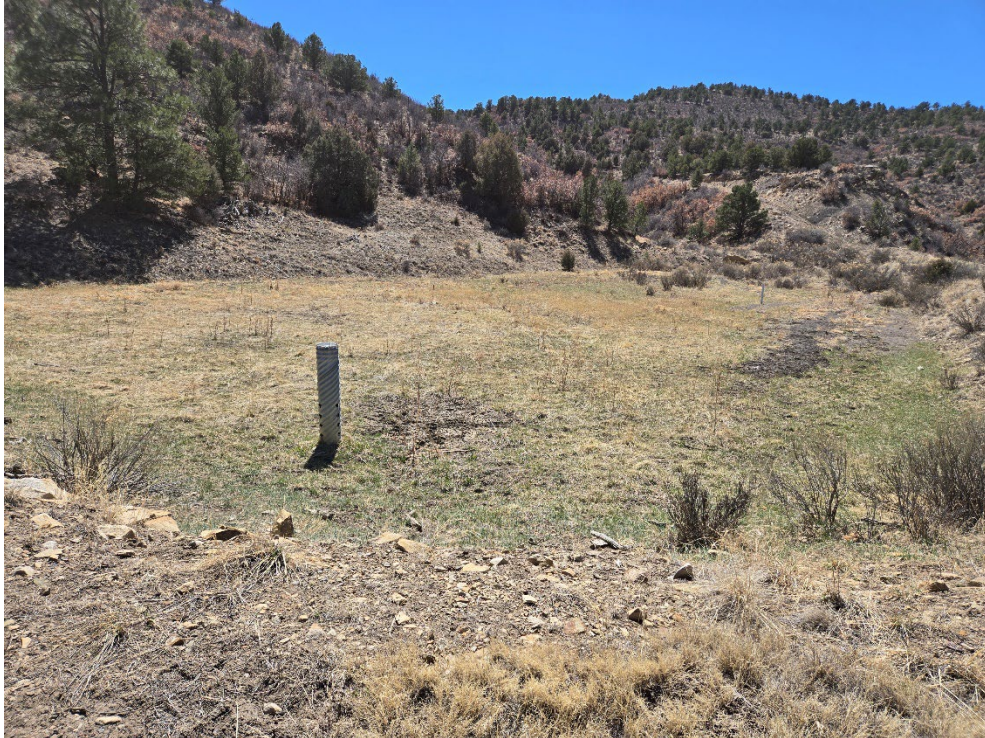
Photo 1: Pond 005

- Pond 005:
 - The pond was dry at the time of the inspection. (Photo 1).

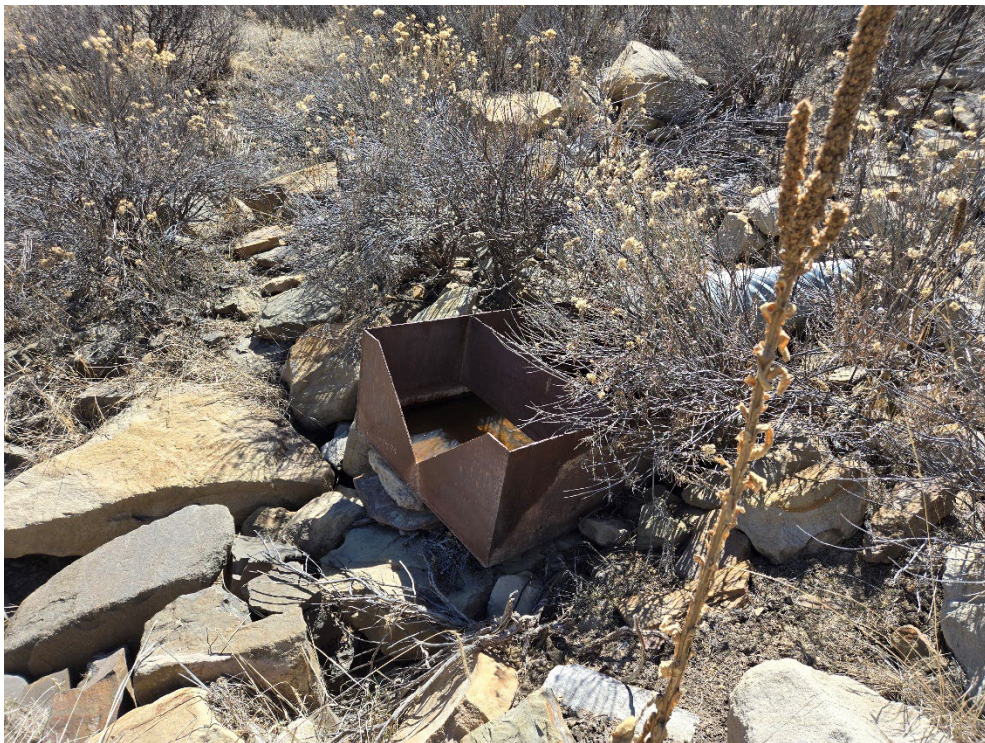
Photo 2: Flume for Pond 005

- The pond embankment appeared to be stable and vegetated.
- The primary and emergency spillways appeared clear and functional.
- The flume contained some water but was not discharging (Photo 2).
- Pond 007a:
 - The pond was dry at the time of the inspection. (Photo 3).
 - The pond embankment appeared to be stable and vegetated.
 - The primary and emergency spillways appeared clear and functional.
 - The flume was dry (Photo 4).
- Pond 009a:
 - The pond contained some water at the time of the inspection. (Photo 5).
 - The pond embankment appeared to be stable and vegetated.
 - The primary and emergency spillways appeared clear and functional.
 - The flume was dry (Photo 6).

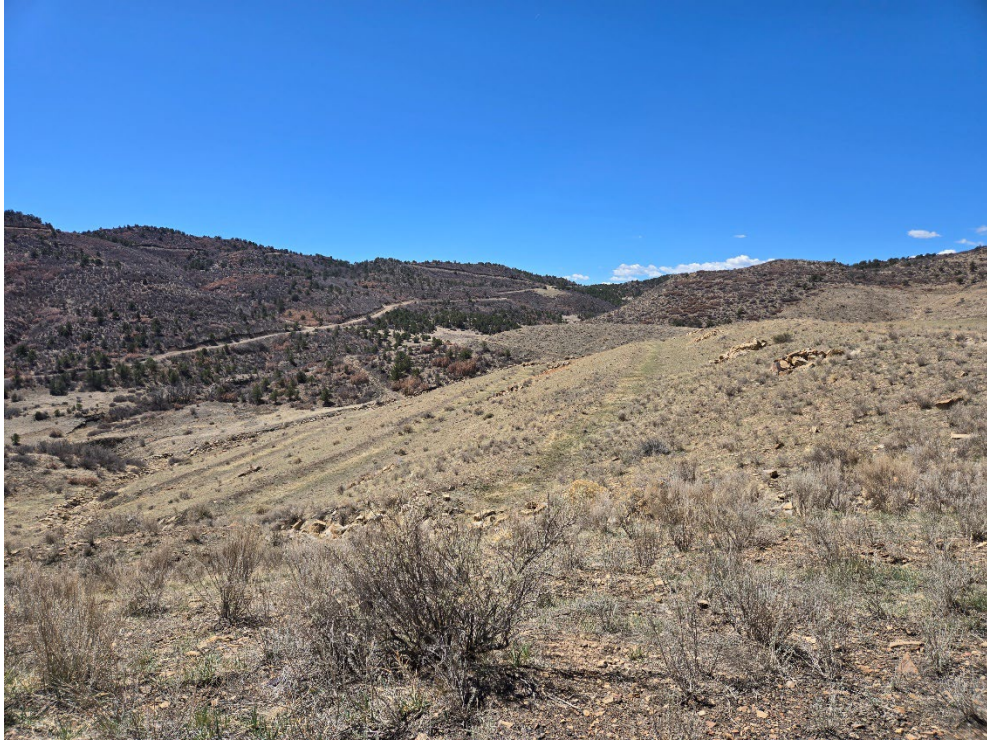
Photo 7: Fill 7

- Fill 7 was observed. Fill 7 was well vegetated and appeared stable (Photo 7).
- Fill 9 was observed. Fill 9 was well vegetated and appeared stable (Photo 8).

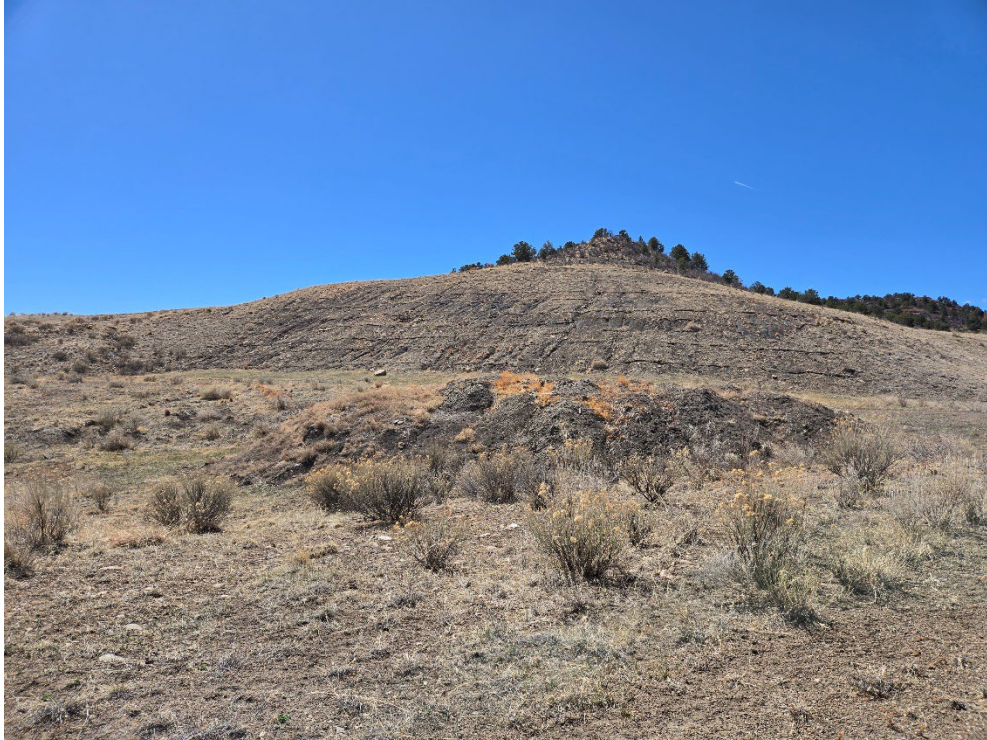
- The area above where NECC stores pond and ditch cleanings consists of a steep slope. This slope was observed during the inspection (Photo 9). Erosion rills and gullies were observed but the vegetation on this slope appears better established this year than in years previously observed by DRMS. NECC is encouraged to continue to monitor this area and conduct maintenance as needed.

Photo 9: Previously reclaimed slope in the background and sediment drying area in the foreground

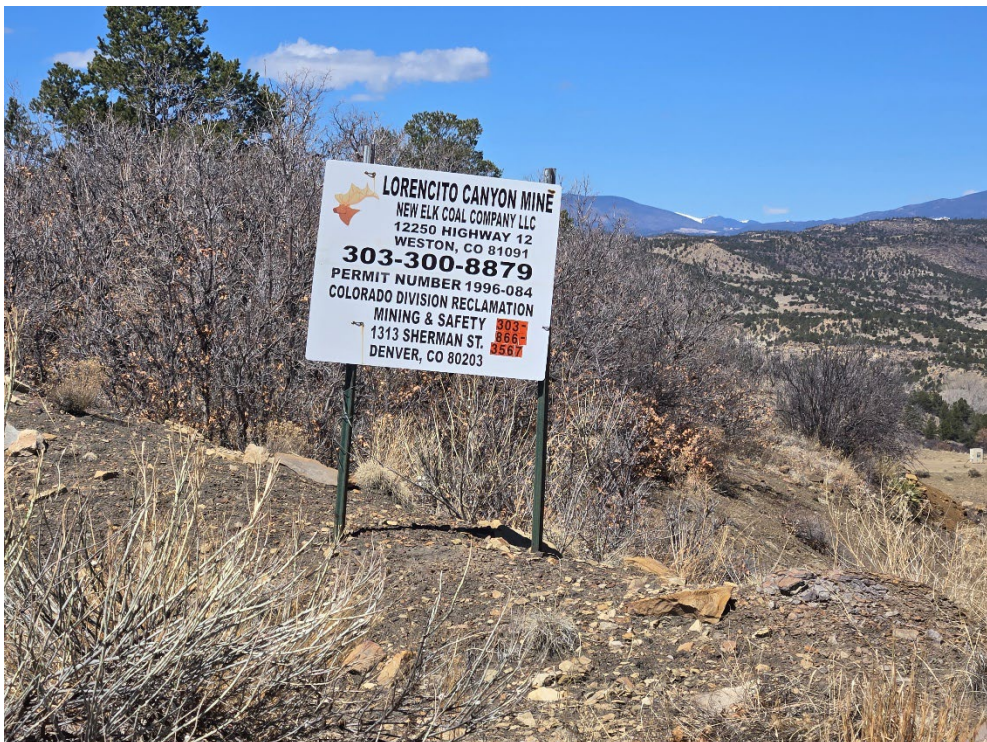
Photo 10: Mine sign

- Mine signs were posted at road entrances and at the entrance to the permit boundary in compliance with Rule 4.02 (Photo 10).
