## aerial Inspection March 2025

**COLORADO**  
 Division of Reclamation,  
 Mining and Safety  
 Department of Natural Resources

**26 March 2025**

Permit Number: C1981010 Mine Name: Trapper Mine Operator: Trapper Mining, Inc. Operator Address:  Mr. Graham Roberts P.O. Box 187 Craig, CO 81626	County: Moffat Operation Type: Surface Permit Status: Active Ownership: Federal
	Operator Representative Present: No as this was an aerial inspection.
This report was issued electronically from the Divisions' Denver Office.

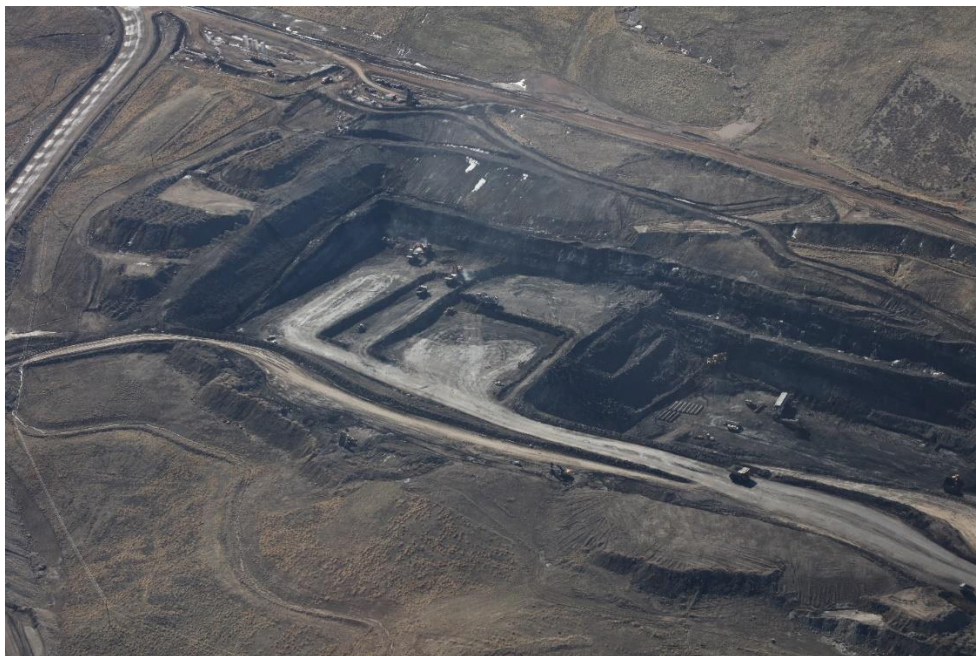
**N Pit:** Loading and hauling of overburden from N Pit excavation was occurring at the time of inspection.

***Photo 1: N Pit activities looking south.***

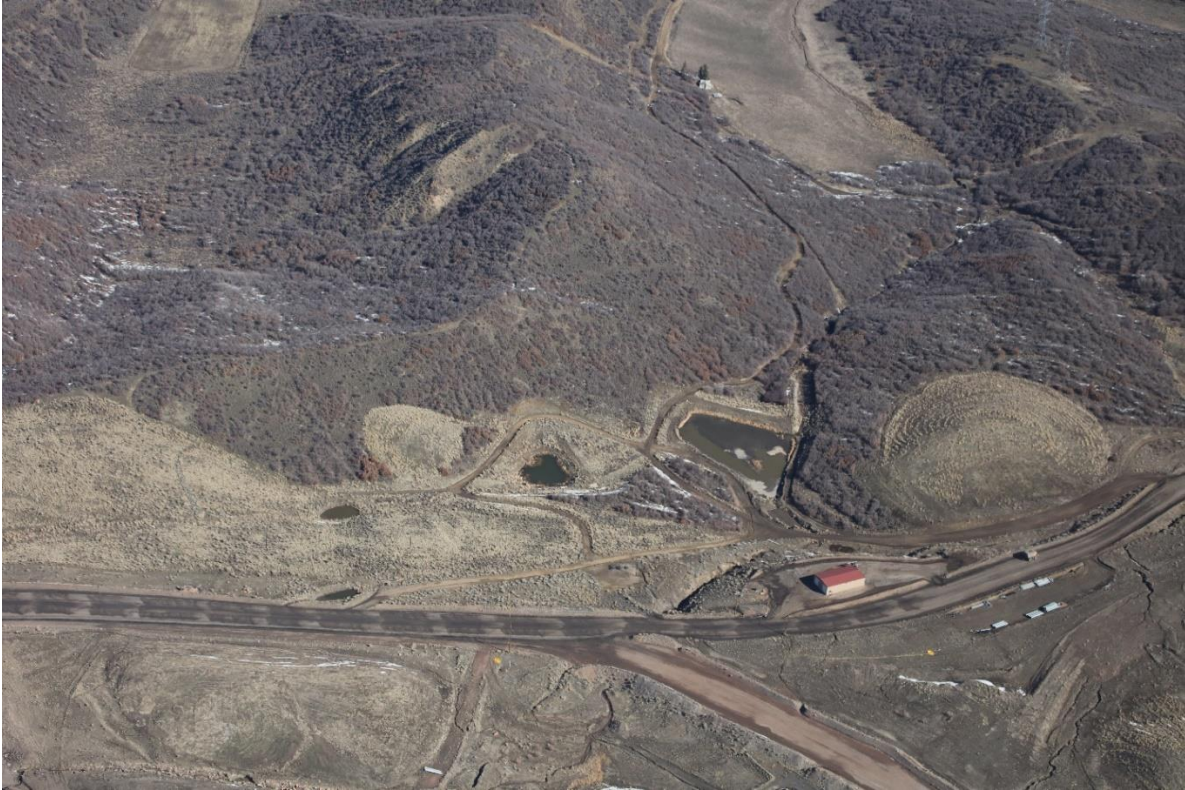
- Ponds appeared to have iced off at the time of inspection and some were held water.

***Photo 2: Middle Flume Pond System.***

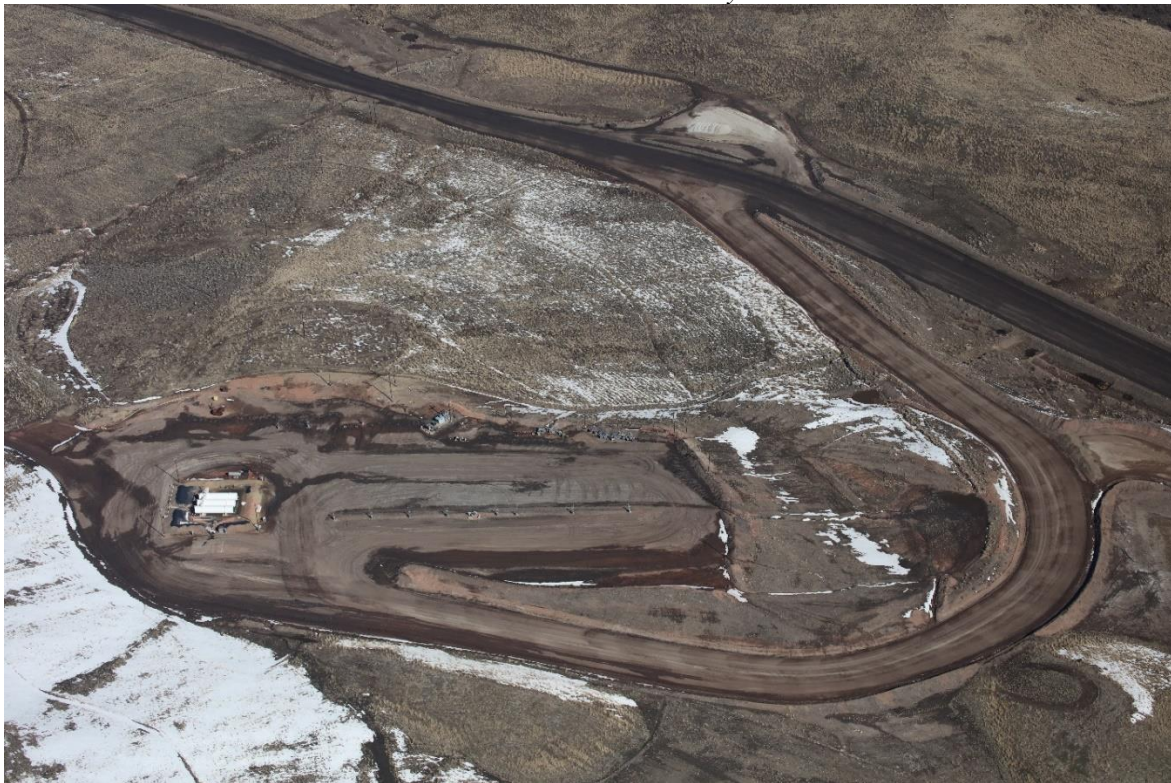
- Main haul roads were frozen, dry and in good repair.
- Access roads to ponds were not accessible. Other access roads to the ash pit and ready line were in good repair at the time of inspection.
- Ditches along haul roads appeared to be functioning adequately.

***Photo 3: The Ready Line appears in good repair without ruts or significant standing water.***

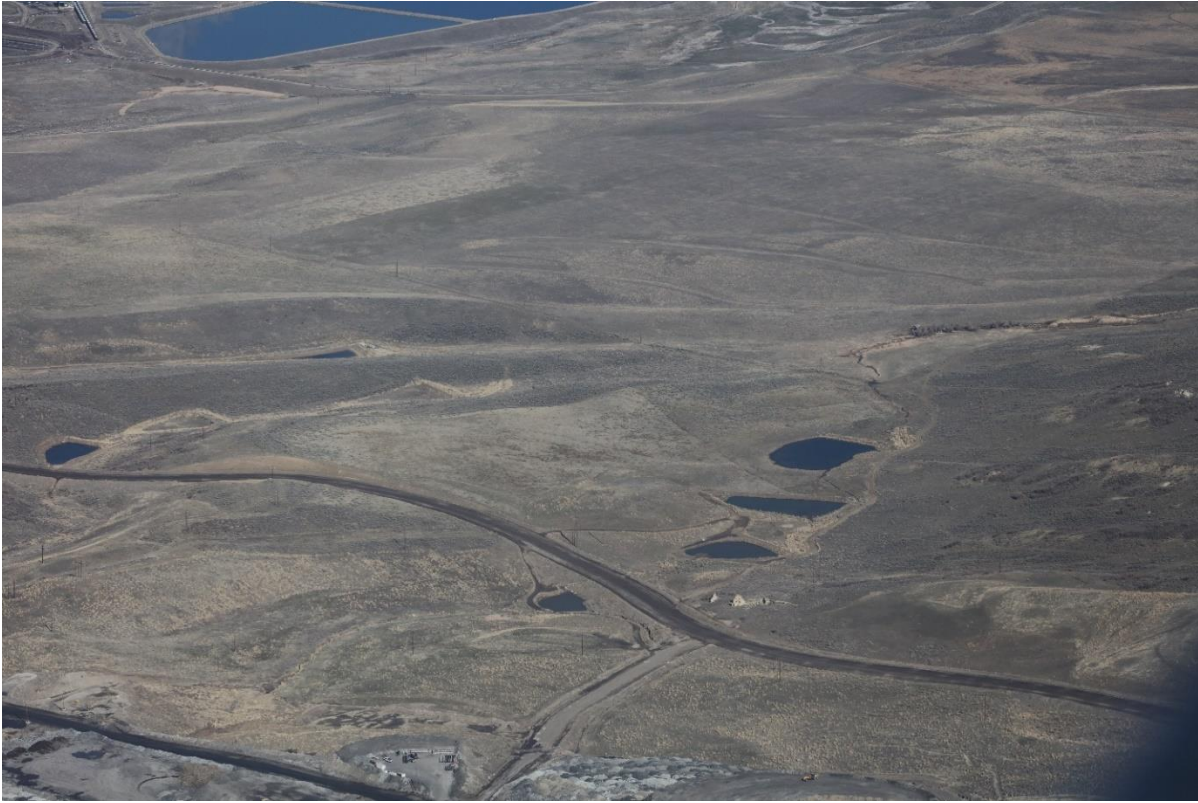
***Photo 4: The Johnson Pond System.***

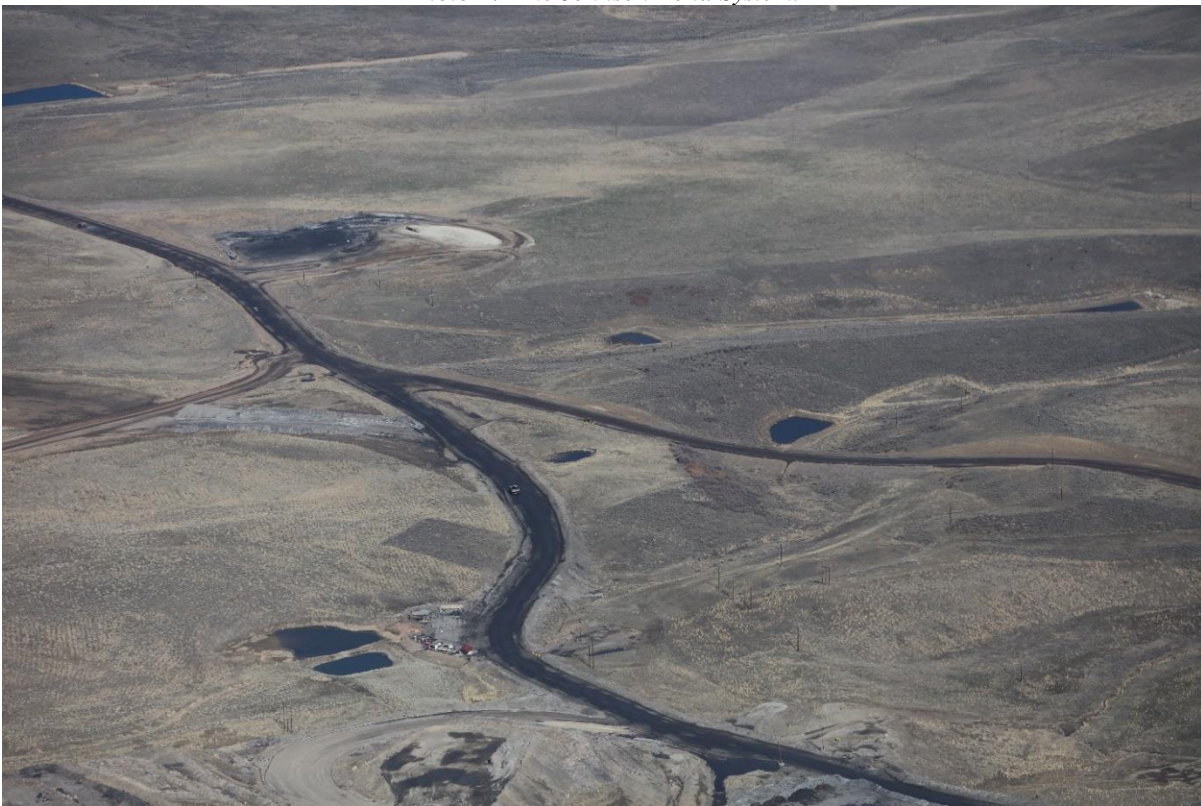
***Photo 5: Various pond, all holding water located at the west end of the site.***

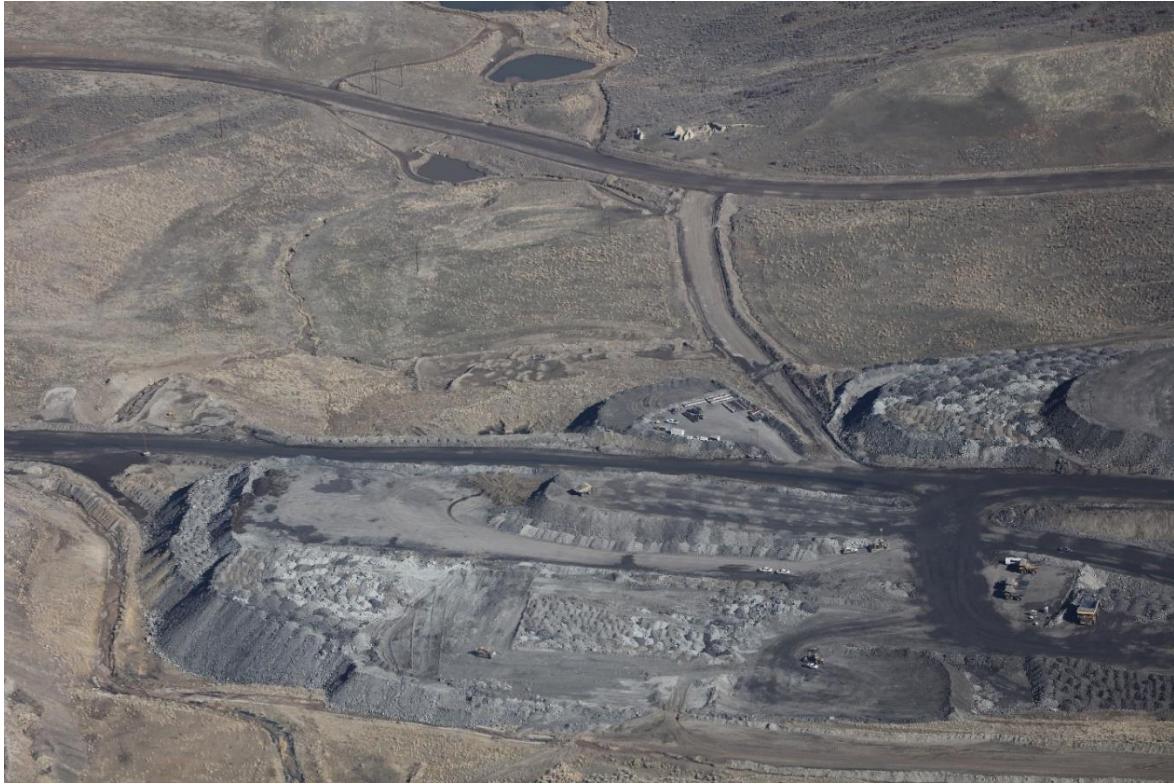
***Photo 6: J Pit activities.***

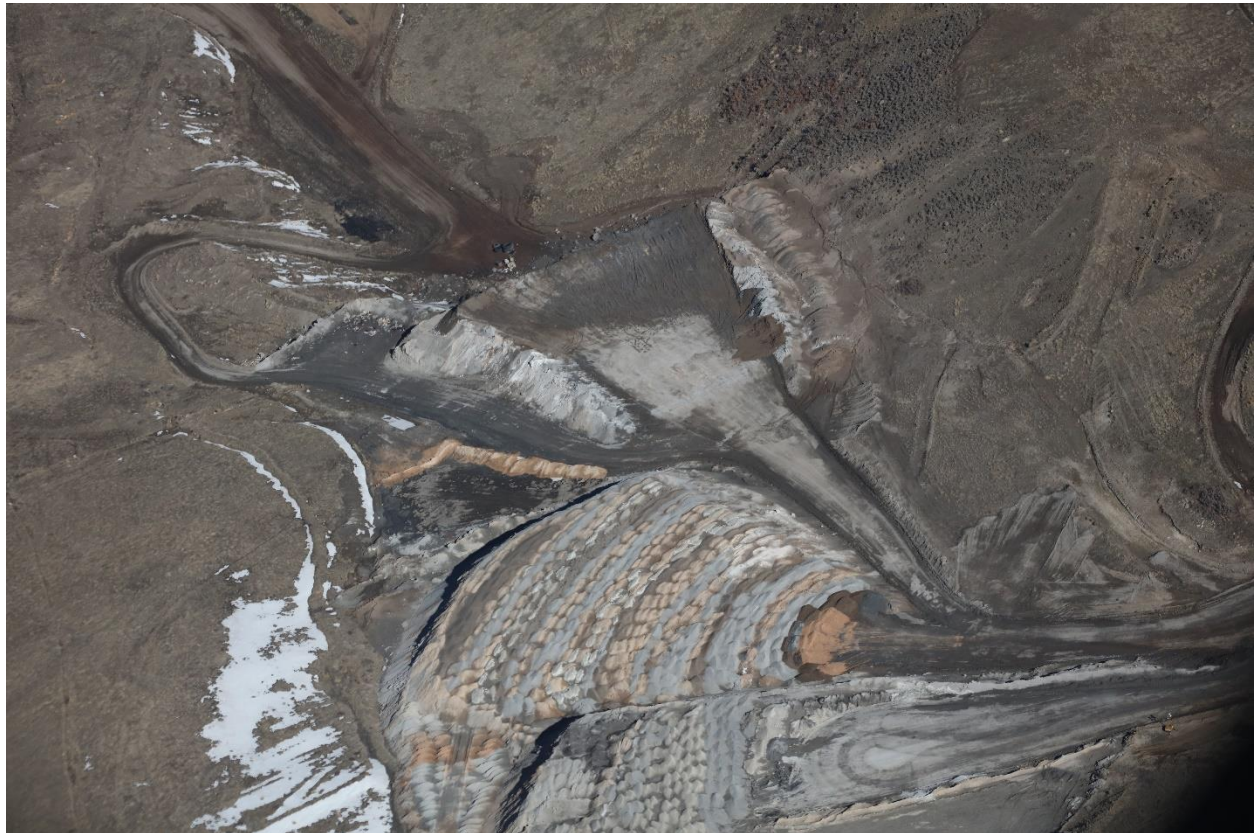
***Photo 7: Ash Pit mounds.***

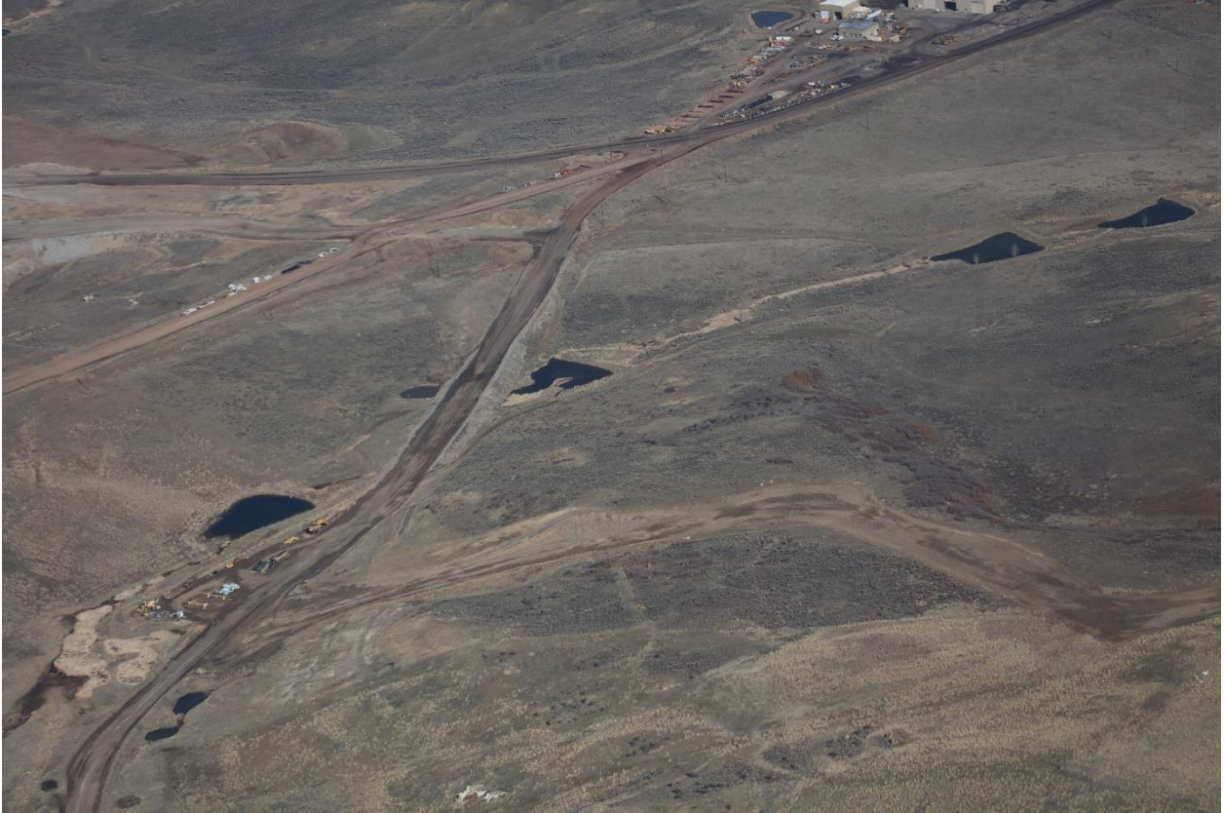
***Photo 8:** Johnson Pond System looking north.*

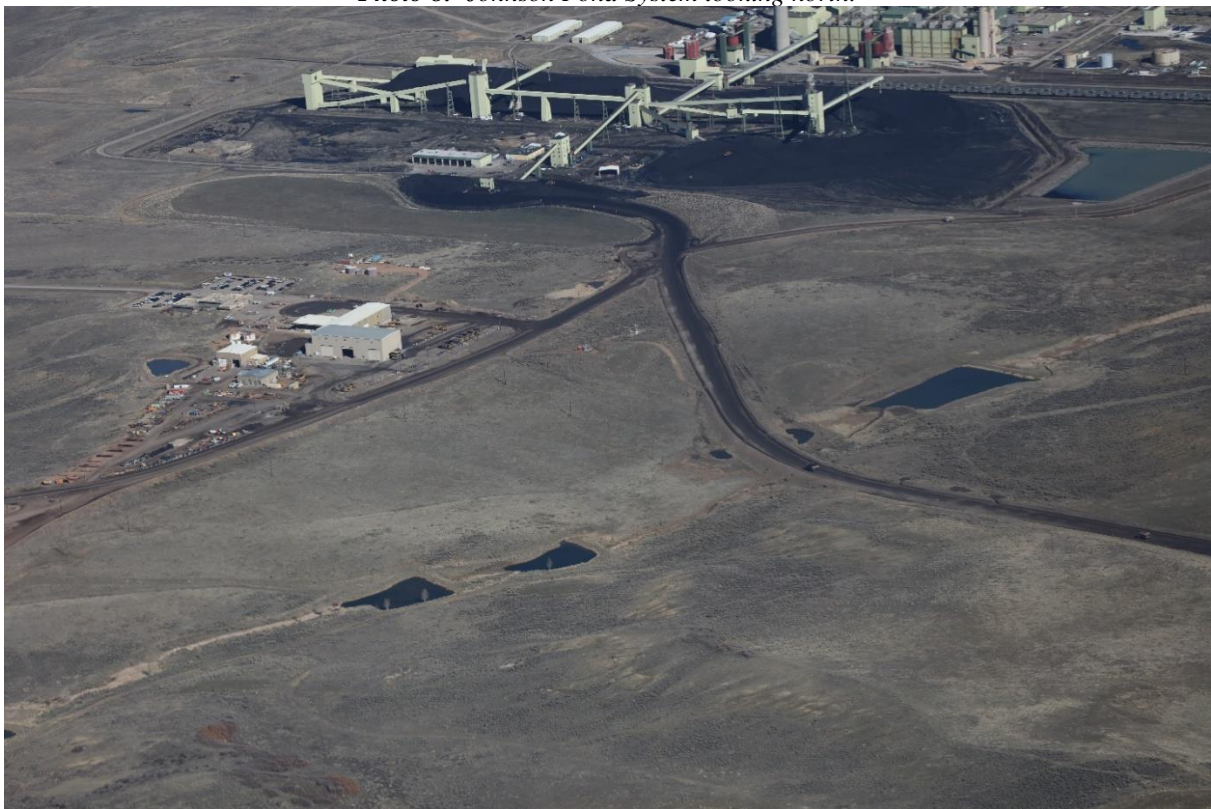
***Photo 9:** Facilities area and coal stockpile at the powerplant, Johnson Ponds in foreground..*

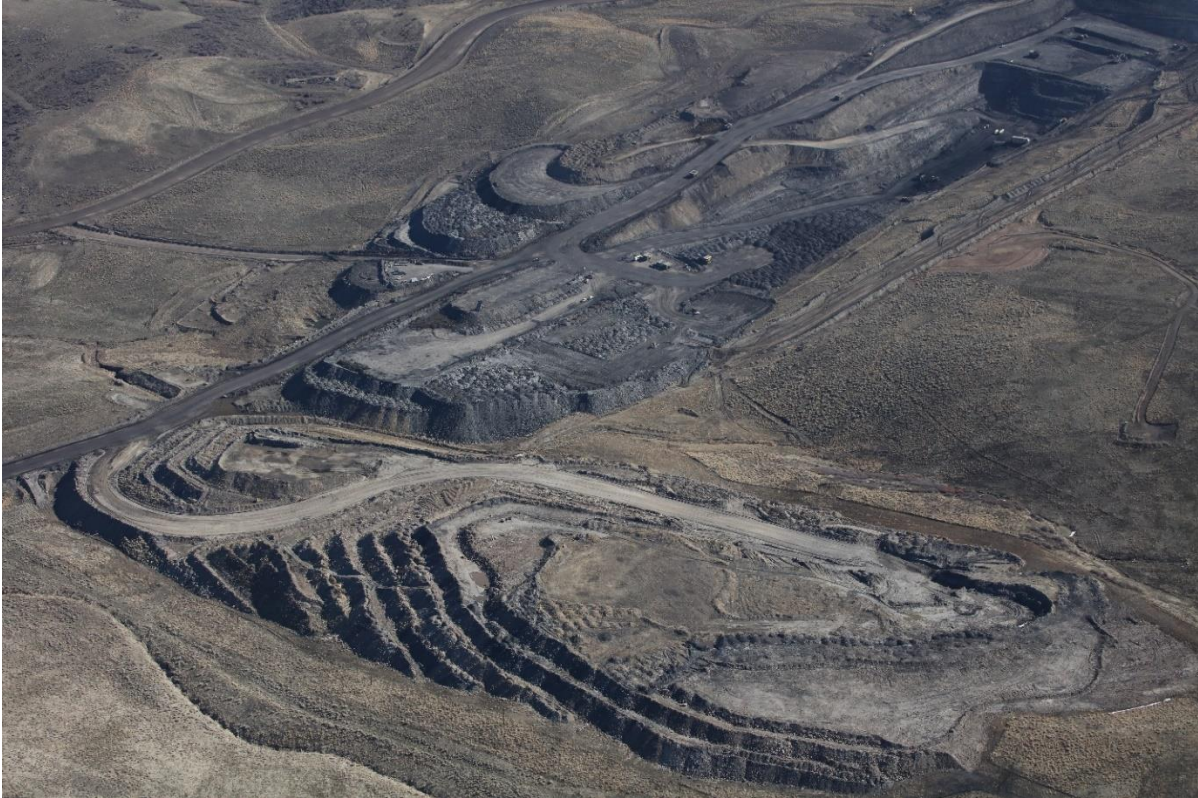
***Photo 10:*** Overview of N Pit and stockpiled overburden.

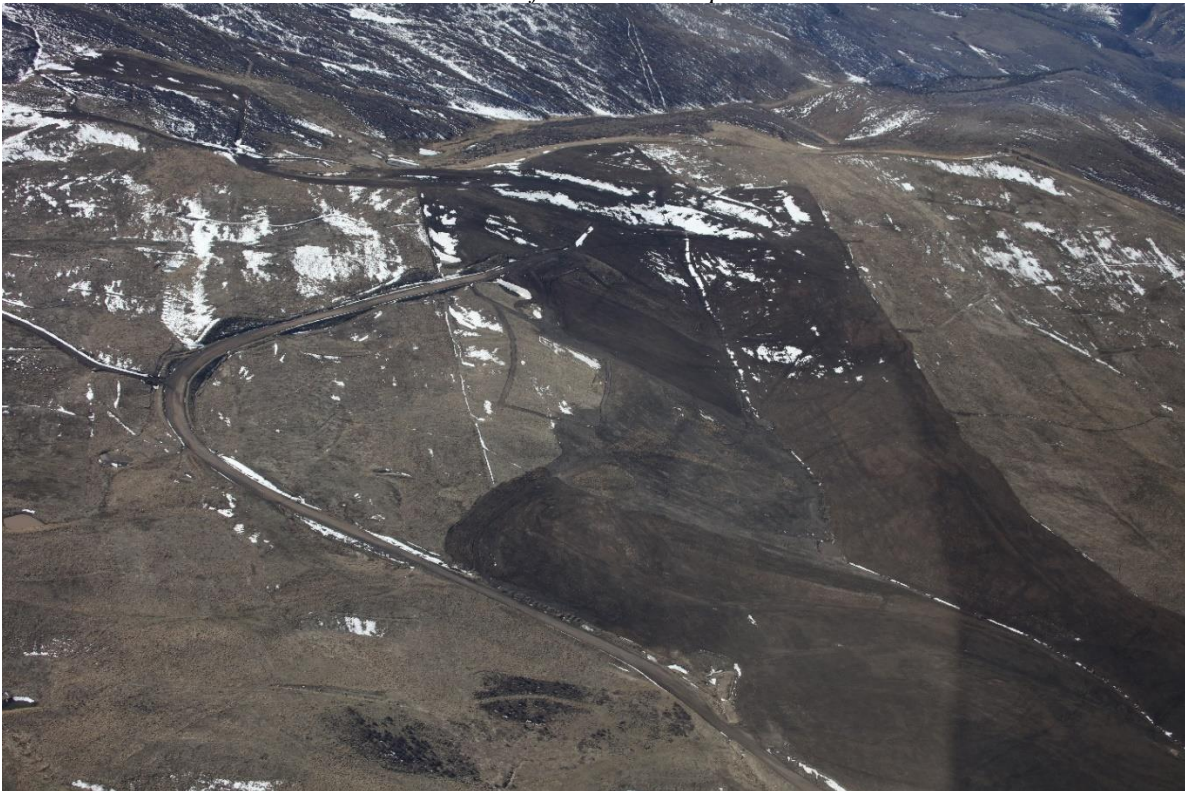
***Photo 11:*** are stripped of topsoil at western boundary of the site.

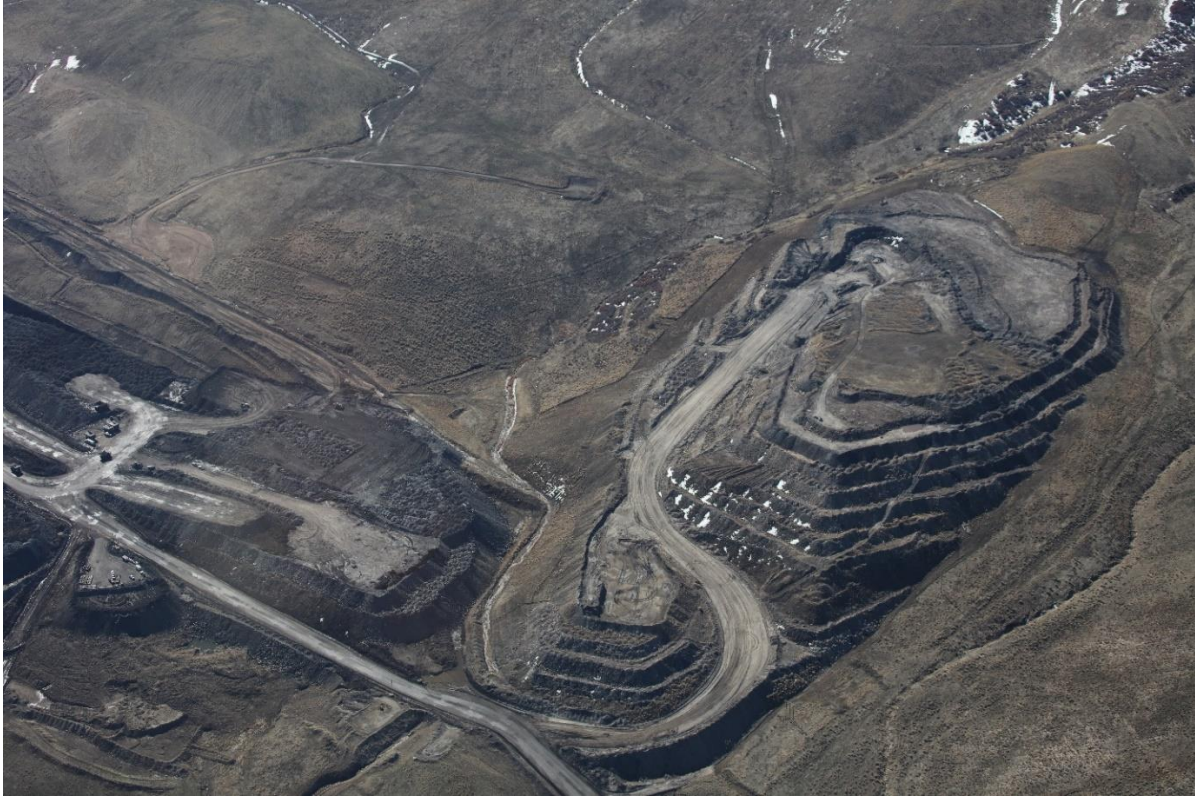
*Photo 12: Stockpiled overburden.*

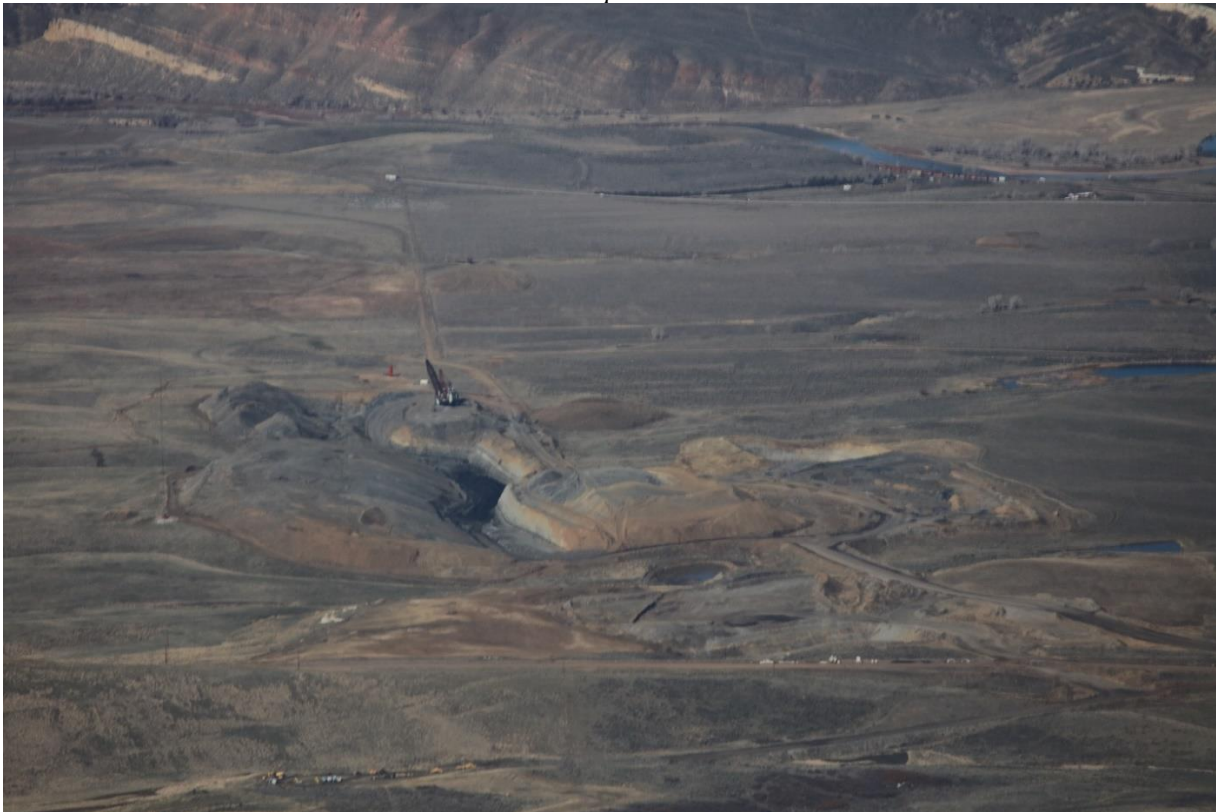
**J Pit West:** The Queen Ann dragline was inactive at the time of inspection.

*Photo 13: Idle drag line in J Pit West with coal piled in the pit awaiting hauling.*
