## Aerial Inspections 2025 March Sage Creek, Williams Fork

**COLORADO**  
 Division of Reclamation,  
 Mining and Safety  
 Department of Natural Resources

26 March 2025

<b>Permit Number:</b> C-1981-044 <b>Mine Name:</b> Williams Fork Mines <b>Operator:</b> Moffat County Mining, LLC  <b>Operator Address:</b> Ms. Miranda Kawcak 29515 Routt County Road #27 Oak Creek, CO 80467	<b>County:</b> Moffat <b>Operation Type:</b> Underground <b>Permit Status:</b> Active <b>Ownership:</b> Private  <b>Operator Representative Present:</b>  None as this was an aerial inspection.
This report was issued electronically from the Divisions' Denver Office.

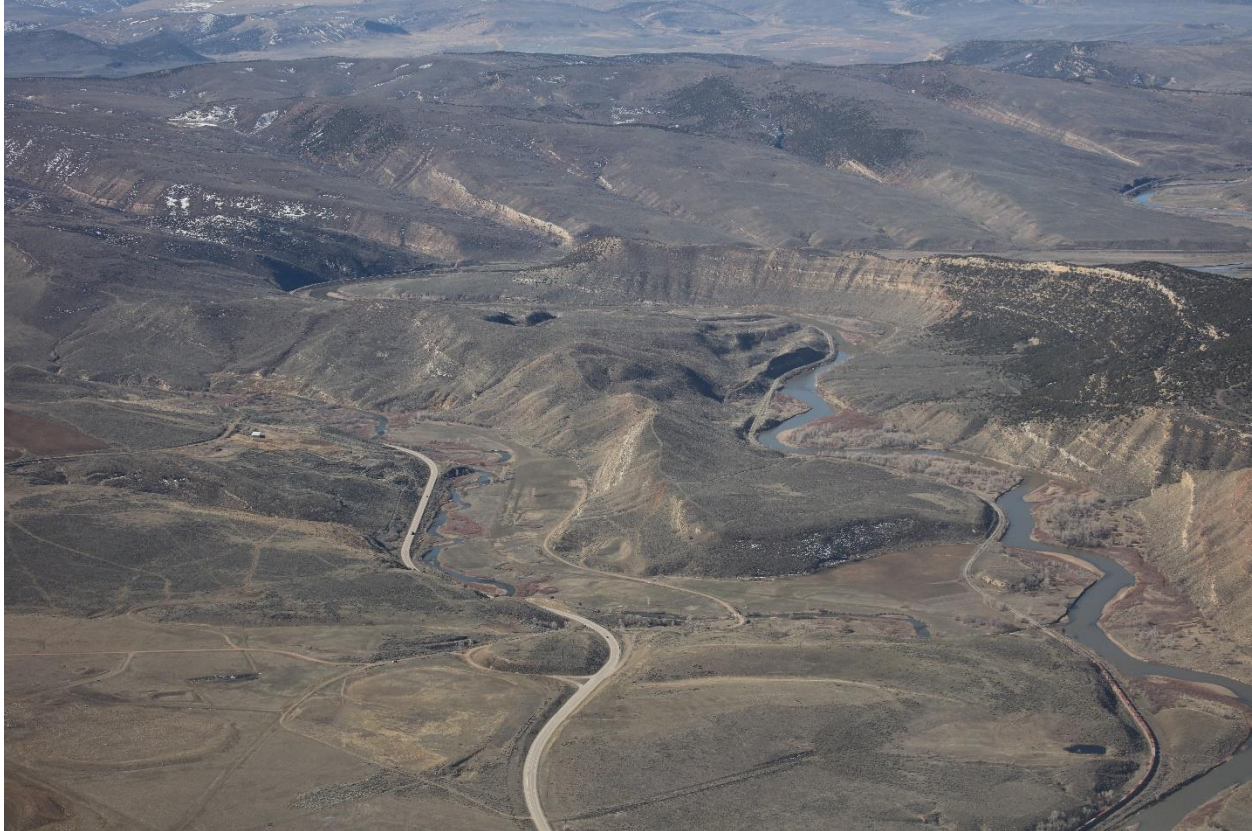
***Photo 1:*** Overview of the Williams Fork mine site, located on the left of the photo, looking south.

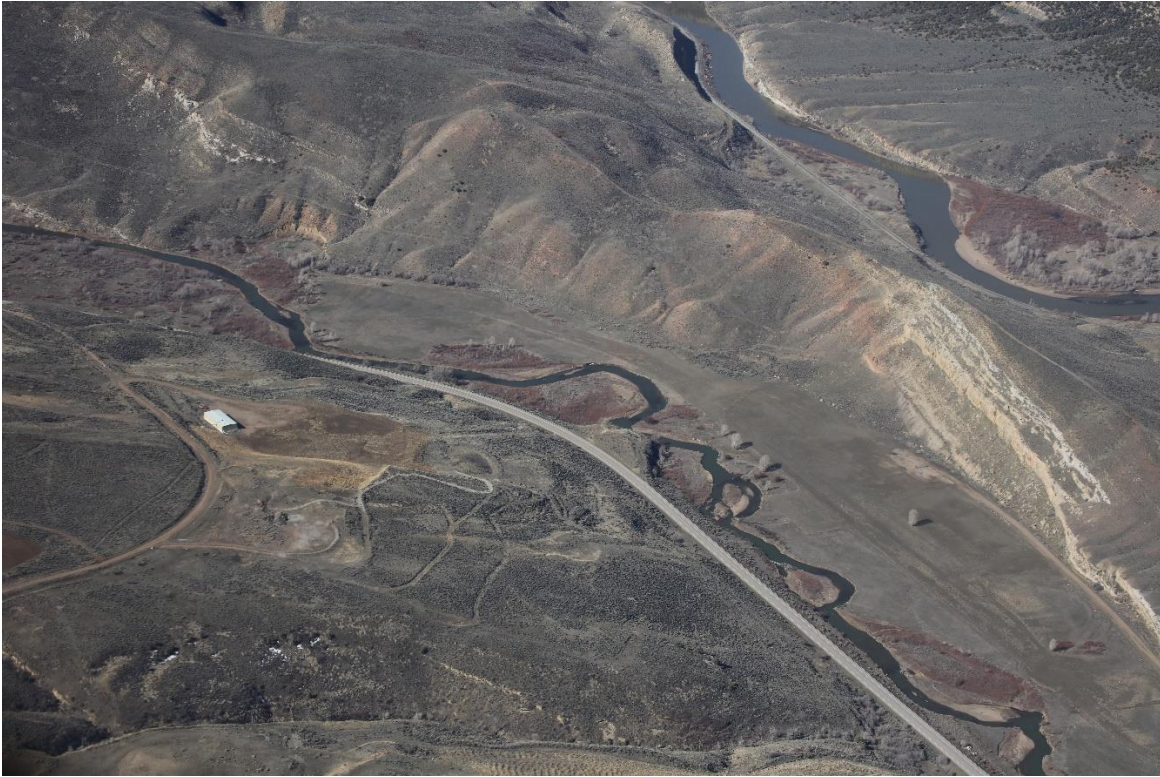
*Photo 2: View of the Williams Fork bottomlands and the portal area below the shop building, looking south.*

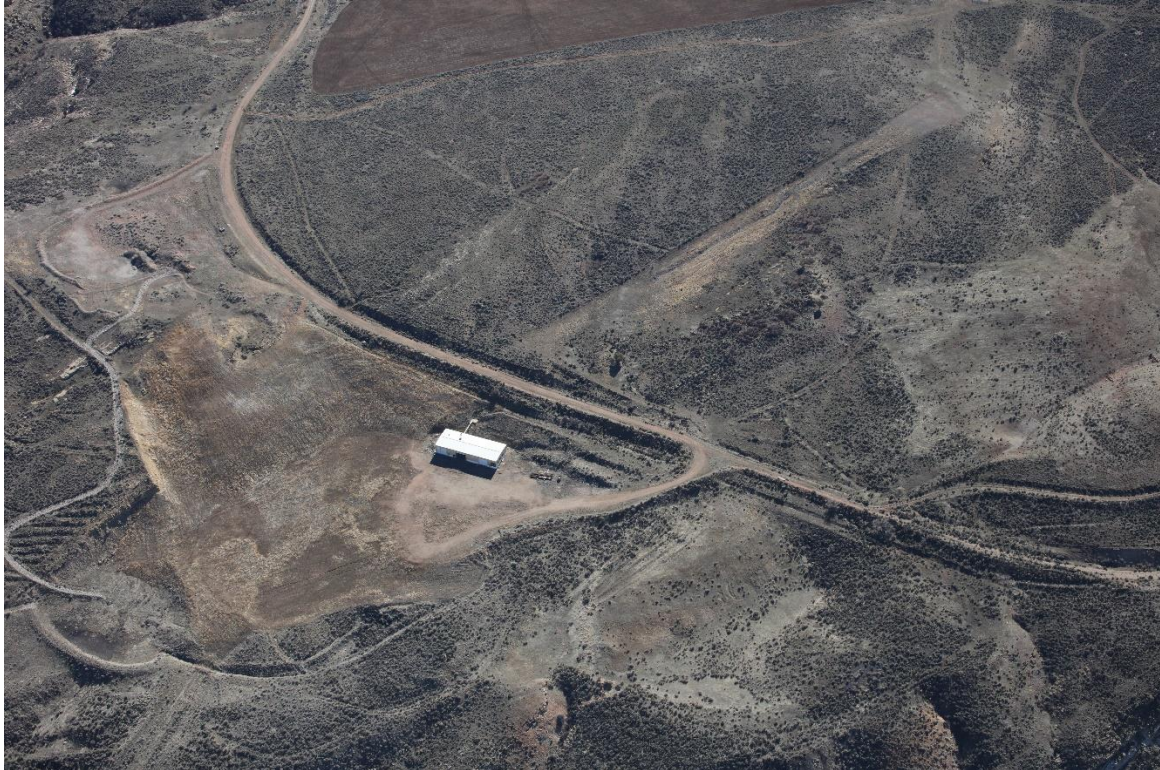
*Photo 3: View of the shop area and Pond.*

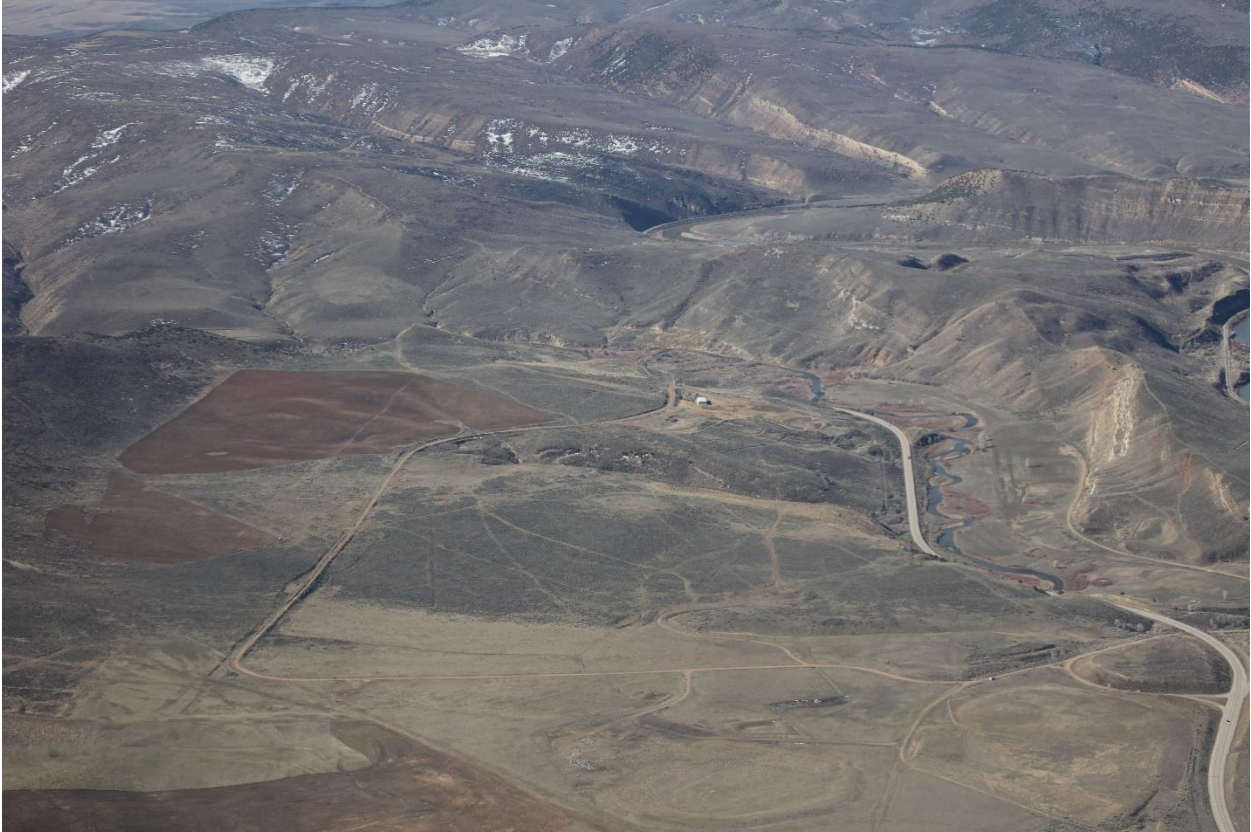
***Photo 4:*** View of the north end of the site with the refuse pile in the lower right side and numerous pond indentations.
