Permit Number: C-1981-012 Mine Name: New Elk Mine Operator: New Elk Coal Company, LLC Operator Address: 12250 Highway 12 Weston, CO 81091	County: Las Animas Operation Type: Underground Permit Status: Active Ownership: Private
	Operator Representative Present: None
Operator Representative Signature: (Field Issuance Only)

Inspection Start Date: March 25, 2025 Inspection Start Time: 14:03 Inspection End Date: March 25, 2025 Inspection End Time: 16:10	Inspection Type: Coal Complete Inspection Inspection Reason: Normal I&E Program Weather: Cloudy
Joint Inspection Agency: None	Joint Inspection Contacts:
Post Inspection Agency: None	Post Inspection Contacts:
Inspector(s): Amber M. Gibson	Inspector's Signature:

This was a complete inspection of the New Elk Mine, Colorado Division of Reclamation, Mining and Safety (“DRMS” or “Division”) permit number C-1981-012, operated by New Elk Coal Company, LLC. (“NECC”). Amber Gibson, with the Division, conducted the inspection. During the inspection, I was unaccompanied by an Operator representative for the Permittee -- New Elk Coal Company, LLC (NECC). The weather was warm, the sky was partly cloudy, and the ground was mostly dry. The entrance to

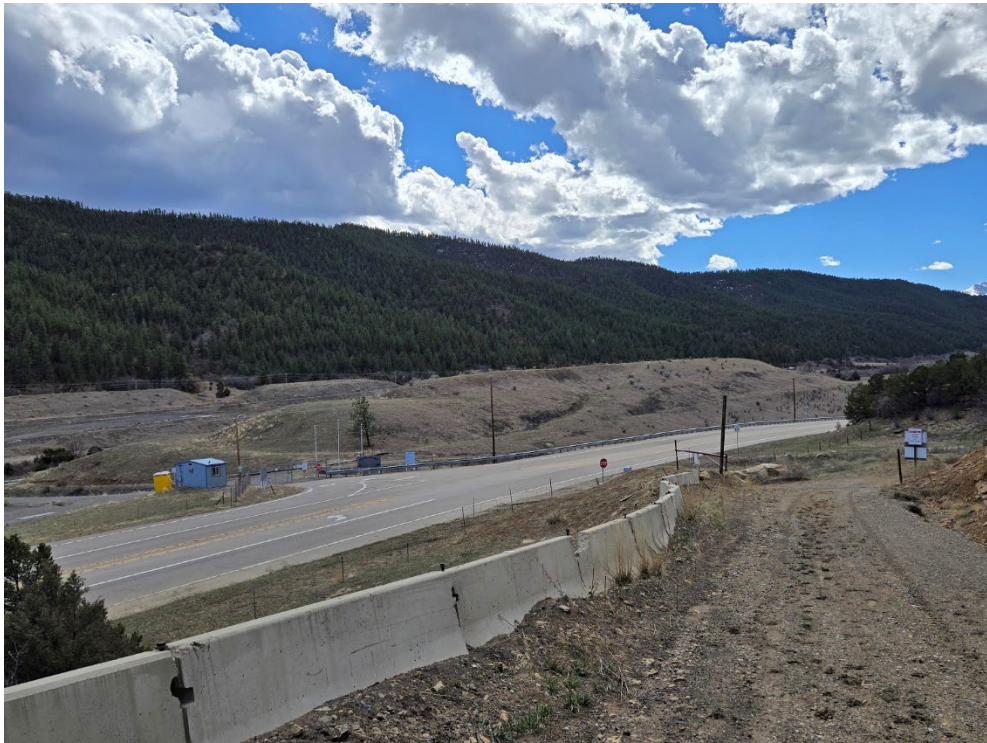
- The sediment basin at the east end of DWDA #2 held water at the time of the inspection.
- No signs of erosion were observed along the slopes of DWDA #1. The slopes appear to be well vegetated and stable (Photo 1).

Photo 1: Looking southwest at the north side of DWDA #1.

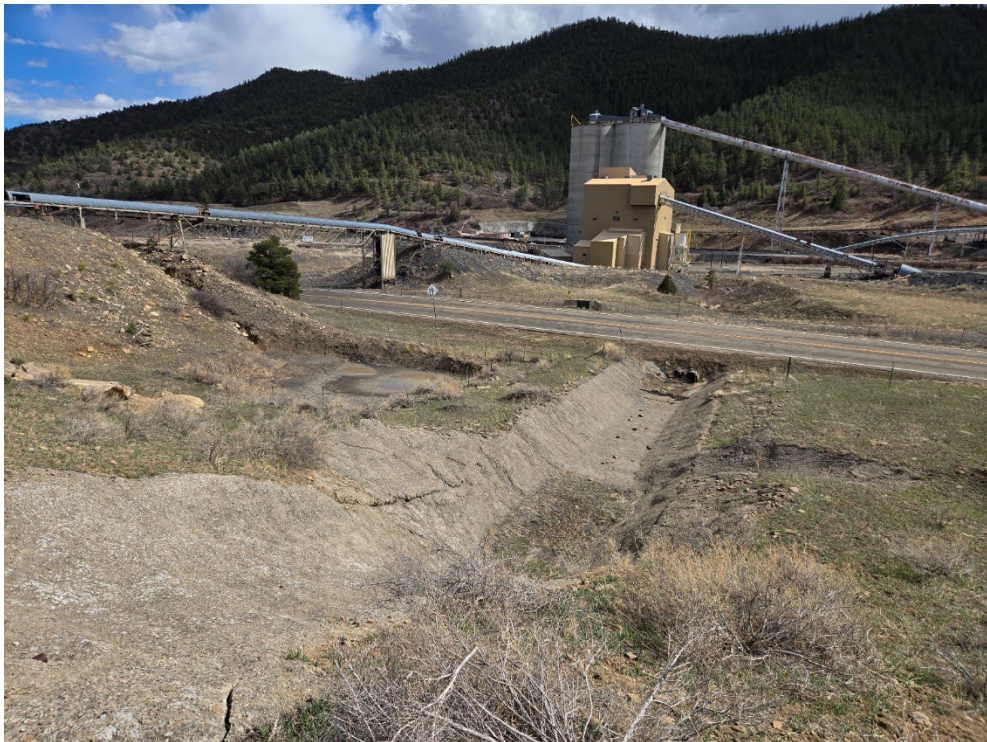
- Containment area #3 was dry.
- Containment area #4 was dry.
- Containment area #5 contained some water and was below capacity (Photo 2).
- Pond 001A held some water at the time of the inspection (Photo 3).
- Pond 004A contained a small amount of water located within the southeast corner (Photo 4).

Photo 2: Containment Area no. 5 and the emergency spillway for Pond 08.

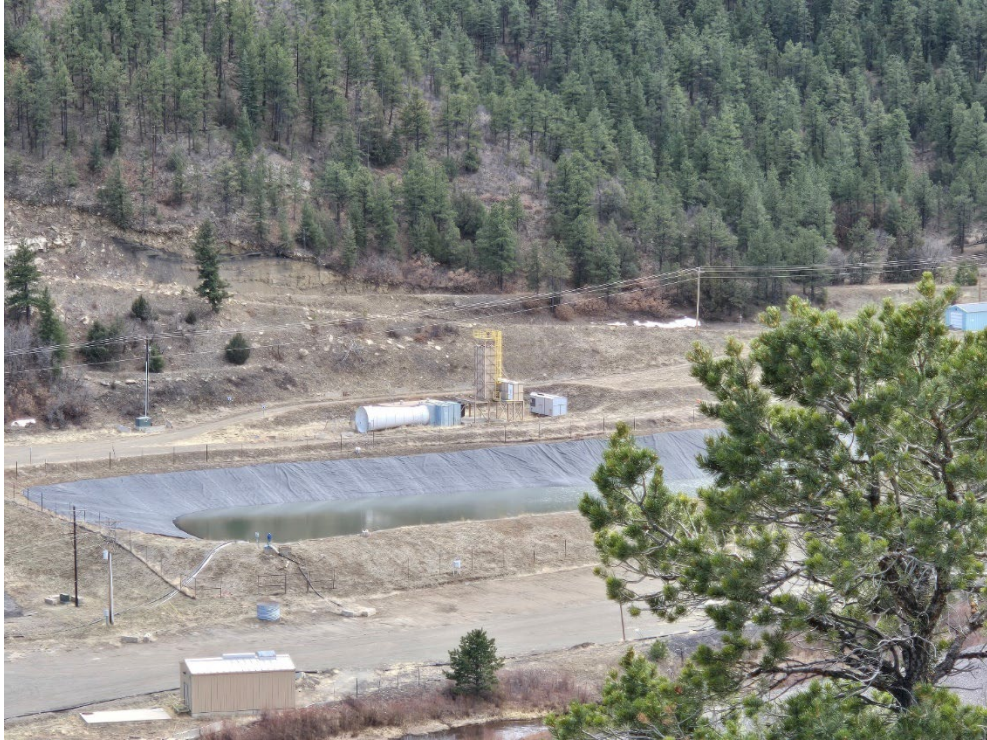
Photo 3: Pond 001a.

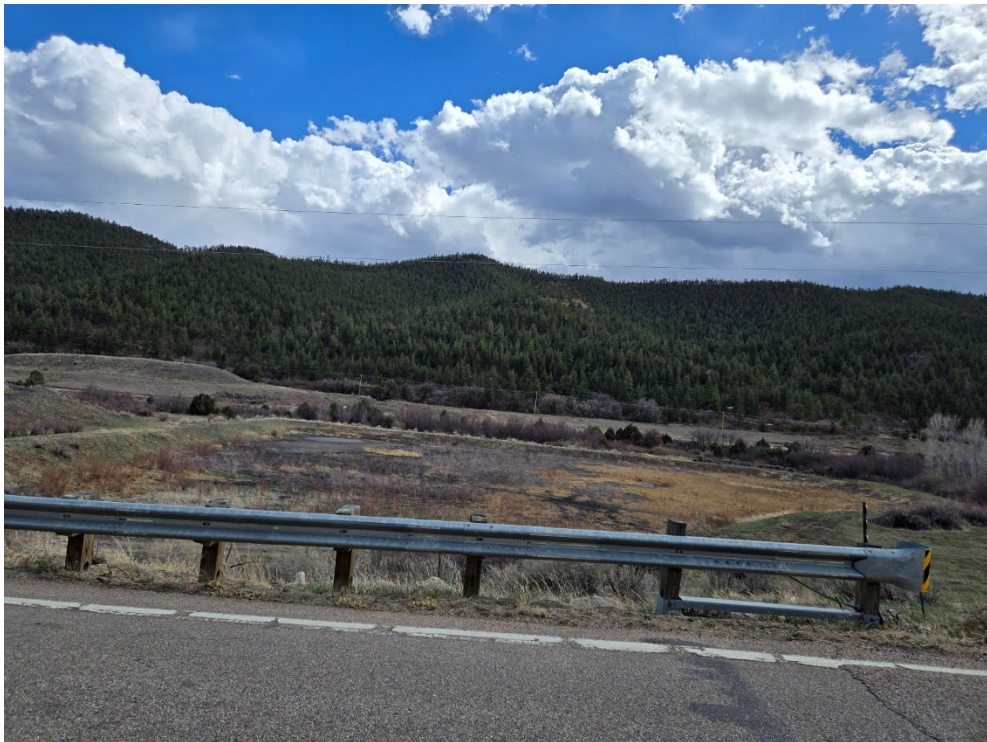
Photo 4: Pond 004a.

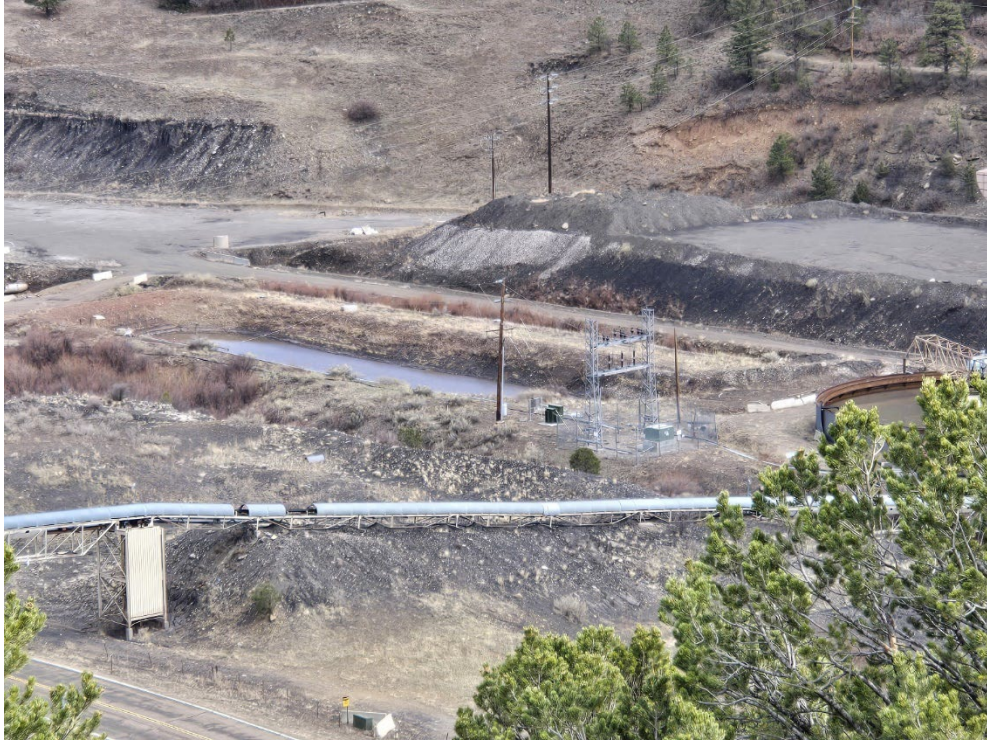
- Pond 006A contained some water at the time of the inspection (Photo 5). The banks of the pond appeared to be stable.
- Pond 007A contained some water at the time of the inspection (Photo 6).
- Pond 08 contained some water at the time of the inspection and was below its capacity (Photo 7). The spillways appeared clear, and the banks were stable. The Division walked along the south facing side of the south bank and it appeared stable (Photos 8-9). Pond 08 was not discharging.

Photo 5: Pond 006a.

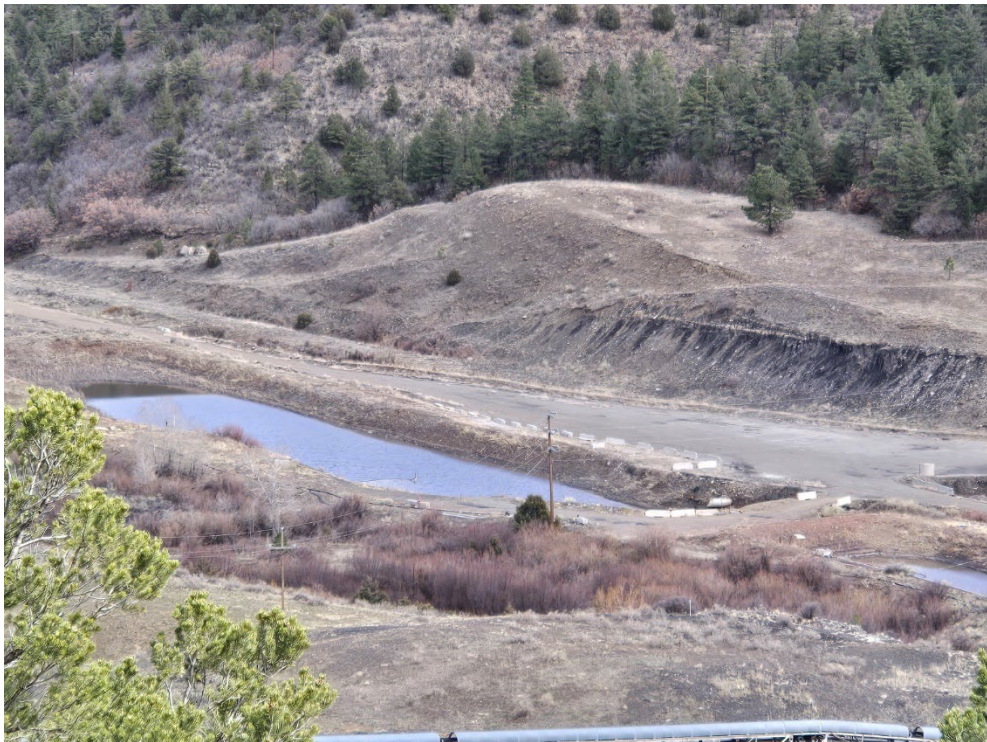
Photo 6: Pond 007a.

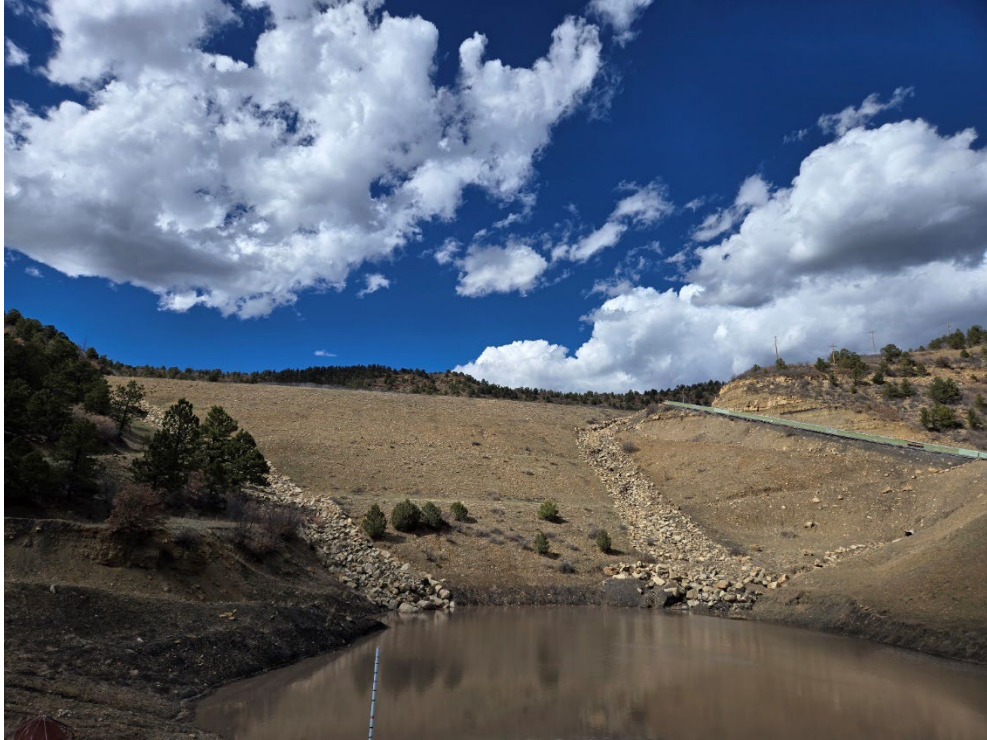
Photo 7: Pond 08 and the reclaimed slopes of the RDA.

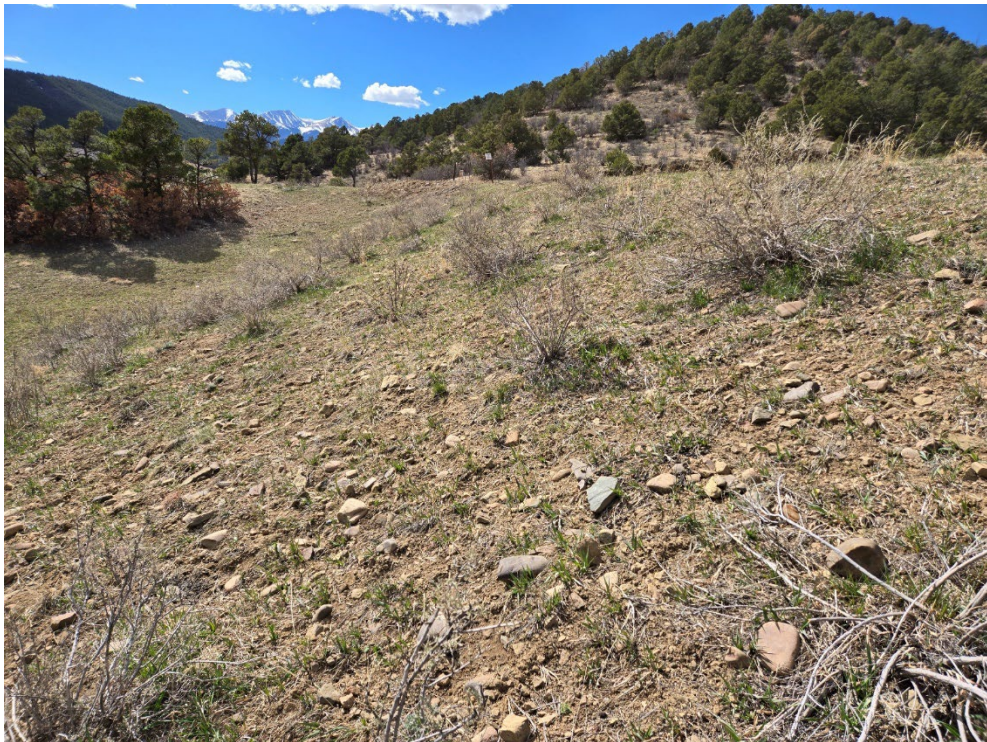
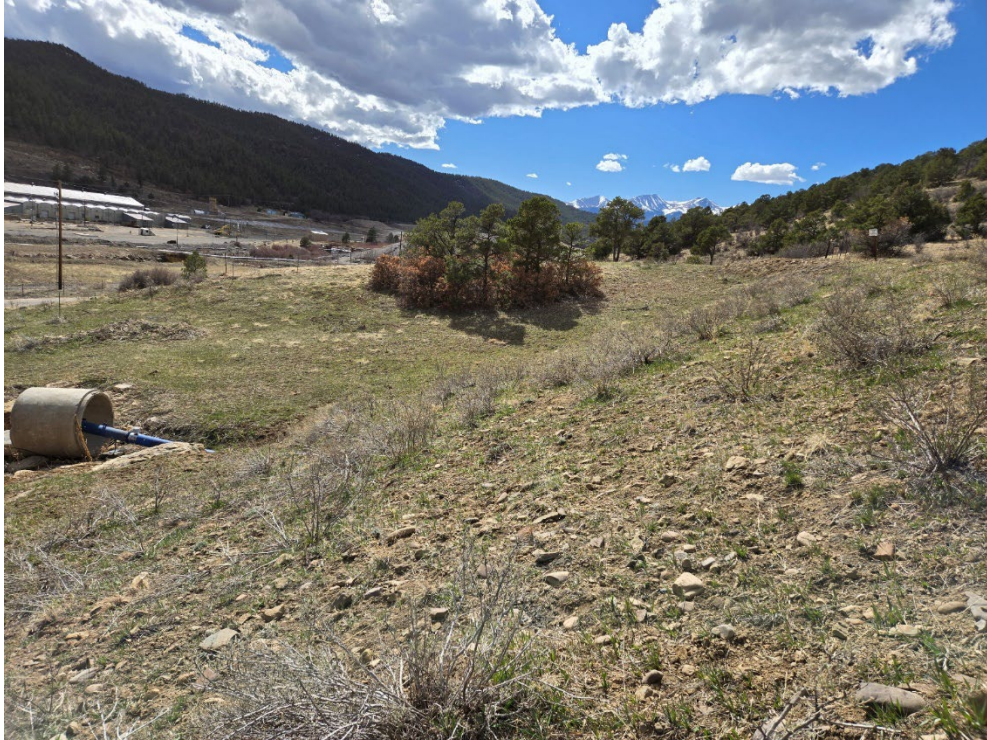
Photo 8: Looking west along the south-facing side of the southern slope at Pond 08.

Photo 9: Looking west along the south-facing side of the southern slope at Pond 08.

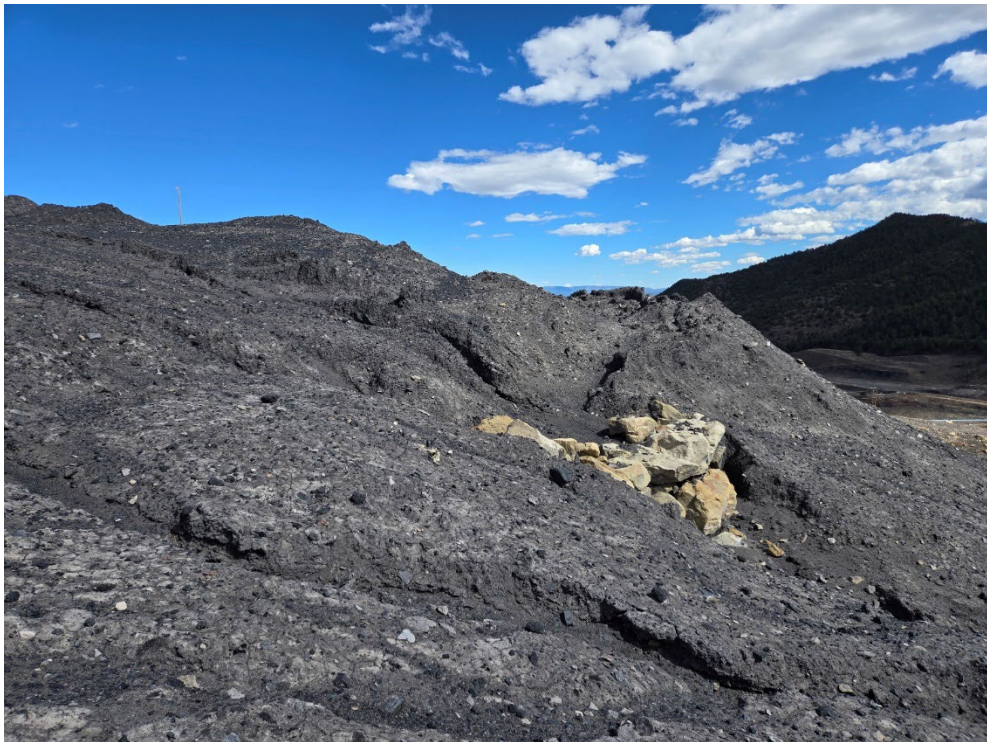
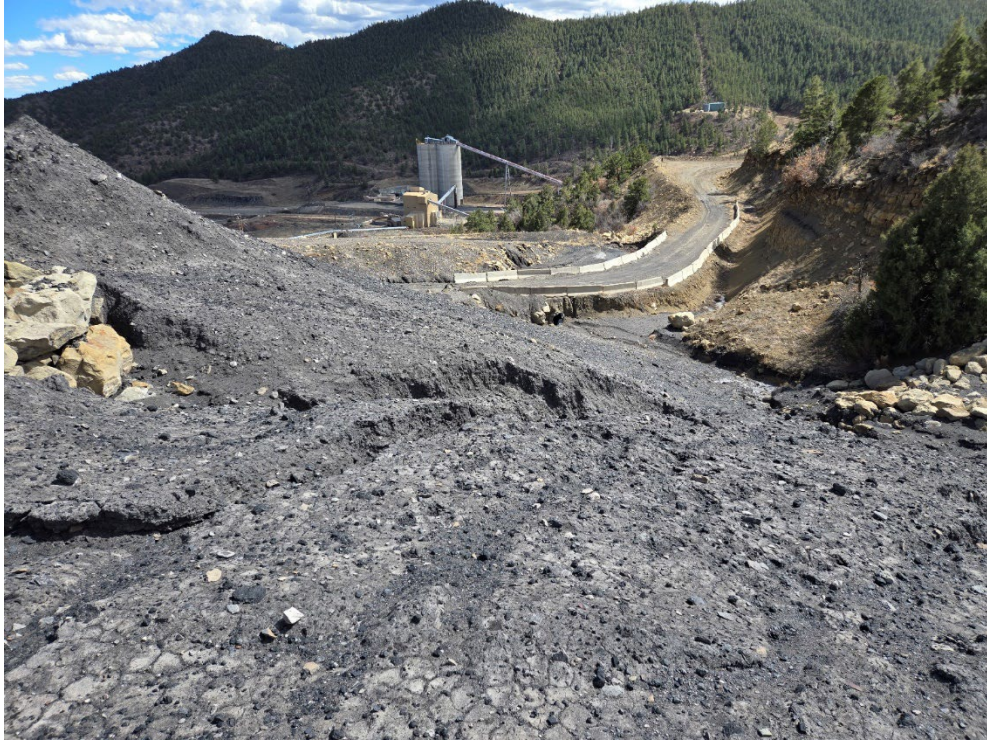
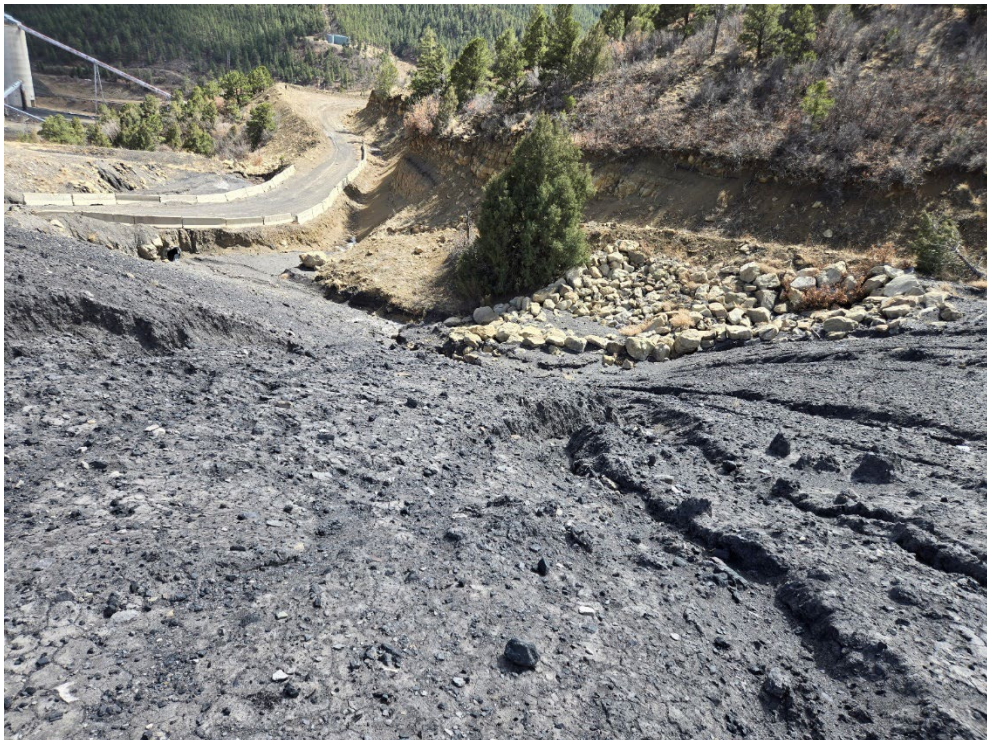
- (December 2024 report) RDA:
 - a. The northernmost bench, before the leveled area at the top of the RDA, has a small ditch that runs east-west toward the drainages on either side of the RDA. The west side of the bench has a check dam to help slow runoff into the area that leads to culvert C81. The check dam appears functional at the end of the ditch, but erosion has cut around on the slope next to the check dam in some areas, leading to increased sedimentation in the basin leading to C81. **The Operator shall implement additional erosion control structures along the west slope of the RDA to help reduce erosion on the slope, and stabilize the eroded slopes.**

Photo 10: Looking at the check dam along the backside of the most recent slope on the RDA.

Photo 11: Looking at where the top of the RDA is eroding into the unnamed ditch east of ditch D55 leads to C81.

Photo 12: Looking down at the unnamed ditch that leads to culvert C81 below the RDA road.

- **See Ongoing Maintenance Items, item #10 at the beginning of this report. Photos 10-12 correspond with #10a. Photo 13 corresponds with Item #10b. Photo 14 corresponds with Item 10#c. Photo 15 corresponds with Item 10#d.**

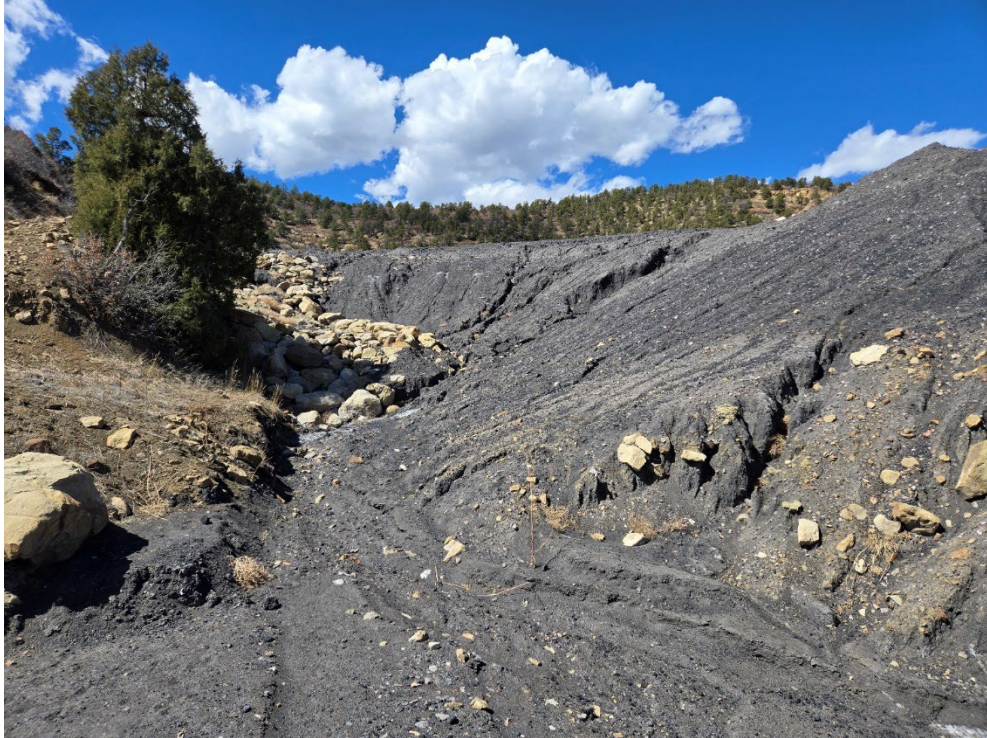
- b. The unnamed ditch east of D55, running along the west side of the RDA contains a few check dams to control run off and reduce erosion along the RDA. The southernmost check dam is damaged and is no longer functioning appropriately. It appears that water has undercut the check dam and has allowed for excess sediment to accumulate at the end of the ditch. **The Operator shall repair the check dam in the unnamed ditch leading to C81.**

Photo 13: Looking north along the unnamed ditch leading to culvert C81.

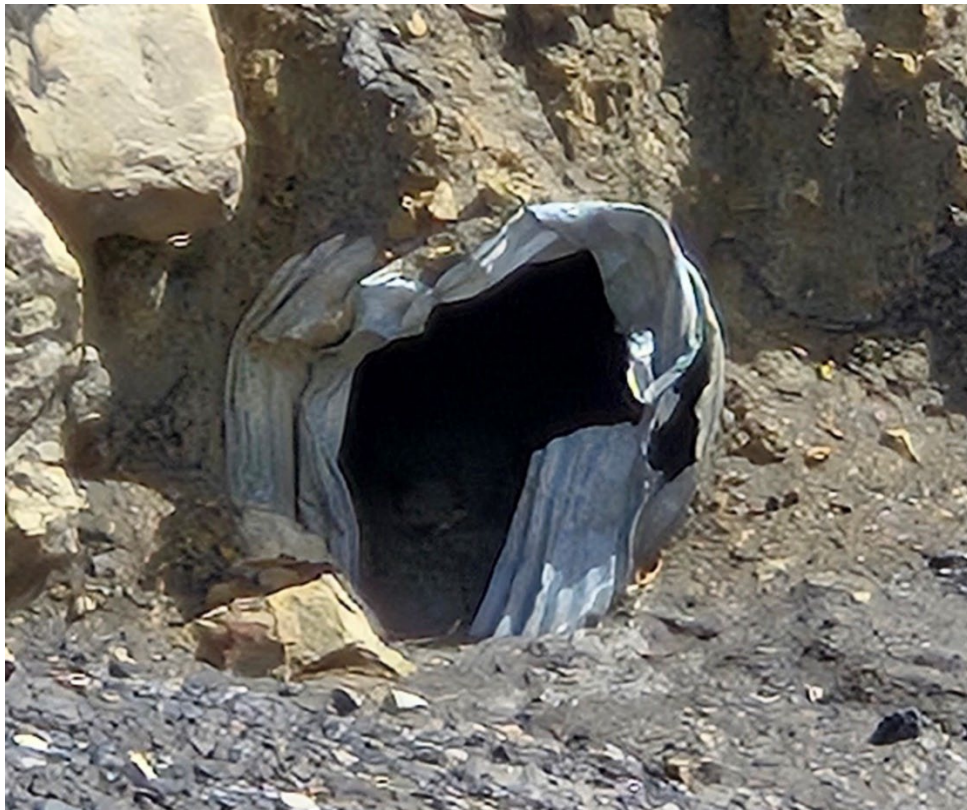
- c. There is a culvert (C81) at the end of ditch D55 and the unnamed ditch that allows runoff to flow under the road and out to the ditch leading to Pond 08. The inlet side of C81 (located on the north side) appears to be clear of obstructions at this time. **However, the Operator shall remove some of the sediment that has accumulated in the basin to the north of C81 to help minimize the sediment load deposited into Pond 08.**

Photo 14: North side of culvert C81.

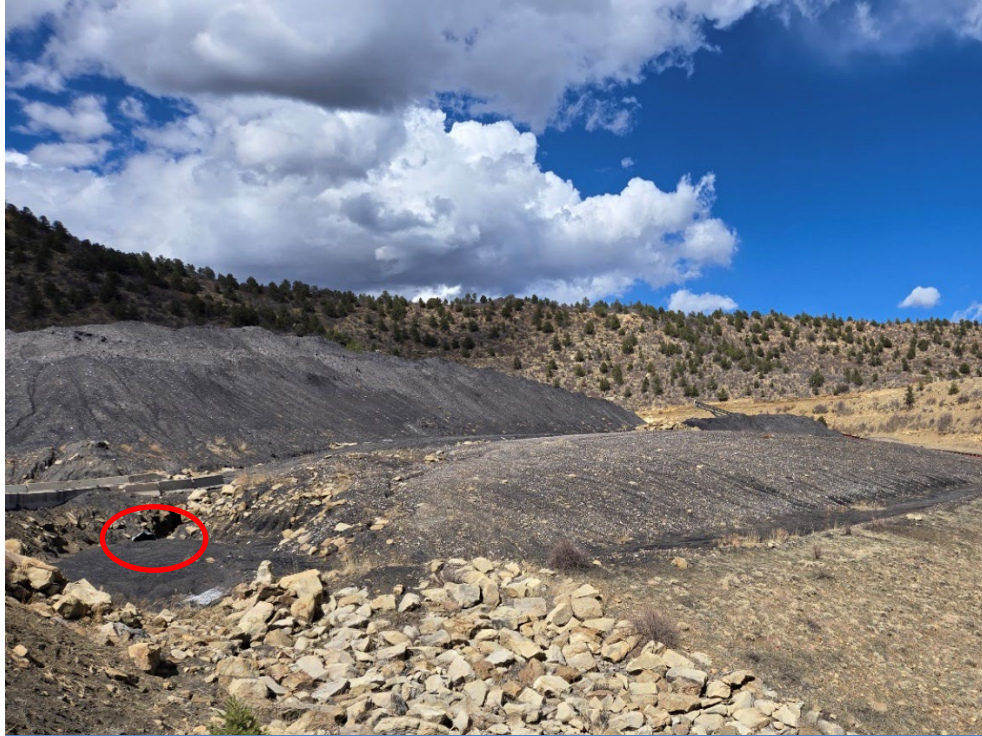
- d. The outlet side of C81 (located on the south side) has been partially filled with sediment. **The Operator shall clean sediment out of C81 and from the area around the culvert.**

Photo 15: Circled is the southside of C81.

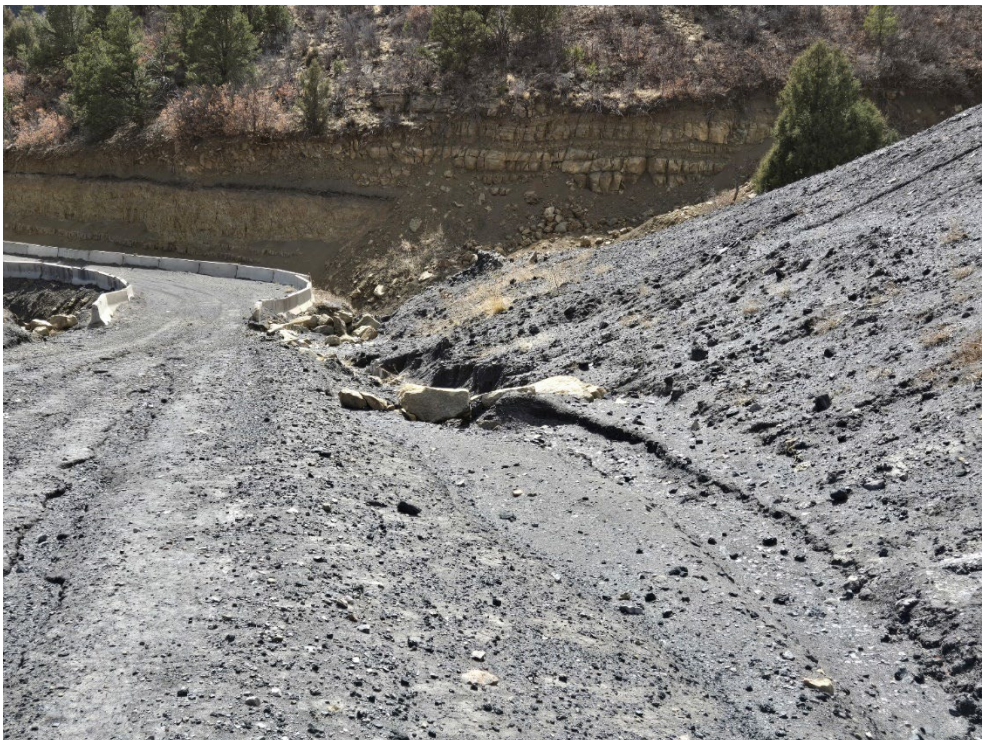
- Check dams line the north and south side of the road leading to the top of the RDA. These ditches along the road have filled with sediment, and many of the check dams in the ditch need to be repaired (Photo 16). **The Operator will need to clean the sediment from these ditches and repair the check dams.**

Photo 16: Looking along the ditch on the north side of the RDA road, at the toe of the most recently placed slope where check dams have been undercut.

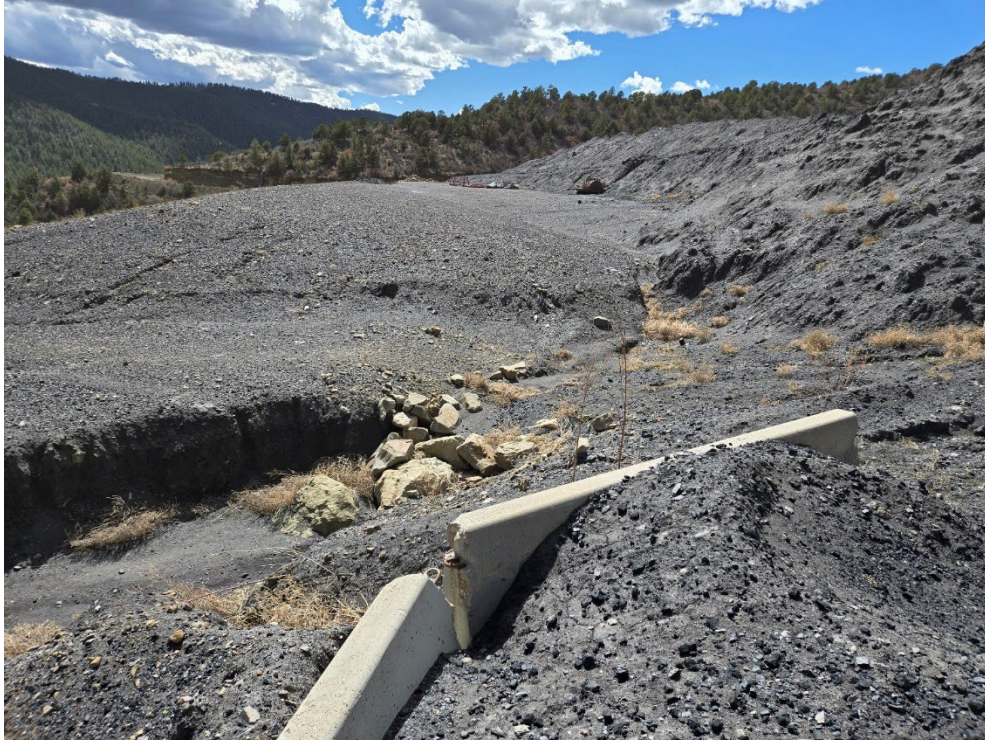
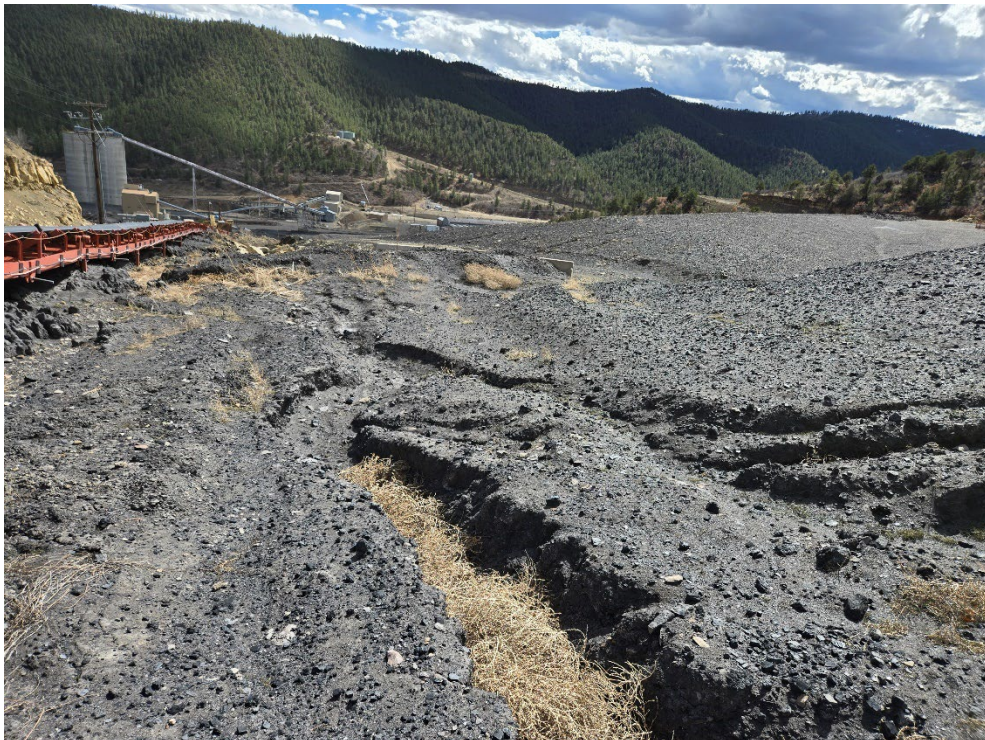
- The check dam on the east side of the unreclaimed slopes, leading to the conveyor belt, have filled with sediment and the area near the conveyor belt has deep erosion rills (Photos 17-18). **The Operator shall clean the sediment from this ditch, stabilize the area near the conveyor belt, and repair the ruts caused by the erosion.**

Photo 17: Looking at the check dam on the east side of the RDA area, leading to the conveyor belt area.

Photo 18: Looking at the erosion running along the west side of the conveyor belt.

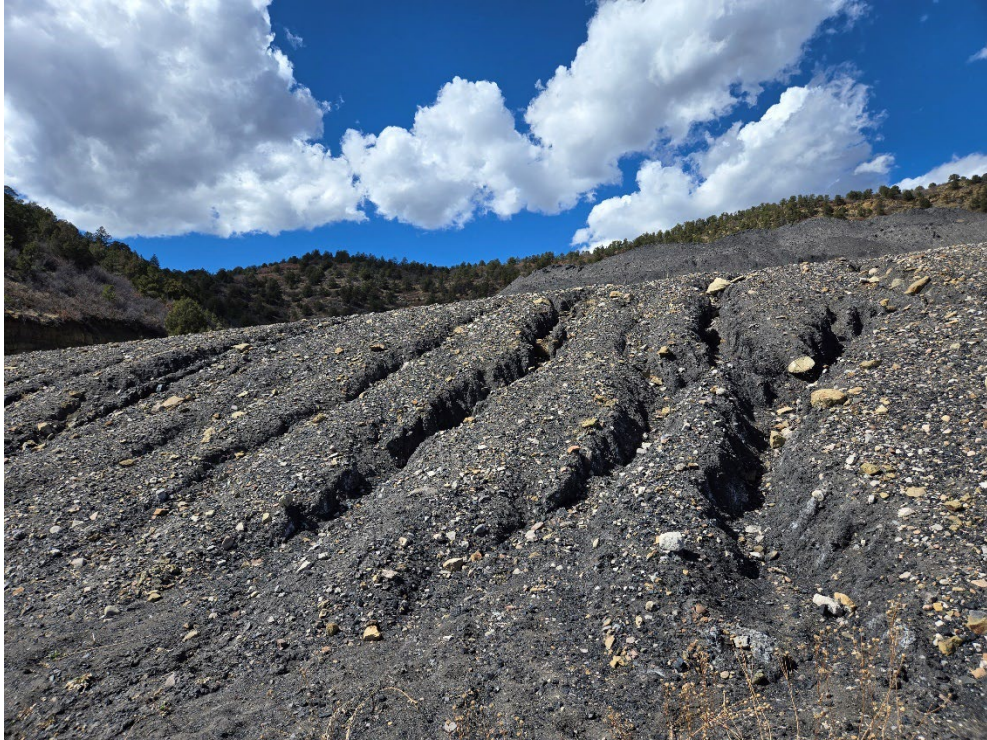
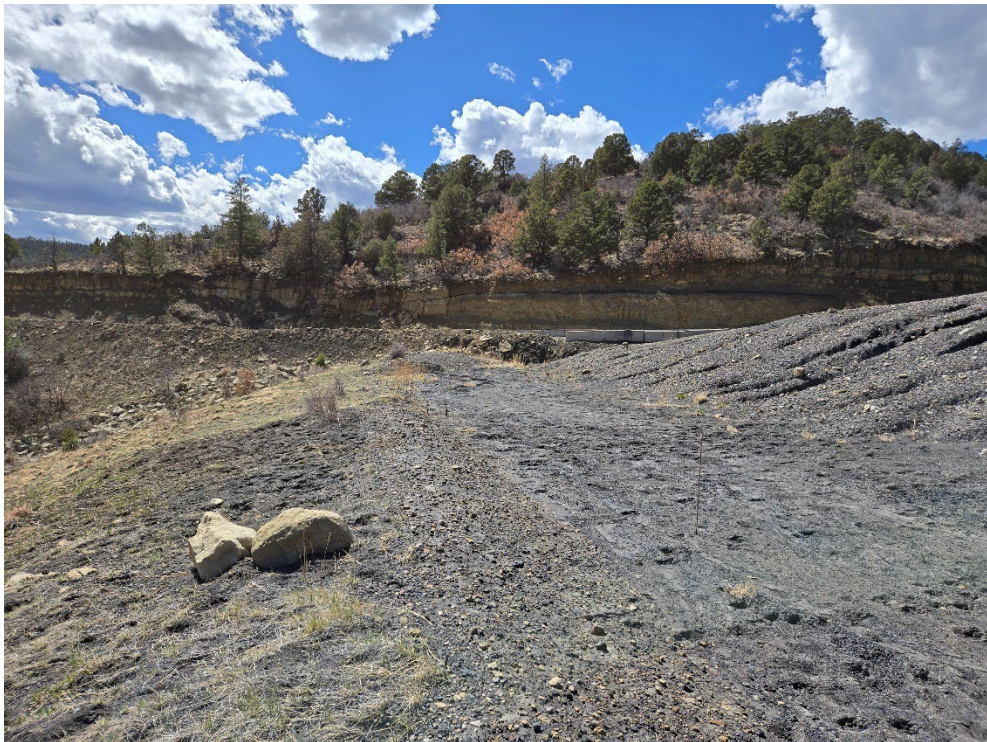
- The ditch at the toe of the oldest unreclaimed slope, above the most recently reclaimed slope, has filled with fine sediment. Deep erosion gullies have formed on the slope above the ditch (Photo 19). A small amount of sediment has run off onto the top of the reclaimed slope (Photo 20). **The Operator shall stabilize the**

Photo 19: Erosion rills on the south-facing side of the first unreclaimed slope.

Photo 20: Looking along the ditch above the most recently reclaimed slope.

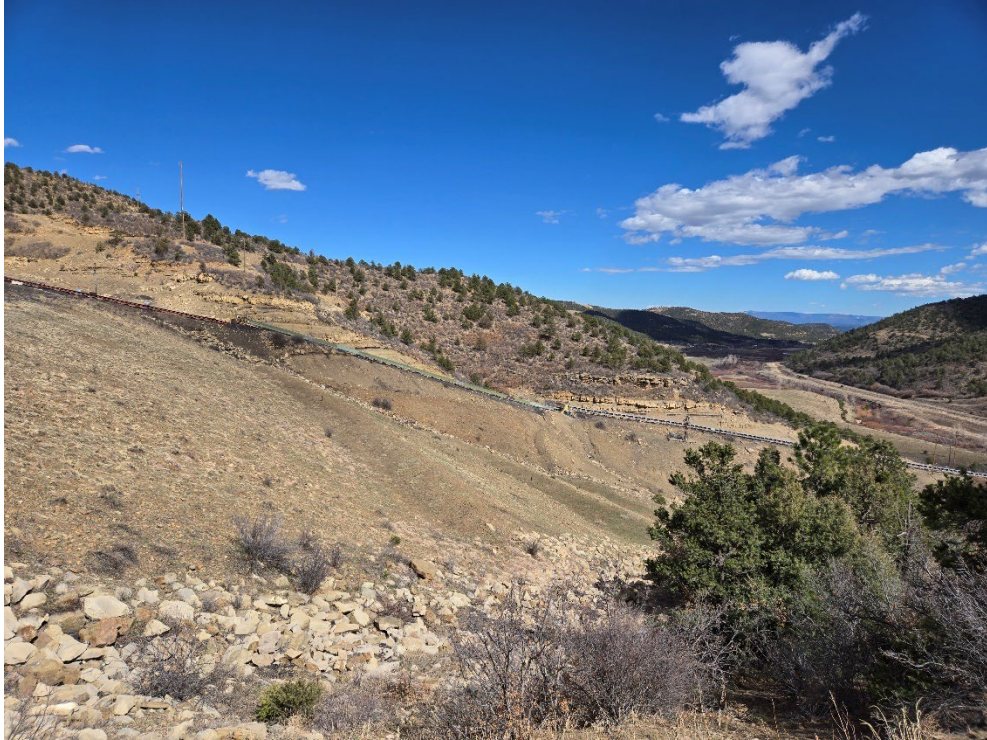
- The reclaimed slopes on the RDA appear to be well vegetated and stable (Photo 21). No signs of erosion on the reclaimed slopes were observed during the inspection.

Photo 21: Looking across the reclaimed RDA slopes.

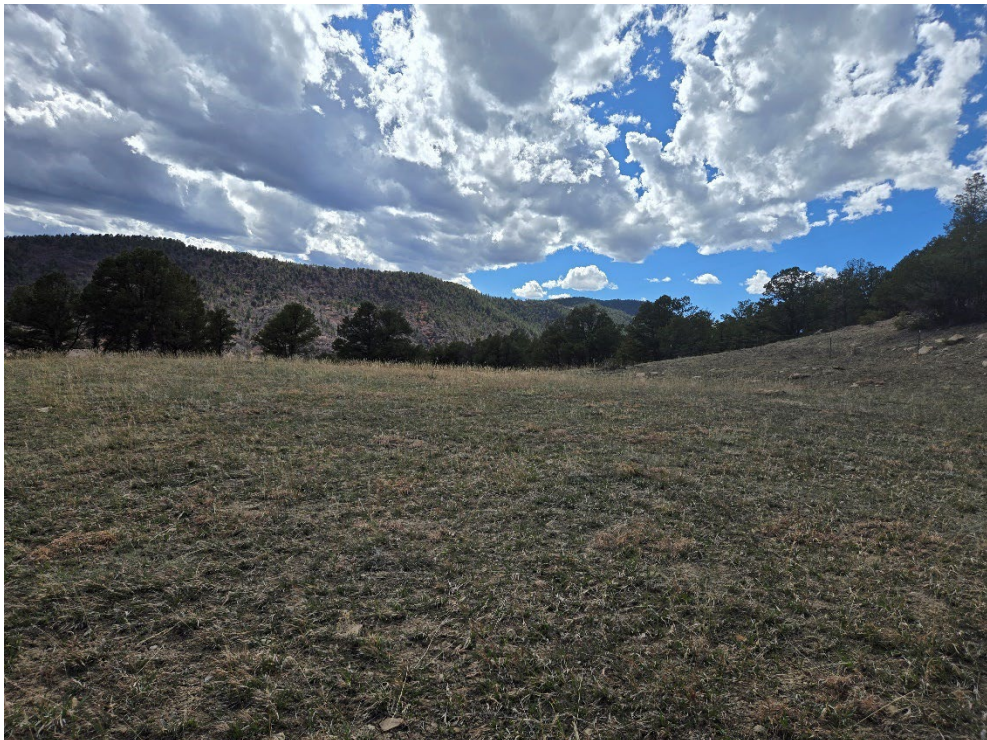
- (December 2024 report) During the Division's June 2024 inspection, it was noted that a lot more vegetation had established since the Division observed the area in November 2023, however there were still a few bare spots. During the September 2024 inspection, the vegetation cover seemed to be recovering. As of this December 2024 inspection, the vegetation seems to have stabilized, but the Operator may want to assess the area to determine species diversity. **The Operator is advised to monitor this area and consider re-seeding if necessary.**

Photo 22: Golden Eagle Ventilation shaft area.

- **See Ongoing Maintenance Items, item #11 at the beginning of this report and Photo 22.**
- The downslope area on the east side of the Golden Eagle ventilation shaft area contains silt fences to help control erosion from runoff onsite. All that remains is the rebar from the silt fences (Photos 23-24). It appears that this area is no longer experiencing erosion control problems, and that the rebar may be able to be removed once the Operator considers releasing the area.

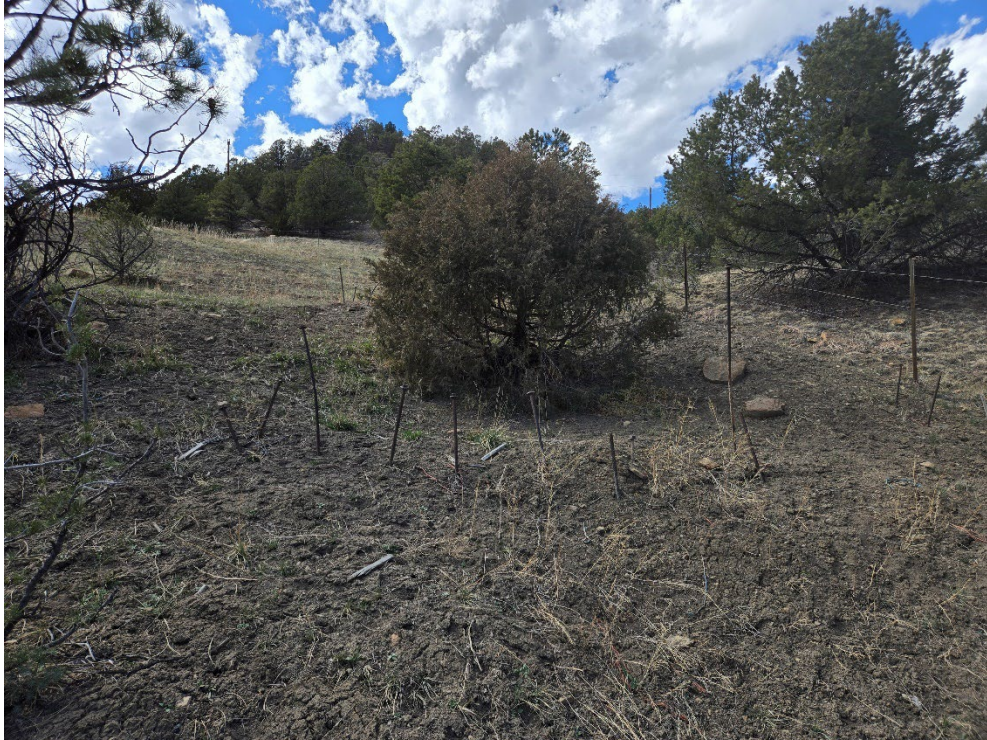
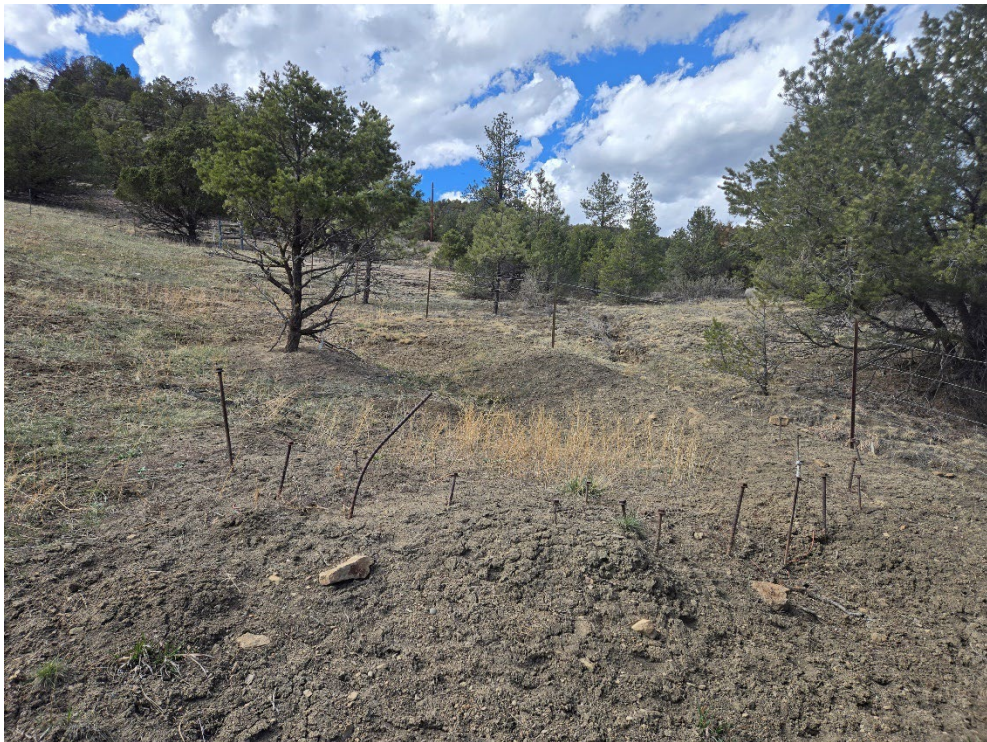
Photo 23: Rebar from silt fences on east side of the ventilation shaft area.

Photo 24: Rebar from silt fences on east side of the ventilation shaft area.

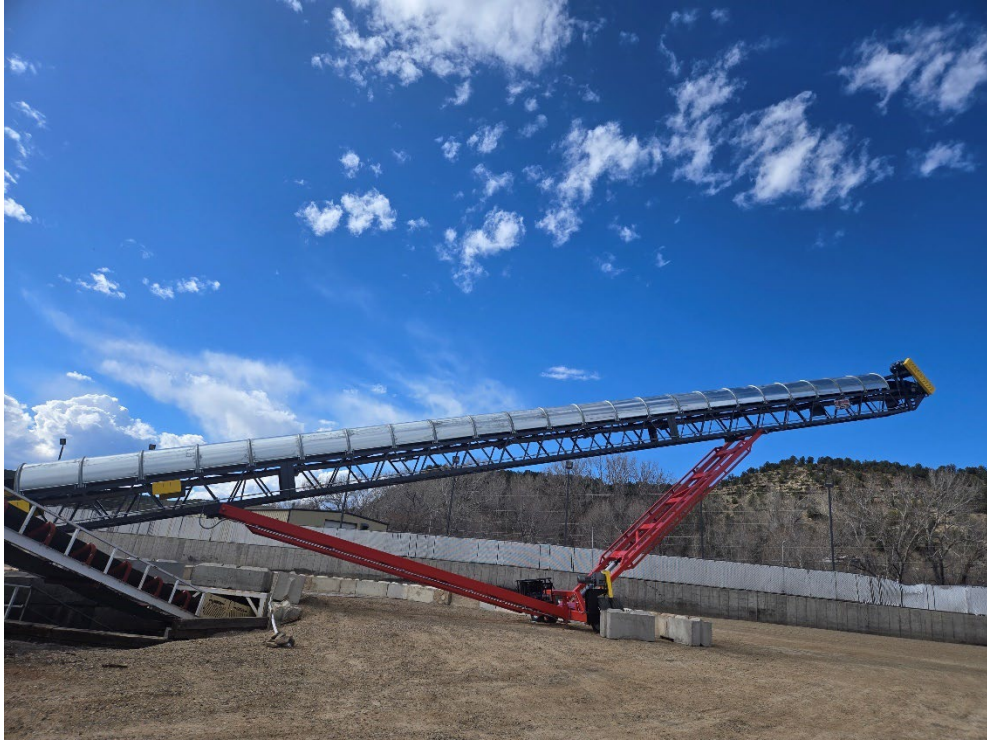
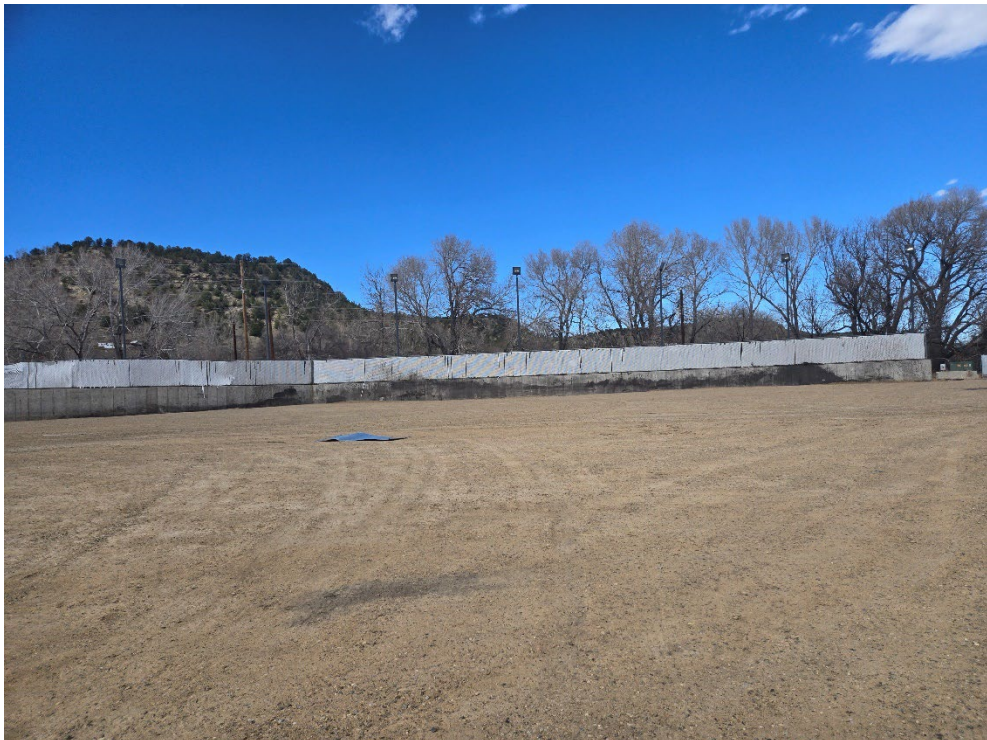
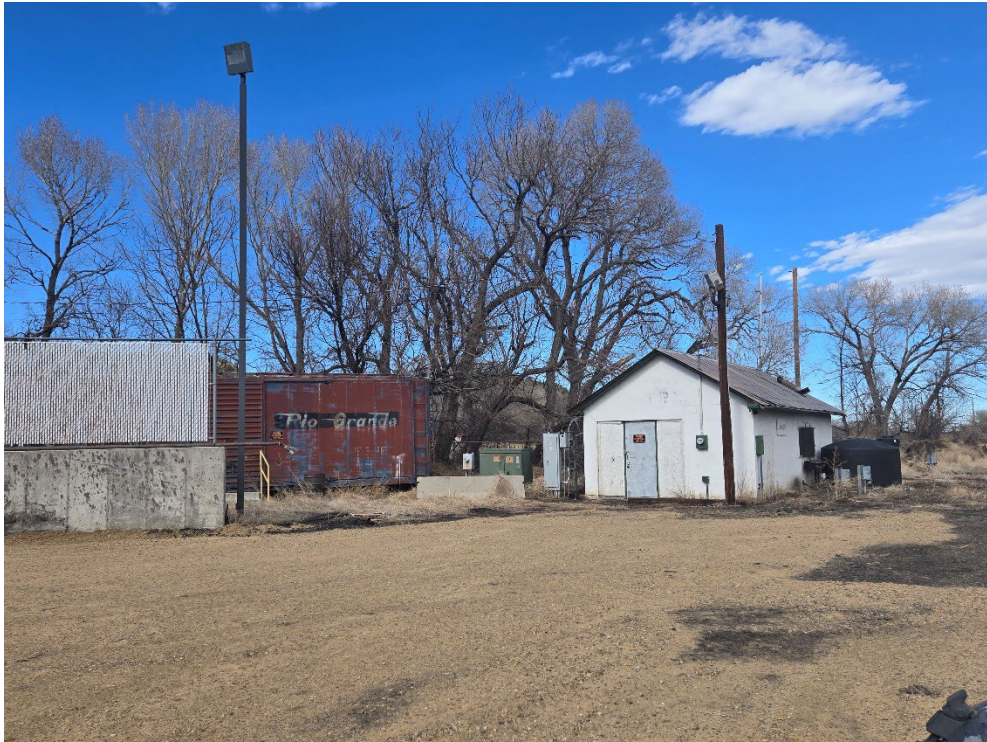
- The facilities at the Jansen Loadout were observed. All equipment on-site appears to be stable at the time of the inspection. A subcontractor for the current tenant was onsite during the inspection and stated that they were working on the conveyor belt system during the Division's December 2024 inspection report. During the March 2025 inspection, it appeared that many portions of the conveyor system have been replaced with new parts (Photo 25).
- Much of the coal in the yard area near the entrance has been removed/covered with what looks like soil and/or gravel (Photo 26). On the east side, near the office trailer, the yard has now also been graveled (Photo 27).
- See **Ongoing Maintenance Item # 13b**.

Photo 25: New conveyor belt part at the Jansen Loadout.

Photo 26: Graveled yard area at the Jansen Loadout.

Photo 27: Office building area is now graveled at the Jansen Loadout Area.
