Keenesburg inspection report

PERMIT INFORMATION

Permit Number: C-1981-028 Mine Name: Keenesburg Strip Mine Operator: Coors Energy Company Operator Address: Mr. Ben Moline P.O. Box 4030 Golden, CO 80402	County: Weld Operation Type: Surface Permit Status: Permanent Cessation Ownership: Private
	Operator Representative Present: None
Operator Representative Signature: (Field Issuance Only)

INSPECTION INFORMATION

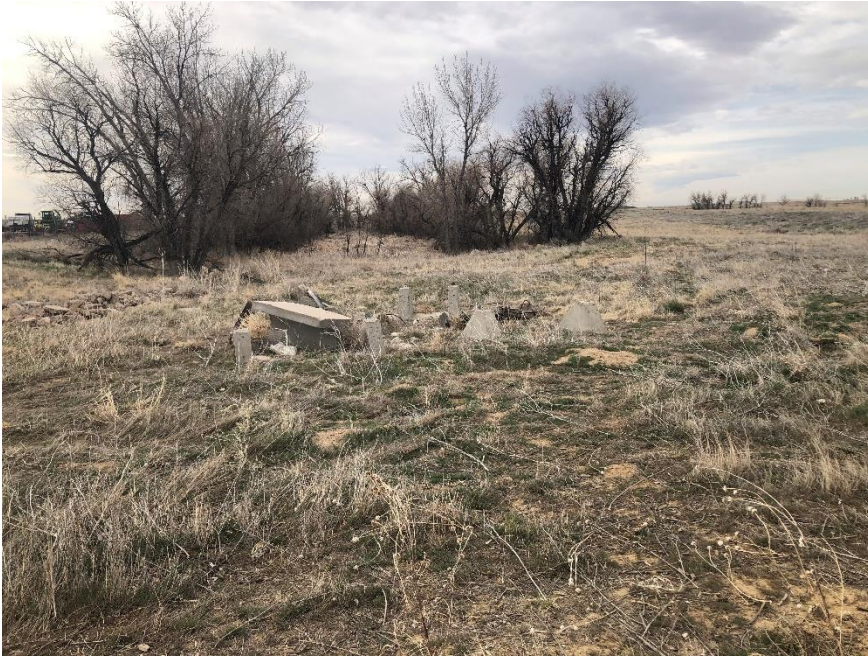
Sediment Pond 2 and the Dugout Pond contained no visible water. The bottoms of both ponds are obscured by vegetation. Neither was discharging during the inspection, and there were no signs that the ponds had discharged recently. No problems were observed with inlets, spillways, or other parts of the ponds.

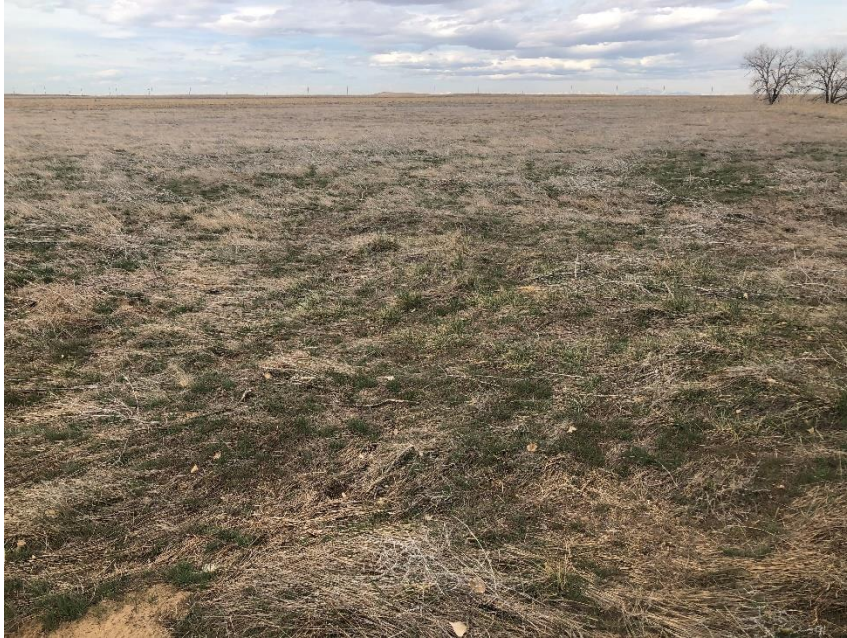
No weed problems were identified. Green grass was emerging in some areas, including Area 42, west of Area 26. One area in the Long Term Spoil Area (Area 36, near Area 37) was largely devoid of vegetation.

Green grass emerging in Area 42, west of Area 26

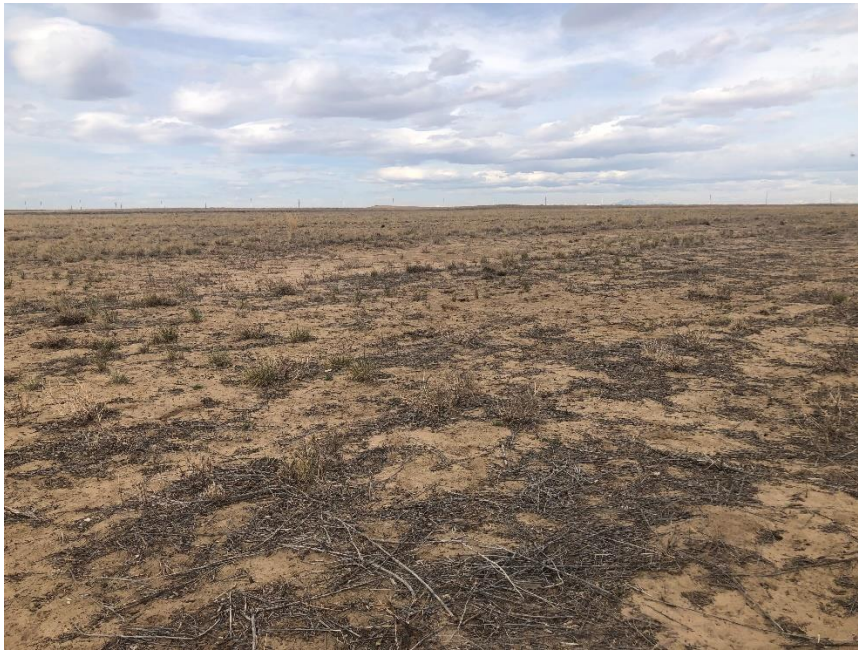
Bare spot in Long Term Spoil Area (Area 36)

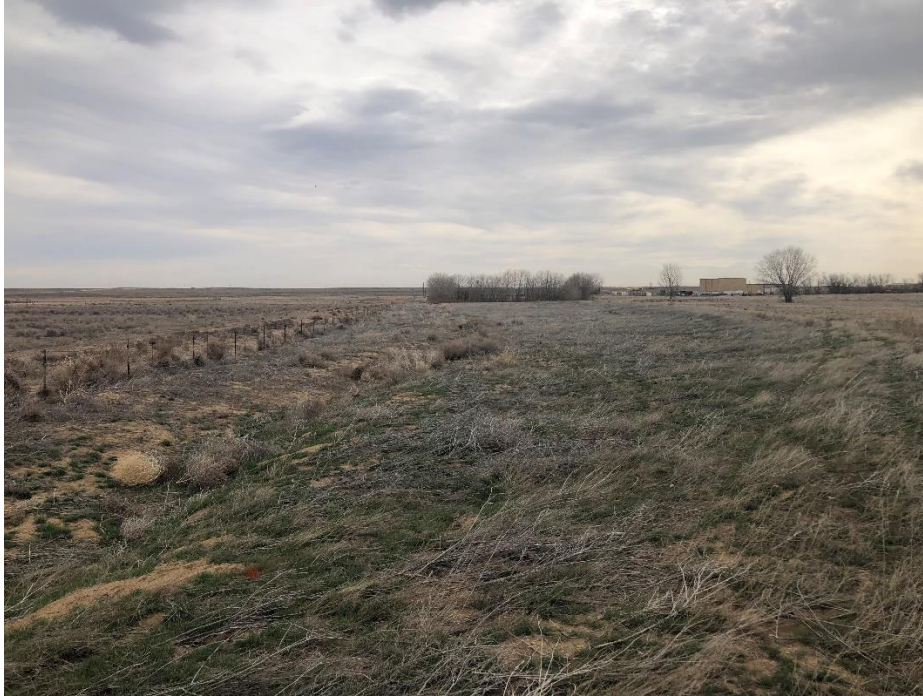
The ditch along the northern boundary was functioning.

Northern boundary and ditch, looking east at Sediment Pond 2

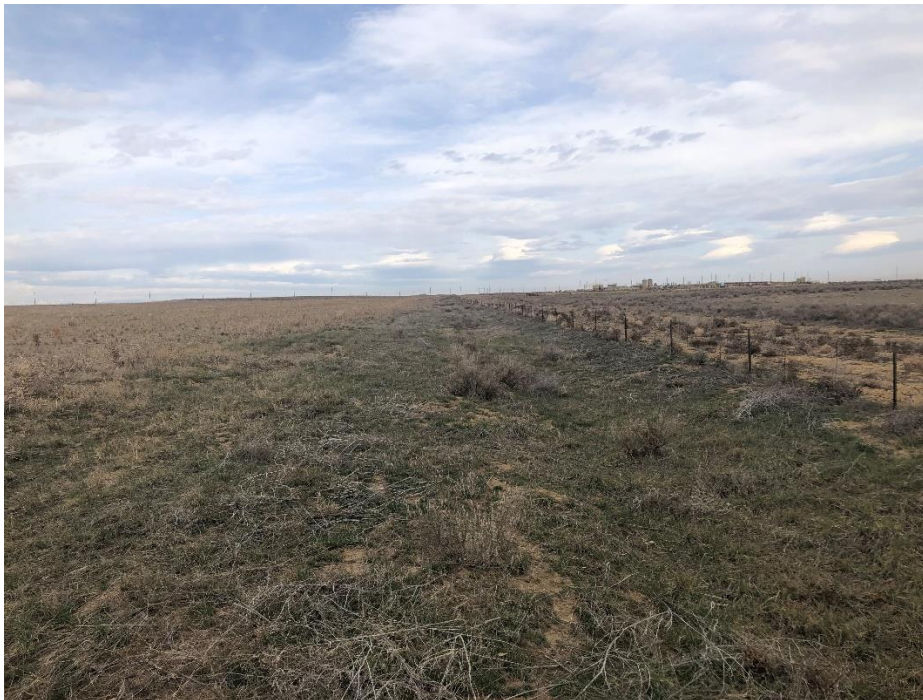
Northern boundary and ditch, looking northwest
