MINERALS PROGRAM INSPECTION REPORT
PHONE: (303) 866-3567

MINE NAME: Moore's Agg Fields	MINE/PROSPECTING ID#: M-2023-044	MINERAL: Unknown commodity	COUNTY: Mesa
INSPECTION TYPE: Illegal(Unpermitted Operation)	WEATHER: Clear	INSP. DATE: April 2, 2025	INSP. TIME: 10:00
OPERATOR: Moore's Ranching	OPERATOR REPRESENTATIVE: Leon and Ray Moore's	TYPE OF OPERATION: IM - Is it Mining	
REASON FOR INSPECTION: Citizen Complaint	BOND CALCULATION TYPE: None	BOND AMOUNT: \$0.00	
DATE OF COMPLAINT: NA	POST INSP. CONTACTS: DRMS	JOINT INSP. AGENCY: None	
INSPECTOR(S): Amy Yeldell	INSPECTOR'S SIGNATURE:

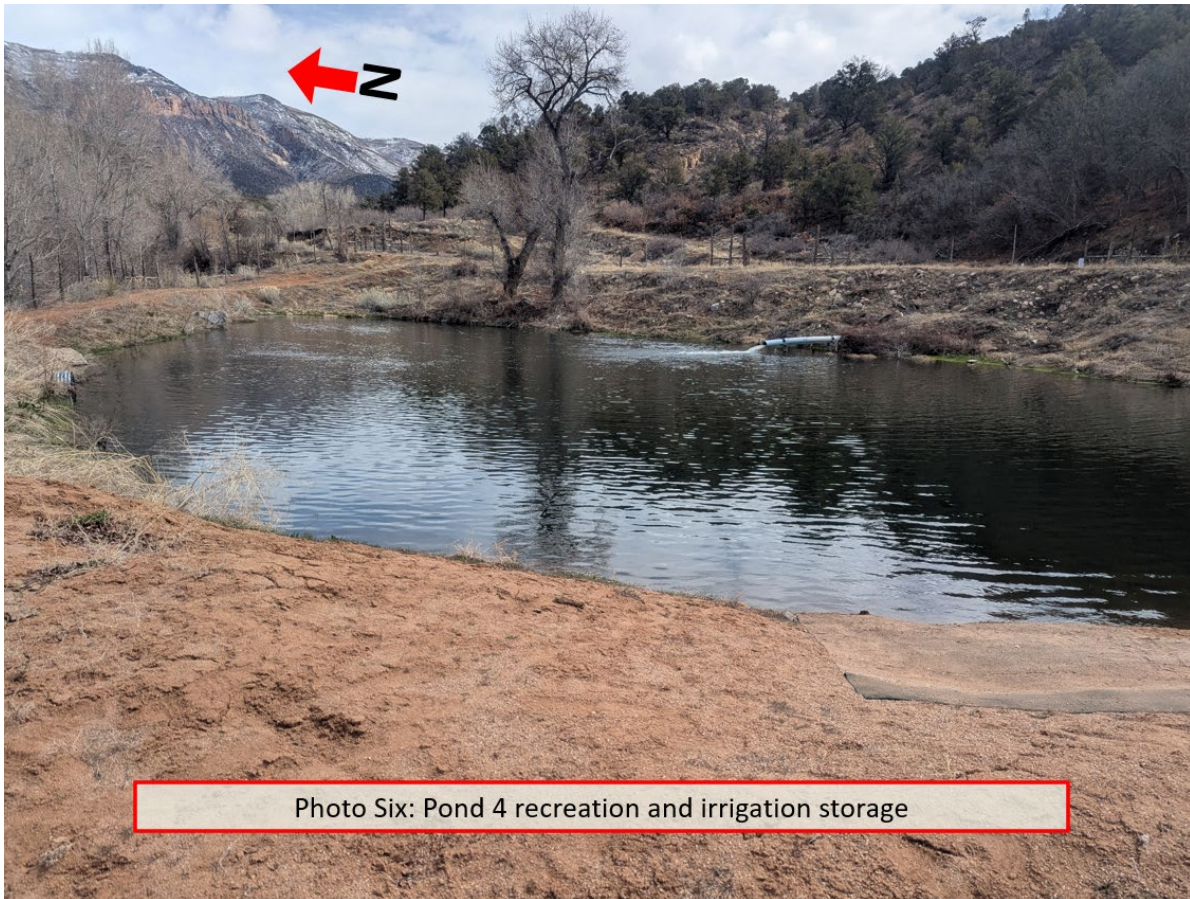
Areas 3 and 4 are ponds. They store excess irrigation water and have been stocked with fish for recreational fishing. Mr. Moores indicated that they have permits on them for stocking of the fish. Banks appear stable with no indications of recent excavations. There is a road to the southeast of the pond in Area 4 that was created for hunting access.

Photo Six: Pond 4 recreation and irrigation storage

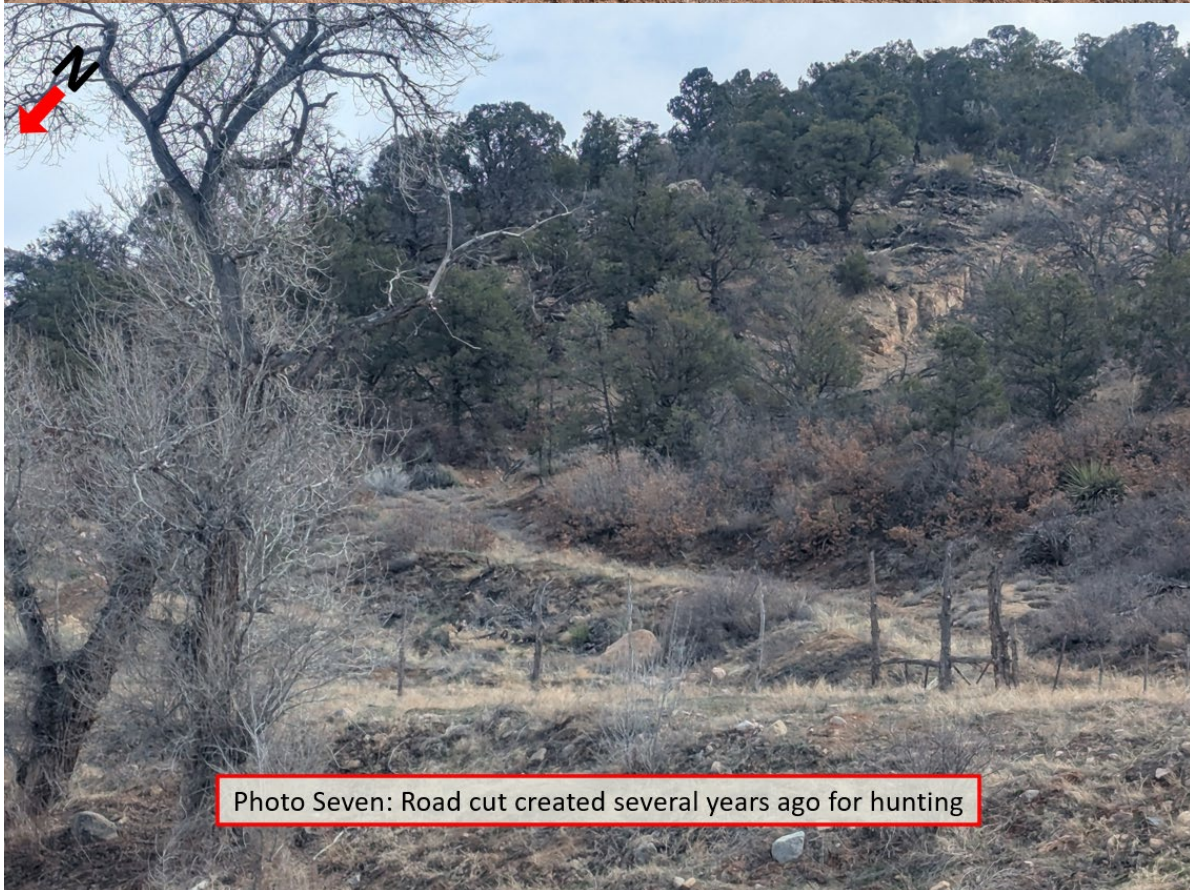
Photo Seven: Road cut created several years ago for hunting

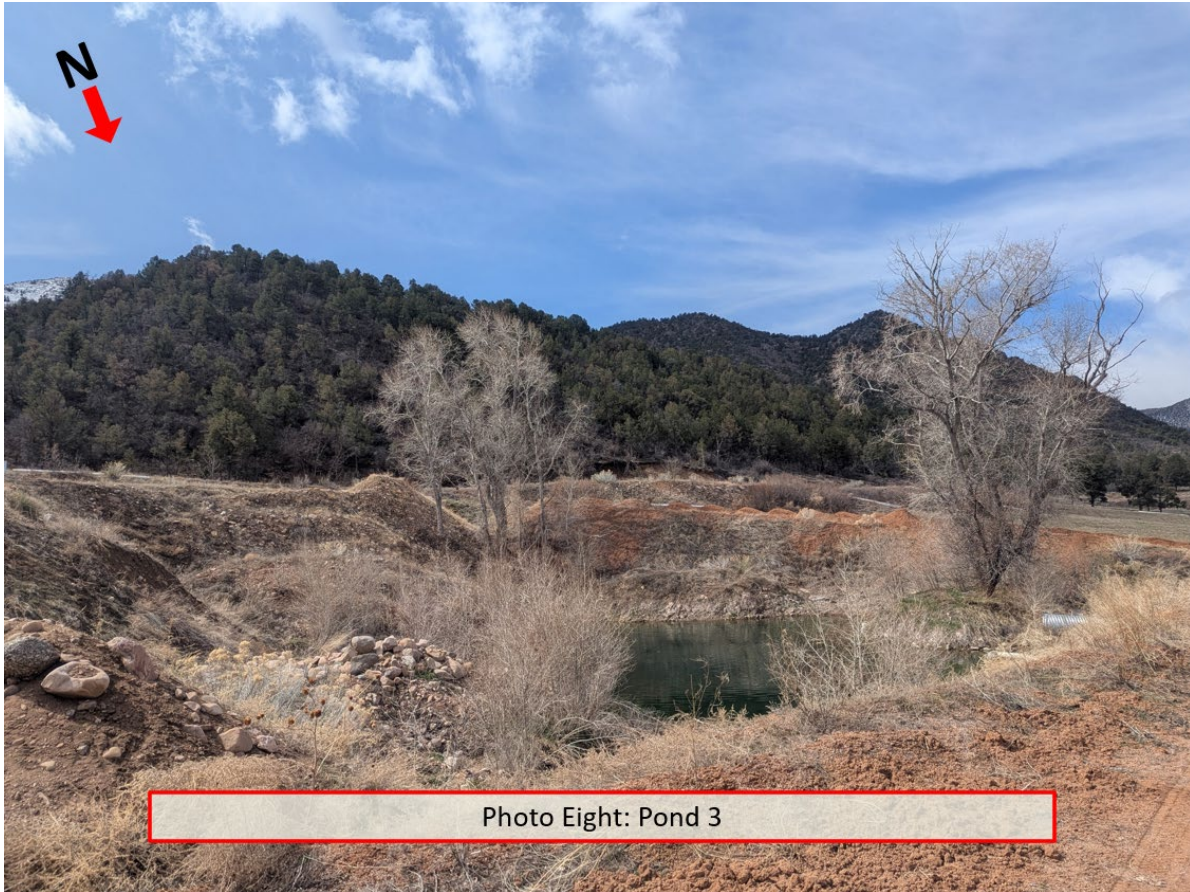
Photo Eight: Pond 3

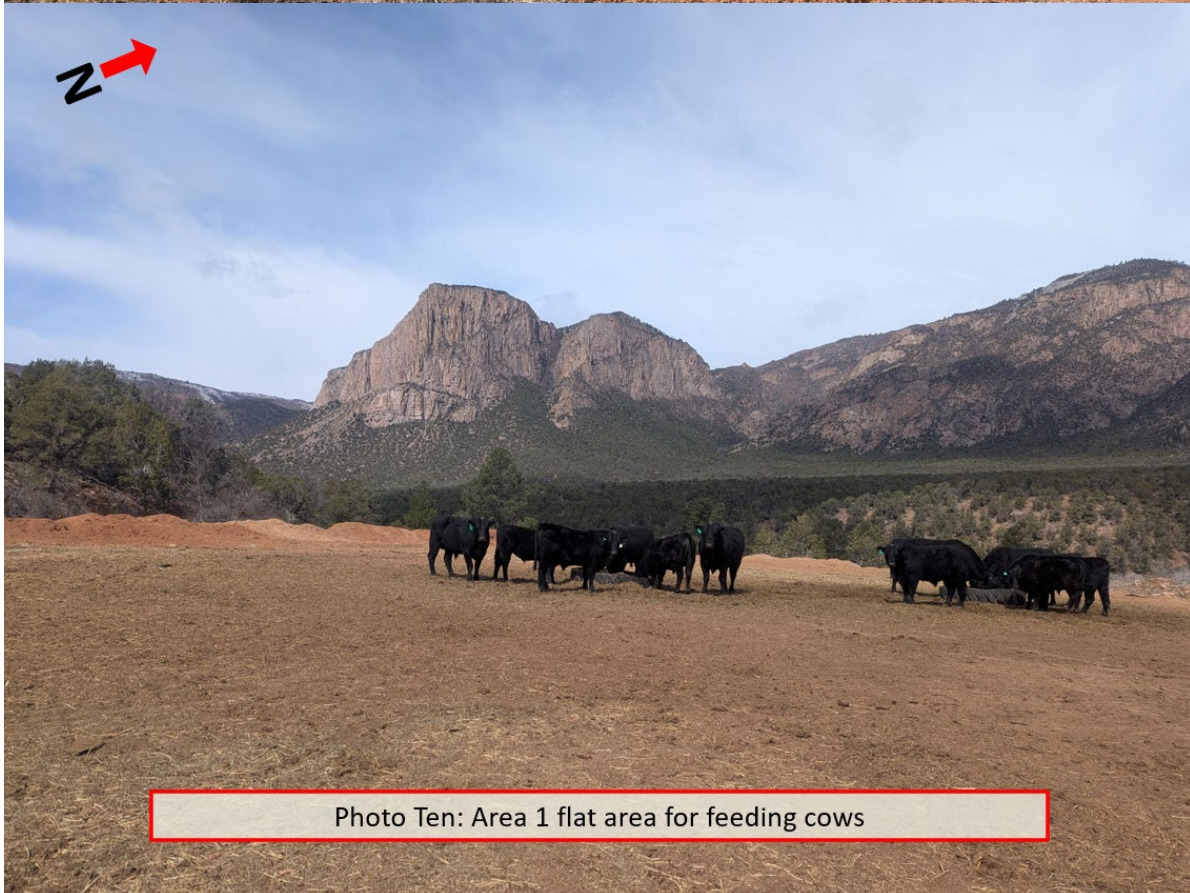
Area 1 was previously investigated in December of 2023. No changes to the site have been made. A screen was located on site but has not been used within the past year. The upper field is flat with fines and being used to feed livestock. The lower field portion has not been completed and is mostly a rocky field. The intention is to clear rocks and level to increase irrigable land and grazing. There is piped irrigation to this area. A road extends from Area 1 to Area 2. This is for agricultural use to check cows and hunting and public land access.

Photo Ten: Area 1 flat area for feeding cows
