## Bowie #1 inspection report

**PERMIT INFORMATION**

<b>Permit Number:</b> C-1981-038 <b>Mine Name:</b> Bowie No. 1 Mine <b>Operator:</b> Bowie Resources, LLC <b>Operator Address:</b> Mr. Art Etter P.O. Box 1488 Paonia, CO 81428	<b>County:</b> Delta <b>Operation Type:</b> Underground <b>Permit Status:</b> Active <b>Ownership:</b> Private
	<b>Operator Representative Present:</b>  None
<b>Operator Representative Signature: (Field Issuance Only)</b>

**INSPECTION INFORMATION**

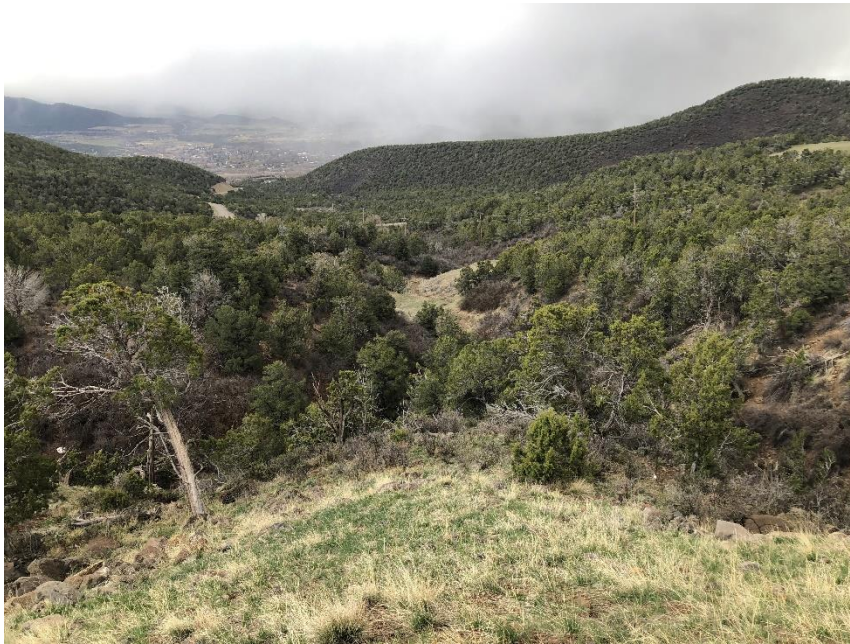
No problems were identified with the reclamation in the area of Ponds 1, 2, 3, and 4 (East Mine).

**Reclaimed Ponds 3 and 4 at East Mine, looking down the valley from the Old Waste Disposal Area**

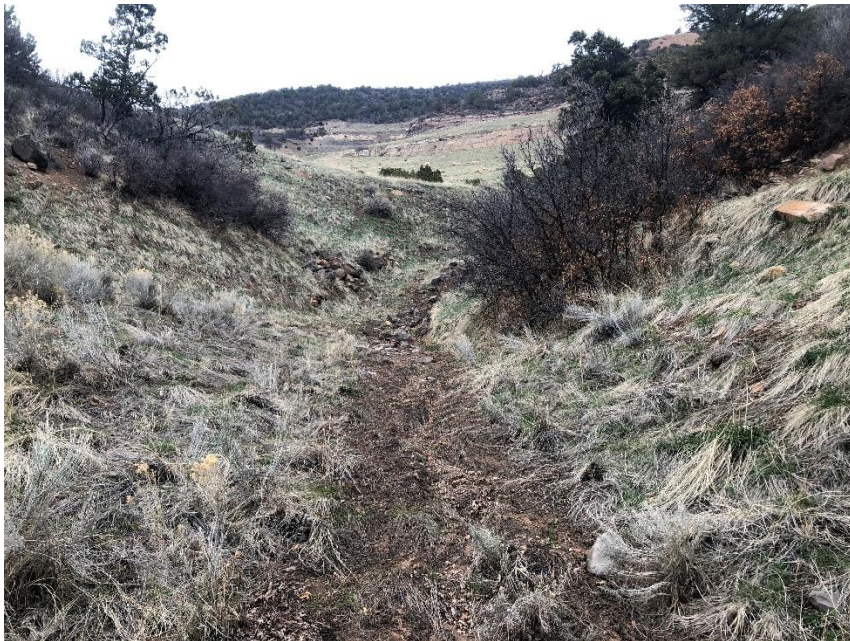
**Reclaimed Pond 2 at the East Mine, looking up the drainage**

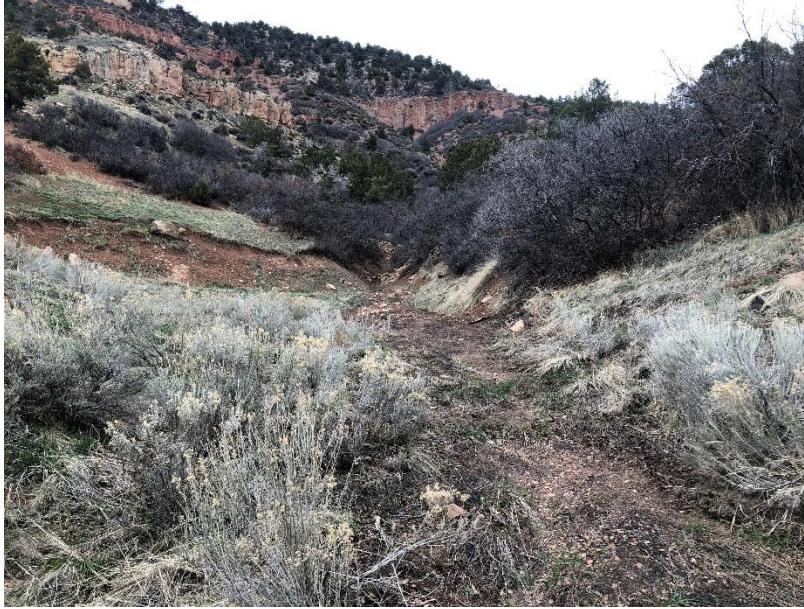
**Reclaimed Pond 1 at the East Mine, looking up the drainage**

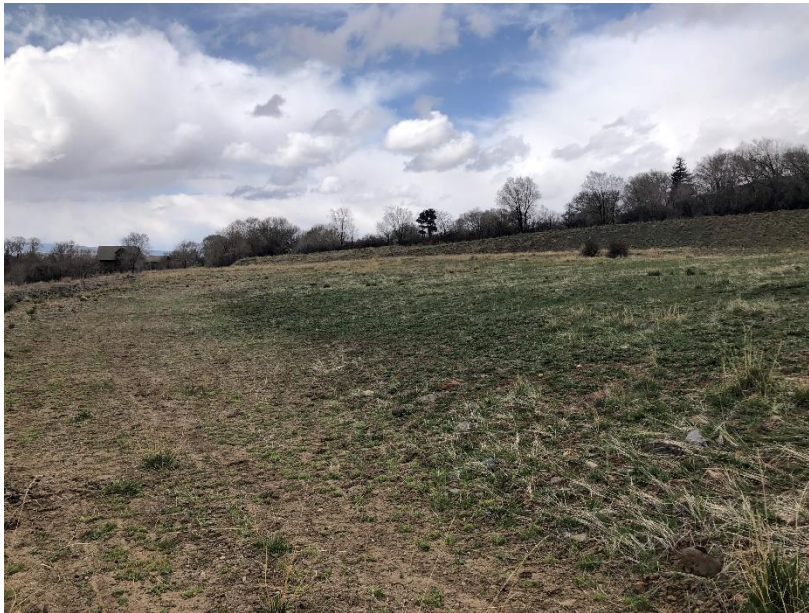
The ponds at the loadout and the Coal Storage Area (near Black Bridge Road and the highway) contained no water. No problems were identified with embankments, spillways, or other aspects of these ponds.

No erosion or other problems were seen with the Coal Storage Area beside Highway 133.

**Coal Storage Area by Highway 133**

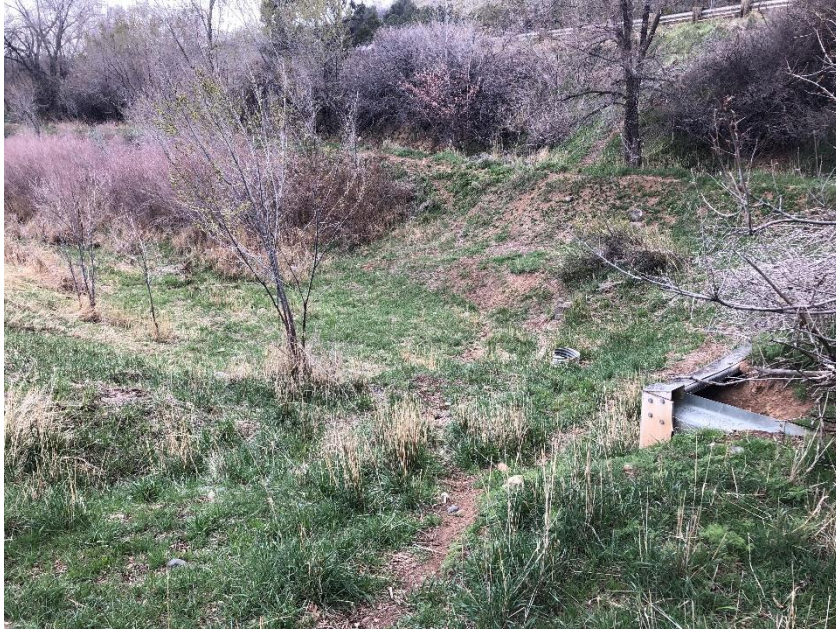
**Pond at the loadout**

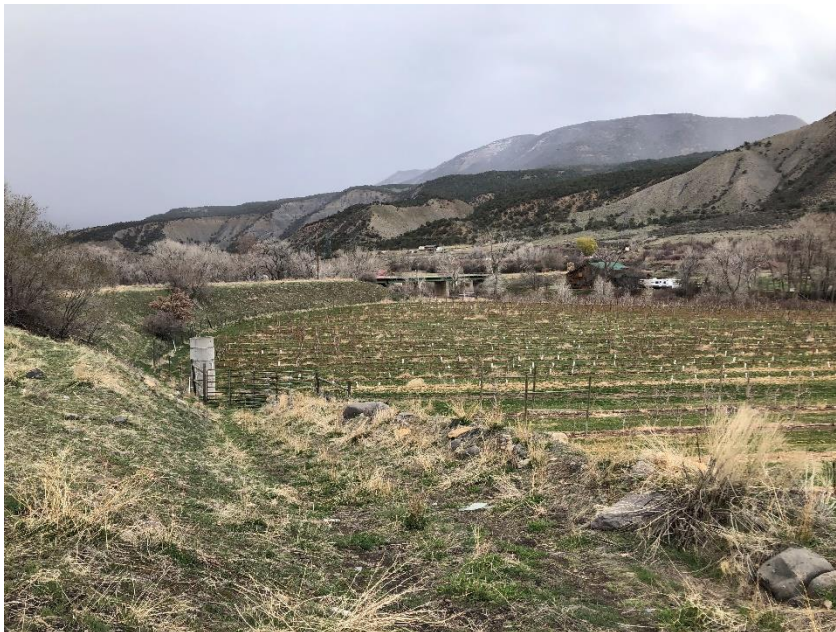
No erosion was seen at the loadout, including the steep slope between the loadout and the orchard below. The trestle across the river appears stable.

**Slope below loadout with the trestle in background**
