Bowie #2 inspection report for April

PERMIT INFORMATION

Permit Number: C-1996-083 Mine Name: Bowie No. 2 Mine Operator: Bowie Resources, LLC Operator Address: Mr. Art Etter P.O. Box 1488 Paonia, CO 81428	County: Delta Operation Type: Underground Permit Status: Active Ownership: Private
	Operator Representative Present: None
Operator Representative Signature: (Field Issuance Only)

INSPECTION INFORMATION

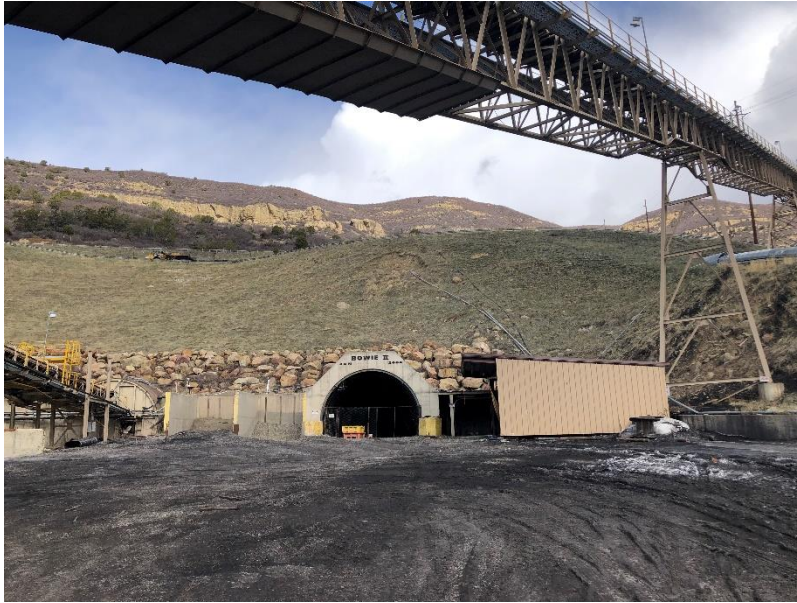
No problems were seen on the slopes above and below the benches. The slides above the B Portal Bench and Curve 11 (noted in the past) look stable. The slide above Curve Number 10 also looked stable, compared to inspections in recent months.

Slump at B Portal Bench (north side)

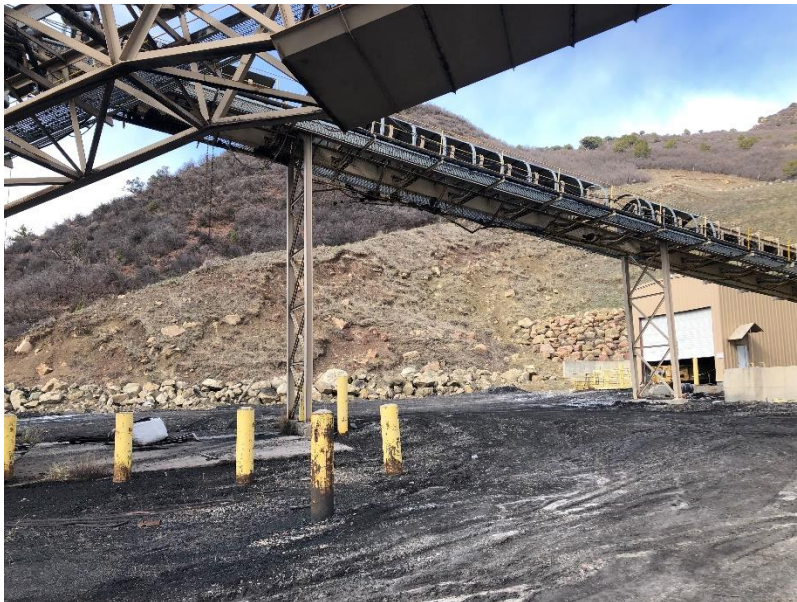
Slump at B Portal Bench (west side)

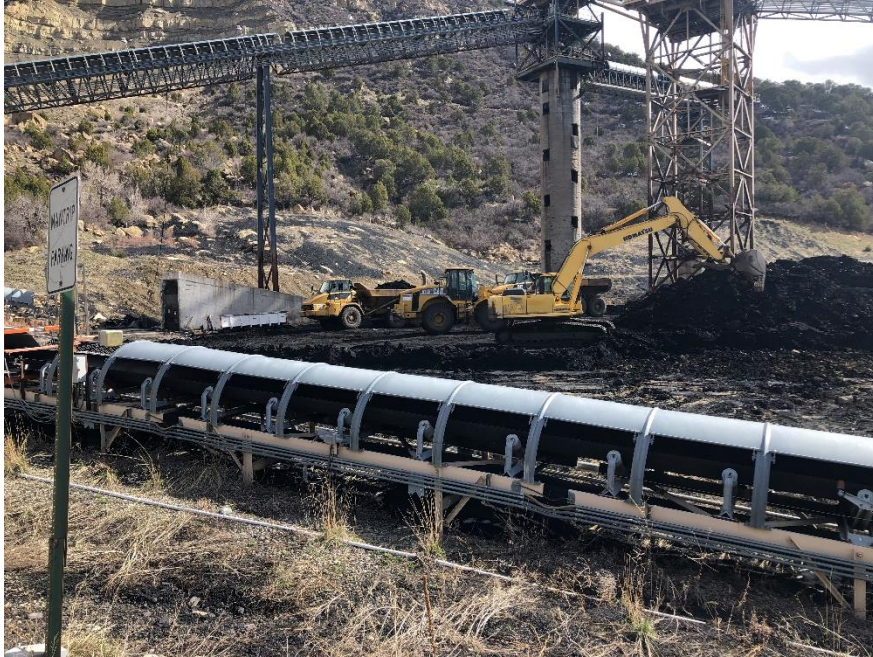
BRL staff were hauling material (soil stained with coal) from the D Portal Bench to Gob Pile #2. The purpose of this operation is to improve drainage from this bench, which will help prevent the slide below (above Curve 10 on the haul road) from getting worse. An excavator, loader, and two haul trucks were being used.

Work on D Portal Bench

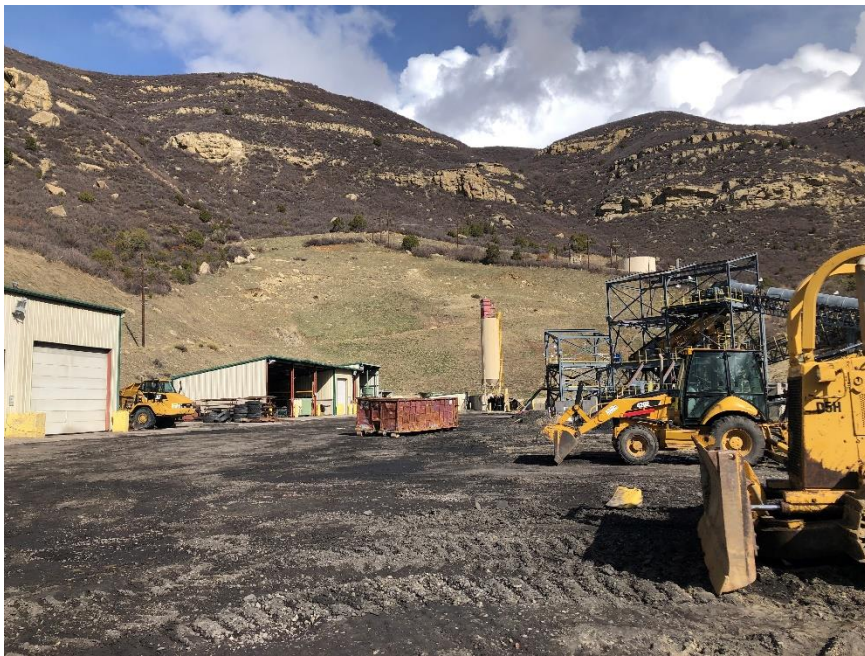
D Portal Bench and slope below Utility Bench

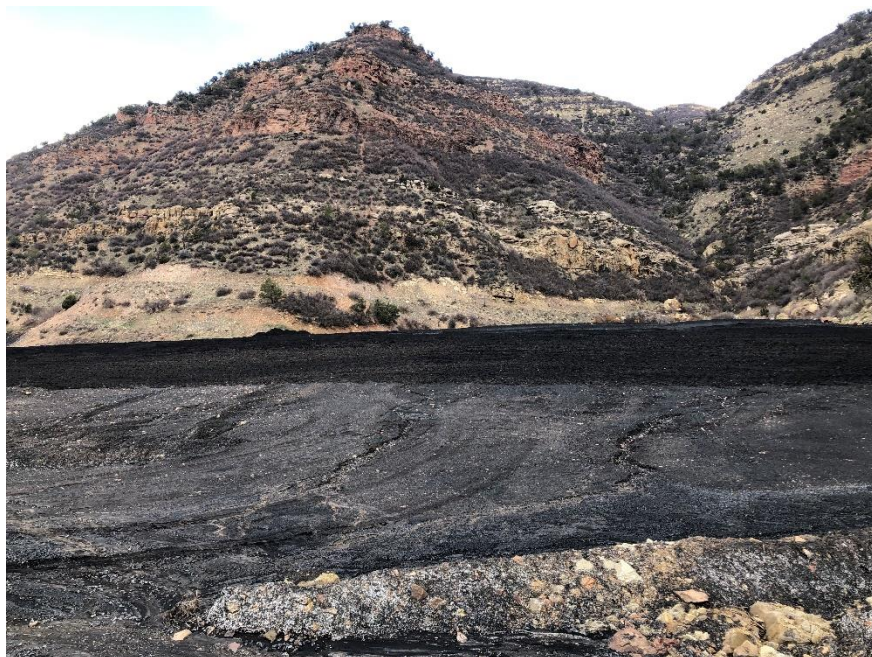
On the upper part of Gob Pile #2, piles were seen on the northern portion of this area. This is the material that is being hauled from the D Portal Bench. On the southern portion of this area, the material has been graded, and some drainage channels have been cut. BRL staff indicated that they are grading the material daily.

Upper portion of Gob Pile #2 (newly placed piles of material in back)

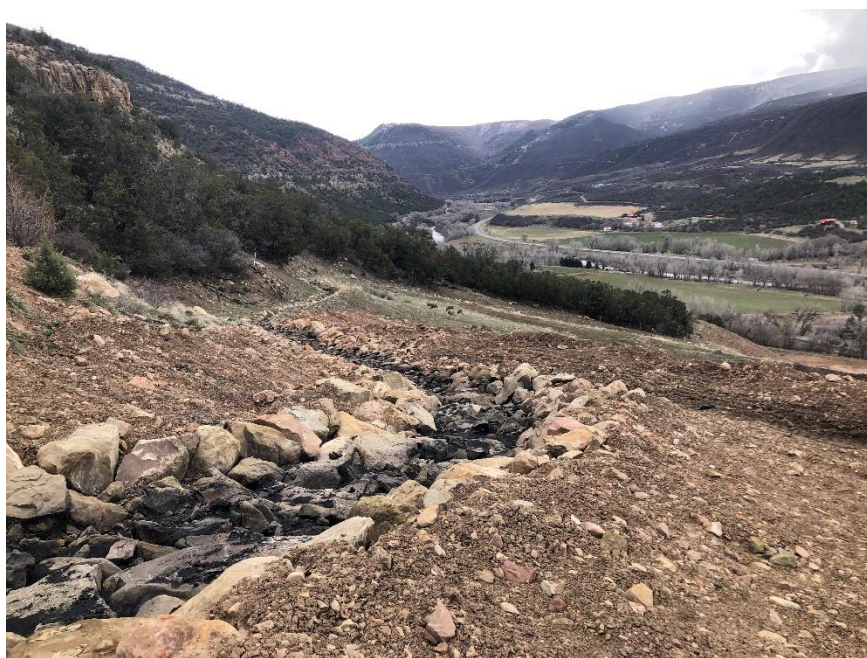
Several deer were seen on the east side of Gob Pile #2.

Ditch below Gob Pile #2 and deer

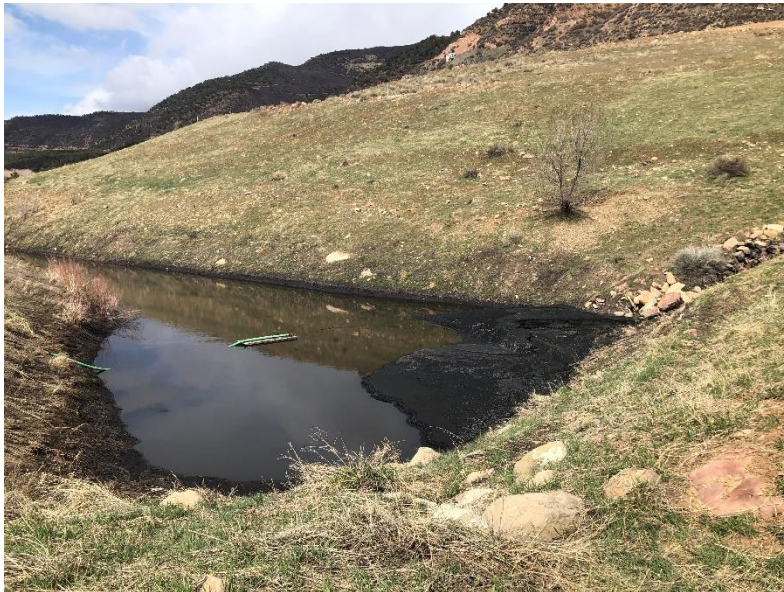
Pond F

Six sediment ponds were inspected: B, C, D, F, J, and K. None of the ponds was close to discharging, but five of them contained water. Pond K was the exception; it was dry. No significant problems were identified with embankments, spillways, inlet channels, or other features of the ponds. A large amount of black sediment was seen by the inlet into Pond F; apparently this is from Gob Pile #2.

To address sediment loading into Pond F, BRL has flattened the ditches on the upper part of Gob Pile #2. BRL

has also removed the sediment trap below the upper part of Gob Pile #2 to eliminate ponding on the pile. The Division agrees with both of these practices.
