Re: GCC Energy, LLC, King II Mine  
CDRMS Permit # C-1981-035  
Sunder, Miller & Associates: Quarterly Inspection: Refuse Pile 1<sup>st</sup> Quarter 2025

March 27, 2025

RE: King Coal I – Quarterly Waste Pile/Embankment Inspection

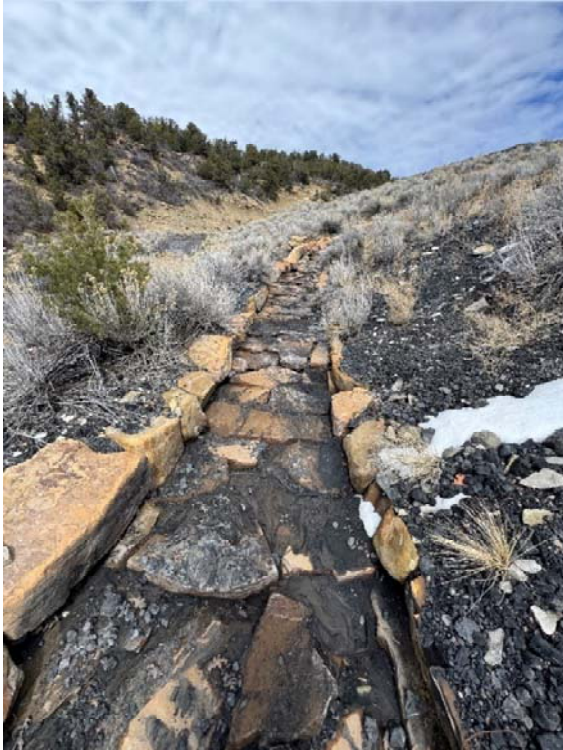
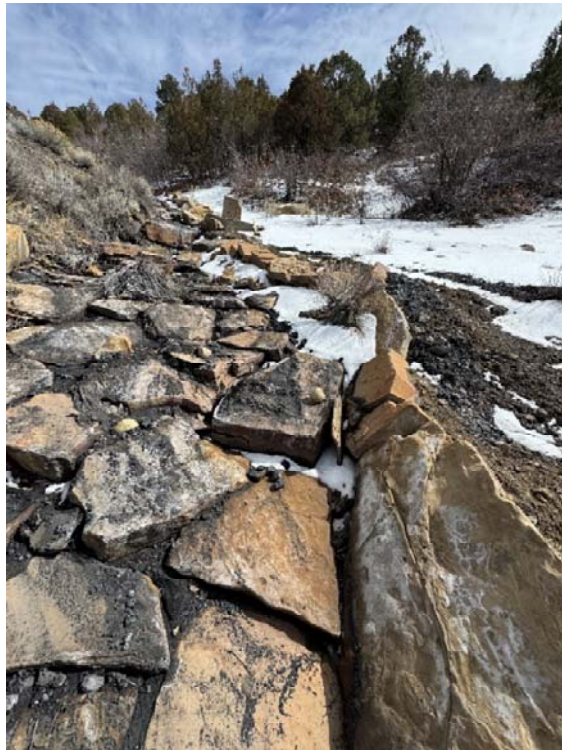
The south treated water ditch (Reach 10) and the north clear water ditch (Reach 1) appeared to be in generally good condition at the time of the inspection. The previously washed-out, now repaired riprap of Reach 10 south haul road switchback remains in good condition and continues to prevent runoff from escaping the channel section (see Pic. 1). The angular riprap added to the upper section of Reach 10 appears to be controlling erosion as intended, though it should be kept under monitoring (see Pic. 2).

Pic. 1a and 1b – Reach 10, riprap between upper and lower waste piles, preventing escape of runoff.

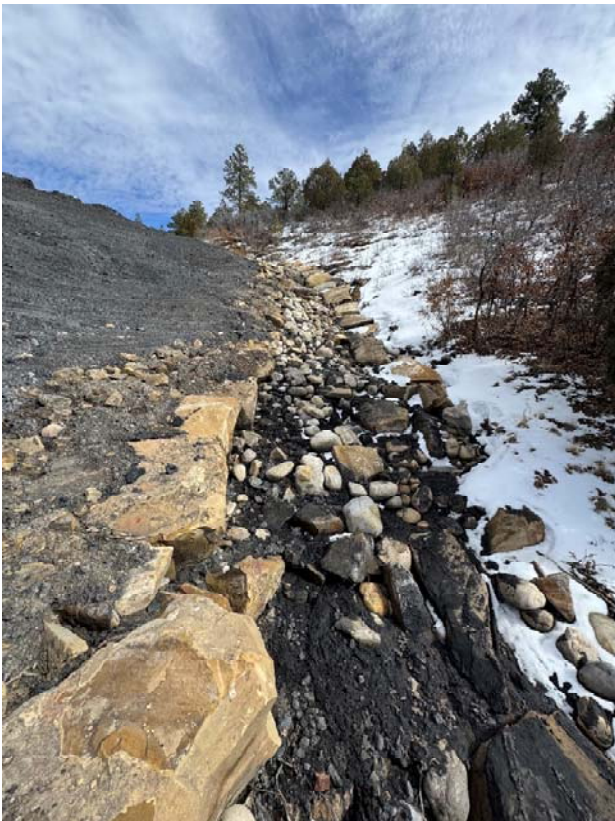
Pic. 2 – Reach 10, upper section channel riprap functioning as intended.

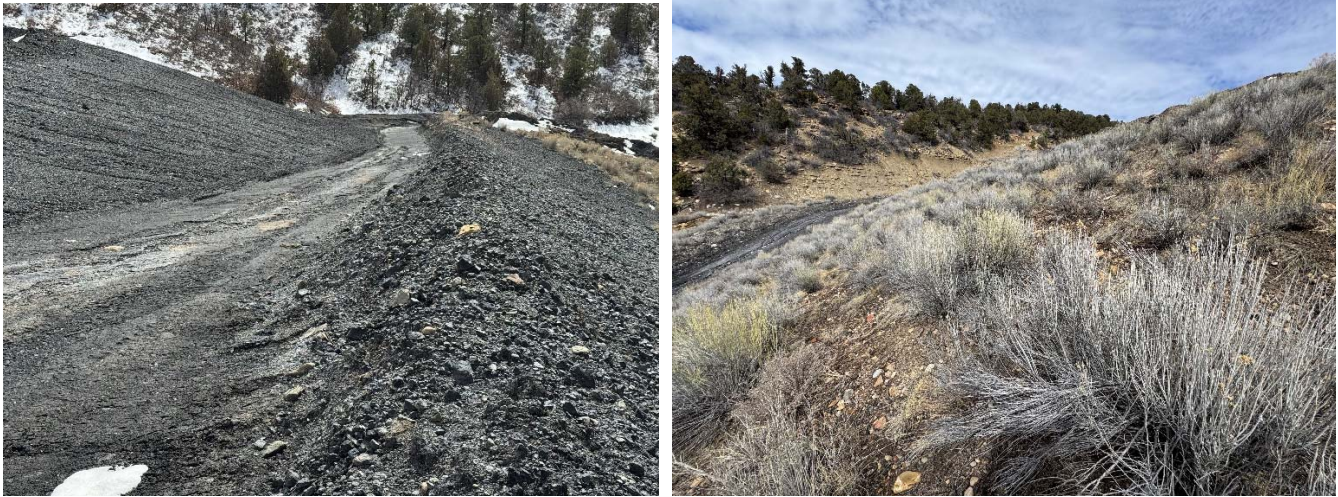
The face of the upper waste embankment pile was found to be in generally good condition (see Pic. 3). There were no signs of instability or sloughing observed on the main waste embankment pile at the time of the inspection. The waste embankment pile level appears to be relatively unchanged since the previous inspection. The grading of the upper waste piles appears to direct surface runoff away from the face of the piles and the required berming is in place. The slope of the top of the existing pile is close to that defined in the Waste Bank Design produced by Don May, 1997.

Pic. 3a and 3b – non-vegetated and vegetated face of the upper waste pile are in good condition.

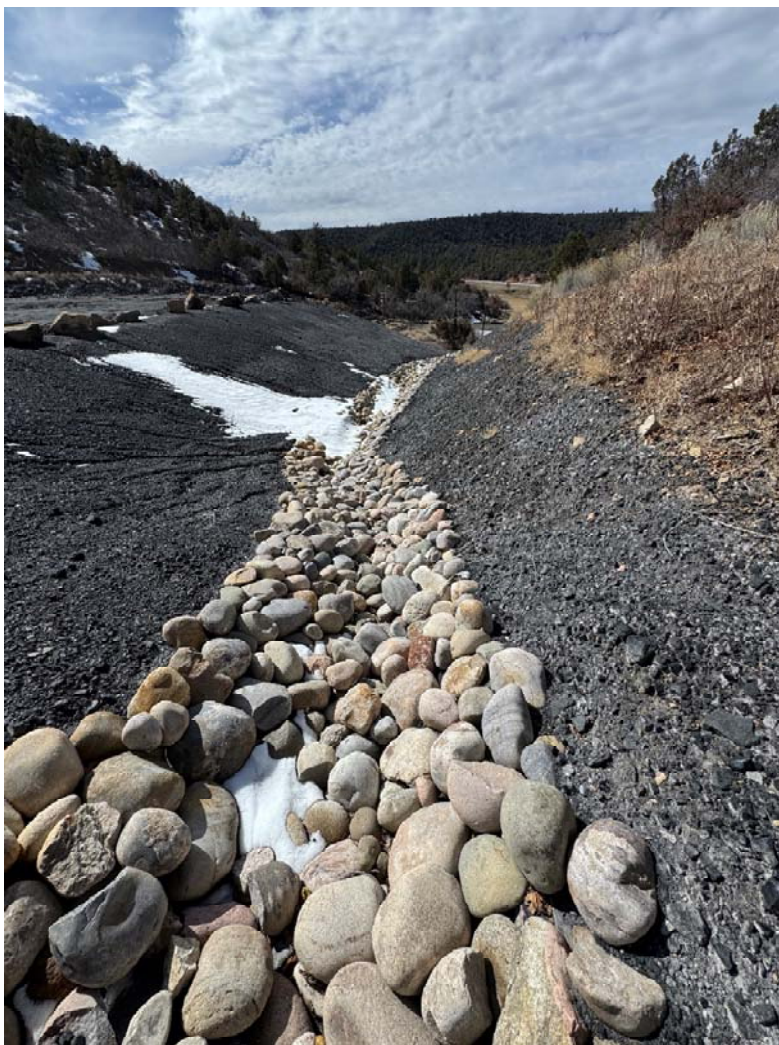
It does not appear that any additional fill material has been placed on the lower waste pile since the previous inspection. The face of the lower pile was found to be in good condition with no signs of instability or sloughing observed. The face of the lower waste pile is at a consistent height and the required berming is in place at the top of the pile to direct runoff away from the face of the embankment pile (see Pic. 4).

Pic. 4 – Drainage off the lower waste pile into rock riprap is generally good condition.
