Re: GCC Energy, LLC, King II Mine
CDRMS Permit # C-1981-035
Sunder, Miller & Associates: Quarterly Inspection: King I 'UbX' = Water Quality
Improvements Inspection 1st Quarter 2025

RE: King Coal I – Quarterly Water Quality Improvements Inspection

RE: King Coal II – Quarterly Water Quality Improvements Inspection

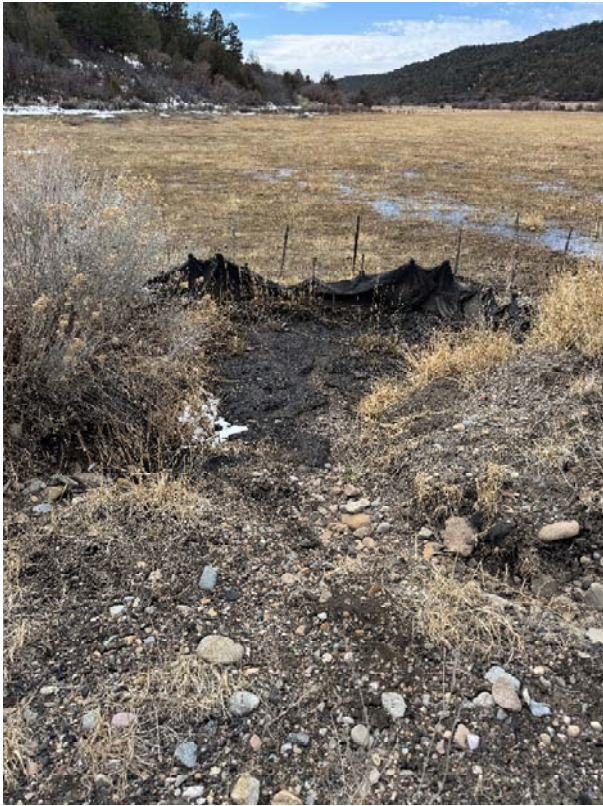
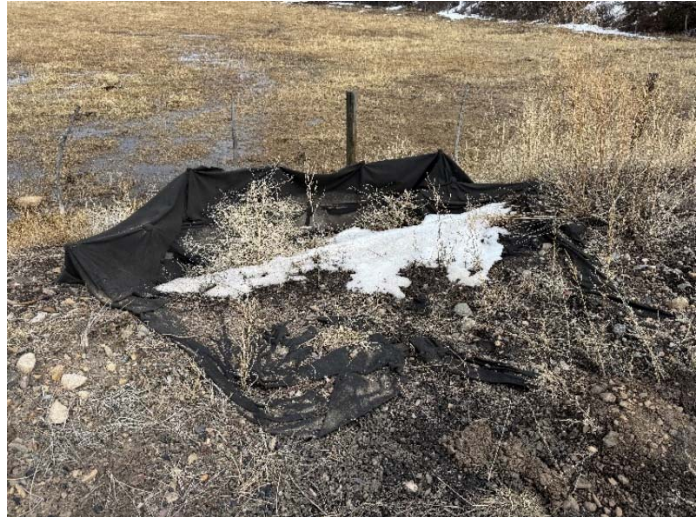
The sedimentation traps at the entrance to the site need dredging, and the eastern sedimentation trap also needs re-anchored into the ground (see Pic. 1). The east pond was dry while the water in the west pond had increased since the time of the last inspection due to winter snowmelt and recent precipitation. Sediment removal operations appear to be unchanged for both ponds since the previous inspection. While the excess material in the west pond should be removed as soon as possible to ensure adequate pond capacity for runoff/storm events, the ponds' overall capacity appears adequate.

Pic. 1a and 1b – Sedimentation traps in need of dredging and anchoring.

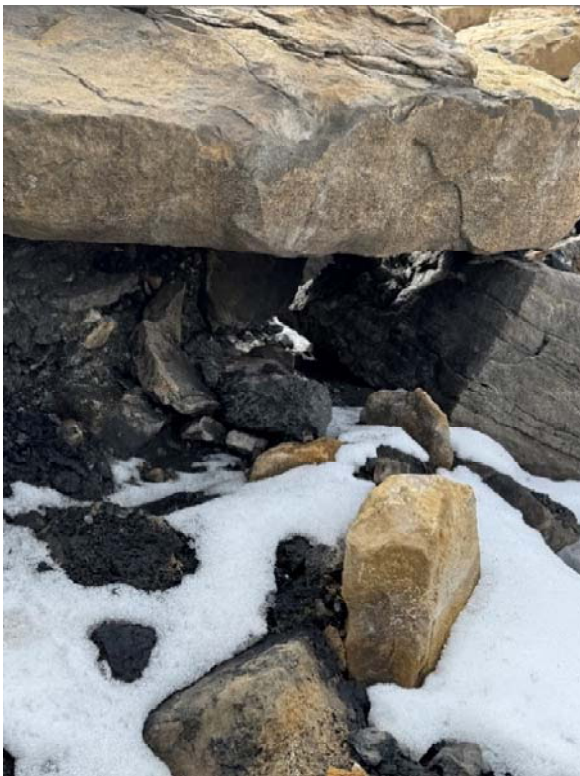
The existing ditches and culverts appear to be generally in good condition at the time of the inspection. Reach 9 has evidence of washout between the rock riprap and could use additional armor to help slow runoff velocity and limit additional erosion (see Pic. 2). Upper portions of Reach 10 appear to be in generally good condition (see Pic. 3), though some erosion and undercutting of the rock armor is beginning to occur where surface water from the upper waste pile enters the ditch (see Pic. 4). There is some damage to the culvert where Reach 10 drains under the road and into the lower waste pile stilling basin, however, drainage does not appear to be impeded (see Pic. 5). The grading along the south side of the face of the upper waste pile was found to be in generally good condition.

Pic. 2 – Reach 9 (at stilling basin) with voids forming between rock riprap.

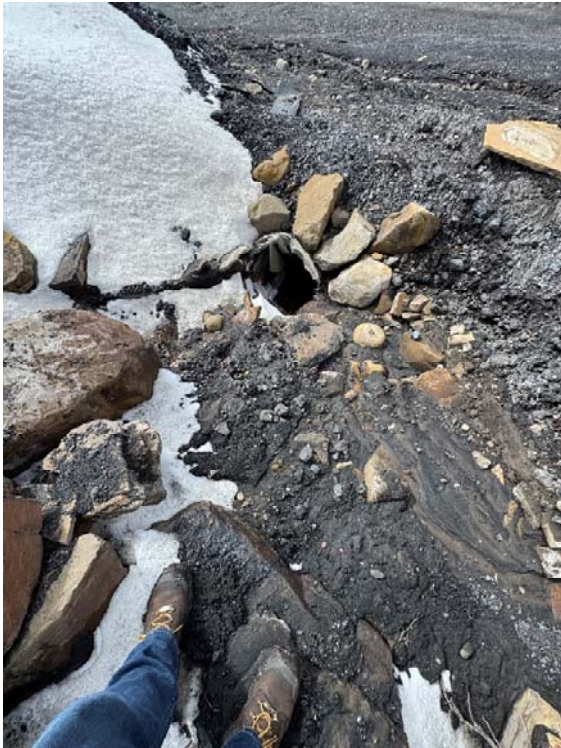
Pic. 3 – Damaged culvert that drains lower Reach 10 under the haul road and into the lower waste pile channel section. Flow does not appear to be impeded.

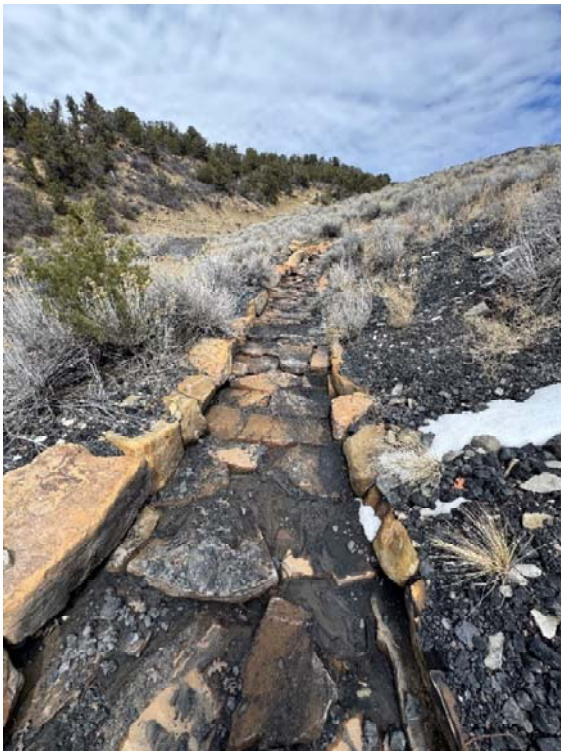
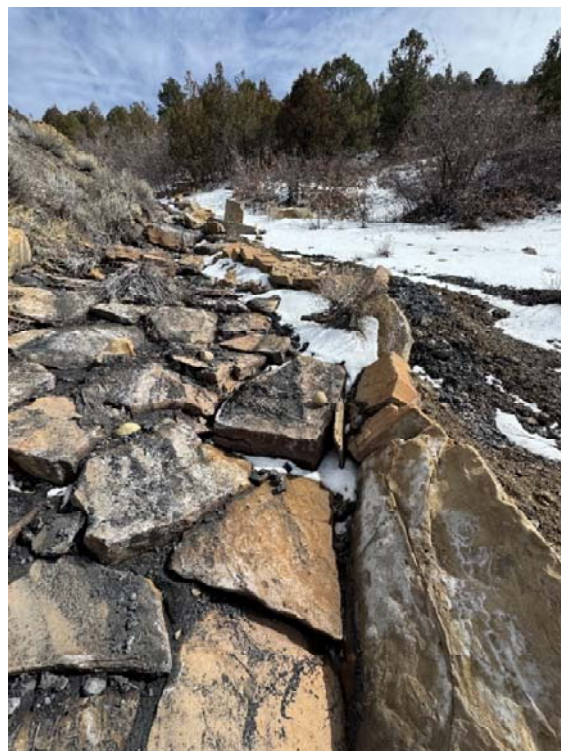
Pic. 4a and 4b – Reach 10, armored sections between upper and lower waste piles.

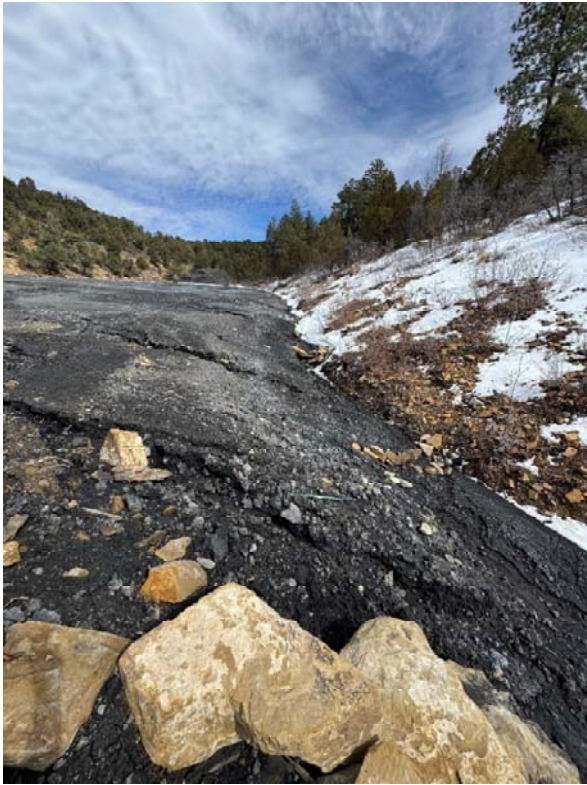
Pic. 5 – Runoff from upper waste pile into Reach 10 showing some erosion and beginning of undercutting at rock armor.

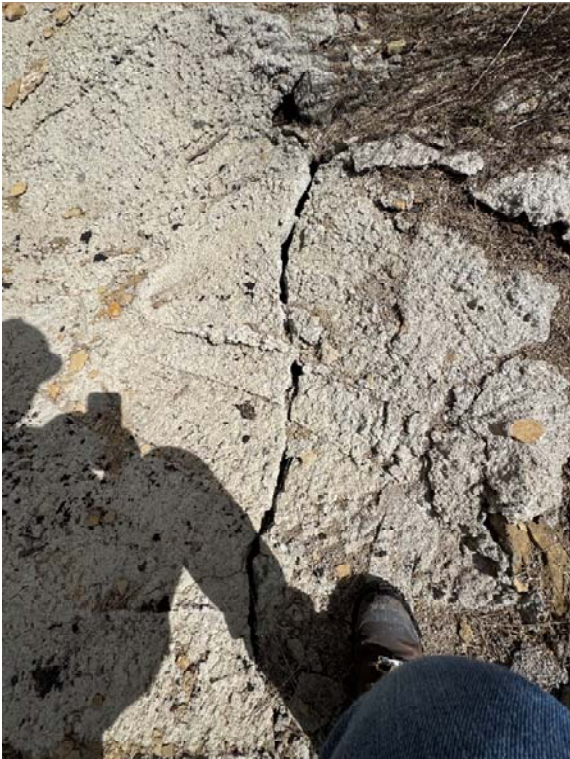
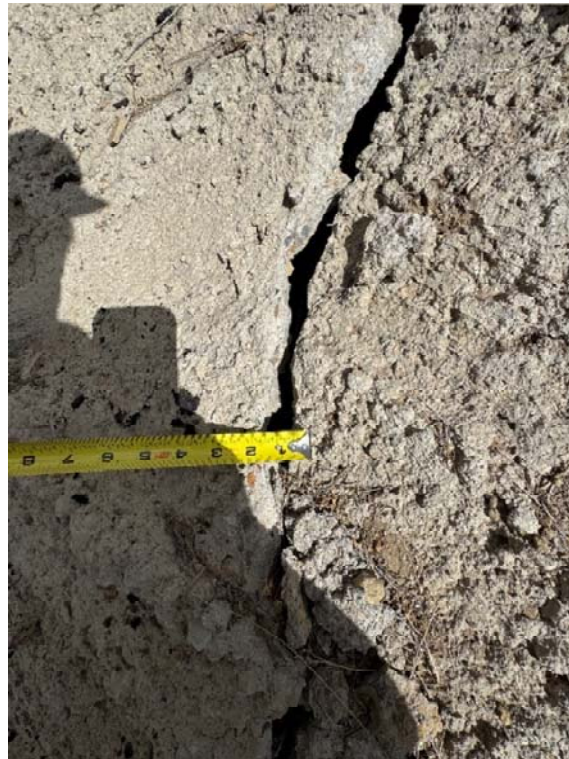
The cracks noted in the lower armored section of Reach 1 appear to be slightly wider than in the previous inspection (see Pic. 6). The upper armored section of Reach 1 should also be monitored for increased cracking and exposed subsurface (see Pic. 7). Grout can be installed in the cracks to prevent water infiltration and locations monitored for additional signs of movement.

Pic. 6a and 6b – Cracks within lower armored section of Reach 1.

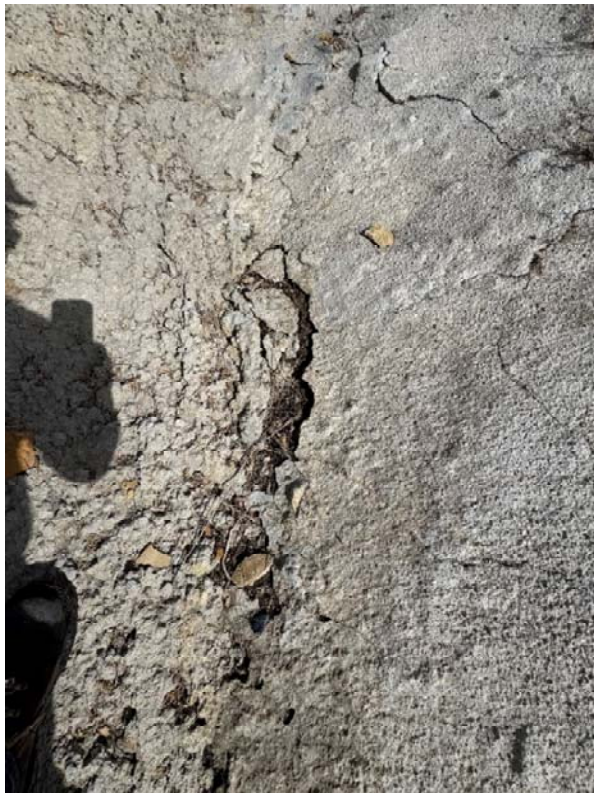
Pic. 7 – Cracking and exposed subsurface in upper armored section of Reach 1.

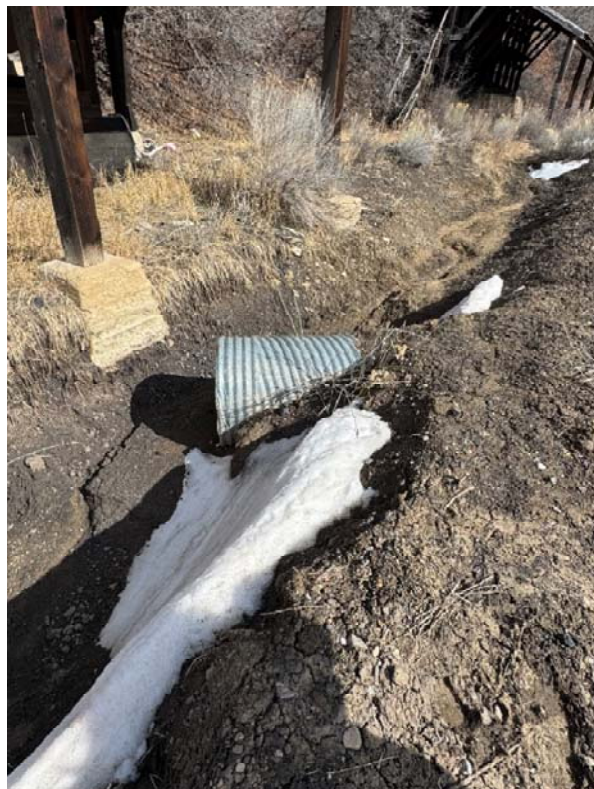
There is some sediment build-up at the culvert outfall near the bottom of Reach 5 (see Pic. 8). Monitor the sediment load and dredge if culvert and ditch flow appear to be impeded.

Pic. 8 – Some sediment accumulation at culvert outlet near bottom of Reach 5.

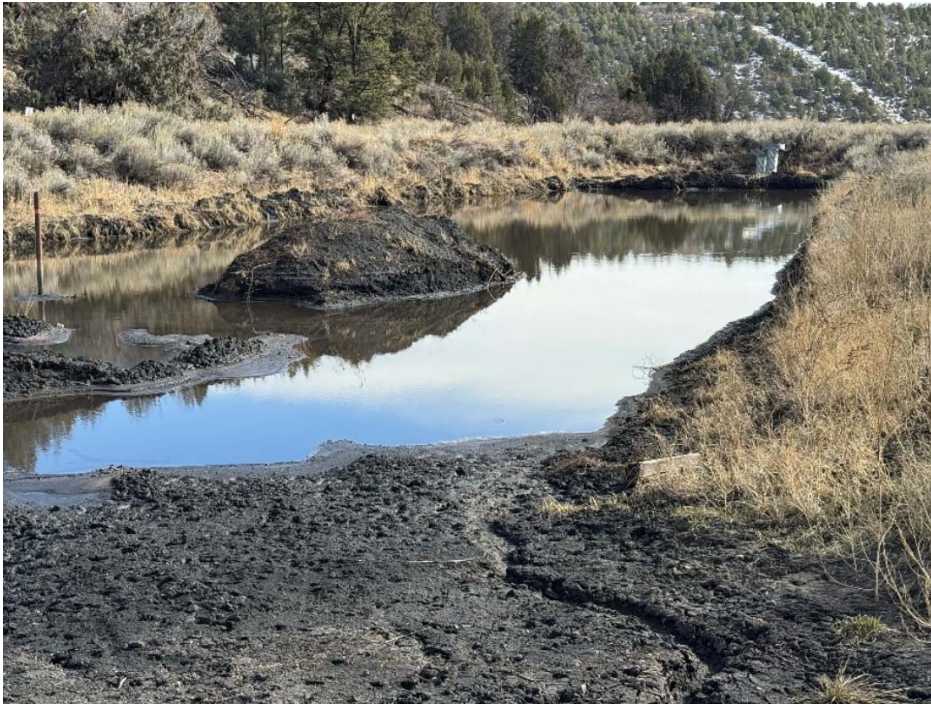
The detention pond held slightly more water as compared to the previous inspection, likely due to the winter snowmelt and recent rain events (see Pic. 1). The sediment elevation at the bottom of the pond could not be determined due to water within the pond. The current water levels make it difficult to assess the progress of sediment removal operations. It appears that sediment level is at the same point as the previous inspection. Excess sediment should be removed from the detention pond as soon as site/weather conditions allow.

Pic. 1 – Water level in the detention pond after recent storms.

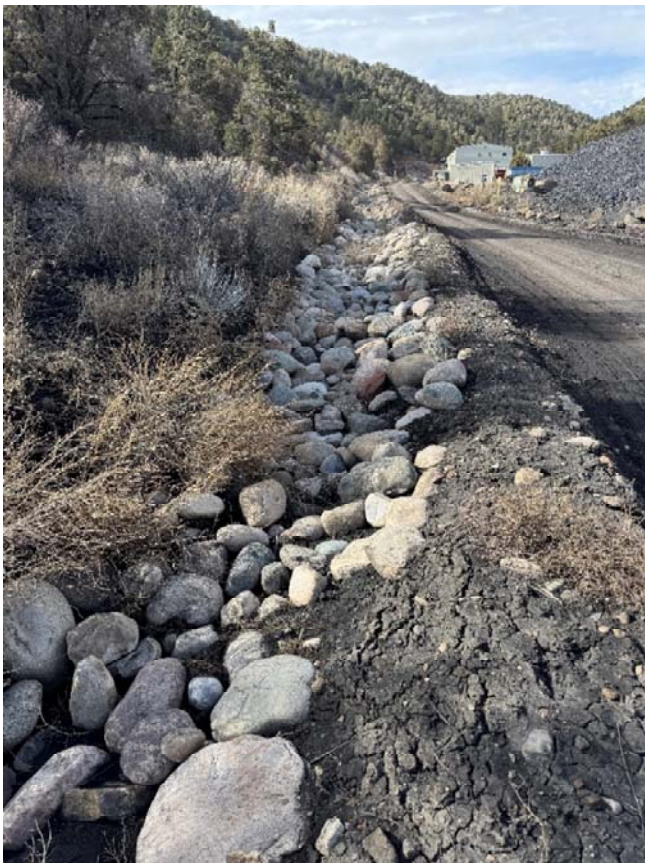
The east clear water ditch, the west clear water ditch (west of the driveway access) and the main drainage ditch (combined clear water ditches) were found to be in good condition and generally clean of debris (see Pic. 2), with the exception of dead vegetation accumulated at the culvert outfalls where the west clear water ditch drains towards the main drainage ditch (see Pic. 3).

Pic. 2 – West Clear Water Ditch.

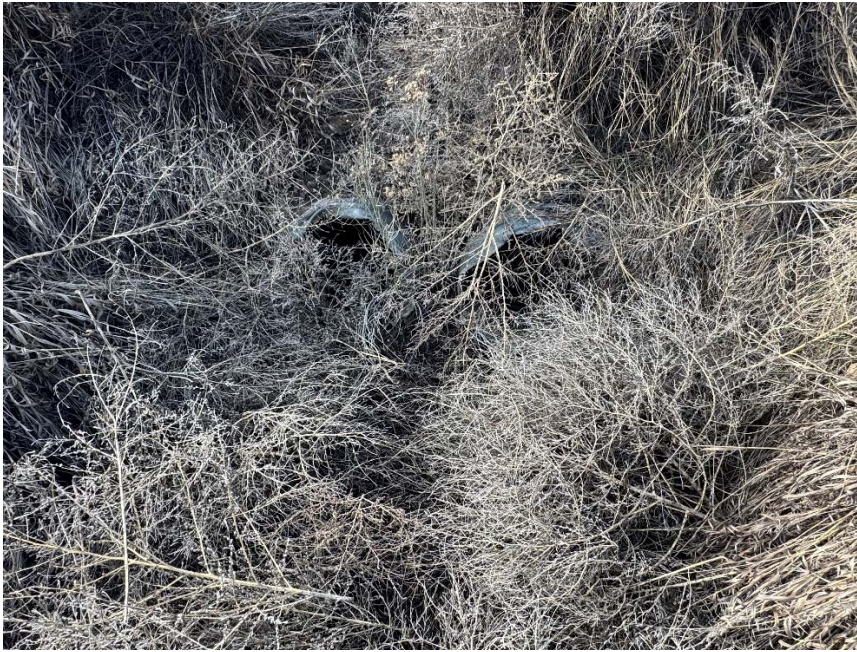
Pic. 3 – Dead vegetation at the culvert outfalls where the West Clear Water Ditch drains towards the Main Drainage Ditch.

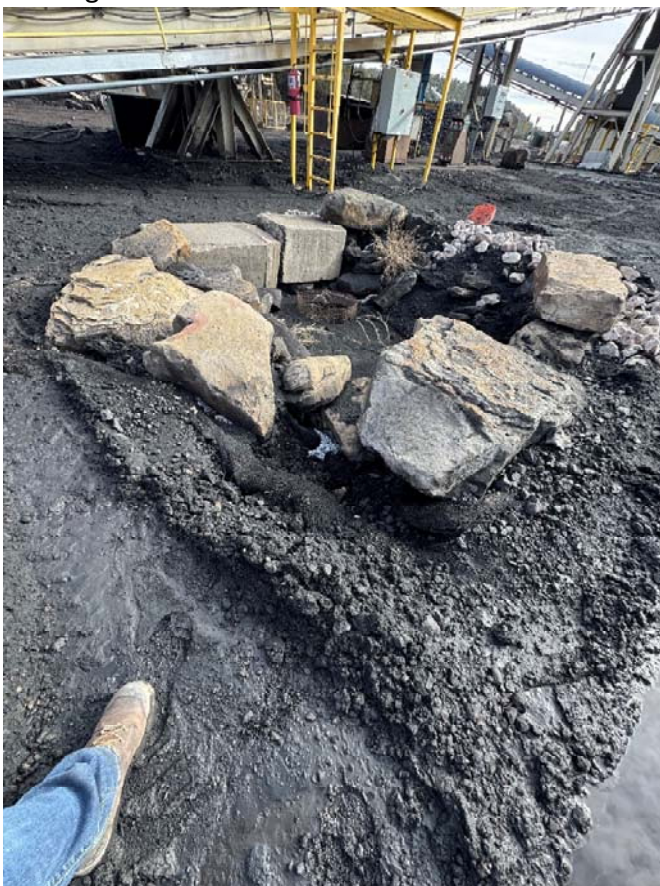
The erosion control structures for the treated water ditch located south of the scale house were found to be in good condition and operating as intended. The inlets located around the conveyor and coal storage piles appear to be in good condition, though some erosion is evident around the rock armor (see Pic. 4).

Pic. 4 – Some erosional cutting to drain near conveyor belt.

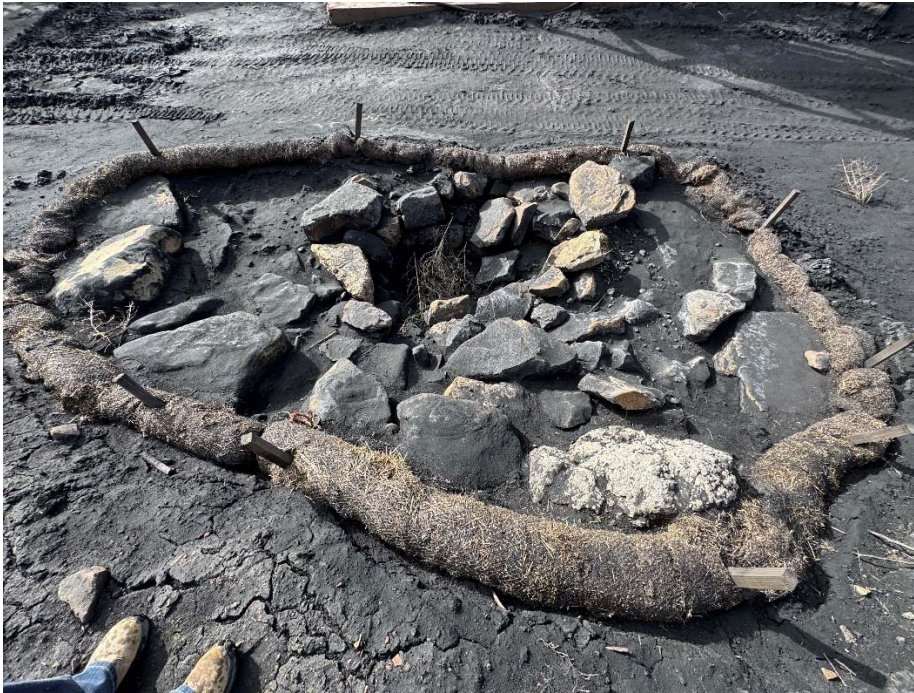
The inlet near the vibratory processing appears in relatively good condition but should be monitored and maintained often due to ongoing operations in that area (see Pic. 5). The inlet east of the power station is in generally good condition. The clear water ditch along the west side of the site appears to be in good condition

Pic. 5 – Straw wattles and rock armor near the vibratory processing area.

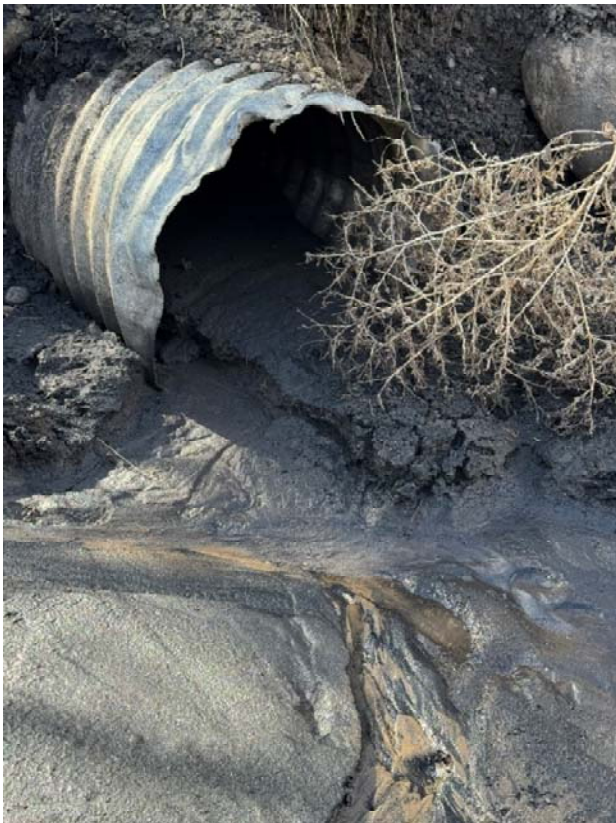
The culvert pipes and ditches on the site were in generally good condition overall. The outlet pipes were free from debris and excessive vegetation, though some sediment accumulation was observed at the outlet pipe from the driveway culvert which discharges behind the scale house (see Pic. 6). The culvert pipes and ditches should be monitored after storm events and cleaned out in the event that sedimentation occurs or debris buildup at the culvert inlets or outlets is observed.

Pic. 6 – Sediment accumulation at the culvert outlet that drains the detention pond (behind scale house).
