PERMIT INFORMATION

Permit Number: C1981033 Mine Name: Bear Mine Operator: N/A Operator Address: N/A	County: Gunnison Operation Type: Underground Permit Status: Revoked Ownership: Private
	Operator Representative Present: N/A
Operator Representative Signature: (Field Issuance Only)

INSPECTION INFORMATION

The Bear mine permit is revoked, the site has been reclaimed, and the required inspection frequency has been reduced to quarterly. The weather was clear and dry.

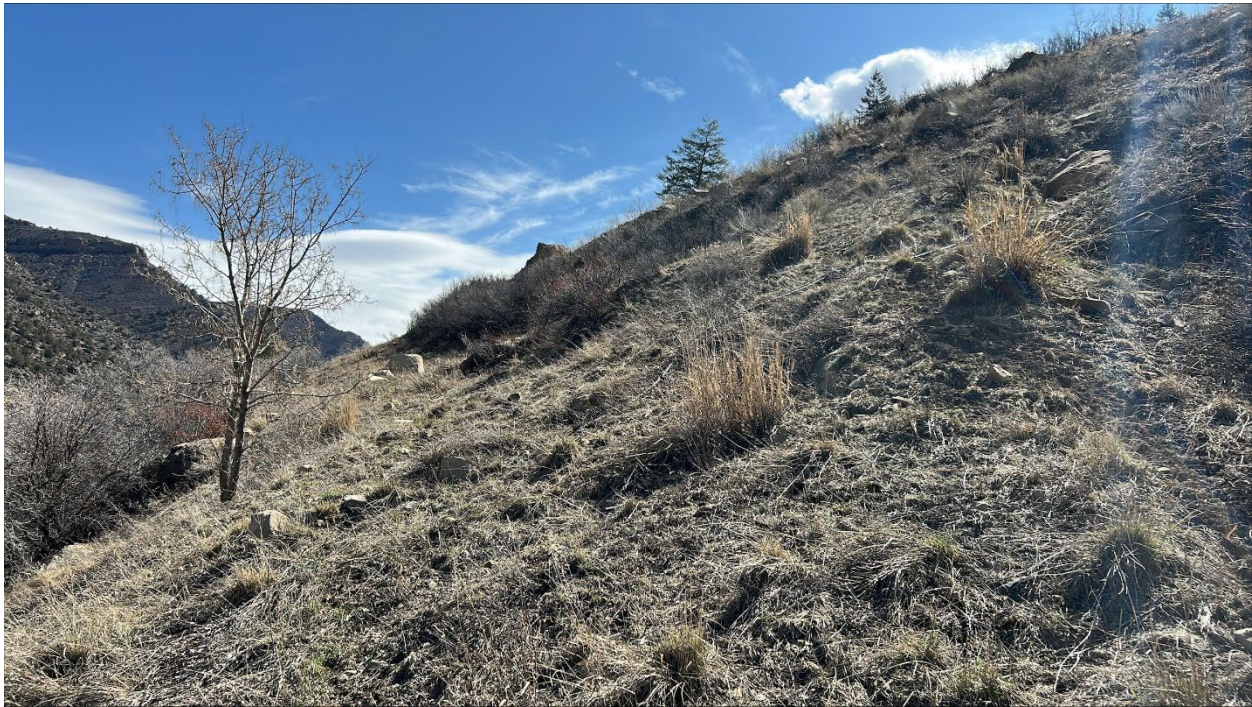
A reclaimed road leading uphill from the lower pad area towards the east was inspected as a possible access option. The reclamation of the road had been quite successful; the regraded surface was well-vegetated and studded with boulders. It was decided that the reclaimed road would likely not be passable without using a blade to re-disturb the surface and an alternative means of access would be preferable.

Figure 1: Reclaimed road, looking east

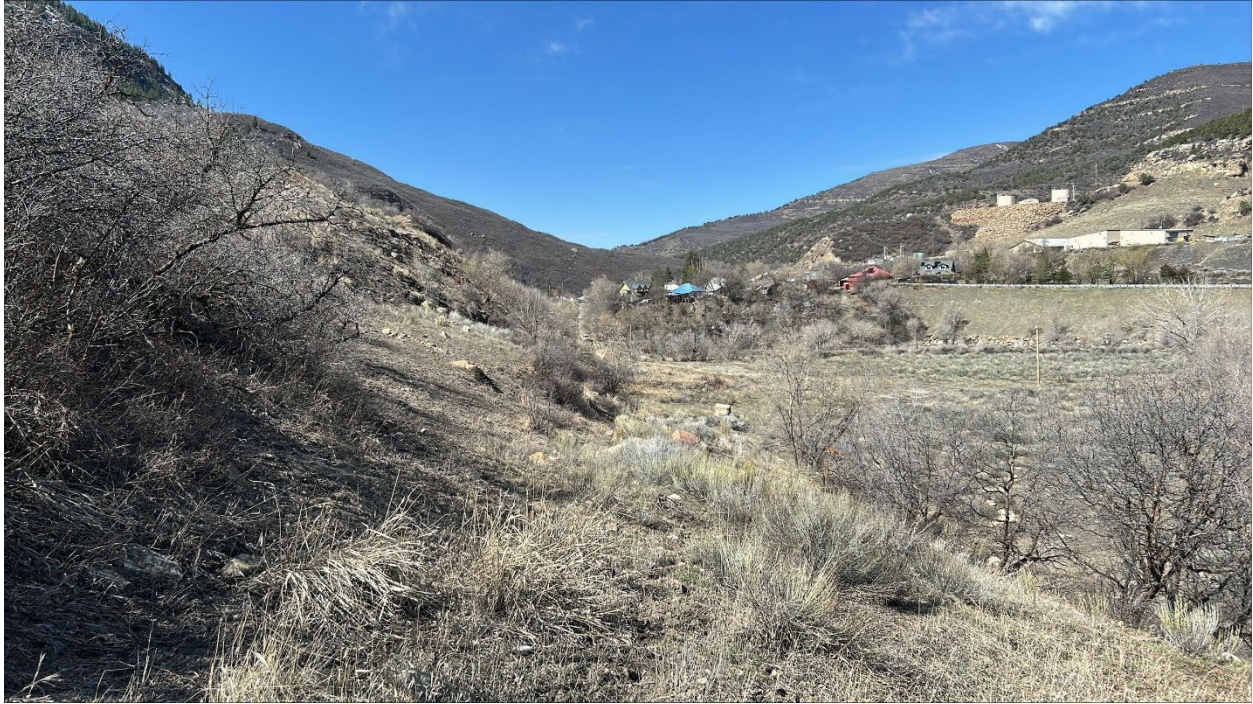
Figure 2: Reclaimed road, looking west

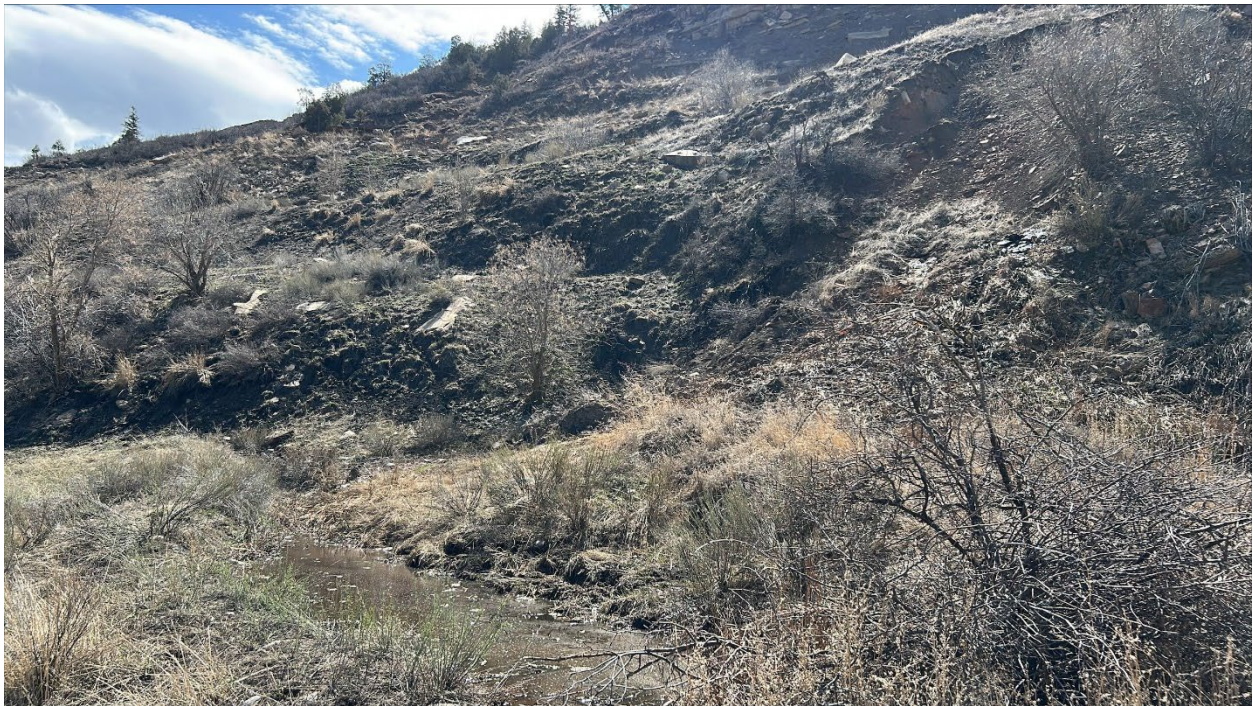
There was no evidence of recent fire or landslide activity. As was the case at the last inspection, groundwater continued to seep from a slump at the toe of the landslide. Material from the slump had obstructed the sinuous channel, so some of the water flowed across the pad to the north, saturating the ground.

Figure 3: Groundwater seep and slump

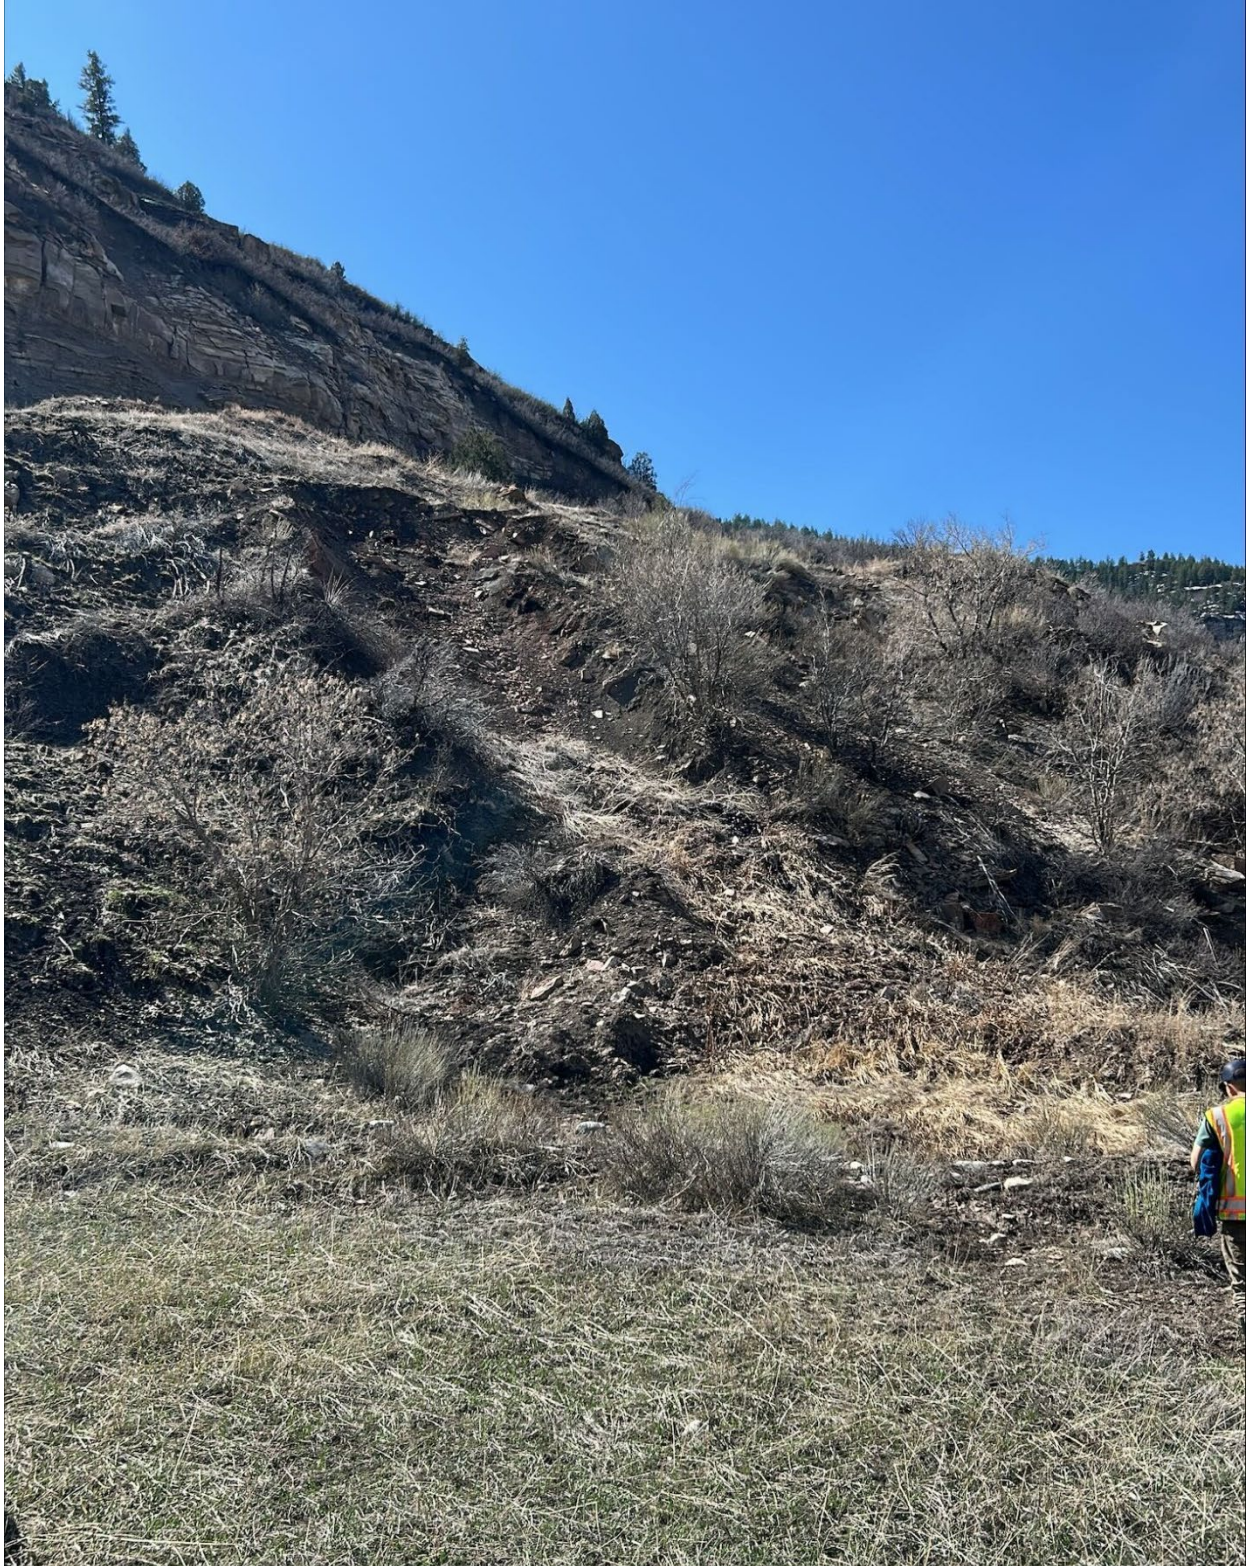
Figure 4: Slumped soil at groundwater seep

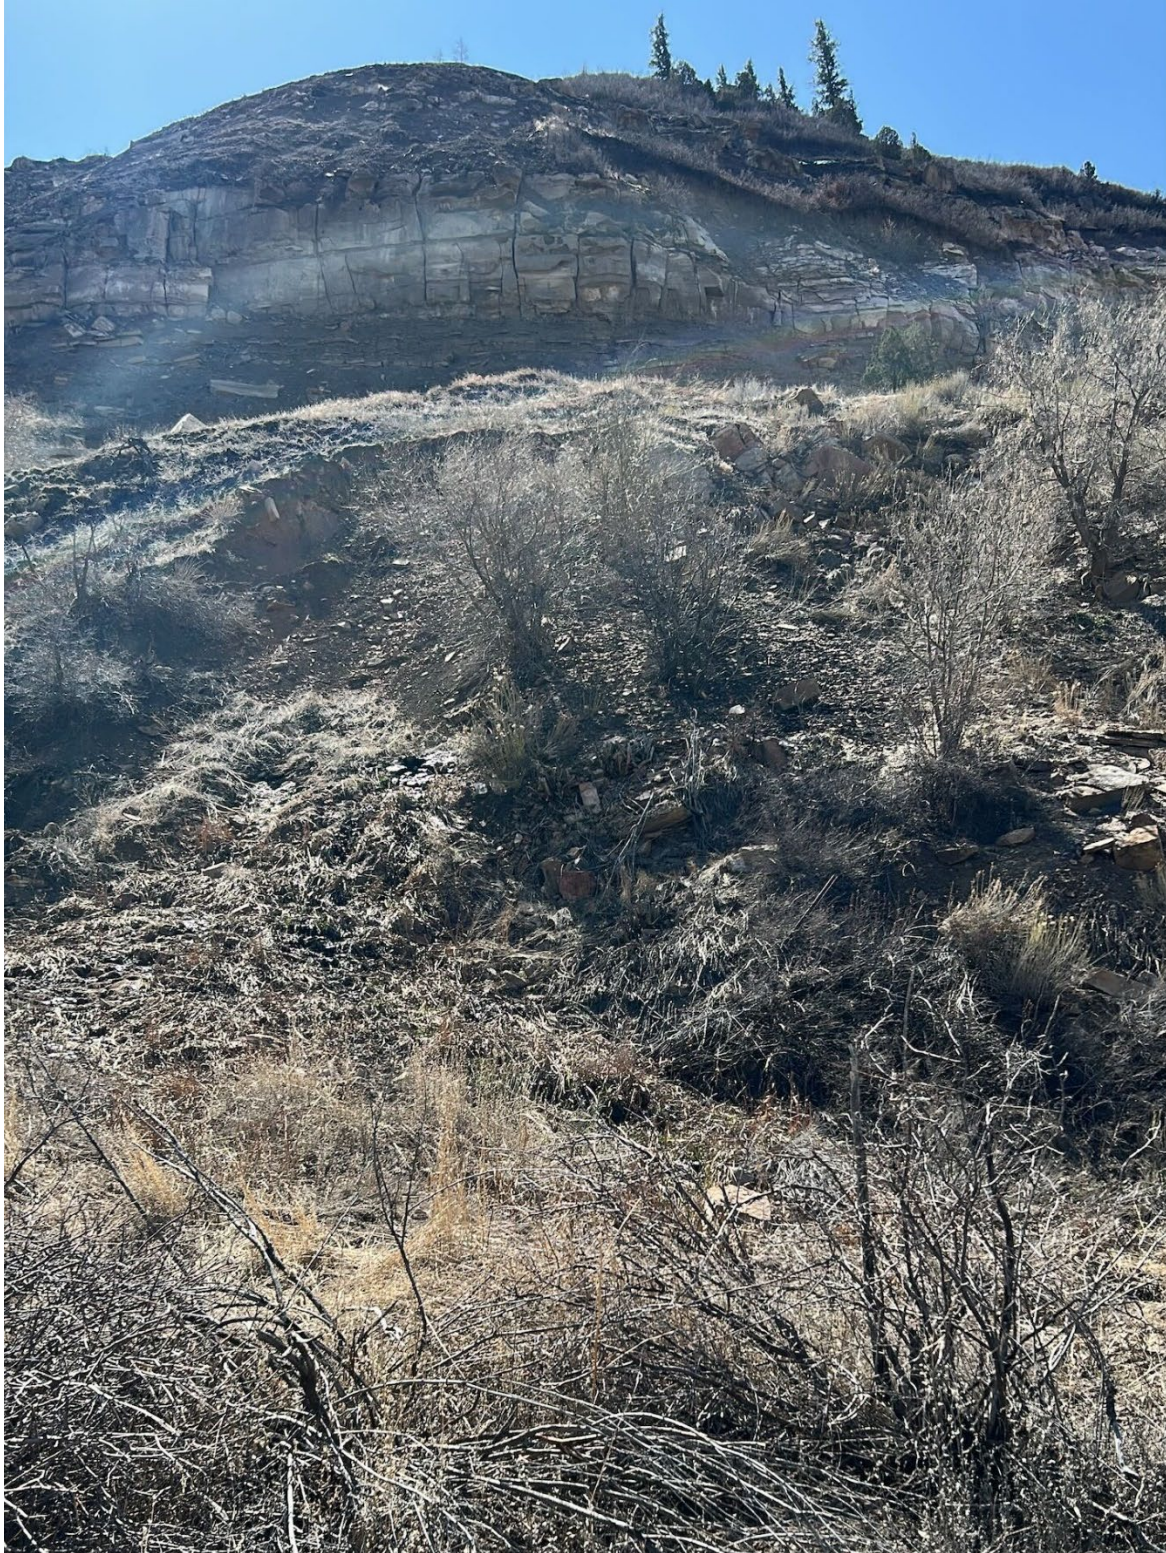
Figure 5: Slump in foreground, with landslide scarpe behind

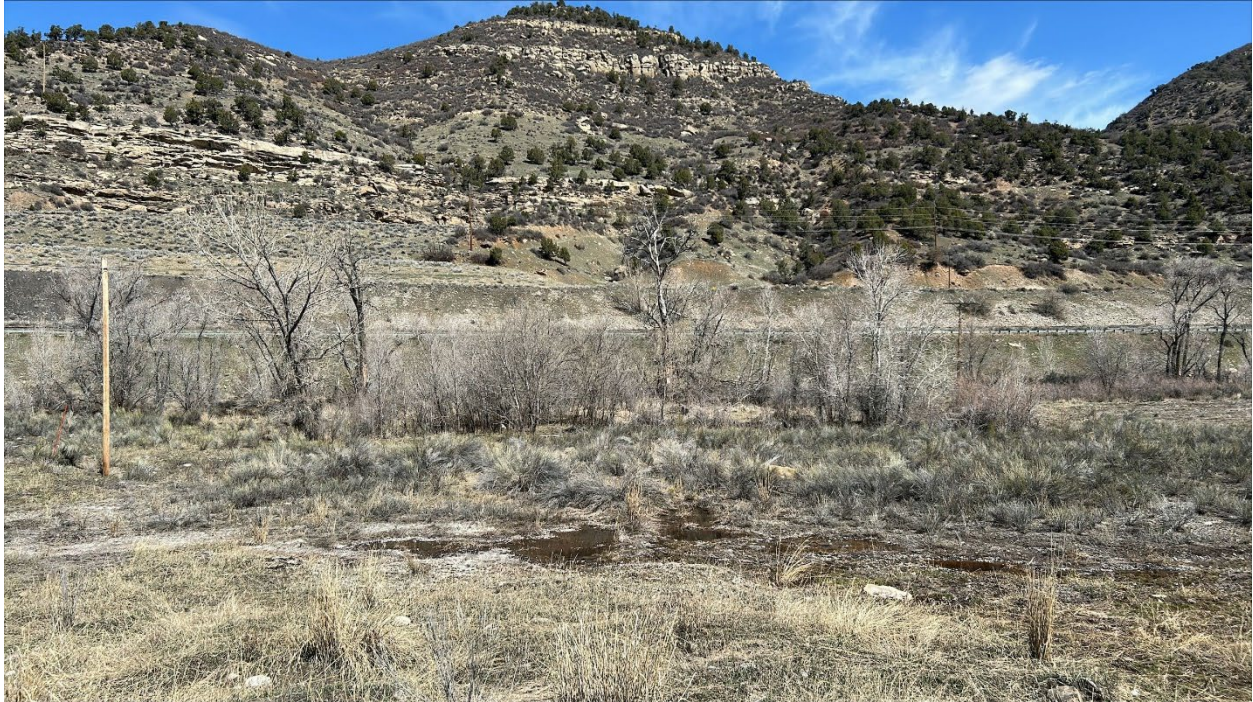
Figure 6: Saturated ground

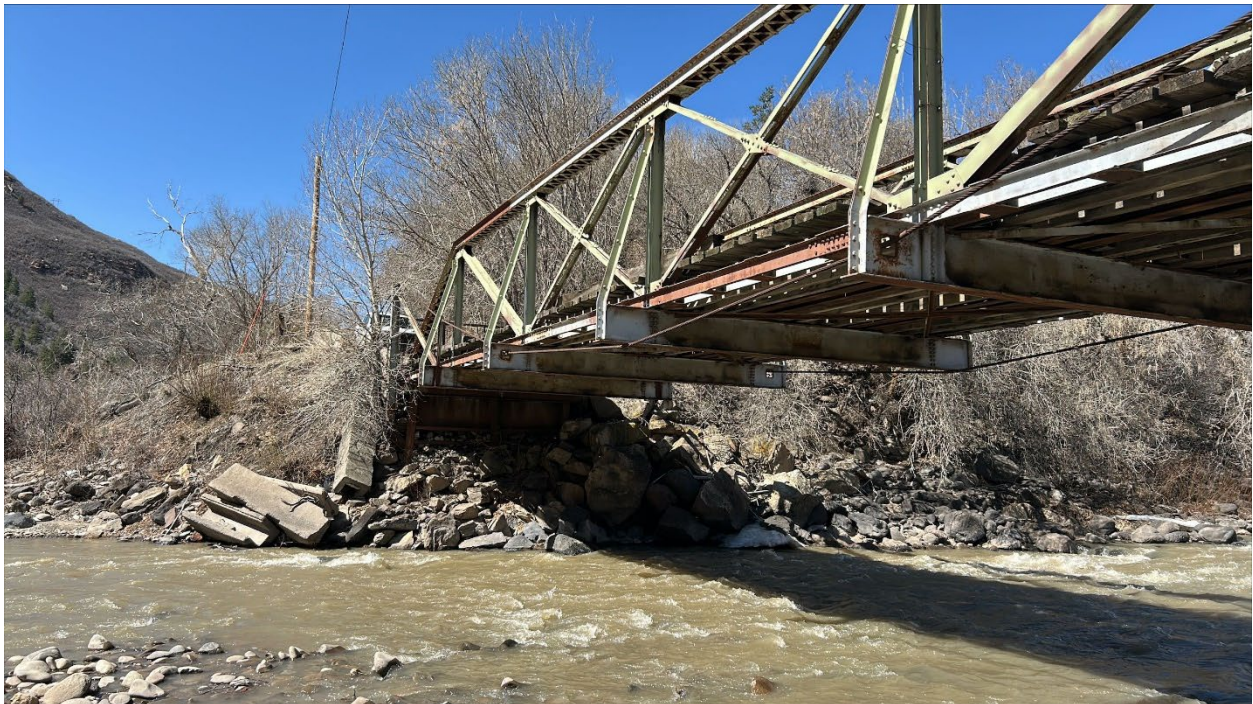
The bridge structure was inspected, including from below, and appeared to be in good condition. The timbers on the bridge had continued to deteriorate. The road surface at either end of the bridge had continued to erode.

Figure 7: Bridge from below

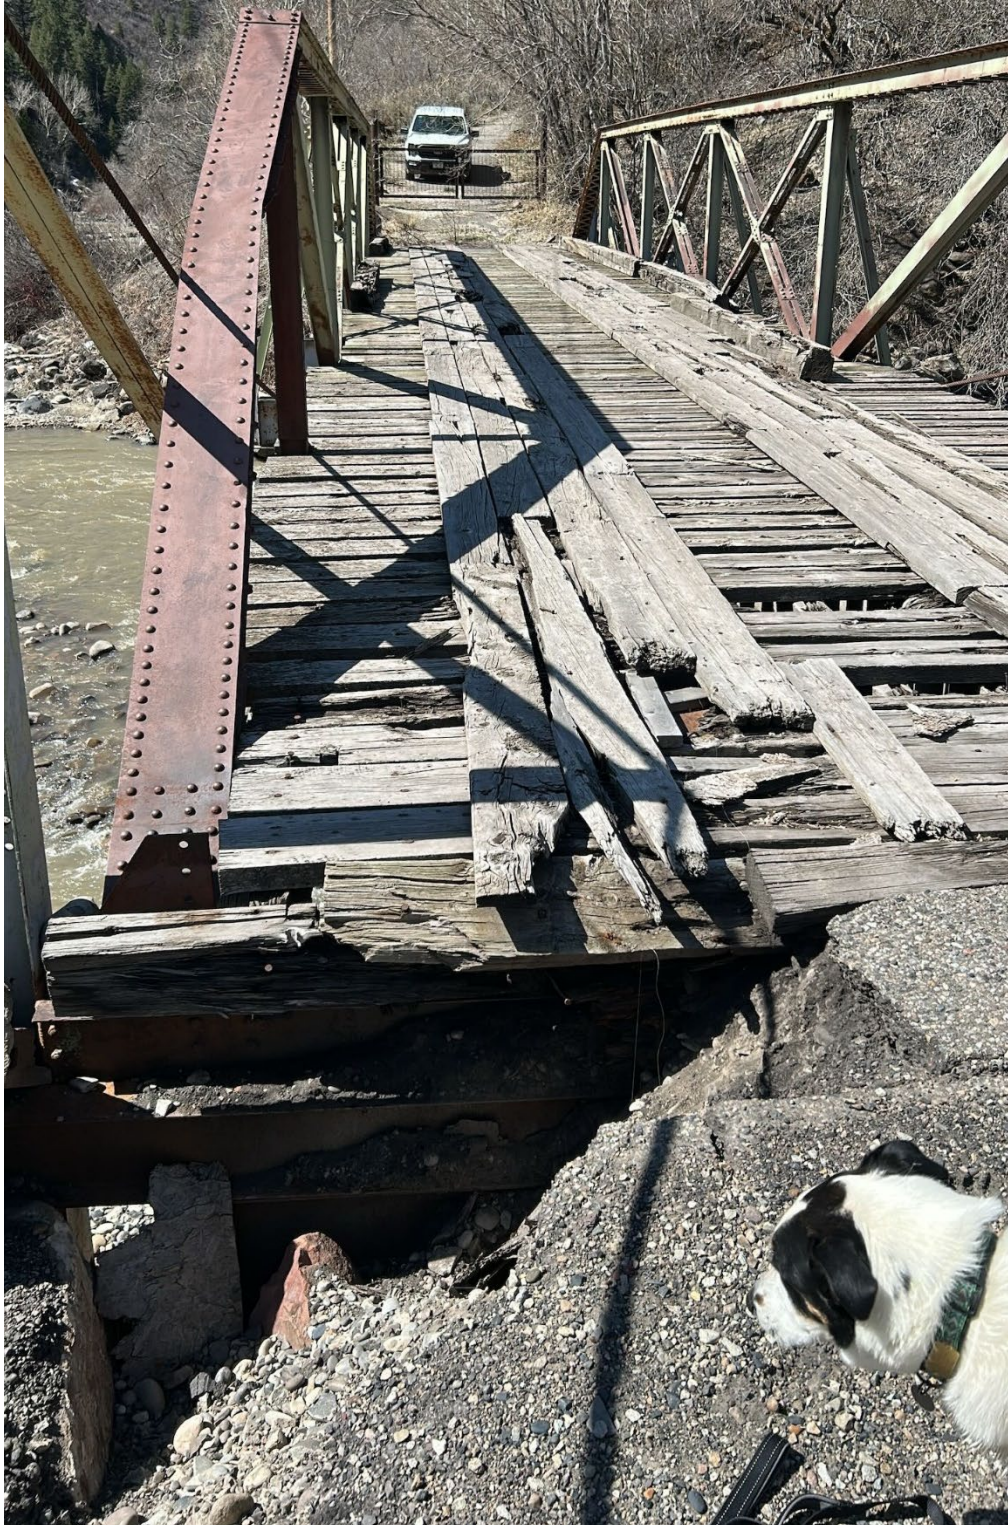
Figure 8: Erosion at edge of bridge, and damaged timber
