## New Horizon 2 Mine, C-1981-008, March Complete Inspection Report

### PERMIT INFORMATION

### INSPECTION INFORMATION

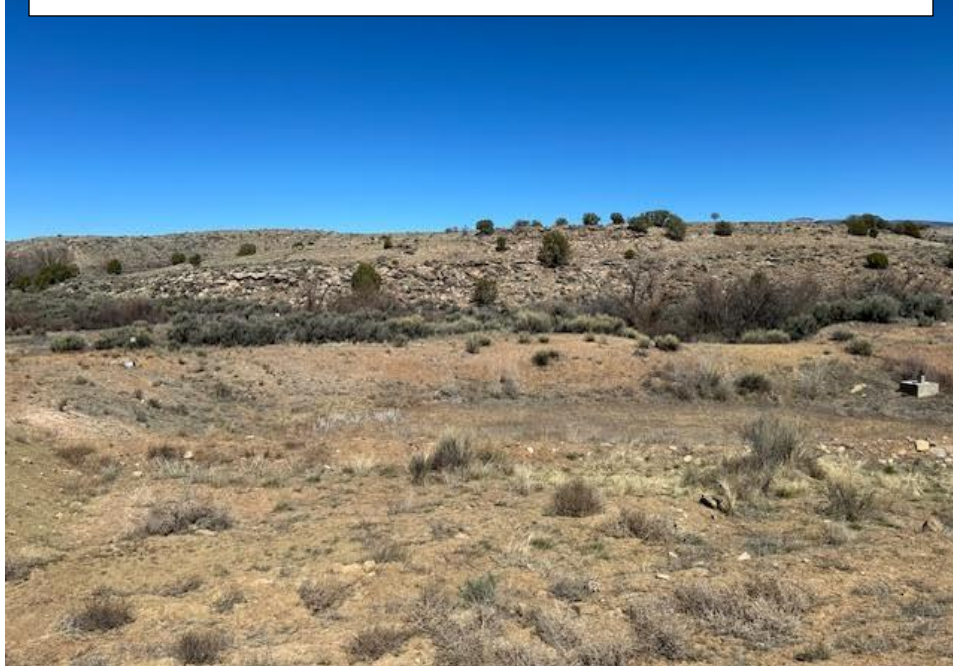
Photo 1: Pond 012.

Pond 12 is located in the northern portion of the reclamation located northwest of 2700 Rd. and BB Road. Pond 012 was dry during the inspection (Photo 1). The embankment was stable with vegetative cover. There were no indications or erosional features or burrows. The outlets for the pond were observed to be clear of debris.

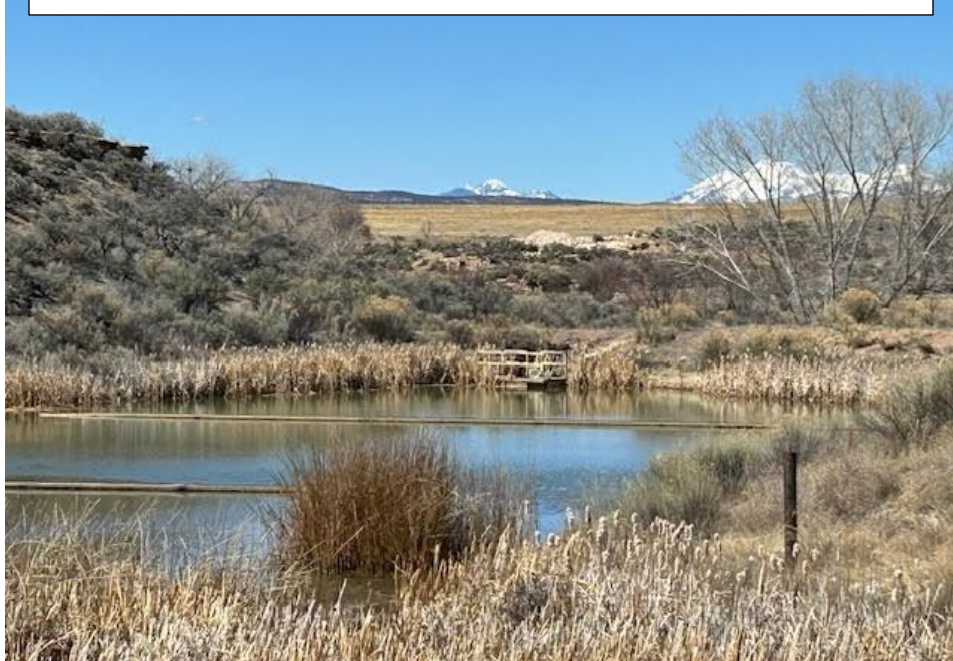
Photo 2: Pond 013

Pond 013 is located in the northwestern portion of the reclamation located in the northwestern corner of the intersection of 2700 Rd. and BB road. Pond 013 was impounding water during the inspection. The level of water in the pond was at the primary discharge outlet (Photo 2). Discharge was observed flowing out of the outlet and through the monitoring flume. The discharge outlet was clear of debris and functioning as designed. The embankment for Pond 013 was vegetated and stable. There were no indications of burrows or erosion.

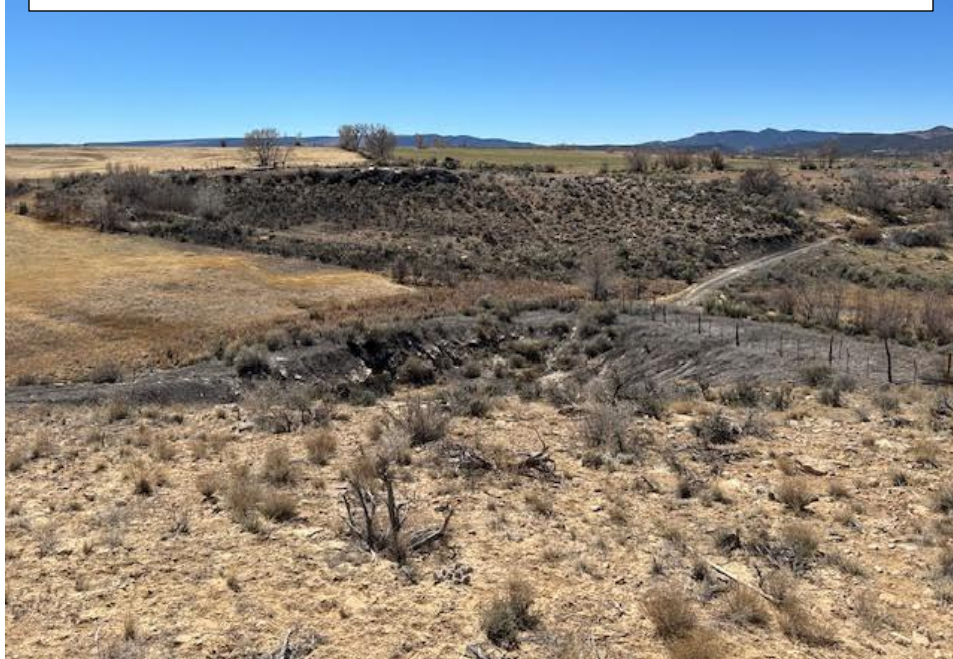
Photo 3: Pond 015

Pond 015 is located within the western portion of the reclamation within the northwest corner of 2700 Rd. and BB road. The pond was dry at the time of the inspection (Photo 3). The embankment was stable with covering vegetation. The outlet for the pond was clear of blockages. There were no observed erosional features other than the minor rills previously observed on the inside of the pond's embankment. The rills have been noted in previous Division reports and do not affect the pond's stability or functionality.

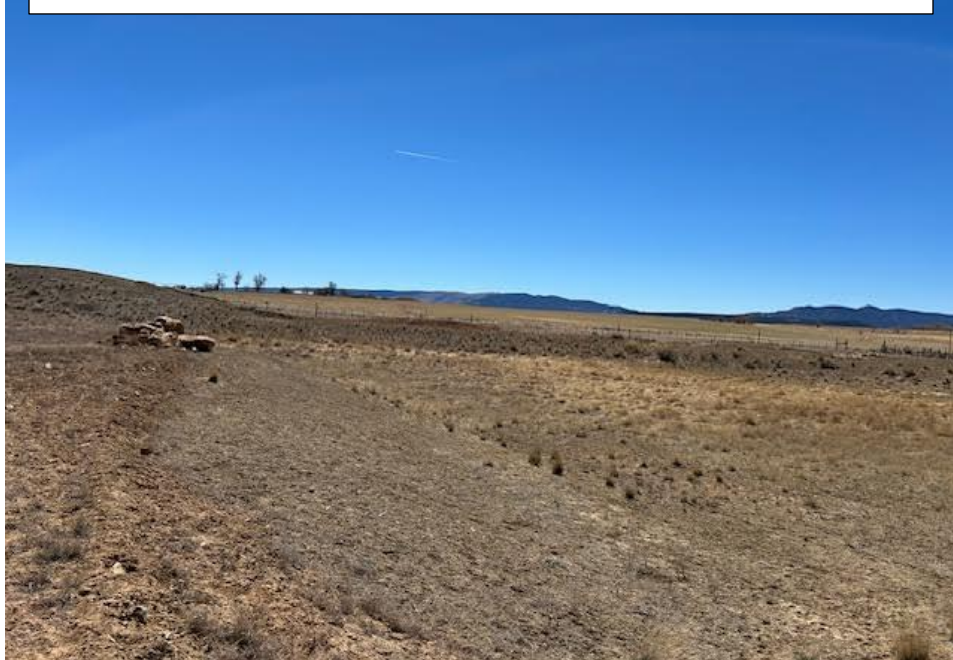
Pond 016 is in the southwestern portion of the reclamation located within the northwestern corner of the 2700 Rd. and BB Road intersection. Pond 016 was dry. The pond's embankment was stable with vegetative cover (Photo 4). There were no erosional features or burrows observed.

Photo 4: Pond 016 inlet and southern embankment.

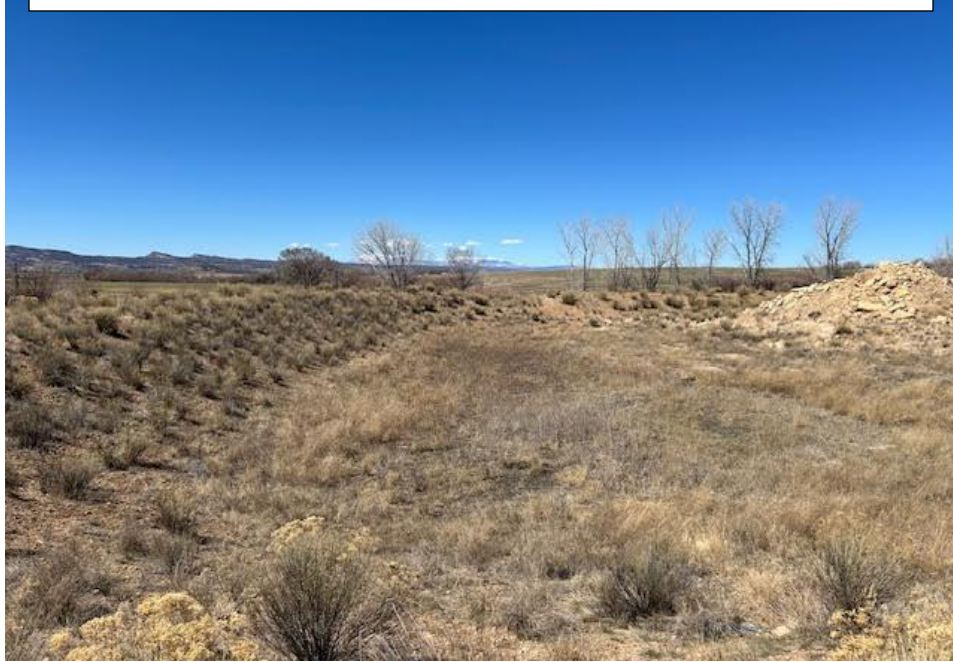
Photo 5: Pond 018.

Pond 018 is located south of the mine office. The pond was dry during the inspection (Photo 5). The embankment was vegetated and stable. There were no erosional features or animal burrows spotted. The outlet for the pond was clear of obstructions.

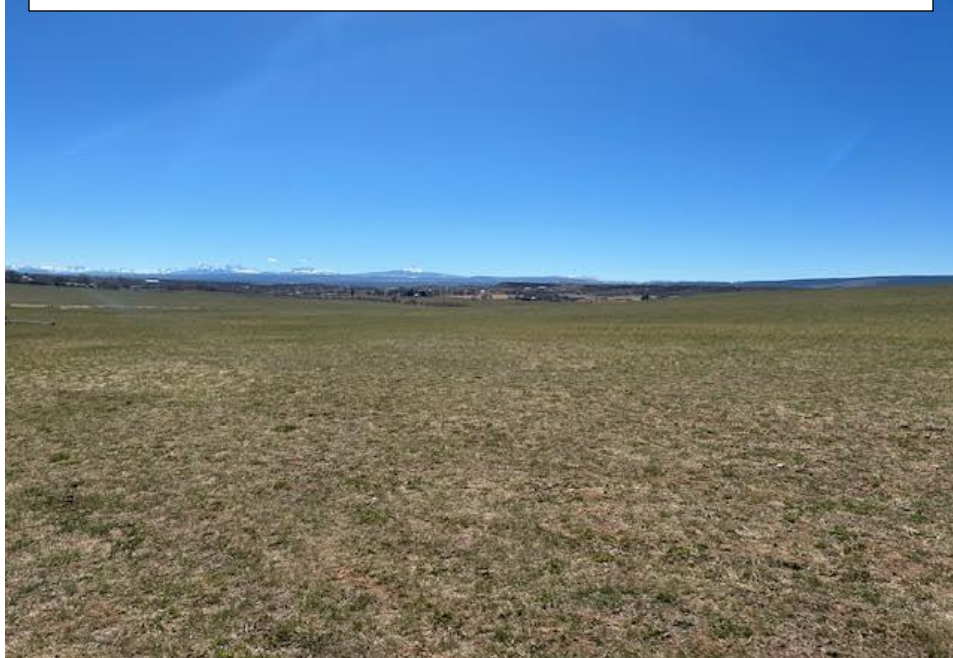
Irrigated pasture IP-10 was stable with vegetative cover (Photo 6). Vegetation on the parcel was green and beginning to grow for the season. There were no erosional features identified. No indications of differential settling were observed.

Photo 6: Irrigated Pasture IP-10 looking to the southeast.

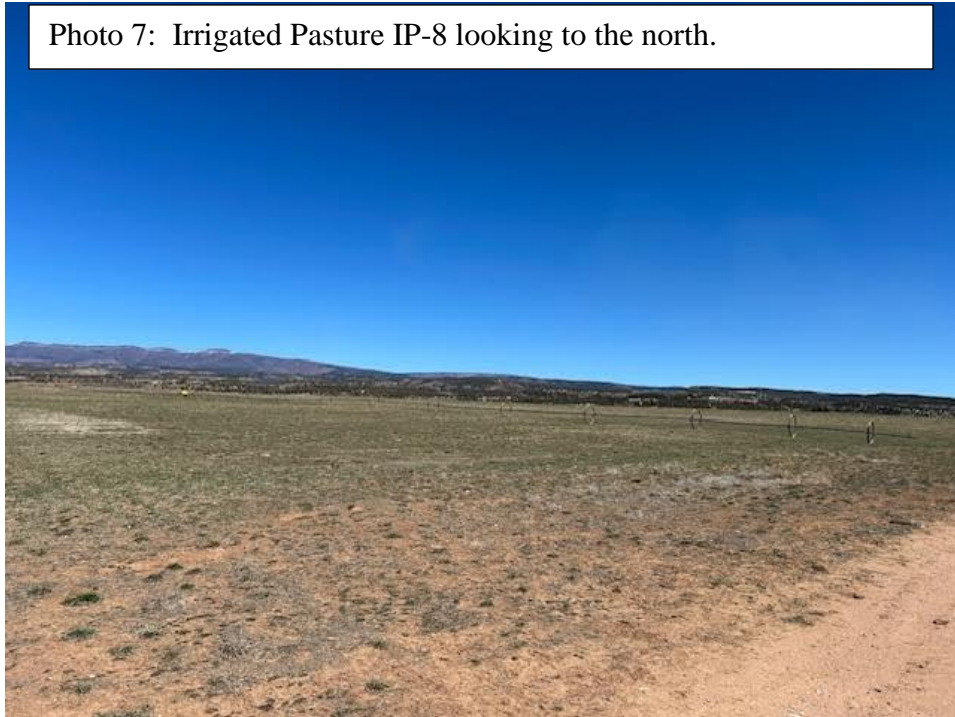
Irrigated pasture IP-8 was stable with no erosional features observed (Photo 7). The reclamation parcel was covered with greening vegetation. There were no concerns of differential settling.

Photo 7: Irrigated Pasture IP-8 looking to the north.

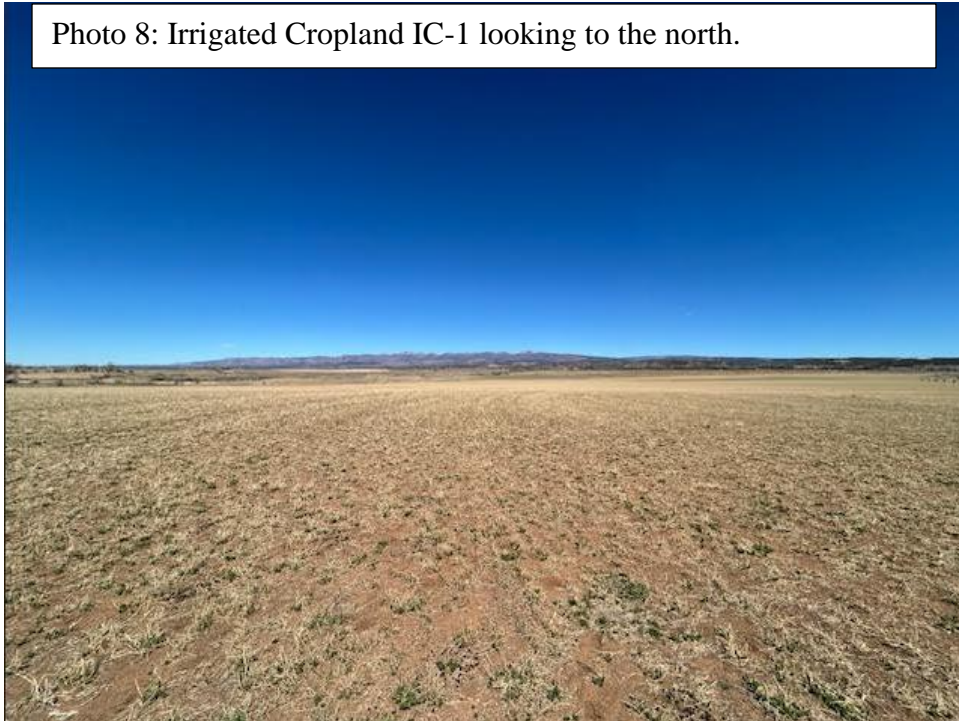
Irrigated cropland IC-1 consists of 107.8 acres and is on the south side of BB Road. Vegetation was green and starting to grow for the season (Photo 8). IC-1 was seeded in 2015. The reclamation parcel was stable with no erosional features identified. There were no indications of differential settling.

Photo 8: Irrigated Cropland IC-1 looking to the north.

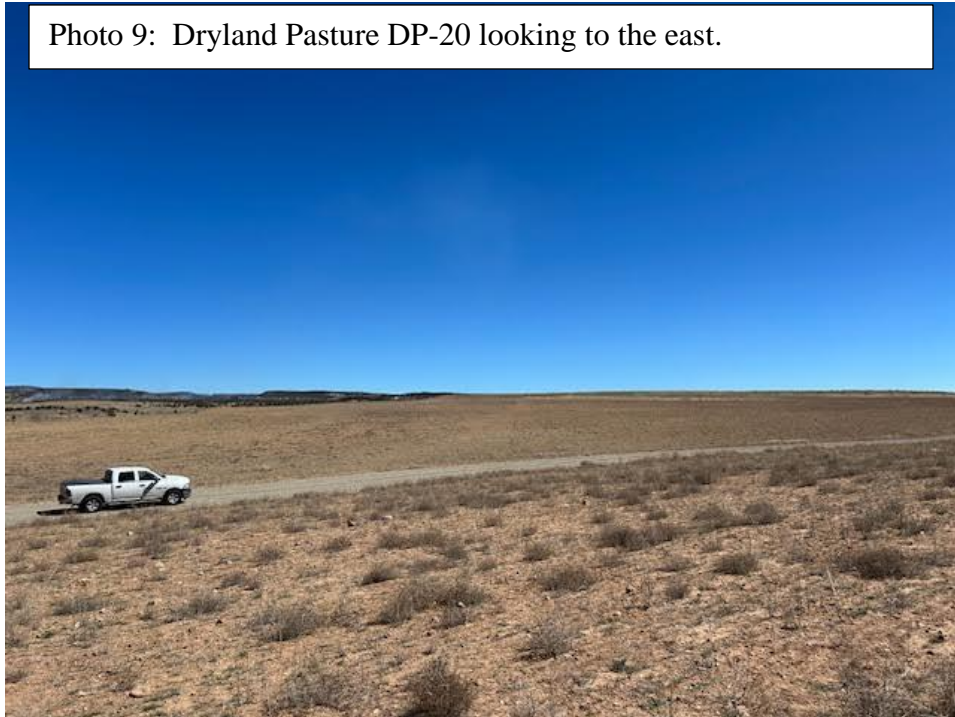
The dryland pasture DP-20 parcel was seeded in 2023. Vegetation was beginning to green for the season along the seeding rows (Photo 9). One south-southwest facing area was observed to be filling in a little slower than the rest of DP-20. This area will be continued to be monitored and addressed if necessary. The site was stable with no erosional features. There were no indications of differential settling.

Photo 9: Dryland Pasture DP-20 looking to the east.

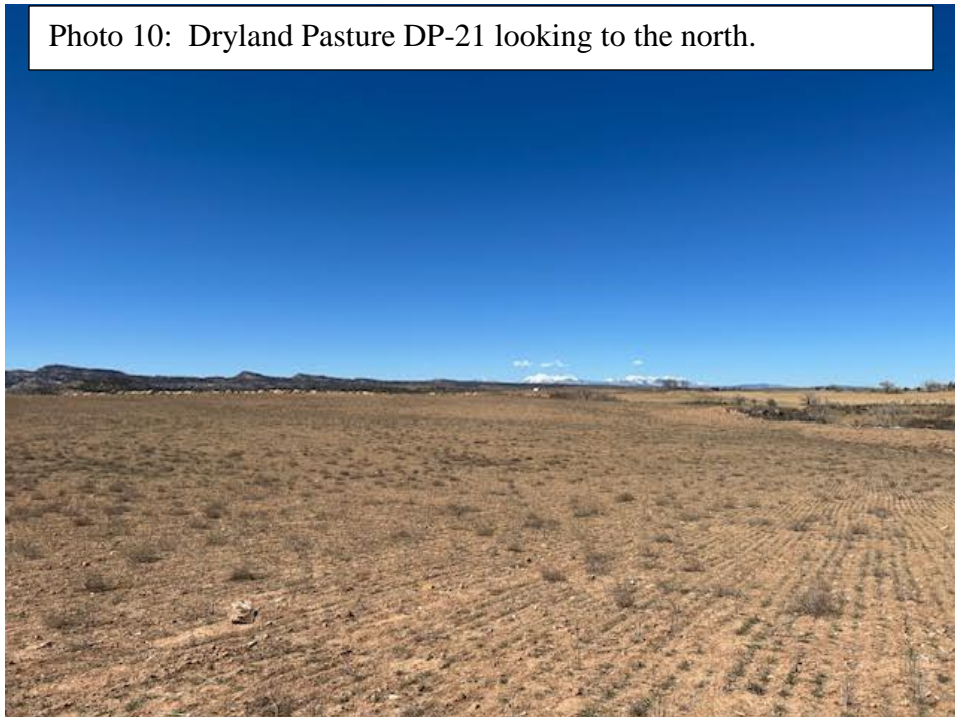
DP-21 (dryland pasture) was also seeded in 2023. The reclamation parcel was found to be stable with no erosional concerns (Photo 10). Vegetation on the site was beginning to green along the seeding rows. No indications of differential settling were noted.

Photo 10: Dryland Pasture DP-21 looking to the north.

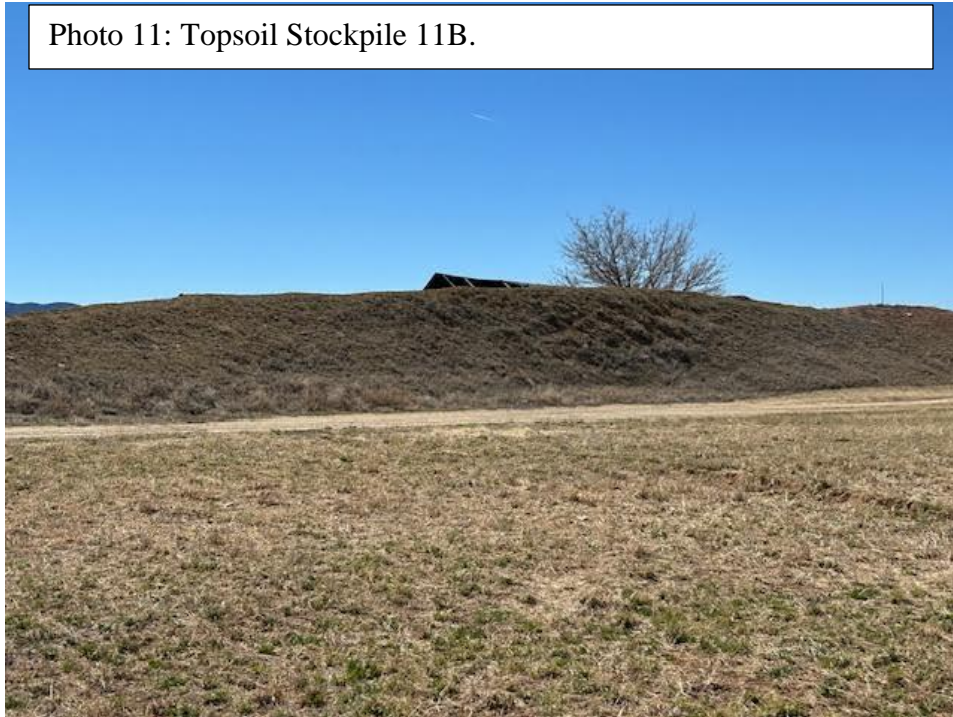
Photo 11: Topsoil Stockpile 11B.

Topsoil Stockpiles 11A and 11B are located to the south of IC-1 (Photo 11). The stockpiles were covered with vegetation and noted to be stable. There were no indications of erosion or loss of topsoil resource. Topsoil pile markers were observed to be posted for both piles.

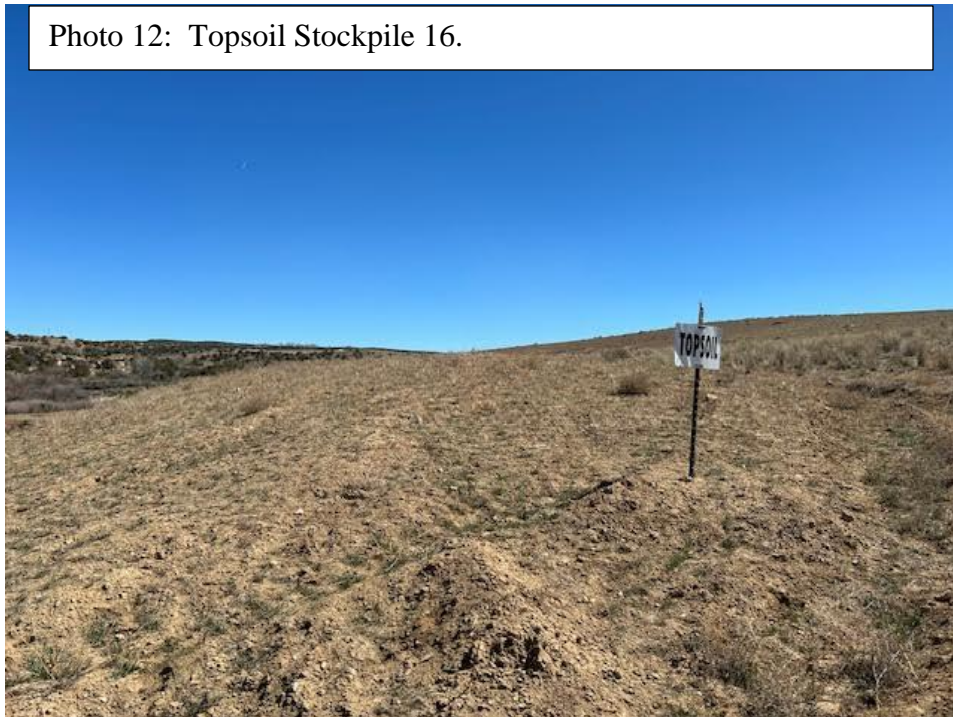
Photo 12: Topsoil Stockpile 16.

Topsoil piles 5, 14, 15, and 16 (Photo 12) are associated with various sediment ponds at the mine site. These topsoil piles were observed to be stable with vegetative cover. There were no indications of erosional features or loss of topsoil resource. Topsoil pile markers were seen for each of the piles.
