**MINERALS PROGRAM INSPECTION REPORT**  
**PHONE: (303) 866-3567**

<b>MINE NAME:</b> Sunday Mine	<b>MINE/PROSPECTING ID#:</b> M-1977-285	<b>MINERAL:</b> Uranium and vanadium	<b>COUNTY:</b> San Miguel
<b>INSPECTION TYPE:</b> Multi Person Inspection	<b>WEATHER:</b> Clear	<b>INSP. DATE:</b> February 27, 2025	<b>INSP. TIME:</b> 12:49
<b>OPERATOR:</b> Pinon Ridge Mining LLC	<b>OPERATOR REPRESENTATIVE:</b> Bruce Smith	<b>TYPE OF OPERATION:</b> 112d-2 - Designated Mining Operation	
<b>REASON FOR INSPECTION:</b> Normal I&E Program	<b>BOND CALCULATION TYPE:</b>	<b>BOND AMOUNT:</b> \$330,242.00	
<b>DATE OF COMPLAINT:</b> NA	<b>POST INSP. CONTACTS:</b> None	<b>JOINT INSP. AGENCY:</b> None	
<b>INSPECTOR(S):</b> Lucas West	<b>INSPECTOR'S SIGNATURE:</b>

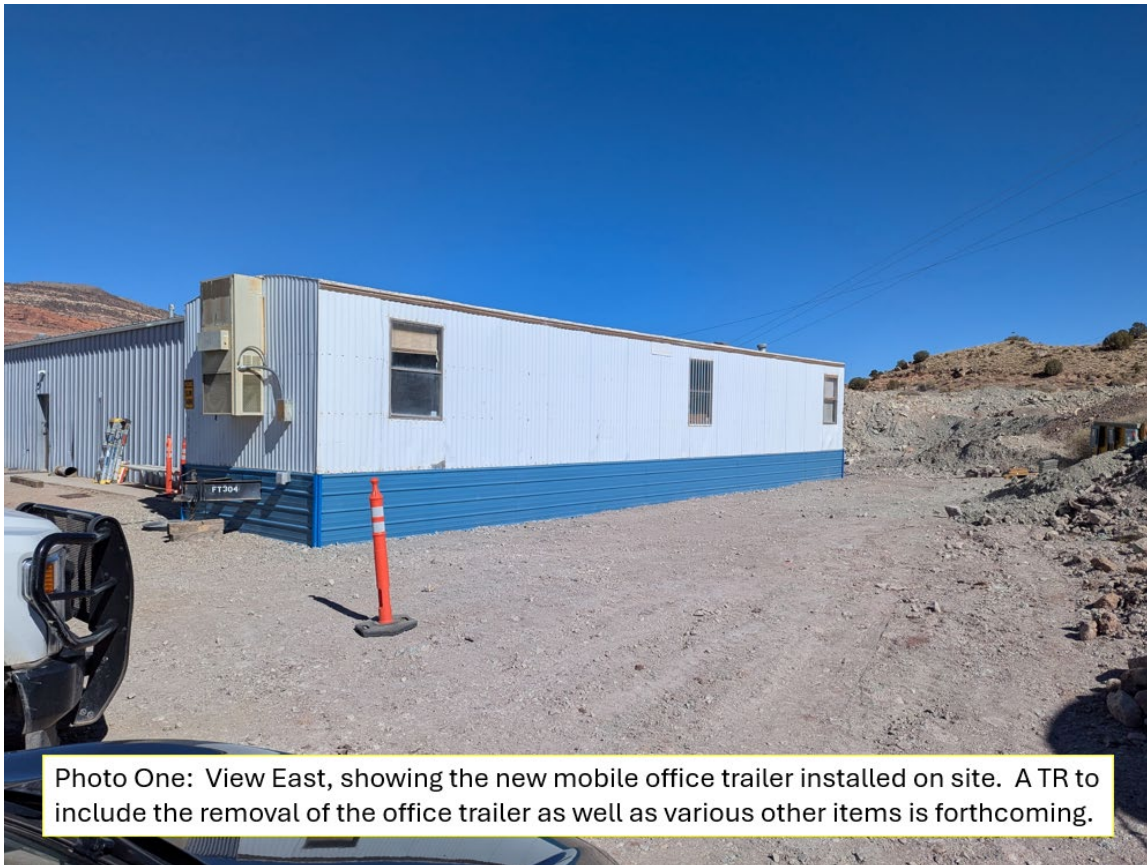
Photo One: View East, showing the new mobile office trailer installed on site. A TR to include the removal of the office trailer as well as various other items is forthcoming.

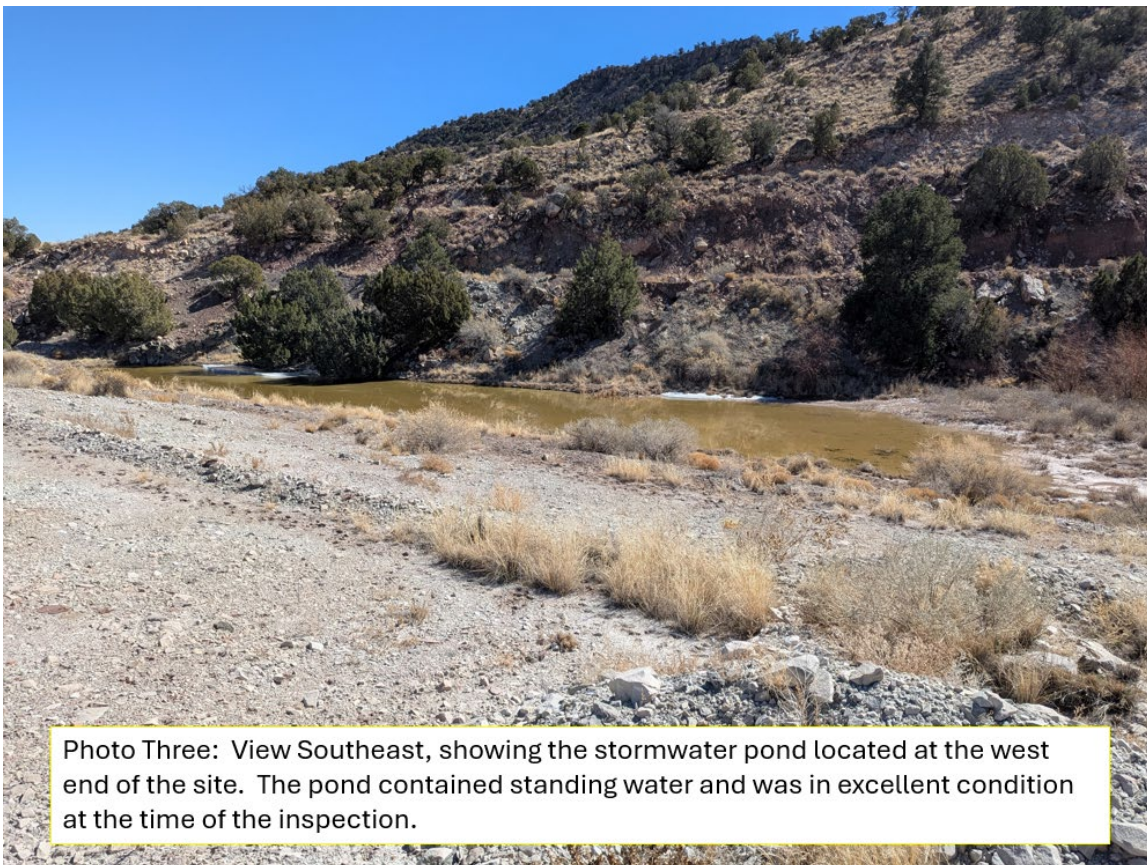
Several stormwater control structures and system are located throughout the site. At the time of the inspection the Western stormwater pond contained standing water from snowmelt and precipitation as seen in Photo Three. The pond is excellent condition and the banks appeared to be stable. Around the toe of the waste rock dump, stormwater is routed to a large catchment basin using ditches, an example of which can be seen in Photo Four. All observed ditches were free from obstruction and appeared to be able to function as designed. The main stormwater basin can be seen in Photo Five. That basin also receives stormwater flows from around the facilities area, along with several other smaller catchments. The catchments in the facilities area can be seen in Photo Six. The series of ponds located adjacent to the low-grade ore stockpile were also observed to be in good condition however did not contain standing water at the time of the inspection. The upland diversion ditches that divert any potential run on water around the site to prevent it from becoming impacted stormwater were not observed during this inspection. On site discussions with Bruce Smith of Western Water and Land revealed that a comprehensive stormwater inspection had been conducted the day before the inspection and that all systems were in good working order.

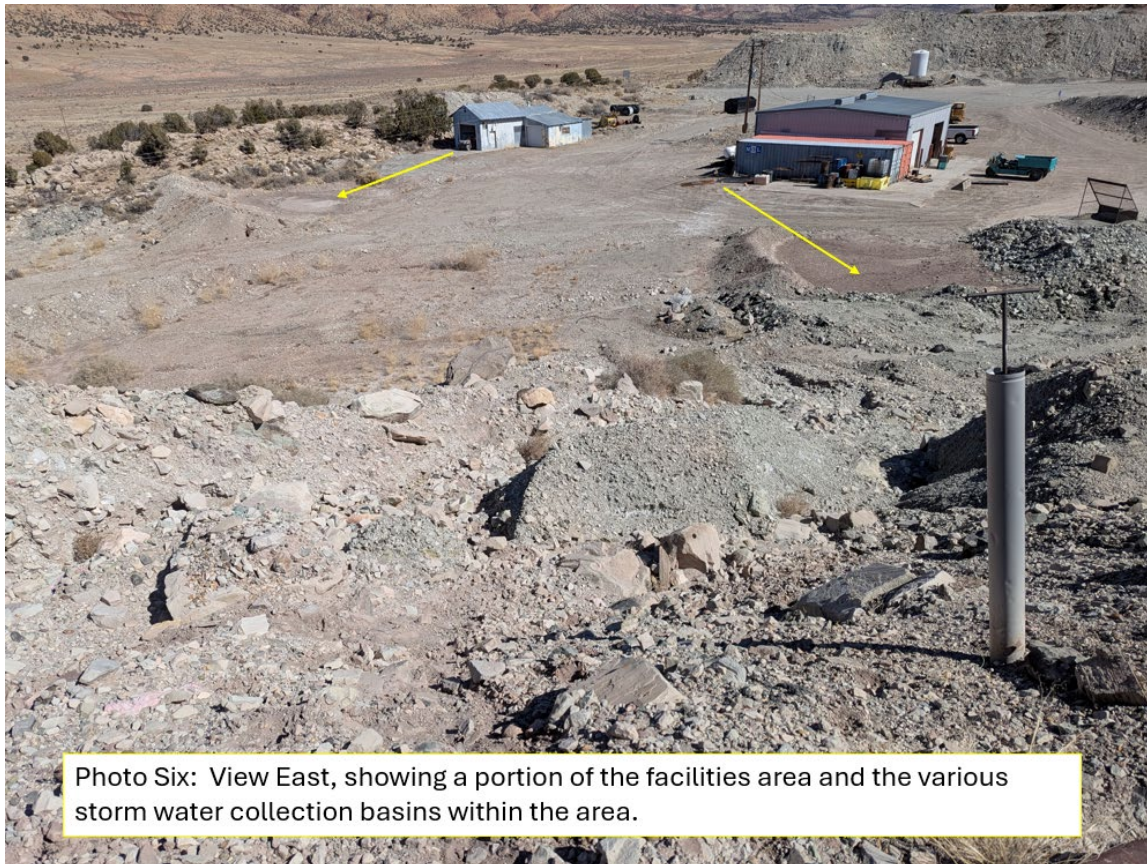
Photo Six: View East, showing a portion of the facilities area and the various storm water collection basins within the area.
