**MINERALS PROGRAM INSPECTION REPORT**  
**PHONE: (303) 866-3567**

<b>MINE NAME:</b> Lascar Pit	<b>MINE/PROSPECTING ID#:</b> M-2025-004	<b>MINERAL:</b> Sand and gravel	<b>COUNTY:</b> Huerfano
<b>INSPECTION TYPE:</b> Pre-operation Inspection	<b>WEATHER:</b> Cloudy	<b>INSP. DATE:</b> March 28, 2025	<b>INSP. TIME:</b> 09:30
<b>OPERATOR:</b> Siete, Inc.	<b>OPERATOR REPRESENTATIVE:</b> Jodi Schrieber and Mike Loya	<b>TYPE OF OPERATION:</b> 112c - Construction Regular Operation

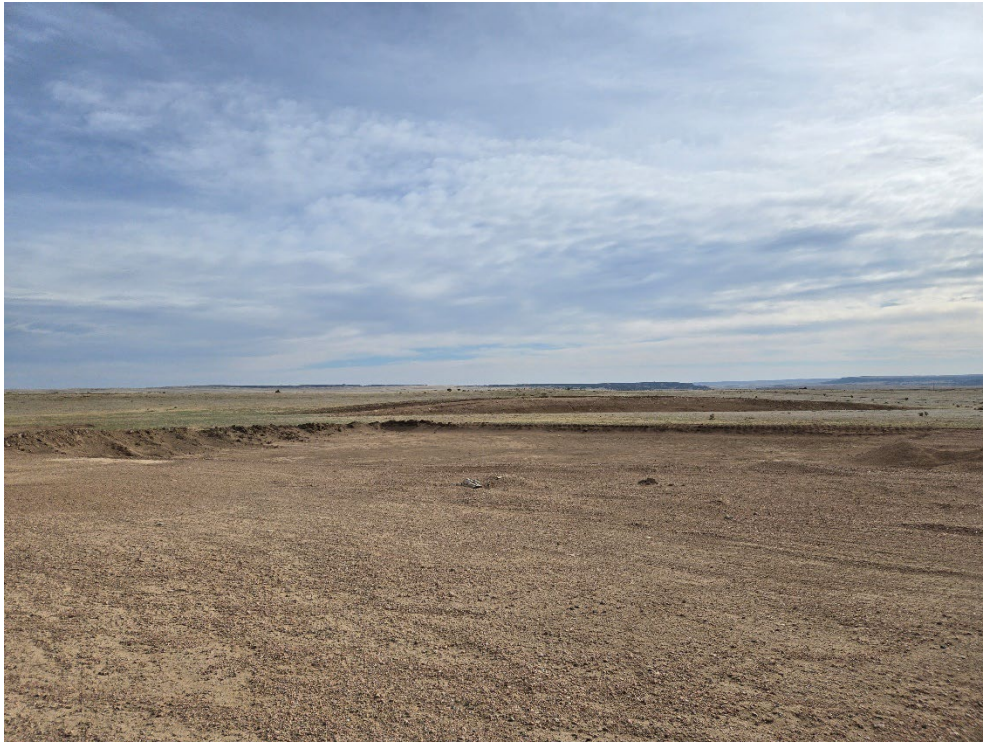
No further activity has occurred since the Division's recently conducted inspection at this site (Photos 1-3). Please see the Division's inspection report from the inspection conducted on September 4, 2024 for permit number M-2023-005.

**Photo 1:** Looking northeast at the northeast corner of the pit disturbance. In the background are the topsoil and overburden/additional topsoil piles seen on Maps 1 and 2.

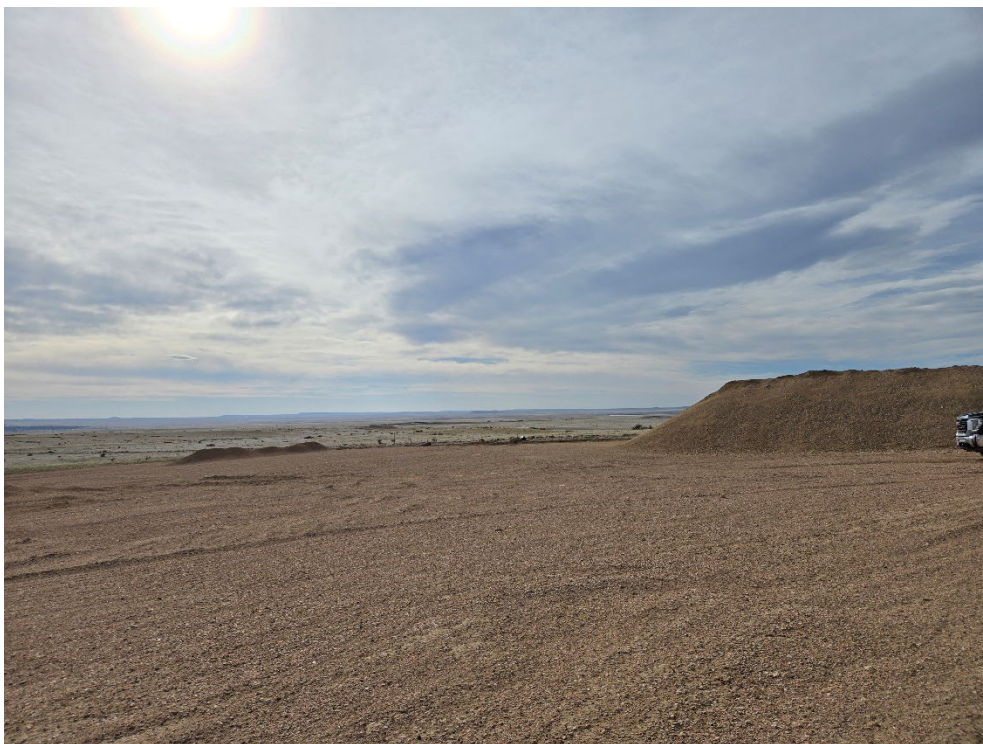
**Photo 2:** Looking southeast within the pit area.

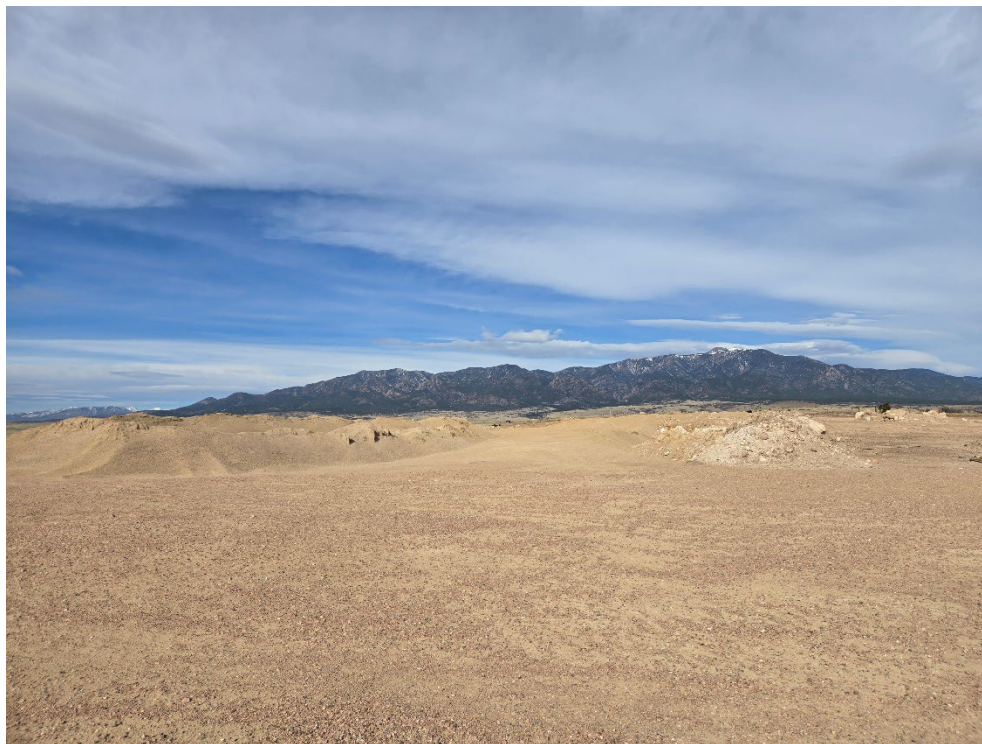
**Photo 3:** Looking west along the pit area.

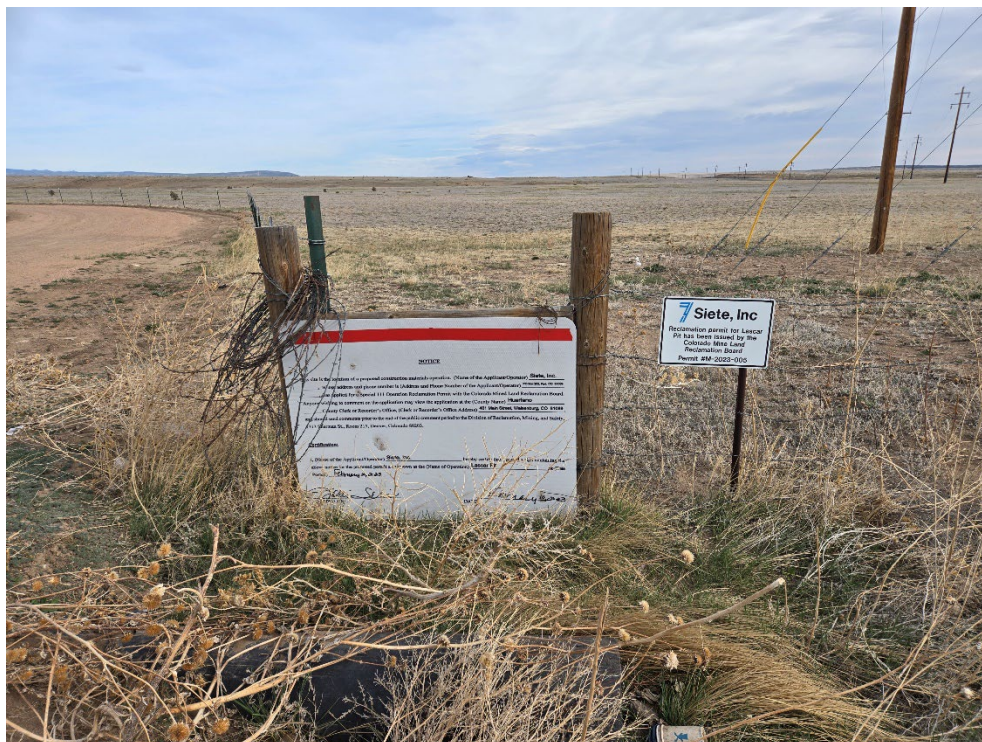
**PROBLEM:** The application notice sign was not posted at the entrance of the mine site. This is a problem for failure to post a proposed mine site notice sign as required by Rule 1.6.2(1)(b) Addendum 1.

The notice sign required by Rule 1.6.2(1)(b) Addendum 1 was not posted. The notice sign posted at the site is from the 111 application (Photo 4). This has been cited as a problem above. The Applicant shall post the notice sign at the road entrance and send a photo to the Division by the corrective action date. The affected boundary at the site is marked both by field posts and a low earthen berm (Photos 5-6; Maps 1 & 2). The geometry of the field markers and marked disturbance boundary appears to match the boundaries shown in the 111 permit application and the 112c permit application maps. However, there appears to be an offset of the boundary to the south. The Applicant is aware of the discrepancy and will work with the Division through the adequacy process to determine the appropriate next steps.

**Photo 4:** Notice sign and mine sign posted at the entrance road correspond to the current 111 permit.

**CORRECTIVE ACTIONS:** The Applicant shall, at the entrance of the proposed mine site post a notice (sign), which shall be clearly visible from the access road, with a minimum size of eleven (11) inches in height and seventeen (17) inches in width, with appropriate font size, to clearly identify the site as the location of a proposed mining operation giving name, address, and phone number of the Applicant, and stating that (name of Applicant) has applied for a mining permit with the Colorado Mined Land Reclamation Board. The Applicant shall submit photo documentation showing that a notice has been posted by the corrective action date.

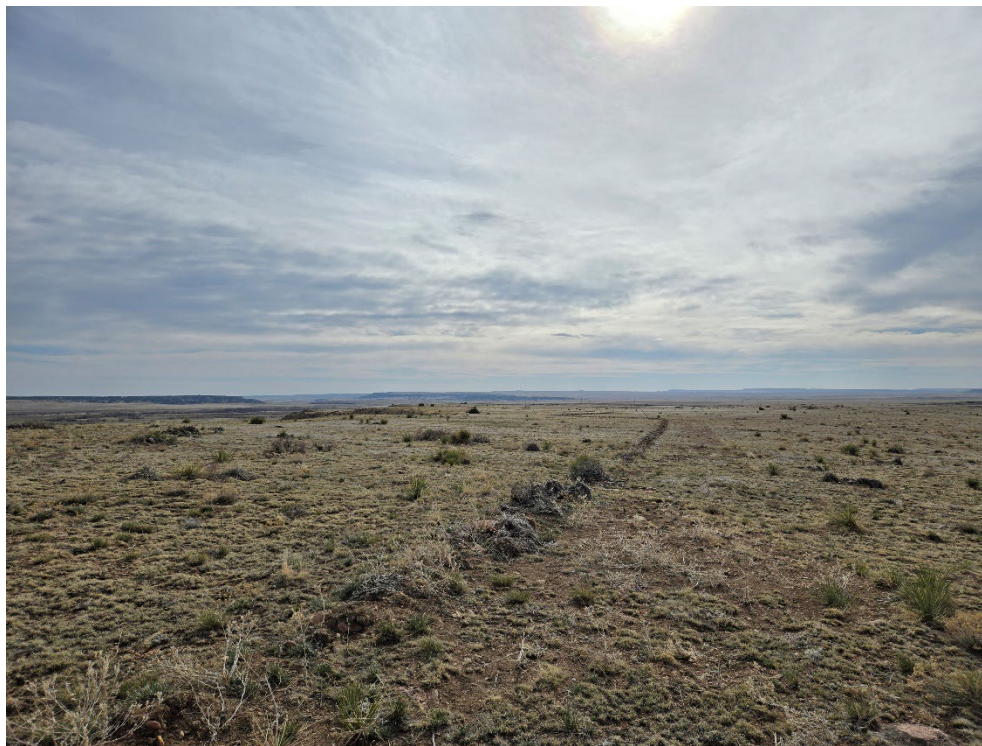
**Photo 5:** Looking east along the low earthen berm that marks the affected land boundary.

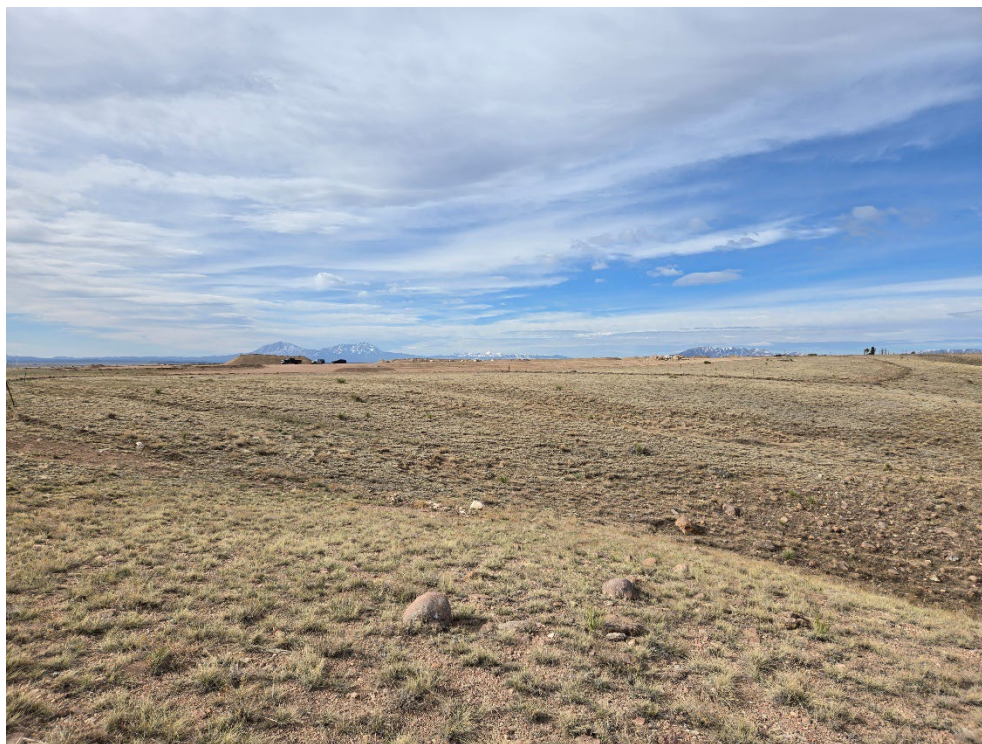
**Photo 6:** Looking southwest at the field markers and the low earthen berm marking the affected land boundary.

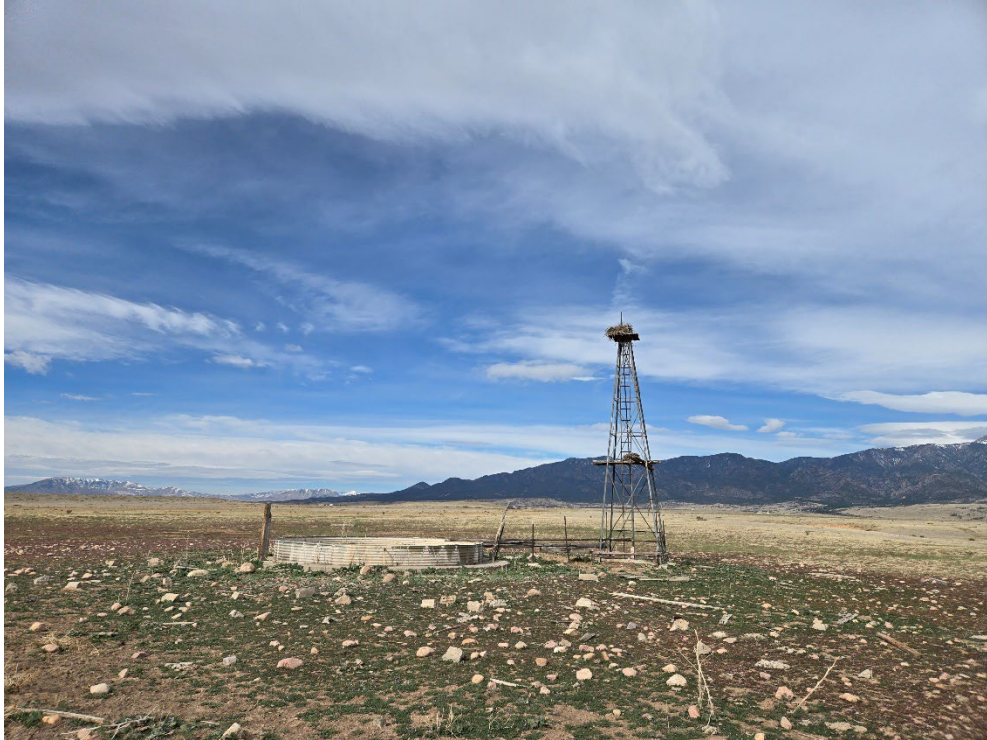
**Photo 7:** Looking west at the stock pond/waterline and windmill.

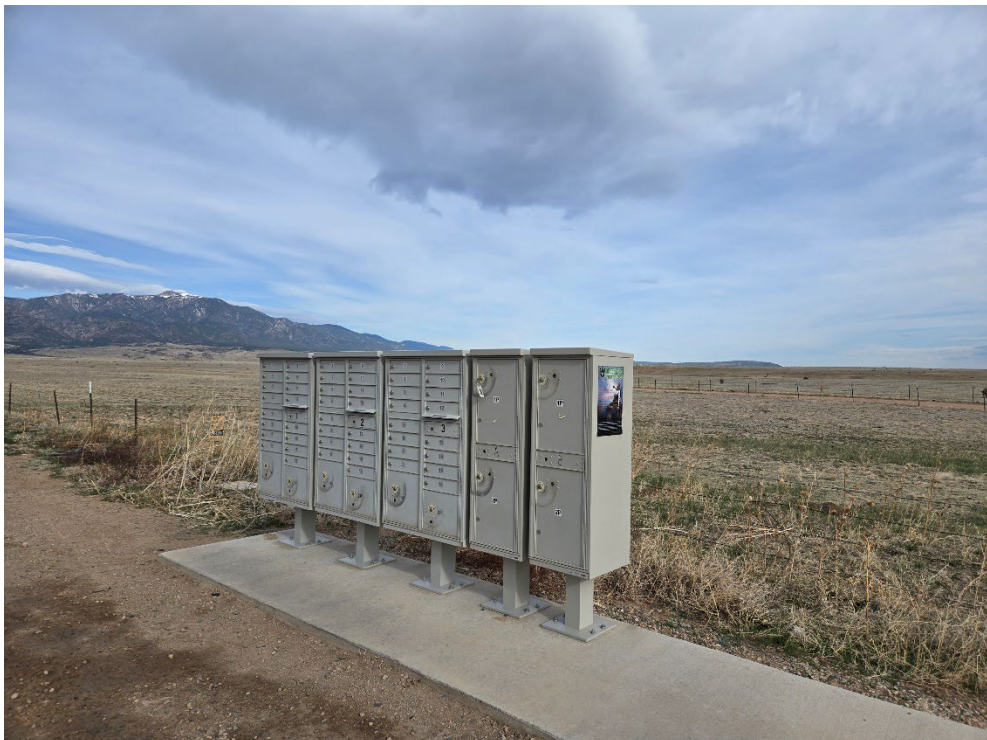
**Photo 8:** Looking northwest at the mailbox bank.

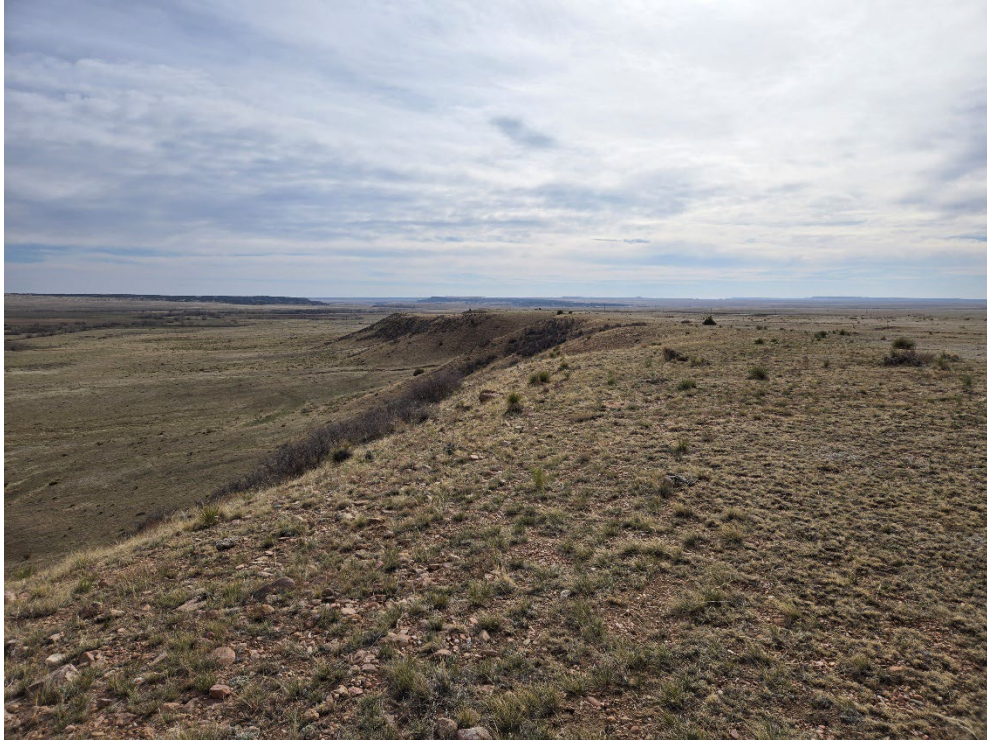
shown on the other maps (see Map 3 at the end of this report). When asked about this during the inspection, the Applicant stated that they believe it was due to a mistake while making the map, as they did not think there were any structures in that location. During the inspection, we looked beyond the north and northeastern boundary (Photo 9) and did not see the structure indicated on the map, thus agreeing that it was likely an accidental addition.

**Photo 9:** Looking east beyond the permit boundary. No stock pond was observed in this area during the inspection.

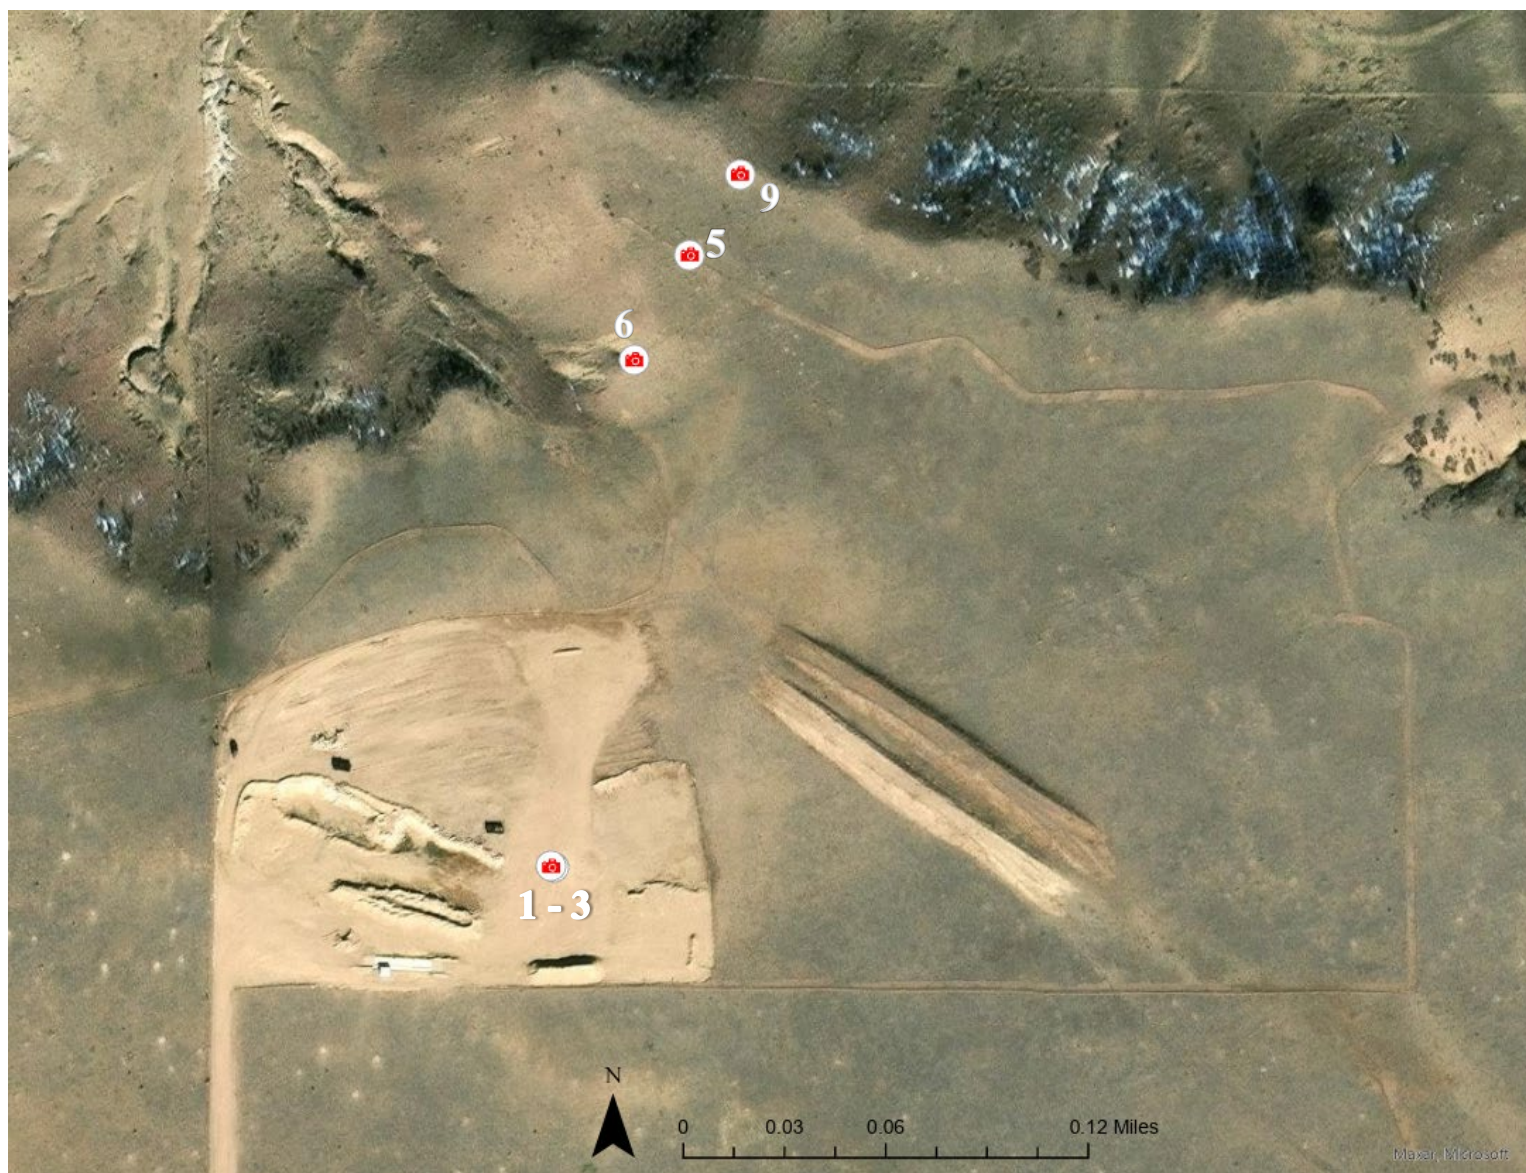
**Map 2:** Closer view of the main site area. The aerial imagery is sourced from ArcPro and is dated November 21, 2024. The affected land boundary can be seen from this aerial view as a low earthen berm. When comparing this boundary to the one shown on the Applicant's maps (see Map 3 below), it appears that the field markers were placed in the planned orientation/geometry, but are offset to the south. Also shown in this photo are the two diagonal stockpiles on the east side of the permit are the topsoil pile (northern pile) and a topsoil/overburden stockpile (southern pile) where the Operator had sifted potential additional material from product to be used later during reclamation mentioned in the Division's 2024 inspection report under permit no. M-2023-005.

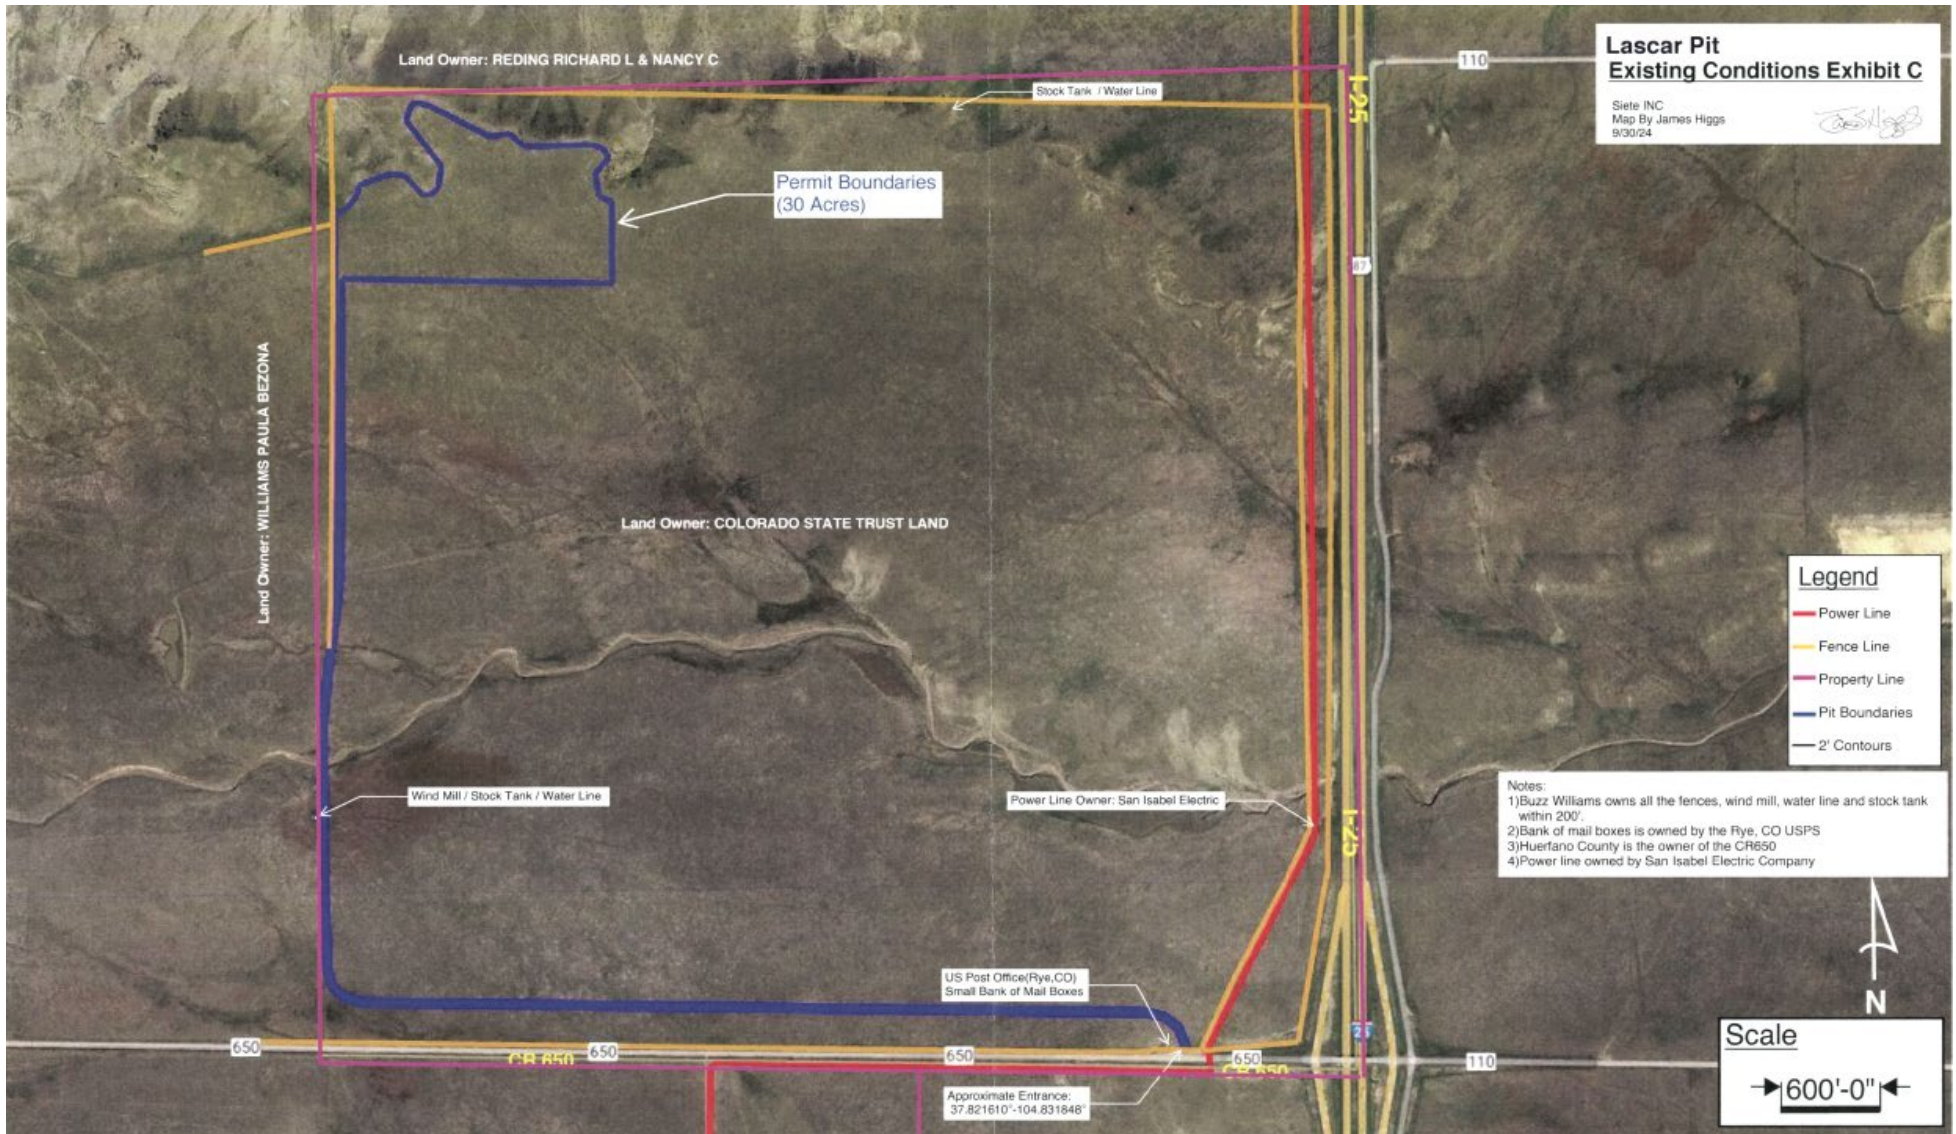
As part of the pre-operational inspection, the Division documented the permanent man-made structures within the affected area boundary and within 200 feet of the boundary. There are no permanent man-made structures onsite. Nearby, there are powerlines, fences, County Road 650, a mailbox bank, a windmill, and a waterline/stock tank (see Photos 7-8 for the windmill, waterline/stock tank, and mailbox bank). There is a stock tank/water line shown on the Exhibit C: Existing Conditions Map included with the application that is not

**Map 3:** Applicant's Exhibit C – Existing Conditions Map. The permit boundary/affected land boundary appears to follow the geometry of the mesa.
