## Spring 2024 Subsidence and Geologic Field Observations Report

# Spring 2024 Subsidence and Geologic Field Observations

## Southern Panels and Sunset Trail Mining Areas

September 2024

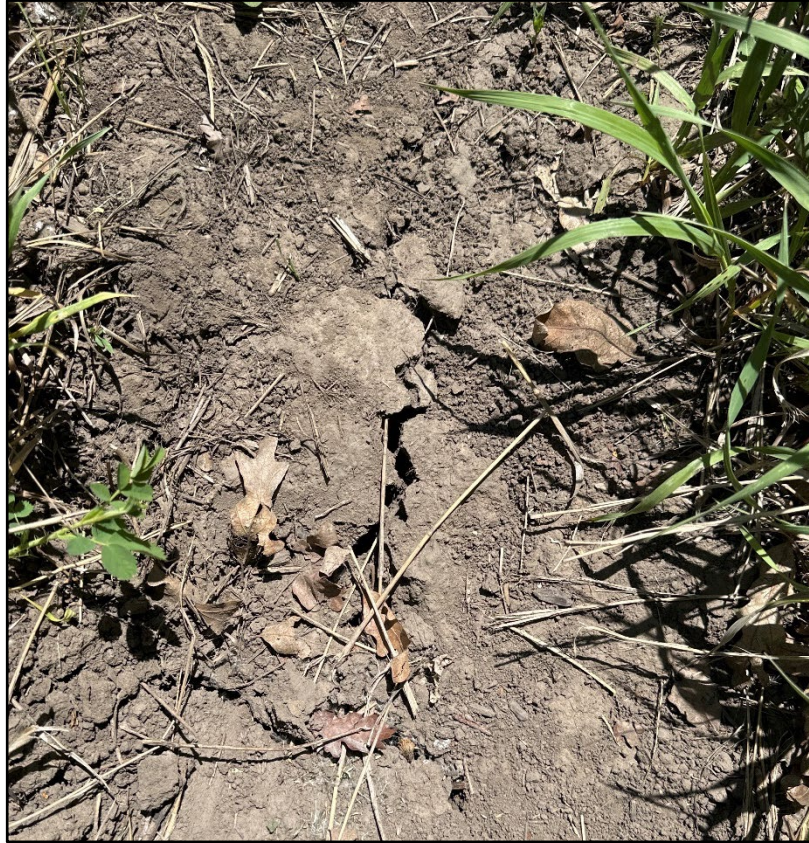
A series of small cracks were observed along the trail that appeared to be subsidence related due to the frequency and linear nature of the cracks, the location relative to the longwall panel layout, and the fact that mining had recently occurred beneath the trail. Based on the mining progression map, Traverse A-A' was mined under around April 2024, approximately 2 months prior to the spring observations.

Figure 1 shows one of the larger cracks observed along this traverse. Most of the cracks had no discernible width and were very shallow.

WWE has observed similar cracks at locations recently mined under in the E-seam longwall mining panels. Typically, these cracks are due to dynamic subsidence processes and heal/seal within a short timeframe. Subsequent observations will determine whether these cracks follow a similar pattern.

Figure 1: Small subsidence crack on trail along Horse Gulch  
overlying Longwall Panel E12.

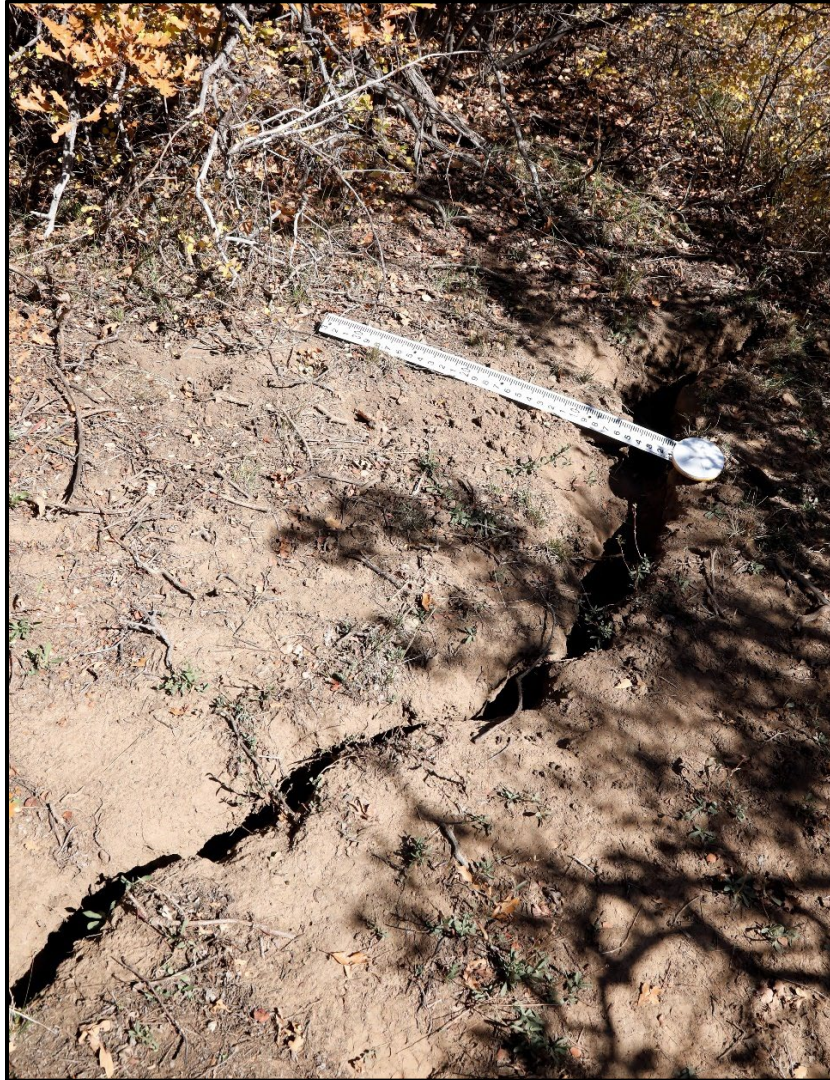
New cracks were first observed south of the access road overlying the north end of E-seam Longwall Panel E14 during the fall 2022 site visit. As shown on Map 1, the cracks were observed at Location 2 adjacent to cross cut 17 of the E14 Headgate. A series of parallel cracks were observed roughly parallel to the E14 Headgate with an orientation of South 40° East. The largest of the observed cracks followed the topographic contour for approximately 100 feet (Figure 2).

Figure 2: The largest of the cracks observed at Location 2 in fall 2022, south of the across road on Traverse C-C'.

The location of these cracks is consistent with locations where the tilt and horizontal displacement are largest near the edge of the panel as shown in Figure 3 of Exhibit 60E (WWE 2018). The existence of the series of parallel cracks was likely a combination of these horizontal strains in combination with the natural sloped hillside. In total, there were 5 cracks observed with the dimensions of the cracks generally decreasing in the downhill direction towards the center of the longwall panel.

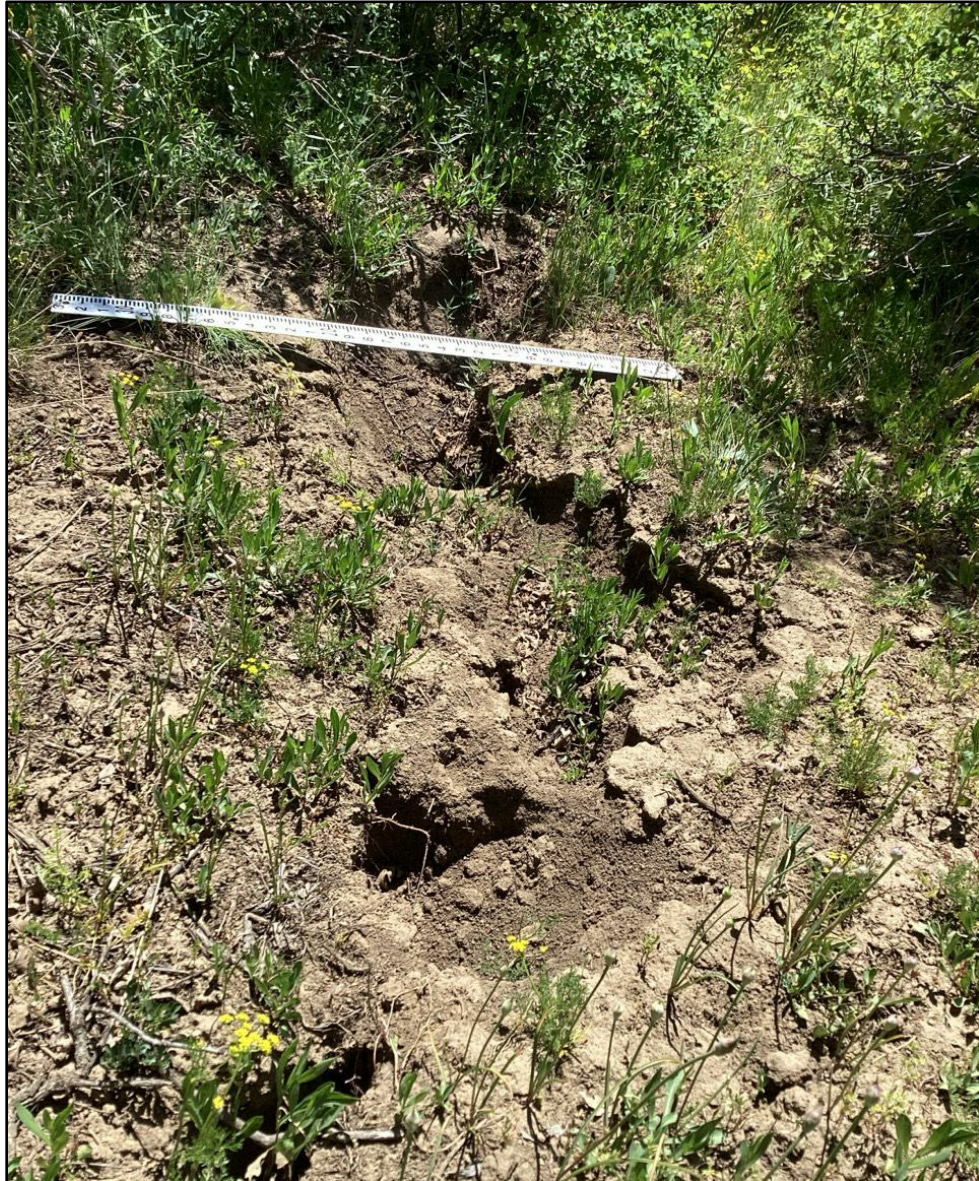
During the spring 2024 site visit, these cracks were still evident but were much less prominent. The smaller cracks had largely healed/sealed, especially where cattle or large game trails occurred. The larger cracks continue to heal; however, the sealing process appears to have stopped as some of the largest cracks remain open (Figure 3).

Figure 3: One of the largest of the cracks at Location 2, south of the across road on Traverse C-C' during spring 2024 visit showing continued healing.

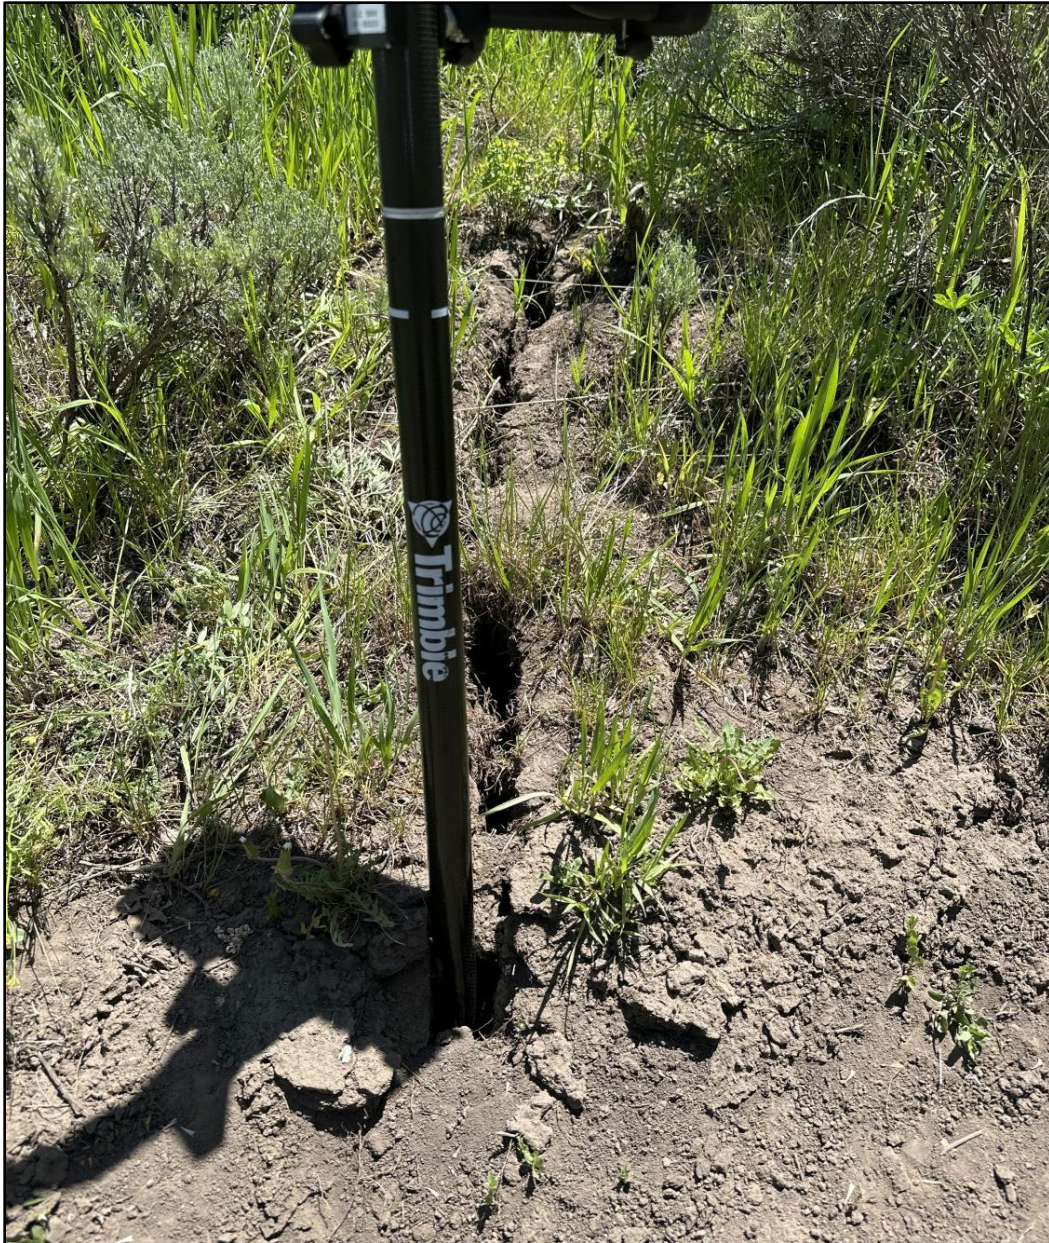
Newly-observed crack was documented along the path overlying E-seam Longwall Panel E15 as shown in Figure 4.

Figure 4: New crack observed over Longwall Panel E15  
during spring 2024 site visit

The location of the crack was at a location that indicates mining occurred shortly after the fall 2023 site visit, at which time no subsidence features were observed. The crack appeared fresh, consistent with the timing of mining occurring beneath the location. The crack was approximately 15 to 20 feet in length with an east-west orientation. The maximum width of the crack was 2 to 3 inches with a maximum observed depth of 1.5 feet.

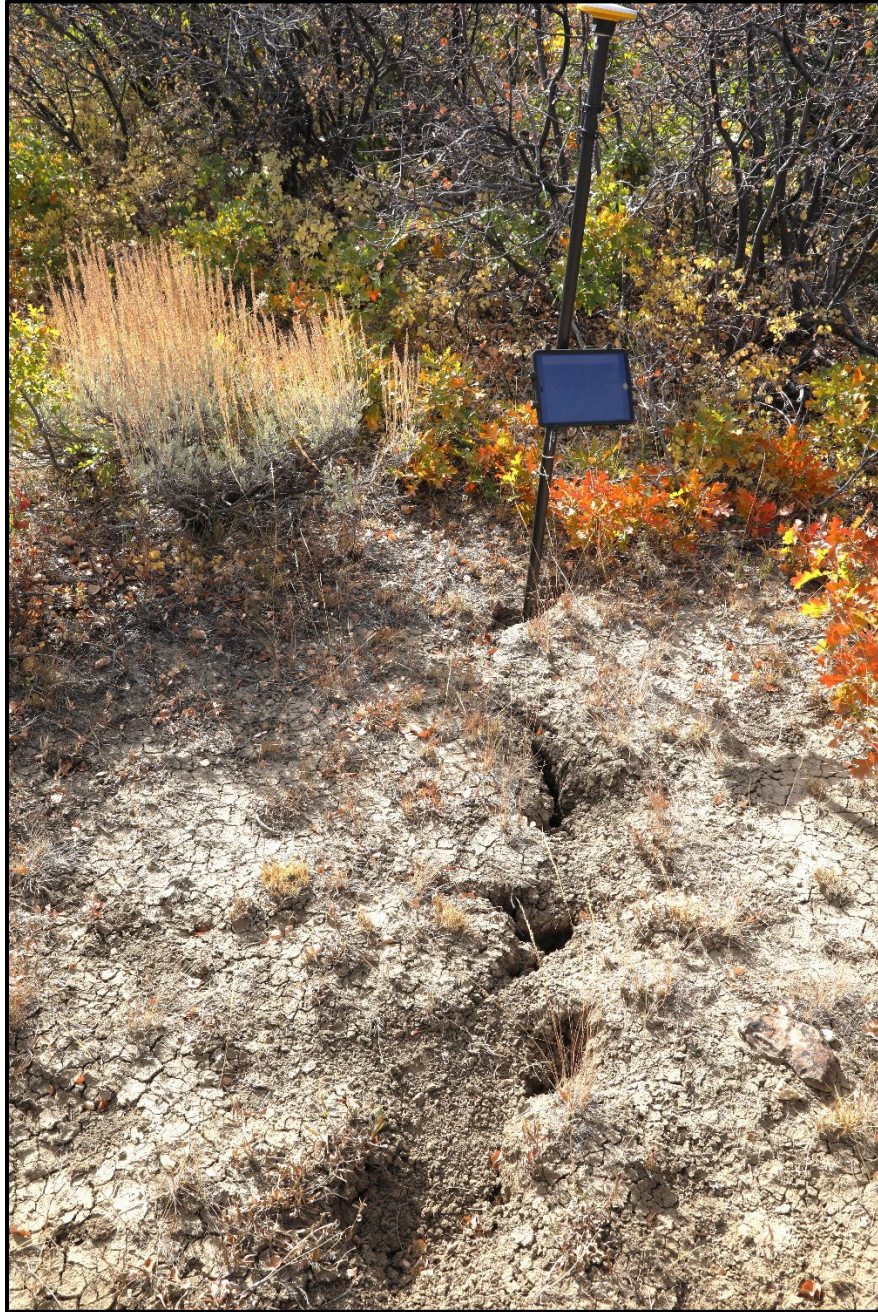
The newly observed cracks were located on both sides of the access road but were not seen on the road itself. This fact may indicate that the cracks were present, but not observed, prior to the fall 2023 site visit. The majority of the observed cracks were located on the eastern side of the road with E-seam overburden depth of roughly 500 to 600 feet. In general, the orientation of the cracks was north-south along the downslope of the topography away from the road that follows a ridgeline over Panel E14. The maximum depth of the cracks was 1.5 to 2.0 feet with a maximum width of approximately 4 inches. Figure 4 shows the largest of the cracks observed at Location 4 in the fall 2023.

Figure 5: Crack observed along D-D' over Longwall  
Panel E14 during fall 2023 site visit.

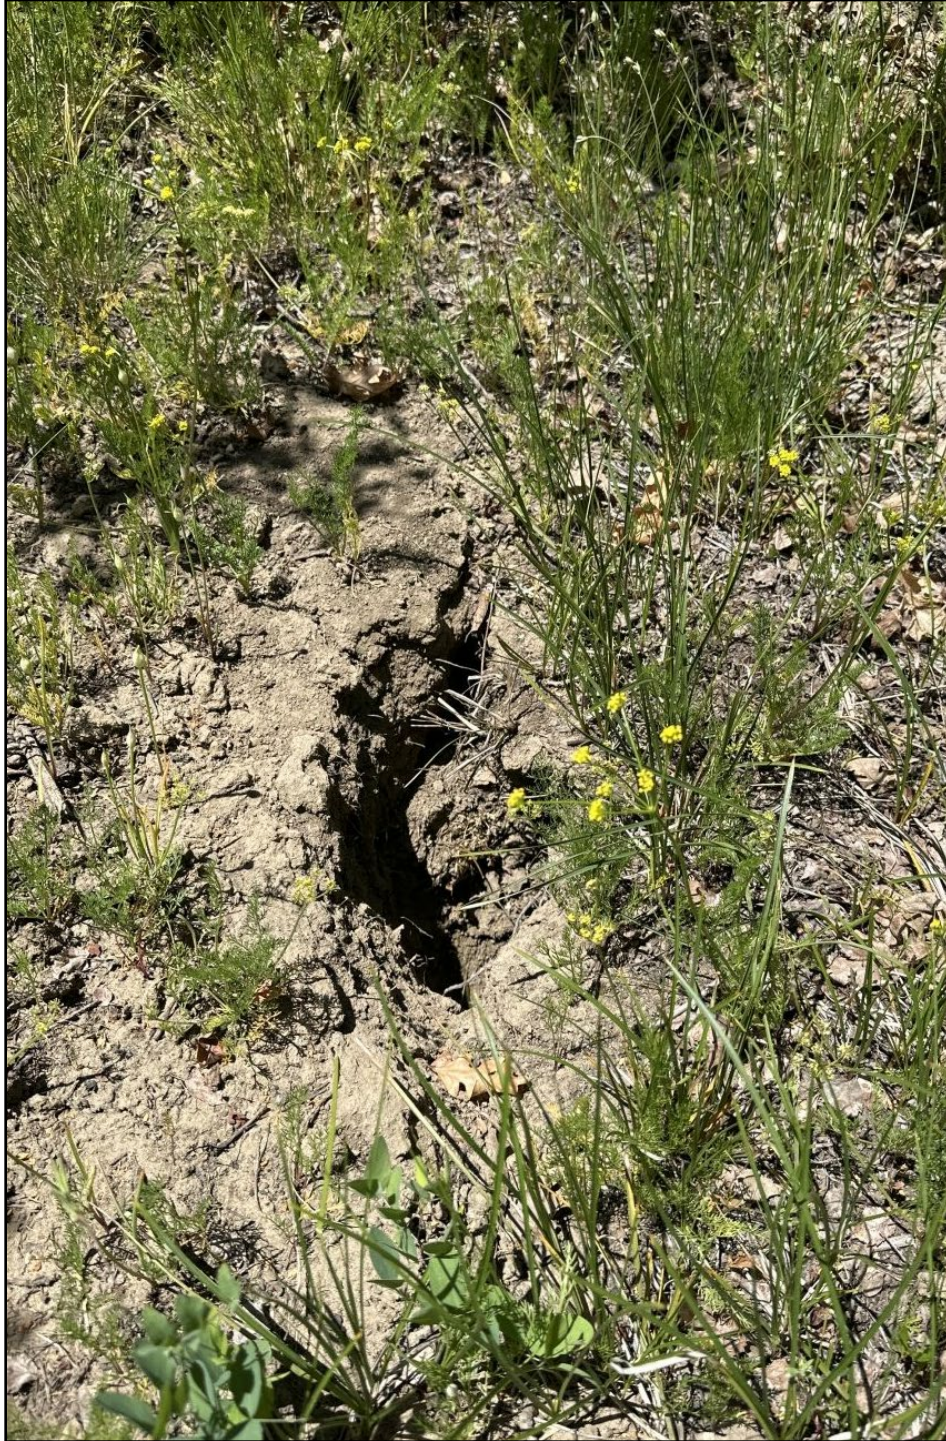
Figure 6: One of the larger cracks at Location 4 showing signs of healing/sealing in Spring 2024

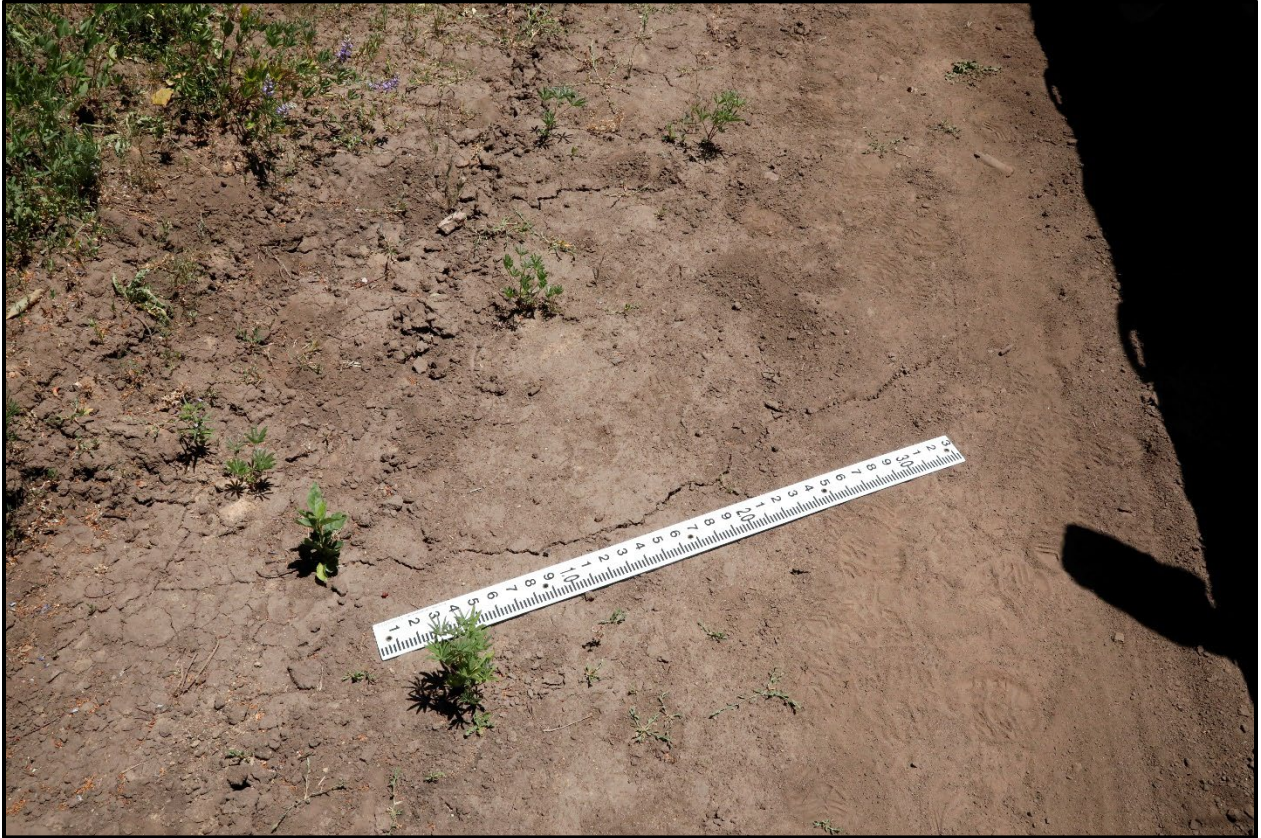
New cracks were observed along the north side of the access road overlying the north end of E-seam Longwall Panel SS3 during the spring 2023 site visit. As shown on Map 1, the cracks were observed between Location 3a and 3b. A series of parallel cracks were observed roughly parallel each other with an orientation of South 37° East. The cracks had no discernable depth or width and were not perpendicular to the road (Figure 6). It is unclear whether these observed cracks were related to mining subsidence; however, their consistent orientation was noteworthy and merited documentation. Longwall mining occurred under Locations 3a to 3b during the months of December 2022 and January 2023.

Figure 7: Example of an observed crack along the north side of E-seam Longwall Panel SS3 during spring 2023 site visit
