## Inspection Report, Mesa DeMaya Pit

<b>MINE NAME:</b> Mesa DeMaya Pit	<b>MINE/PROSPECTING ID#:</b> M-2014-019	<b>MINERAL:</b> Sand and gravel	<b>COUNTY:</b> Las Animas
<b>INSPECTION TYPE:</b> Monitoring	<b>WEATHER:</b> Clear	<b>INSP. DATE:</b> March 26, 2025	<b>INSP. TIME:</b> 12:33
<b>OPERATOR:</b> Las Animas County	<b>OPERATOR REPRESENTATIVE:</b> Keith Woodring and Brian Heguy	<b>TYPE OF OPERATION:</b> 110c - Construction Limited Impact	
<b>REASON FOR INSPECTION:</b> Normal I&E Program	<b>BOND CALCULATION TYPE:</b> None	<b>BOND AMOUNT:</b> \$0.00	
<b>DATE OF COMPLAINT:</b> NA	<b>POST INSP. CONTACTS:</b> None	<b>JOINT INSP. AGENCY:</b> None	
<b>INSPECTOR(S):</b> Amber M. Gibson	<b>INSPECTOR'S SIGNATURE:</b>

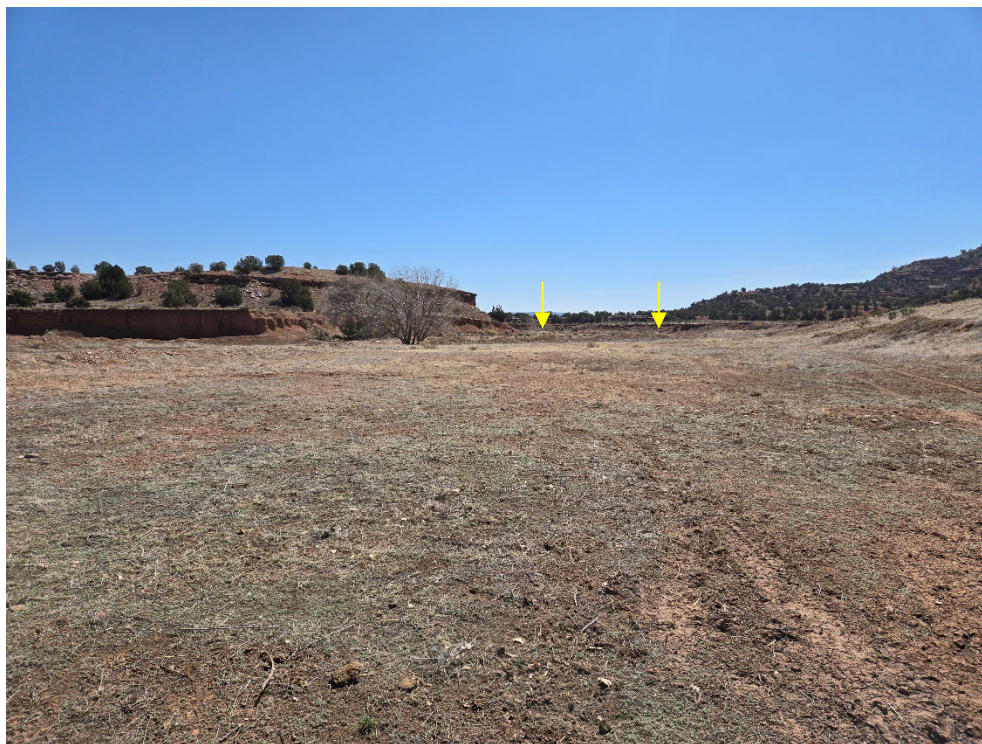
Mining had extended north, northeast, and east from the entrance, with the stockpiling area located to the southeast (Photo 1). The mined area along the east portion of the north half of the site, has been leveled to the floor of the old creek bed that runs through the permit (Photos 2-4 and see Hydrologic Balance section below). There are what the Operator believes to be safety berms along the processing/stockpiling area to prevent equipment from falling into the depressed excavated area.

**Photo 1:** Looking south along the north half of the permit area. The arrows point to some of the safety berms lining the processing area and indicate where the “north half” ends. This area had stockpiles in the southeast corner. The area has since been graded and revegetated.

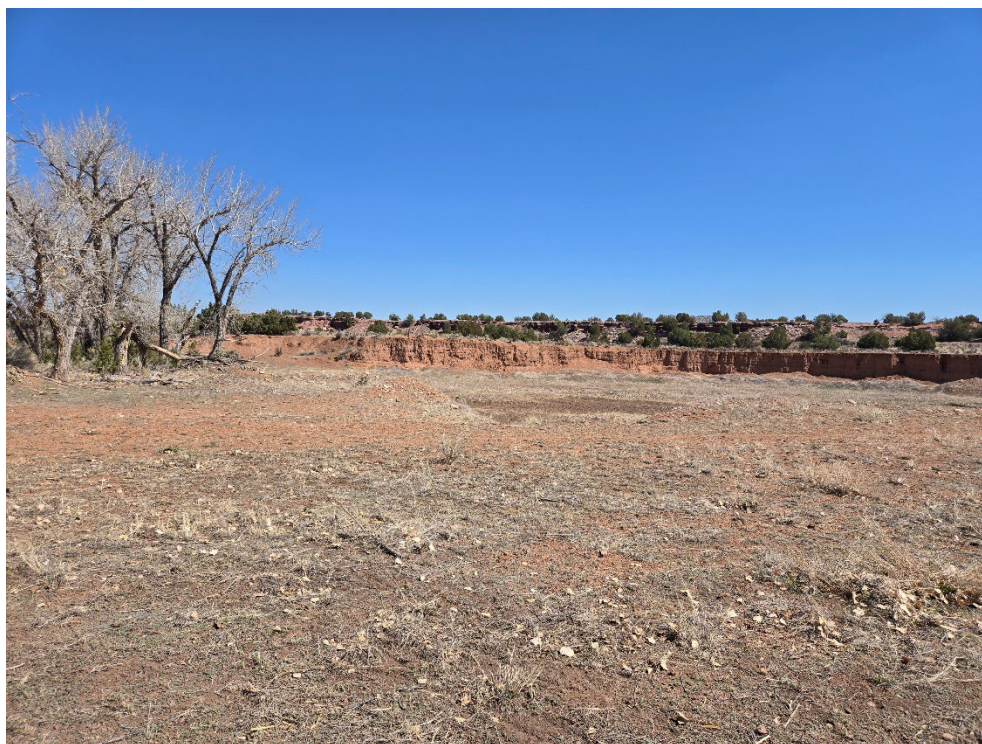
**Photo 2:** Looking east across the processing area into the depressed area that was excavated.

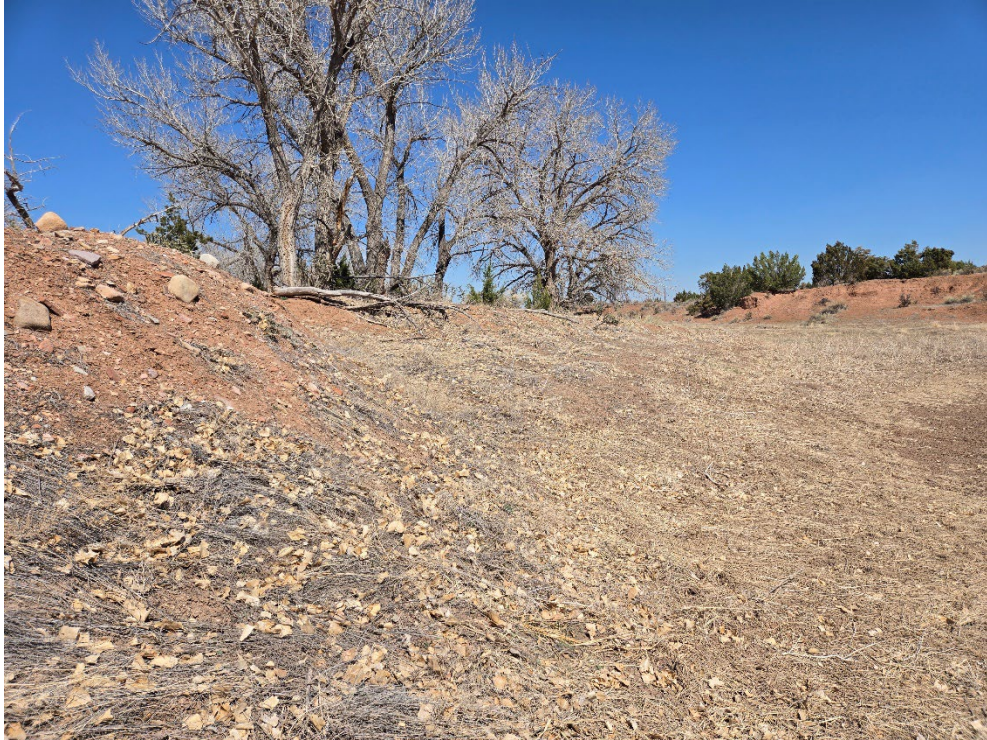
**Photo 3:** Looking along the west slopes within the depressed area that have been graded and seeded.

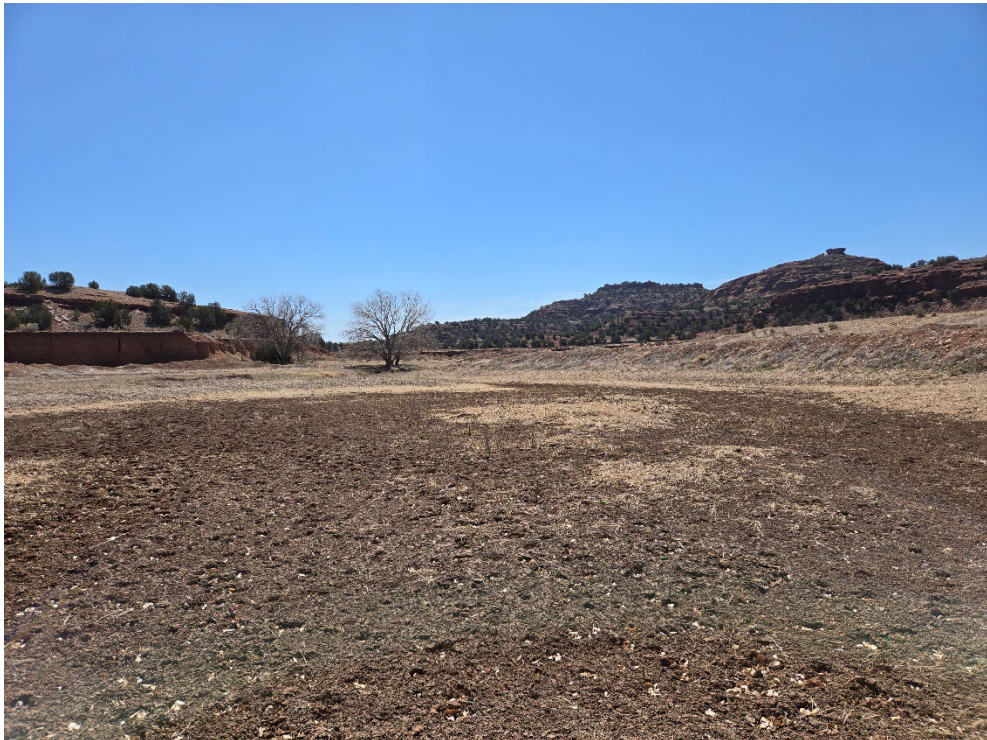
**Photo 4:** Looking southwest along the depressed area. The slopes on the west side have been graded and seeded.

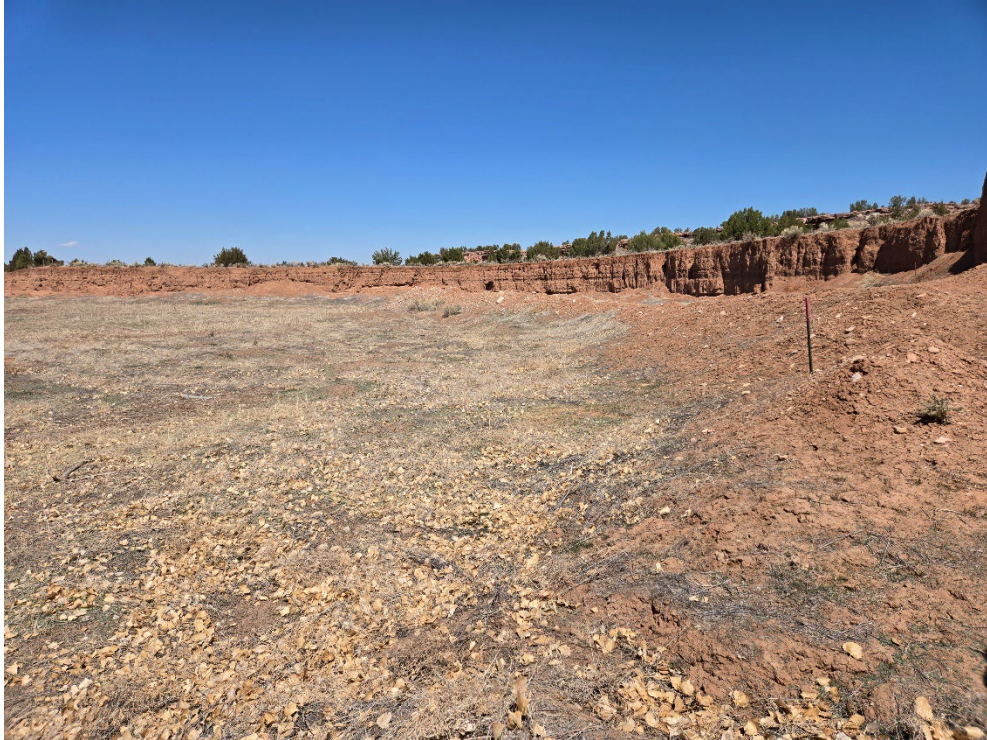
There are natural highwalls lining the east side of the permit boundary and the southwest side of the boundary (Maps 1 and 2). The permit boundary is located inside each bounding highwall (Photos 5-7). In the depressed area in the north half of the permit, there are earthen berms consisting of disjunct piles approximately four feet high lining the boundary. It is unclear why they were placed there but it appears that they may have been used to help prevent runoff from leaving the site. Upon reclamation, the Operator shall grade these berms/piles to a 3H:1V or shallower and revegetate them.

**Photo 5:** Looking northeast at the eastern highwall within the north half of the permit area.

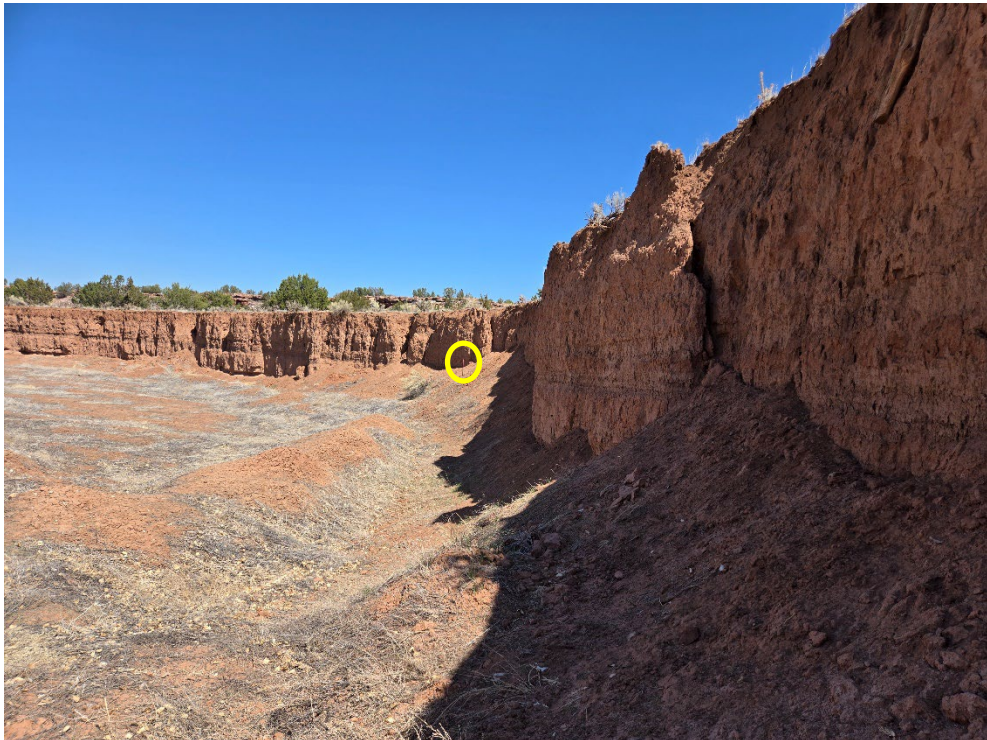
**Photo 6:** Looking east along the eastern highwall in the north half of the permit. The circle shows a t-post that has been placed in the material that has naturally sloughed off the highwalls.

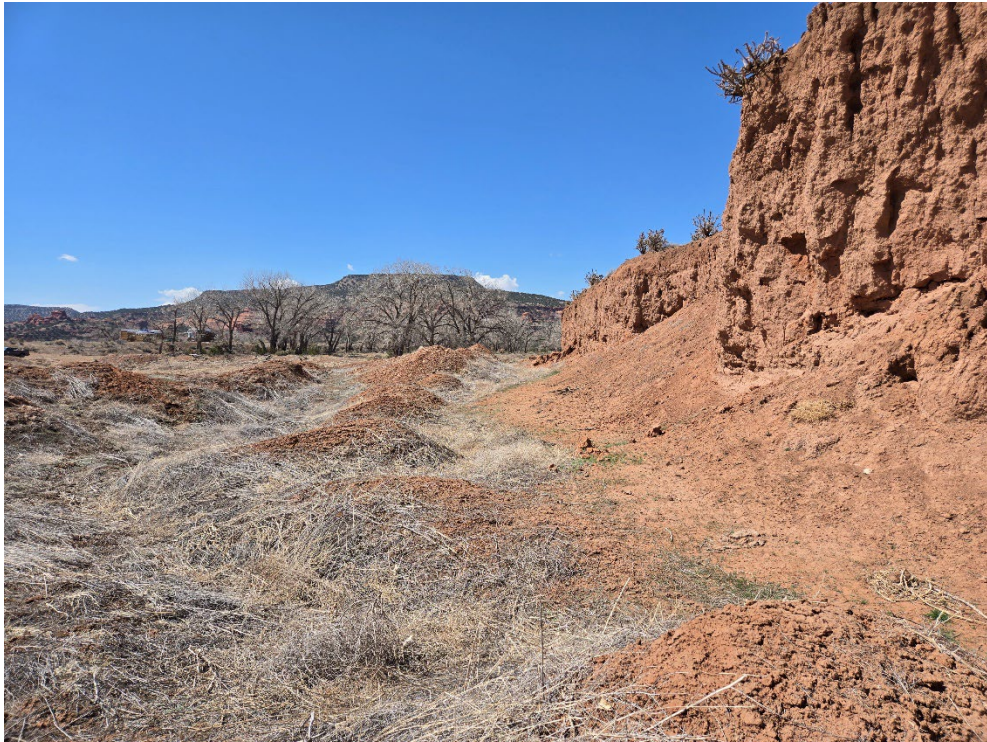
**Photo 7:** Looking north along the east wall in the norther half of the site. Material has naturally sloughed off the highwalls in some areas. Some of the t-posts are placed within the natural deposition (see Photo 6 above).

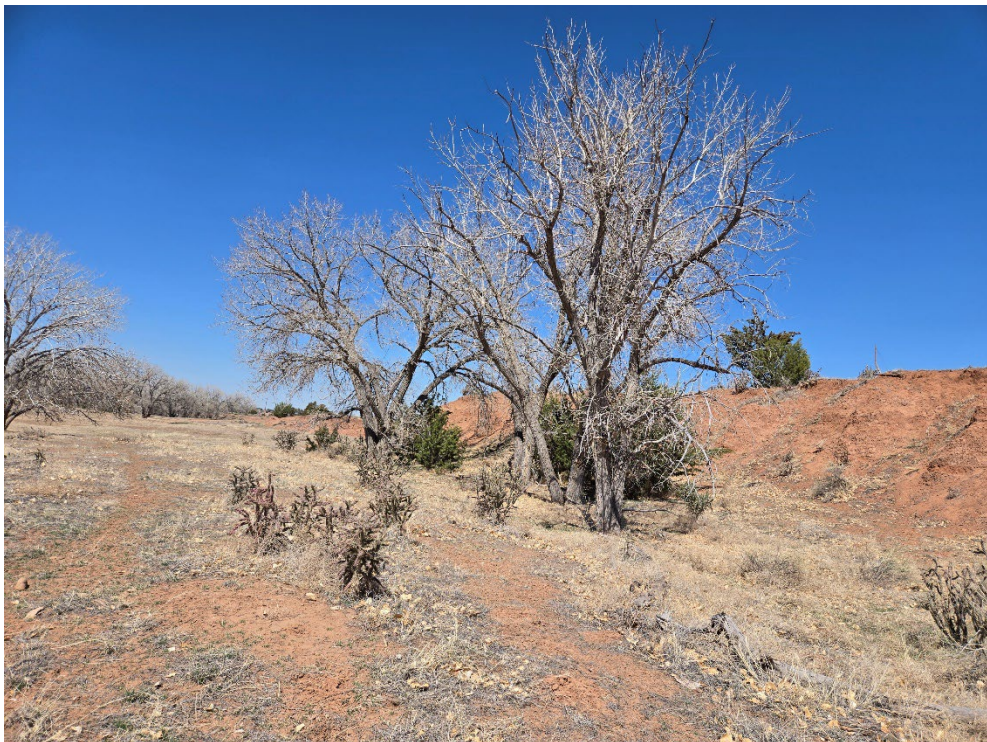
Many cottonwood trees were observed during the inspection along the creek bed (Photo 8). During the permitting application process, the Colorado Division of Parks and Wildlife (CPW) recommended that the old cottonwood trees be undisturbed as they are vital to the wildlife in the area and would be impossible to replace. The Operator then included the following sentence in their Reclamation Plan Exhibit: *"There are existing cottonwood trees at the eastern and western boundaries of the proposed pit. Efforts will be made to not disturb the trees that are near the boundaries."* During the inspection, the Division reminded the Operator that should

**Photo 8:** Cottonwood trees within the permit area.

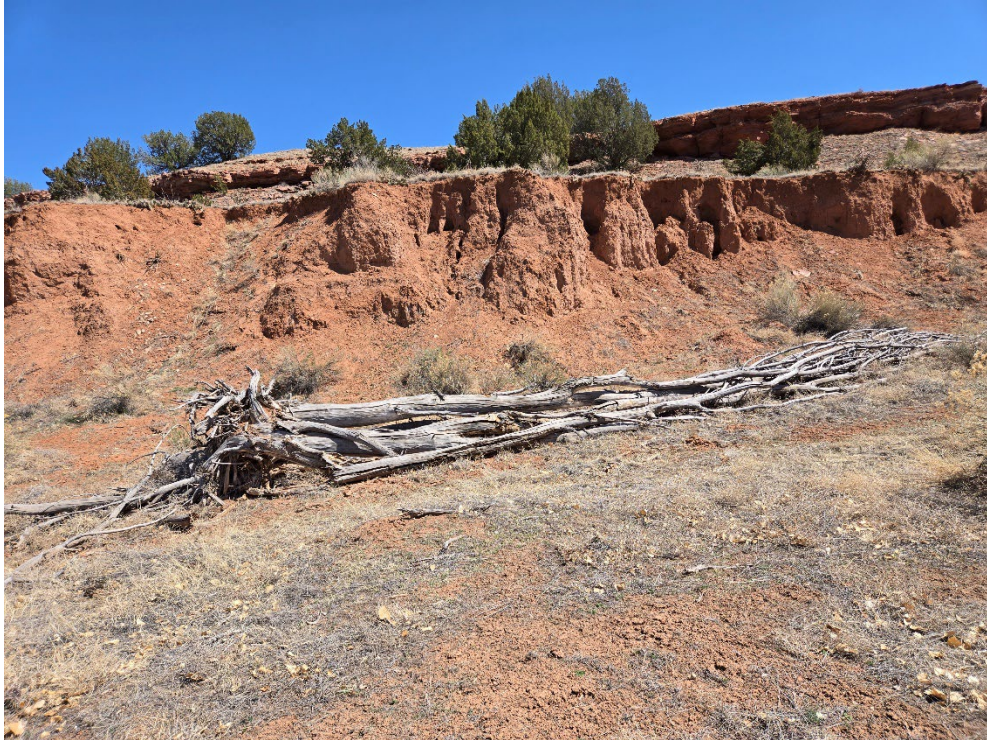
mining operations commence, the Operator is to do all that they can not to disturb the cottonwoods. A cottonwood tree was observed lying along the southeast boarder of the permit boundary where mining has not yet taken place (Photo 9). The Operator was unsure of who removed the tree or why it was placed there. Upon reviewing the aerial imagery post-inspection, it appears that there was a cottonwood tree just southeast of the disturbance boundary in the north portion of the site as of February 5, 2013 (Figure 1). In Google Earth, the tree is present in the 2016 aerial image, but in the next aerial image (2020) the tree is no longer there. The tree can be seen in the location observed during this 2025 inspection in the aerial images taken in 2022 and 2024. The Operator may want to consider placing markers around the trees to ensure that no additional trees will be disturbed for the life of the operation.

**Photo 9:** Looking east at the fallen/removed tree along the east highwall in the southern half of the permit area.

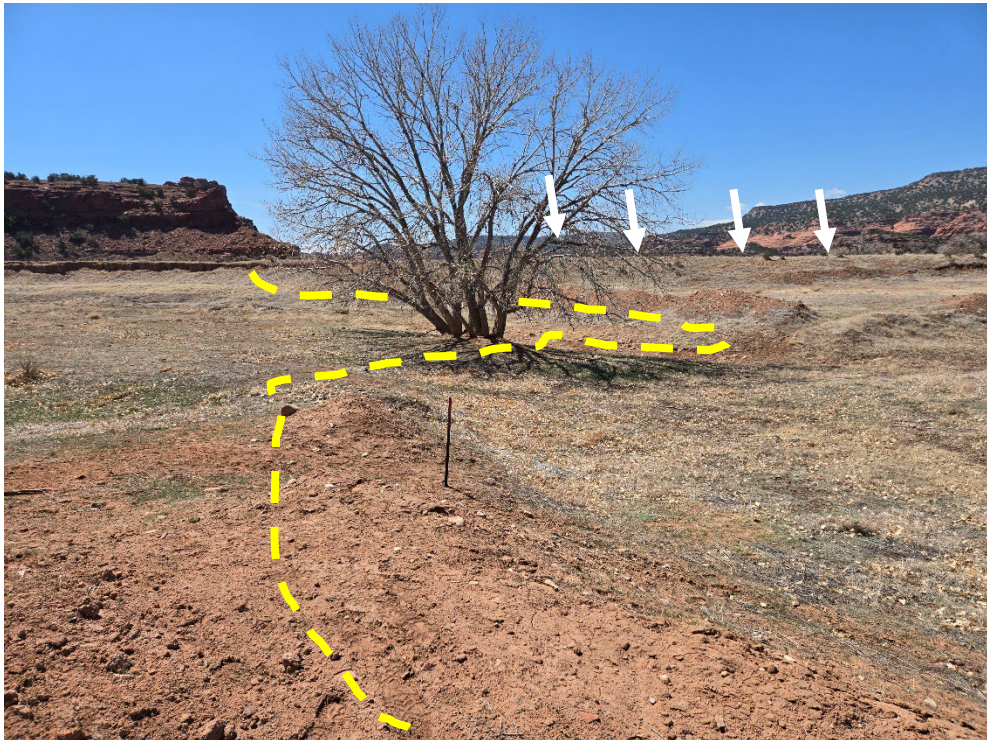
The disturbance appears to have been backfilled, graded, and revegetated along the southeast side of the northern half of the site. The slopes leading into the depressed area appear to have been backfilled, graded, and seeded along the west side. As mentioned in the General Mine Compliance section above, the berms/piles lining the boundary on the northeast side of the permit shall be graded to a 3H:1V and revegetated upon reclamation. The topsoil pile located in the north half of the site, shown on the mining plan map, no longer exists. The inspector and the Operator suspect that it probably was used to reclaim the stockpile area that has been revegetated.

**Photo 10:** Looking west across the site. The dotted line indicates approximately where mining disturbance ends between the northern half (right side) and southern half (left side) of the site. The white arrows point to where the slopes in the northern portion of the site have been backfilled, graded, and revegetated.

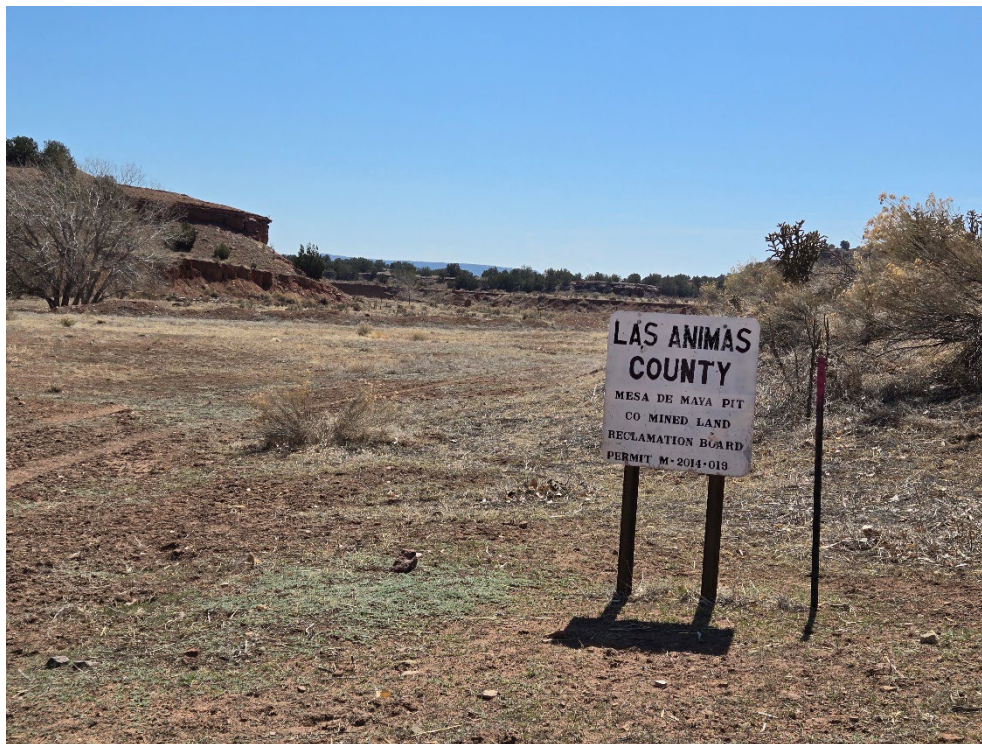
A mine sign was posted at the entrance to the site in compliance with Rule 3.1.12(1) (Photo 11). The affected area boundary/permit boundary was marked within the northern half of the site. The boundary was marked with t-posts. The west side of the southern half of the site is missing boundary markers along the highwall (Photos 12-14). The Operator stated that they will replace these markers prior the resumption of mining. The southeast portion of the site, where the boundary diagonals up to the east highwall, is currently marked with fence posts (Photo 15). It appears that there had been a fence there at the time the site was permitted, but the barbed wire has since detached from most of the posts. The fence appeared to mark the southeast boundary, however, it does not match with the coordinates in the application. A polygon drawn from coordinates provided in Exhibit A of the application, indicating the 8.5 acre permit boundary, is shown on Map 1. Figure 2 shows that the diagonal posts in the field are offset about 15 feet outside of the permit boundary polygon drawn from the coordinates provided in Exhibit A. Upon looking closer at the Mining Plan map, this offset appears to be indicted on the approved mining plan map as well (Figure 2). Because there are no boundary markers accurately depicting the southern half of the boundary, this has been **cited as a problem above**. The Operator shall install permit boundary markers matching the coordinates provided in Exhibit A and the orientation depicted on the Mining Plan Map by the corrective action date. Once installed, the Operator shall provide photo evidence to the Division.

**Photo 11:** Mine sign posted at the site entrance with a t-post boundary marker next to it.

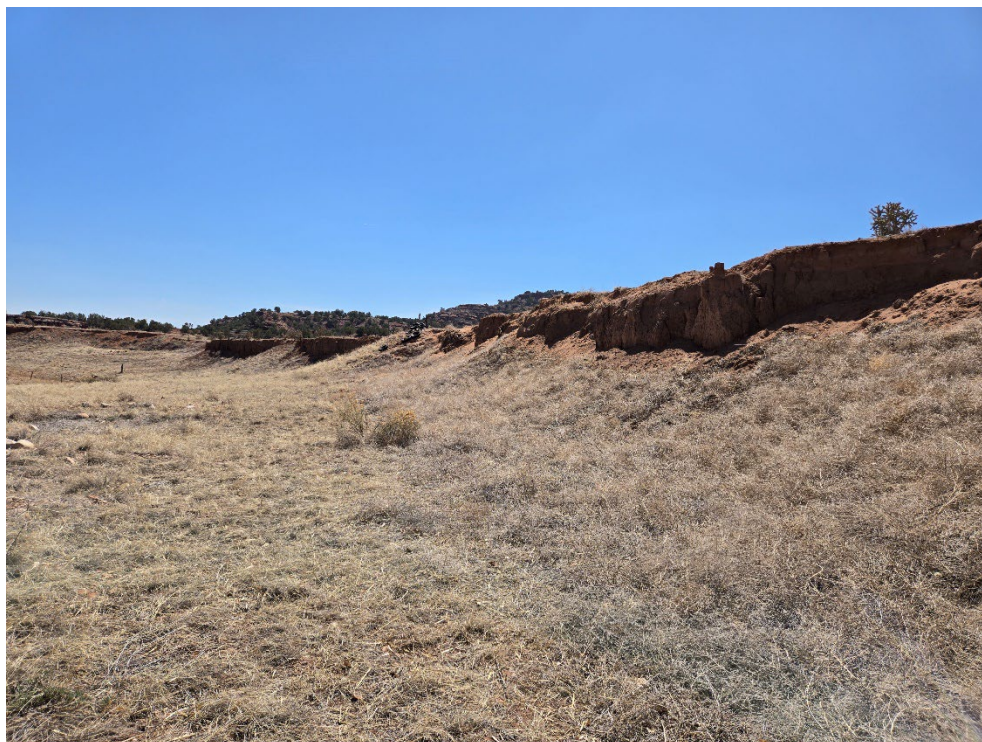
**PROBLEM:** The affected area boundary markers are missing or incorrectly placed. This is a problem for failure to maintain boundary markers around the affected area as required by Section 3.1.12(2) of the rule.

**Photo 12:** Looking south along the western highwall in the southern half of the site. No mining has occurred in this area yet. This area needs to be marked with markers.

**CORRECTIVE ACTIONS:** The Operator shall replace the boundary markers in the correct location(s). The Operator shall provide proof to the Division that this has been done by the corrective action date.

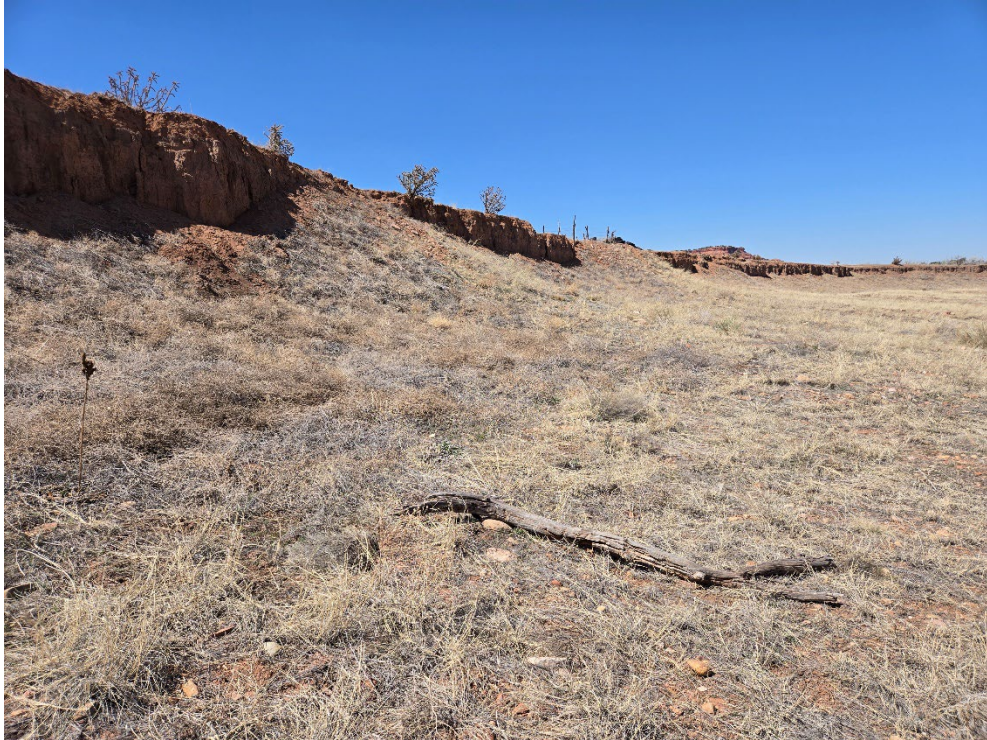
**Photo 13:** Looking north along the western highwall in the southern half of the site. No mining has occurred in this area yet. This area needs to be marked with markers.

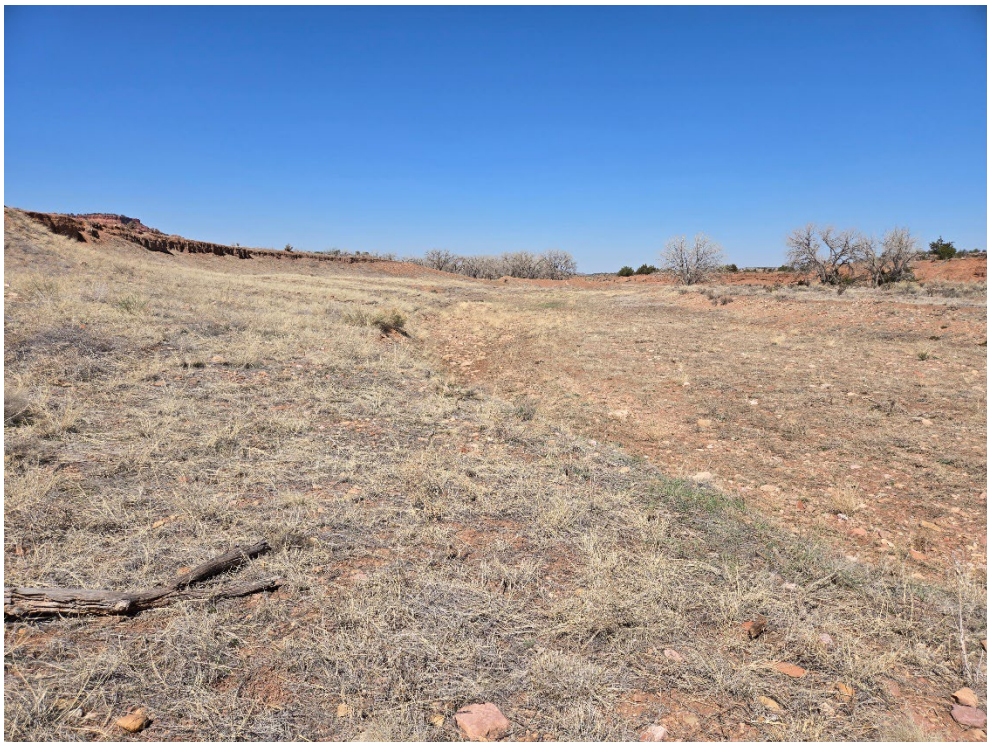
**Photo 14:** Looking northeast at the creek bed from the southern permit boundary.

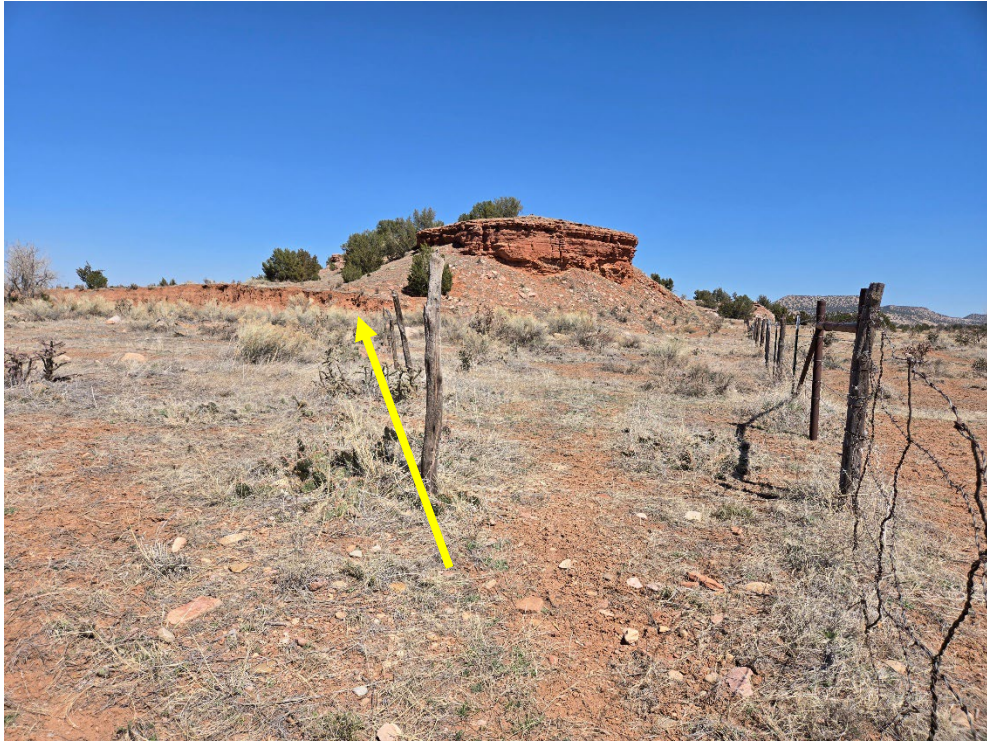
**Photo 15:** Looking east at the diagonal fence posts in the southern portion of the site.

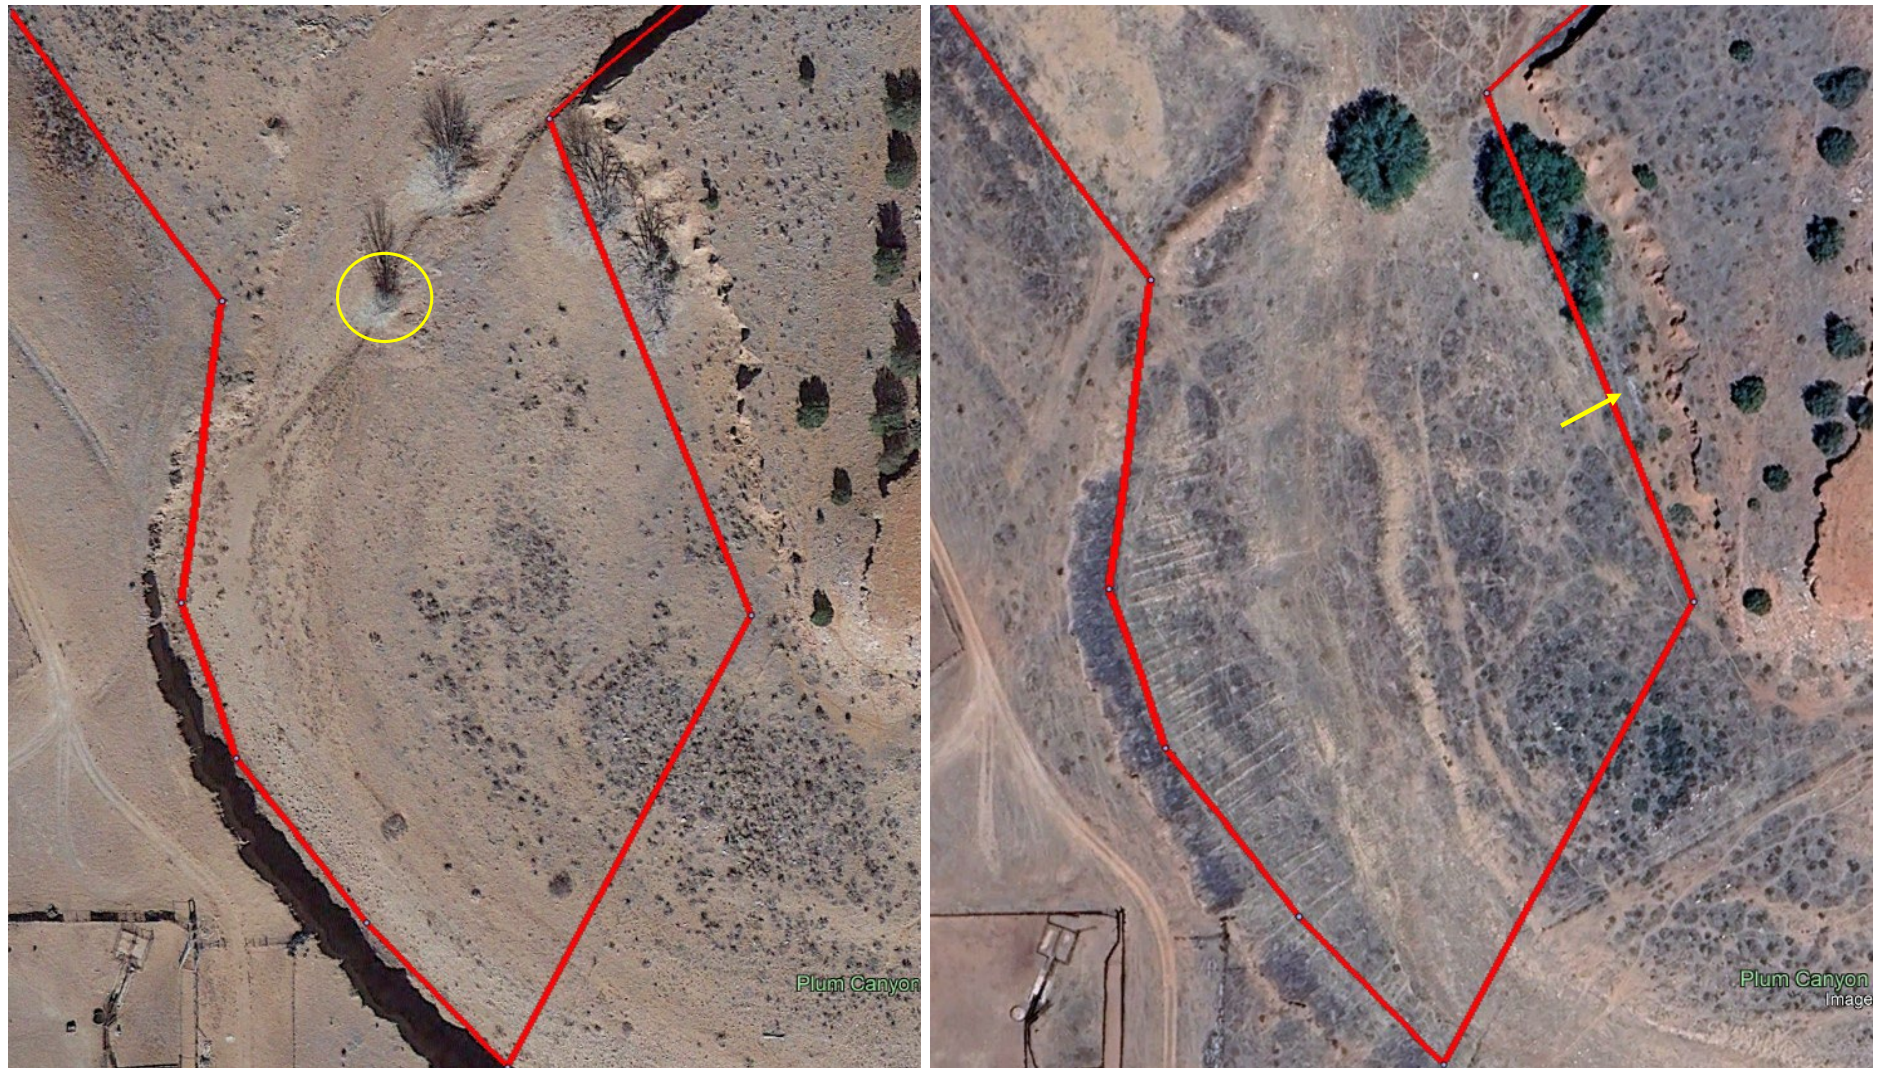
**Figure 1:** (Left) Image dated February 2, 2013. Circled in yellow is a cottonwood tree along the creek bed. (Right) Image dated May 17, 2024. The tree circled in the left image is no longer standing. Instead, a downed tree is present just outside of the boundary along the southeast wall.

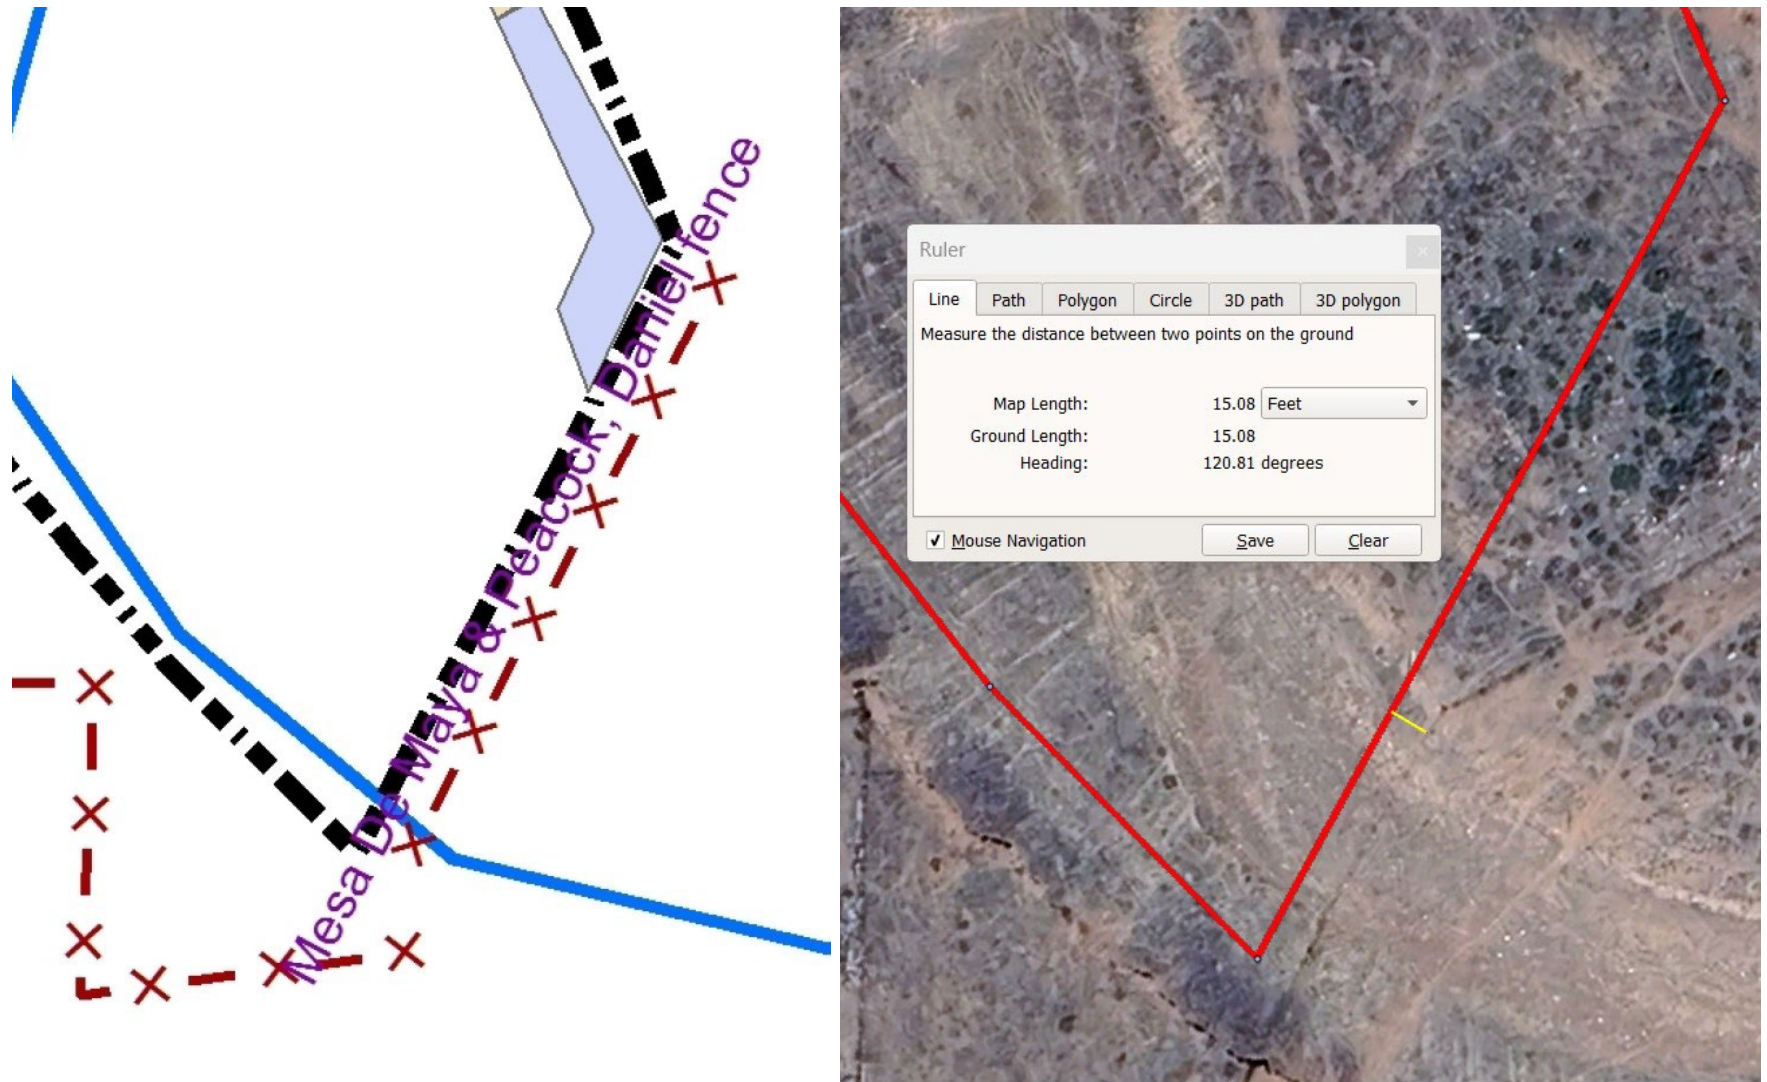
**Figure 2:** (Left) A screenshot from the mining plan map (see Map 2 above). The dashed black line is the permit boundary. The map appears to indicate that there is an offset from the diagonal fence. (Right) A screenshot taken in Google Earth. The red line represents the permit boundary. The yellow line measures the approximate distance from the permit boundary to the diagonal fence and indicates that the markers need to be placed about 15' northwest of the diagonal posts.
