McClane Canyon Mine, C-1980-004, March Complete Inspection Report

PERMIT INFORMATION

INSPECTION INFORMATION

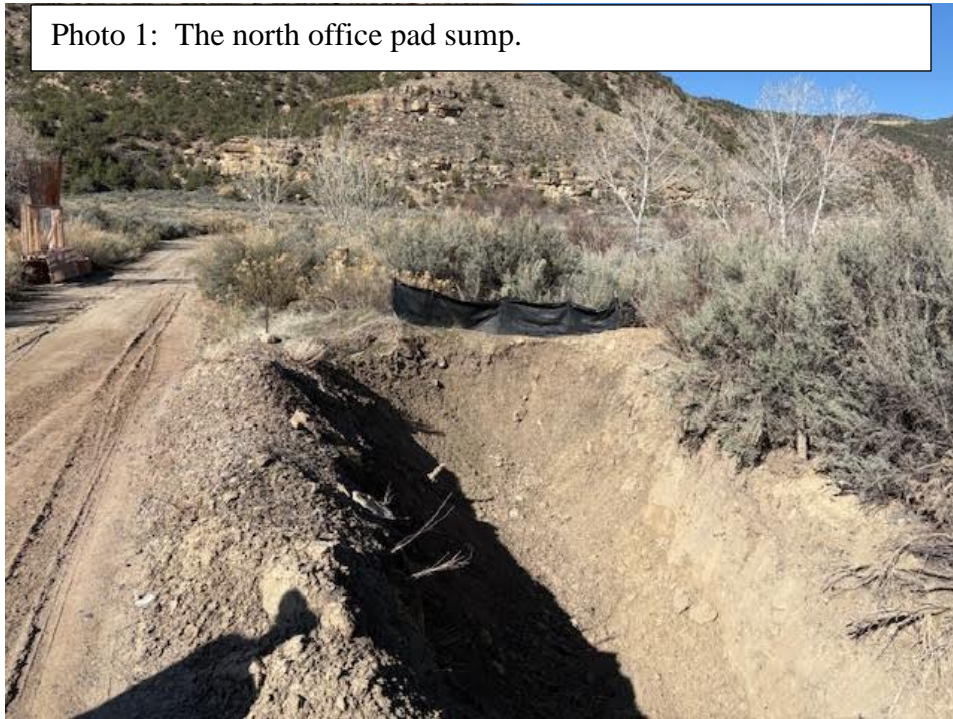
The other is on the south side of the haul road. The northern sump was dry (Photo 1). The sump was stable with no erosional concerns. The silt fence at the outlet was in good condition. The south sump was also dry (Photo 2). The sump was stable. There were no indications of erosion. The silt fence was in good repair.

Photo 1: The north office pad sump.

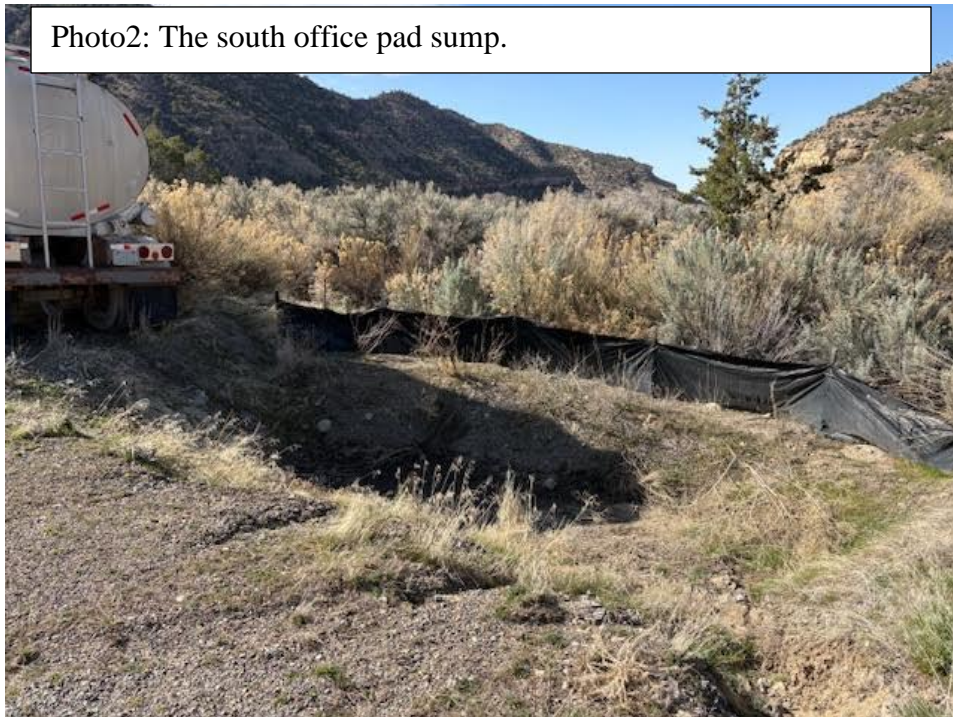
Photo2: The south office pad sump.

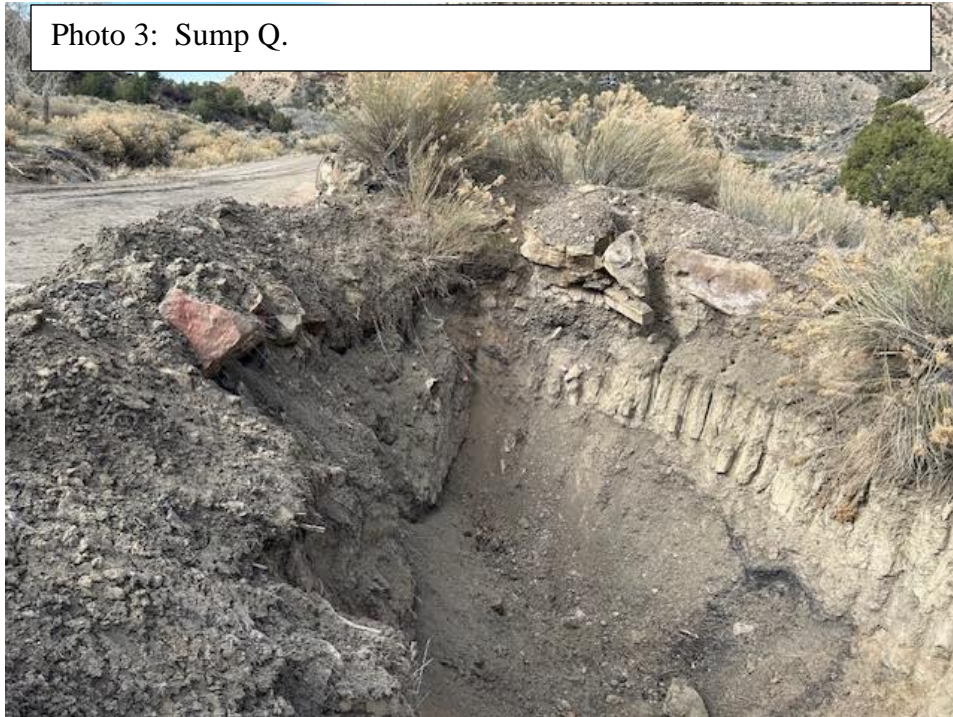
Sump Q was also dry at the time of the inspection (Photo 3). The culvert outlet for the sump was clear of debris. The sump was stable and there were no erosional features observed.

Photo 3: Sump Q.

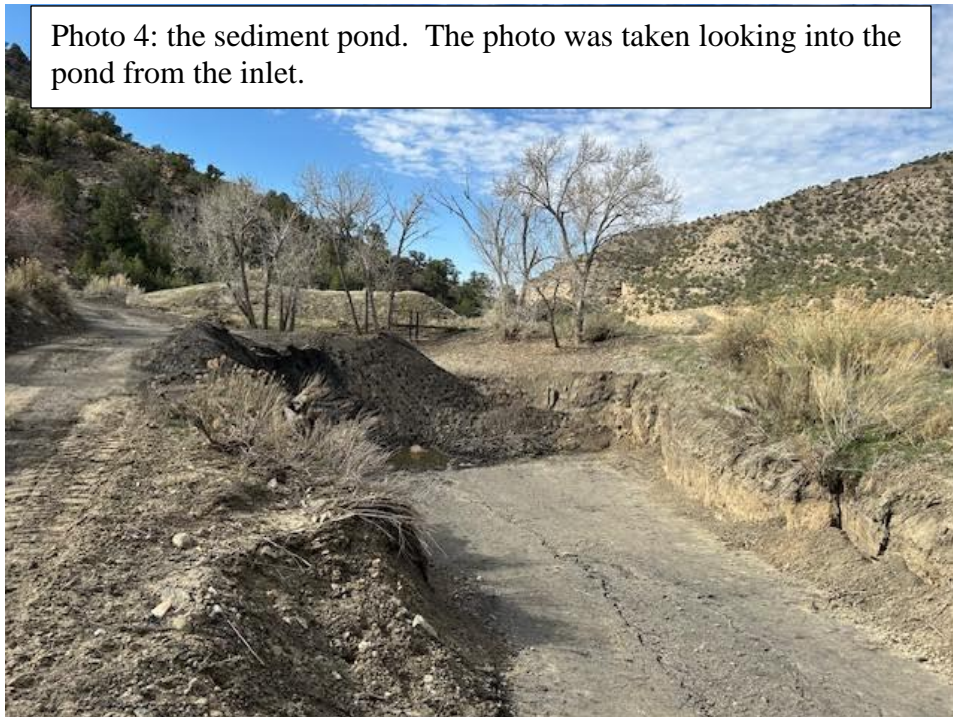
The sediment pond was holding a small puddle of water in it during the inspection (Photo 4). The level of sediment within the pond requires cleaning. The operator's representative stated that cleaning will continue as the soil conditions in the bottom of the pond allow. Equipment can clear some material at a time before muddy sediment is exposed and the equipment must wait for the sediment to dry again. The sediment pond was approximately 2/3 cleaned at the time of the inspection. The primary discharge pipe was clear of blockages (Photo 5). The emergency discharge channel was also unobstructed. The embankment for the pond was vegetated and stable. There were no erosional features identified.

Photo 4: the sediment pond. The photo was taken looking into the pond from the inlet.

Spring maintenance of the sediment control structures is being conducted as conditions allow. If the sediment gets too damp the equipment runs the risk of getting stuck. **Please continue to clean the sediment control structures as soon as conditions allow to ensure proper functionality is retained. Please replace and repair the rocks under the Sump E concrete embankment as soon as possible. Please send the Division a photo of the completed maintenance item once the repairs are completed.**

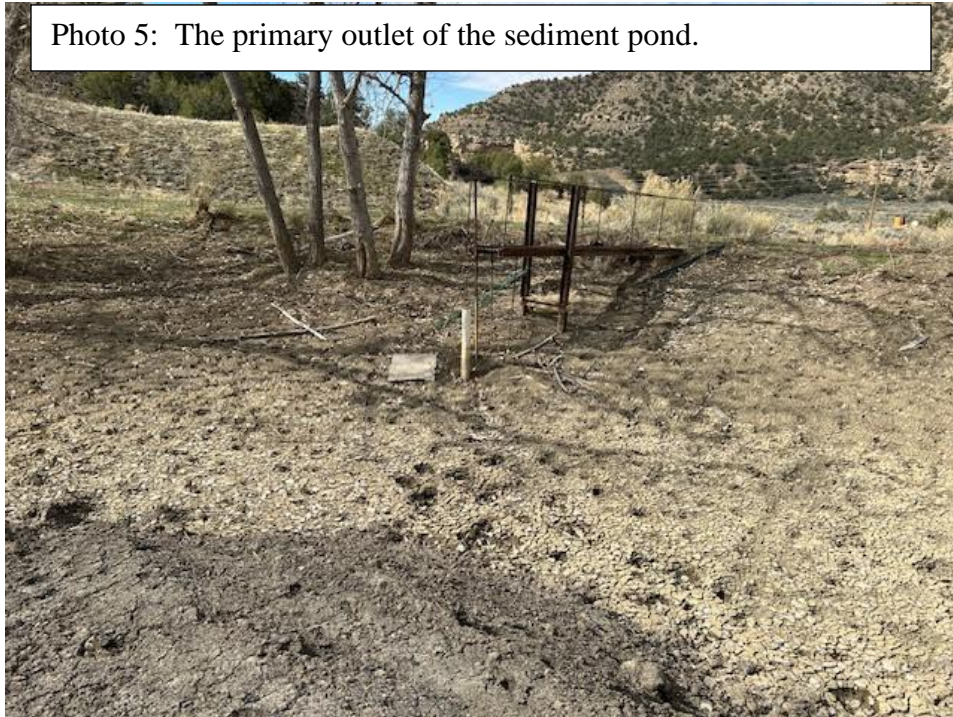
Photo 5: The primary outlet of the sediment pond.

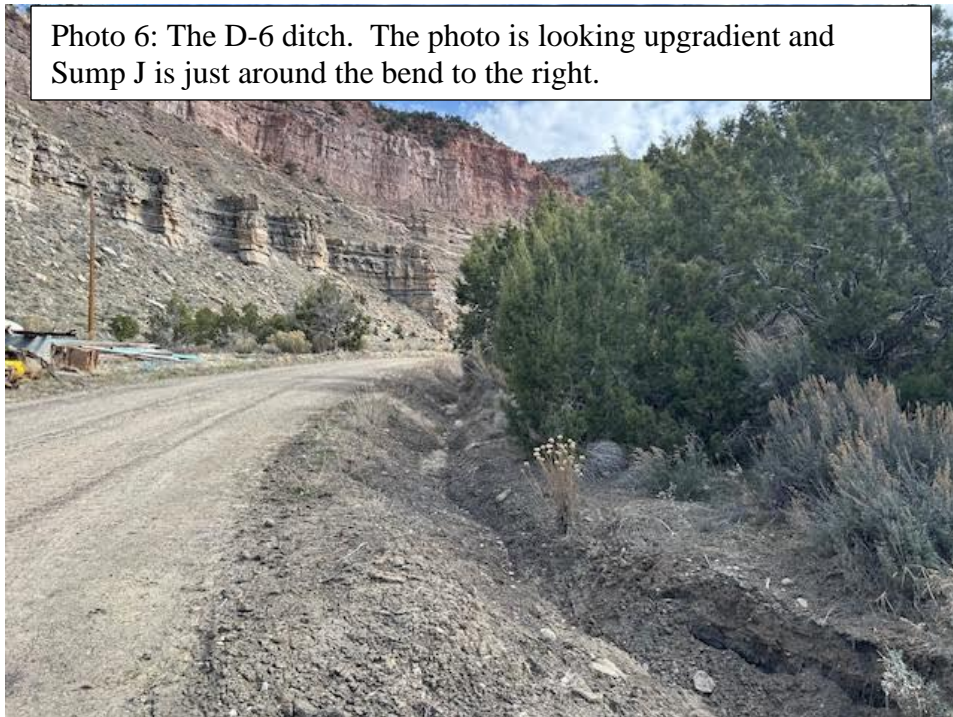
The D-6 ditch connects Sump J to the sediment pond and parallels the south side of the haul road (Photo 6). The channel was dry and clear of obstructions. No erosion was observed.

Photo 6: The D-6 ditch. The photo is looking upgradient and Sump J is just around the bend to the right.

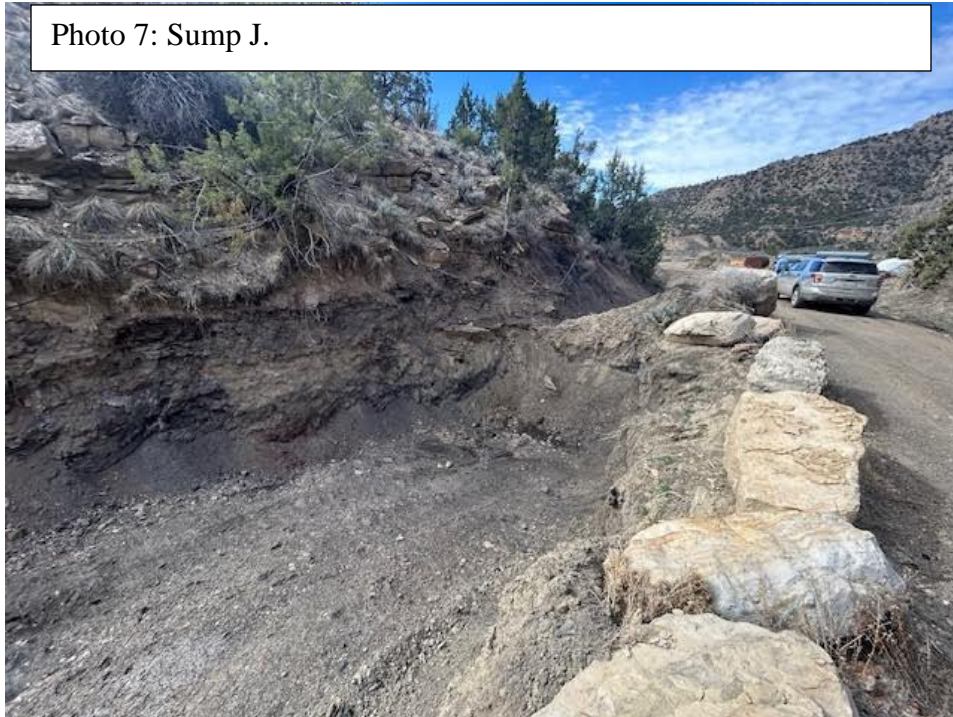
Sump J is located on the south side of the haul road just east of the sediment pond. Sump J was not holding any water during the inspection (Photo 7). The outlet channel for the sump was clear of debris. The sump was stable and there were no erosional features noted.

Photo 7: Sump J.

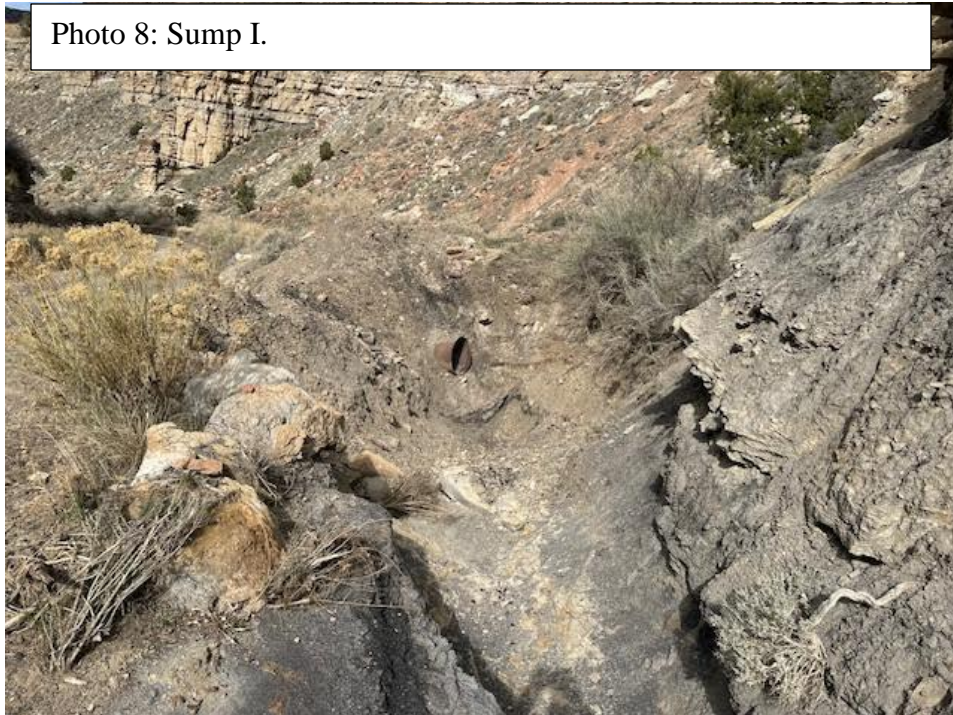
Sump I is located on the north side of the haul road, just west of the lower bench of the portals area. The sump was dry and stable (Photo 8). The culvert outlet for the sump was clear of debris. There were no erosional features.

Photo 8: Sump I.

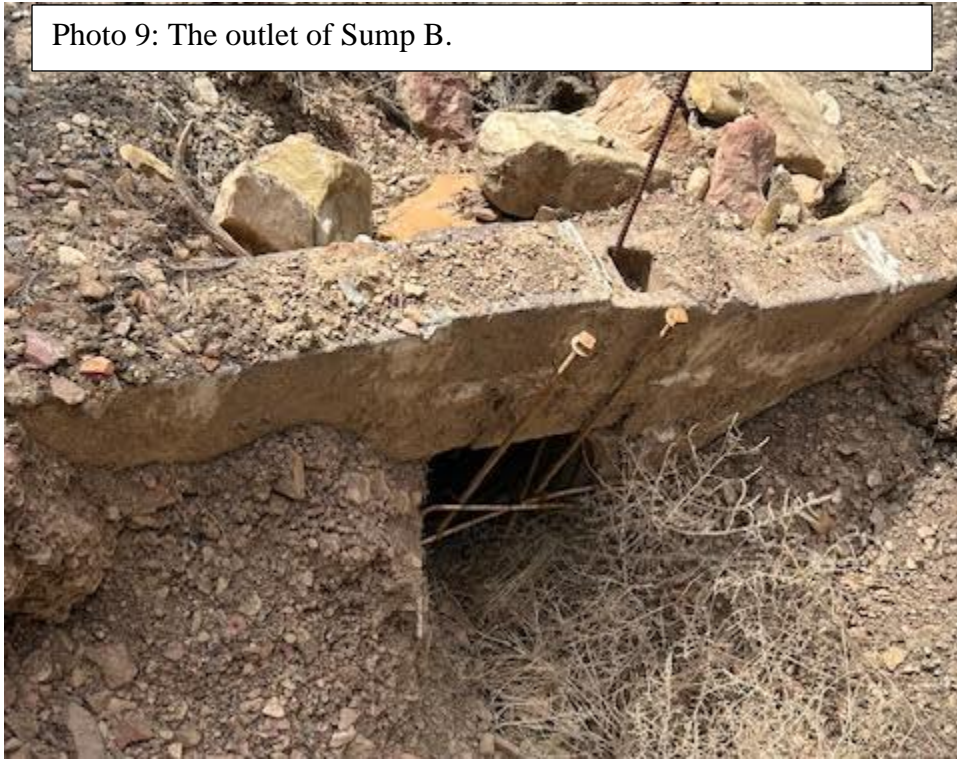
Sumps A, B, C, and E are located on the portals pad. Each of the sumps intercept and collect water from undisturbed areas. The clearwater is then piped underneath the portals pad and discharged to Upper McClane Creek. Sump B is located on the northwest side of the portals pad. The sump was dry and stable. The culvert outlet was clear of obstructions (Photo 9). There were no erosional concerns noted. Sump A is located on the northeast side of the portals pad. Sump A was also dry (Photo 10). The sump was stable with no erosional concerns. The grate over the discharge pipe was clear of obstructions. Sump C is located on the east side of the portals pad. Sump C was not holding any water during the inspection (Photo 11). The sump had no indications of erosional features or instability. The grate covering the discharge outlet was unobstructed. Sump E is located on the southeast side of the portals pad. The sump was dry during the inspection. The culvert outlet was unobstructed. A small area of soil underneath the concrete embankment appeared to have sloughed (Photo 12). The concrete embankment was stable and there had not been a breach through the embankment. The operator will replace rocks and soil in this location when an excavator with a thumb on the bucket is available.

Photo 9: The outlet of Sump B.

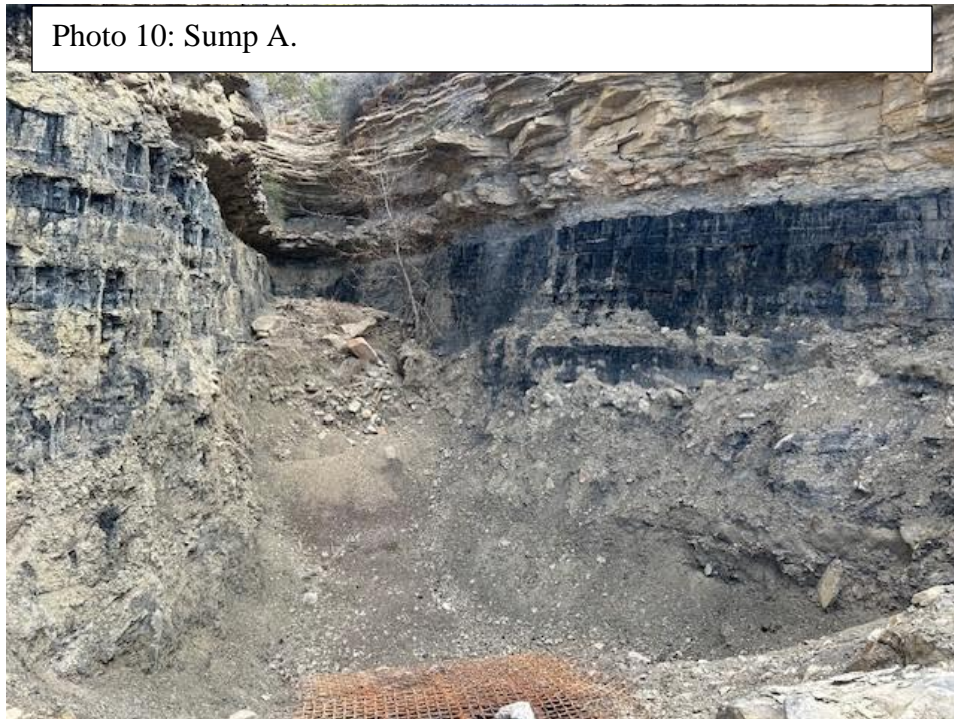
Photo 10: Sump A.

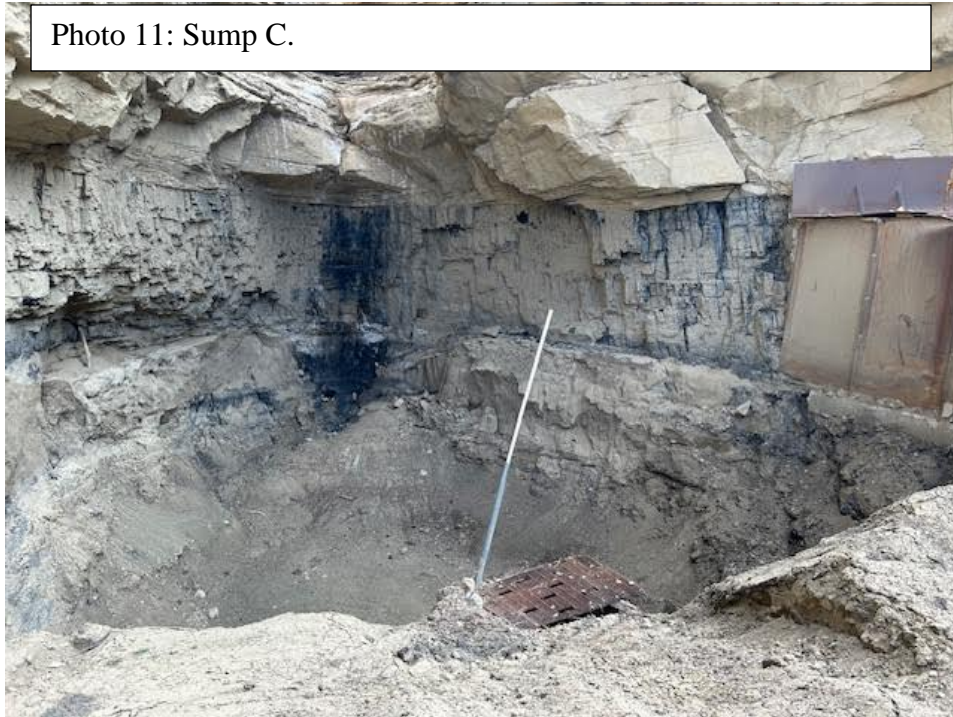
Photo 11: Sump C.

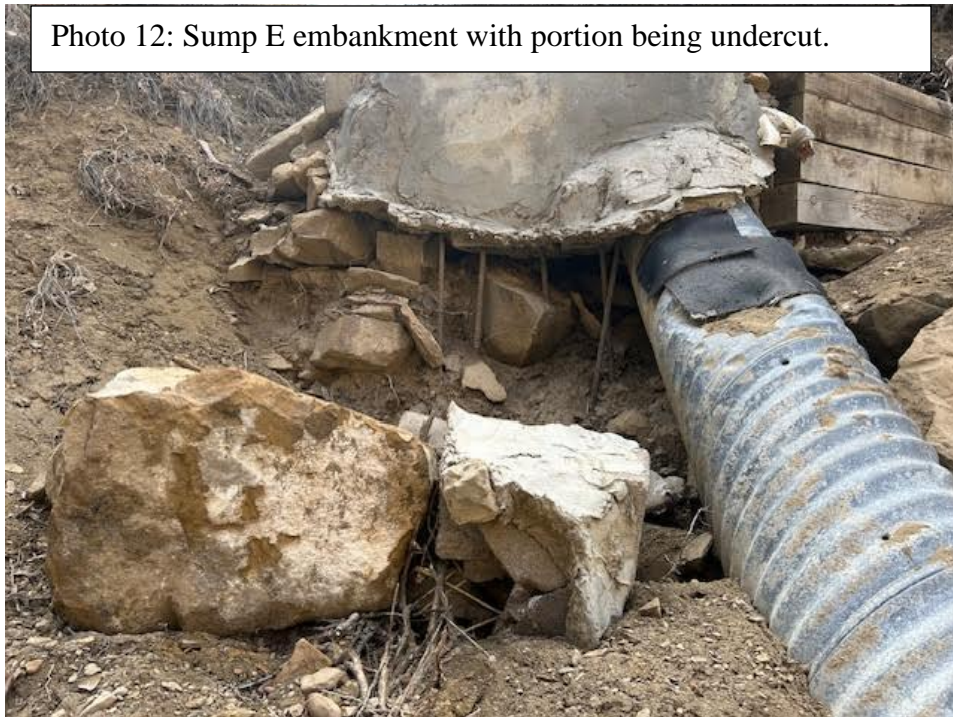
Photo 12: Sump E embankment with portion being undercut.

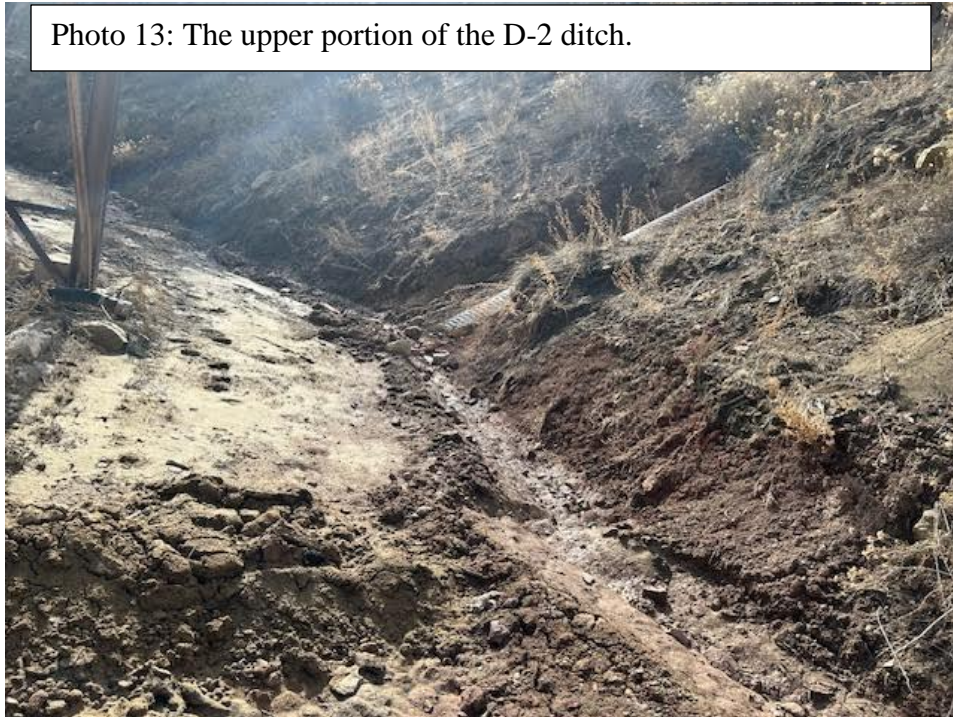
The D-2 ditch connects the upper bench on the south side of the portals pad to the D-3 ditch. The D-2 ditch was muddy and partly full of sediment (Photo 13). The ditch is scheduled to be cleaned during the spring maintenance. The ditch as it would continue to function as designed until then. The ditch was stable and clear of debris. The open culvert extending down the slope to the D-3 ditch was also stable and unobstructed (Photo 14).

Photo 13: The upper portion of the D-2 ditch.

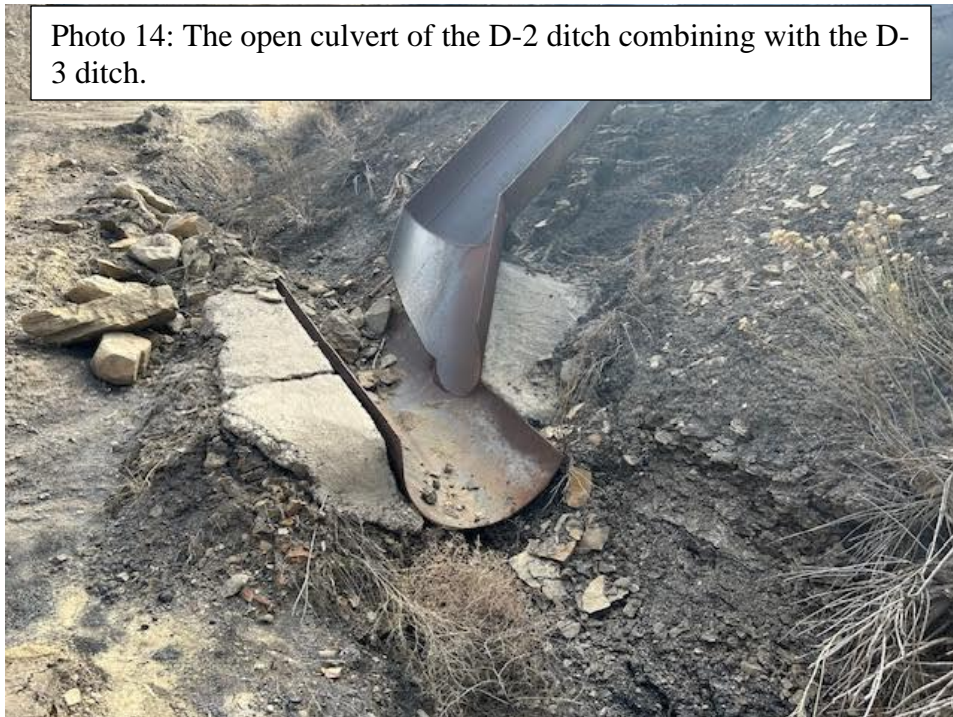
Photo 14: The open culvert of the D-2 ditch combining with the D-3 ditch.

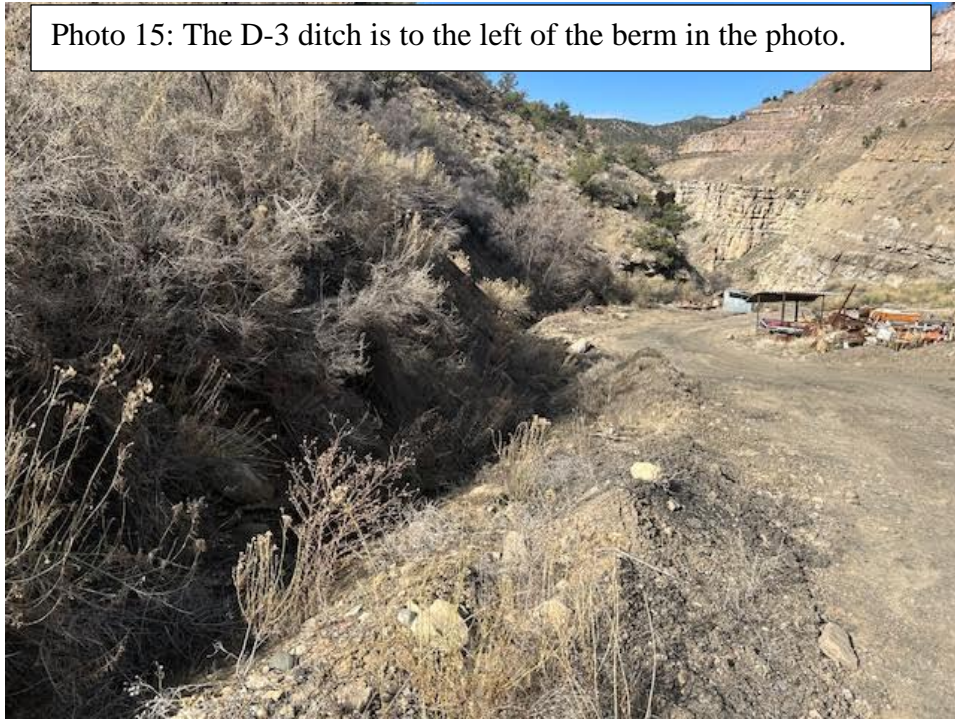
The D-3 ditch is on the south side of the lower bench of the portals pad. The ditch was dry and clear of debris (Photo 15). There were no indications of instability or erosion.

Photo 15: The D-3 ditch is to the left of the berm in the photo.

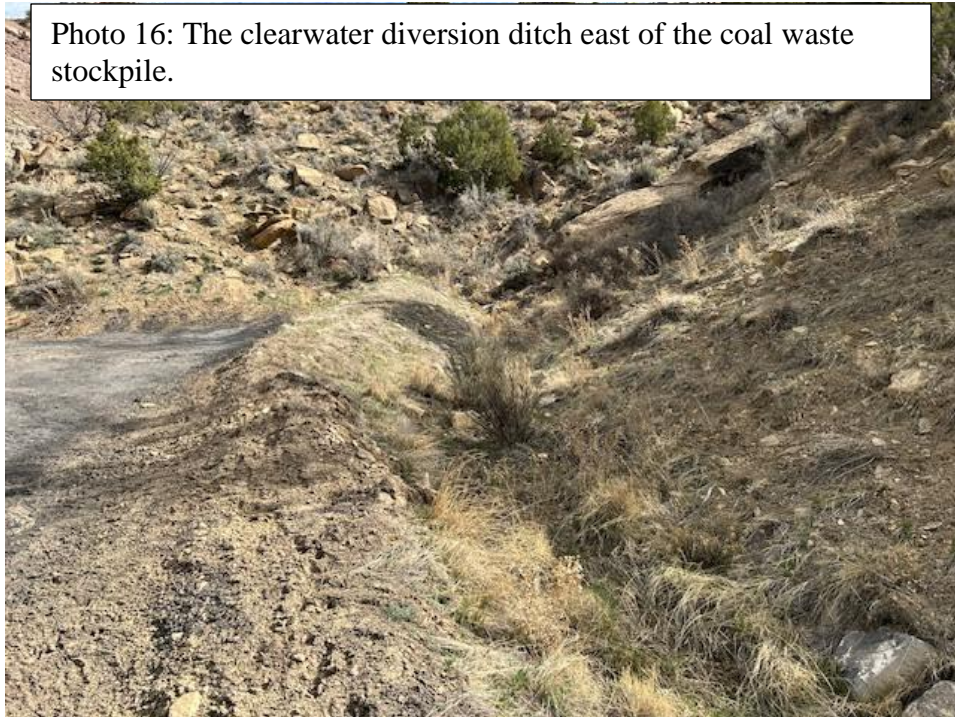
The coal waste pile had sediment placed on it from the material cleaned out of the sediment pond. The pile was stable and there were no erosional concerns identified. The clear water diversion ditch on the east side of the pile was clear of obstructions and dry (Photo 16). There were no indications of instability.

Photo 16: The clearwater diversion ditch east of the coal waste stockpile.

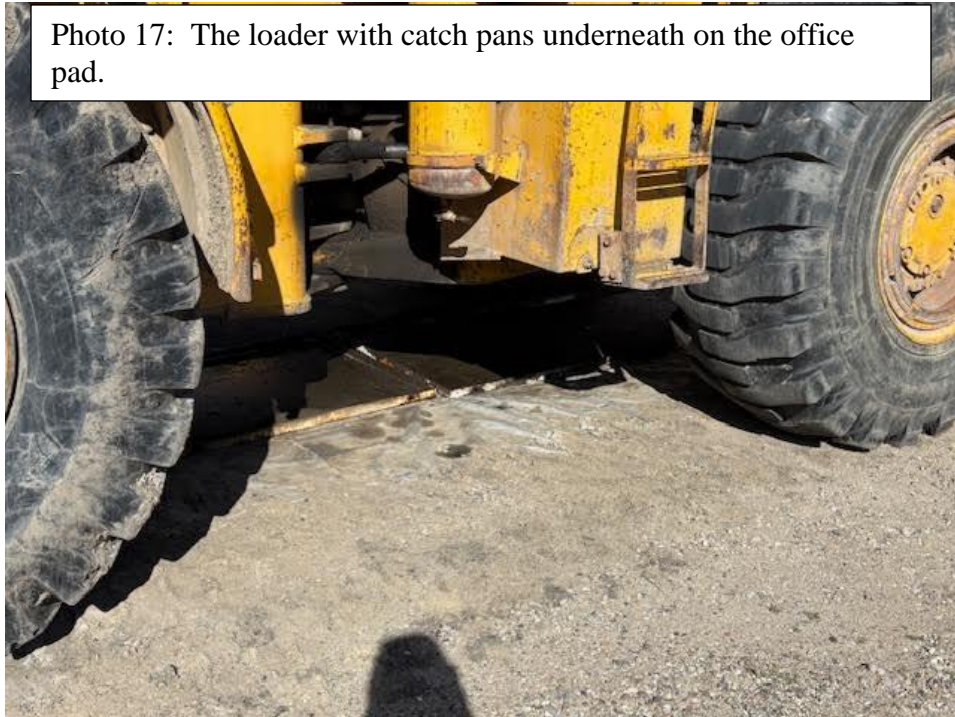
The office pad is on the east side of East Salt Creek. The pad was well kept, and no trash or debris were spotted. Catch pans were observed to be placed under the equipment parked on the pad (Photo 17). Any hydrocarbons were placed in the appropriate secondary containment. The pad was stable with no erosional features. The berm surrounding the pad was stable with vegetative cover.

Photo 17: The loader with catch pans underneath on the office pad.

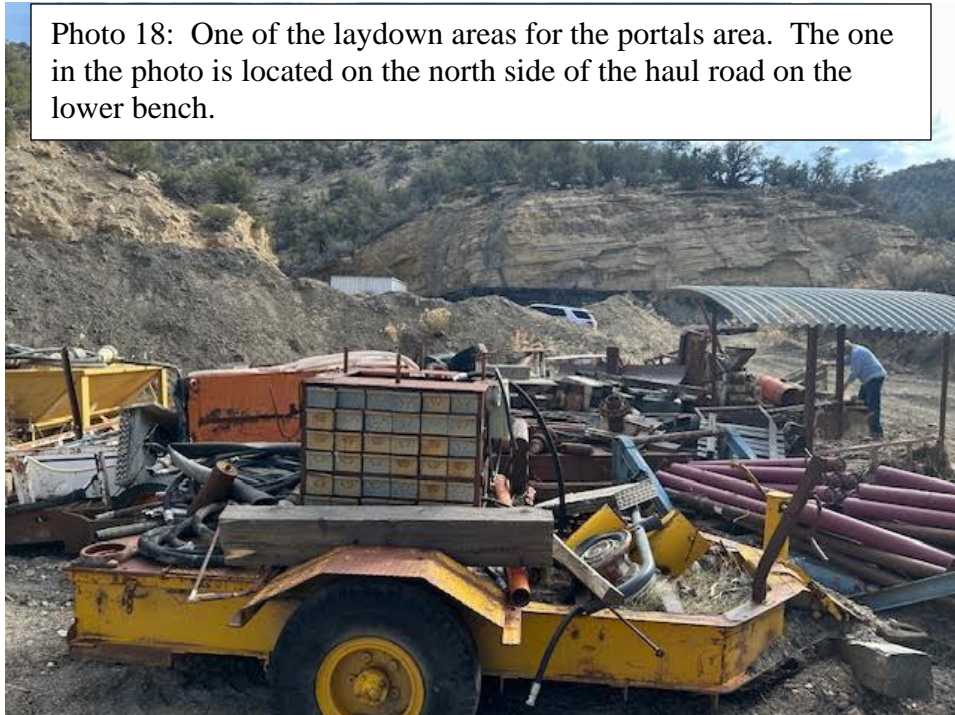
The portals pad was also free of trash or debris. Materials were placed in respective laydown areas (Photo 18). A catch pan was placed beneath the loader parked by the shop. The pad was stable and there were no erosional concerns.

Photo 18: One of the laydown areas for the portals area. The one in the photo is located on the north side of the haul road on the lower bench.

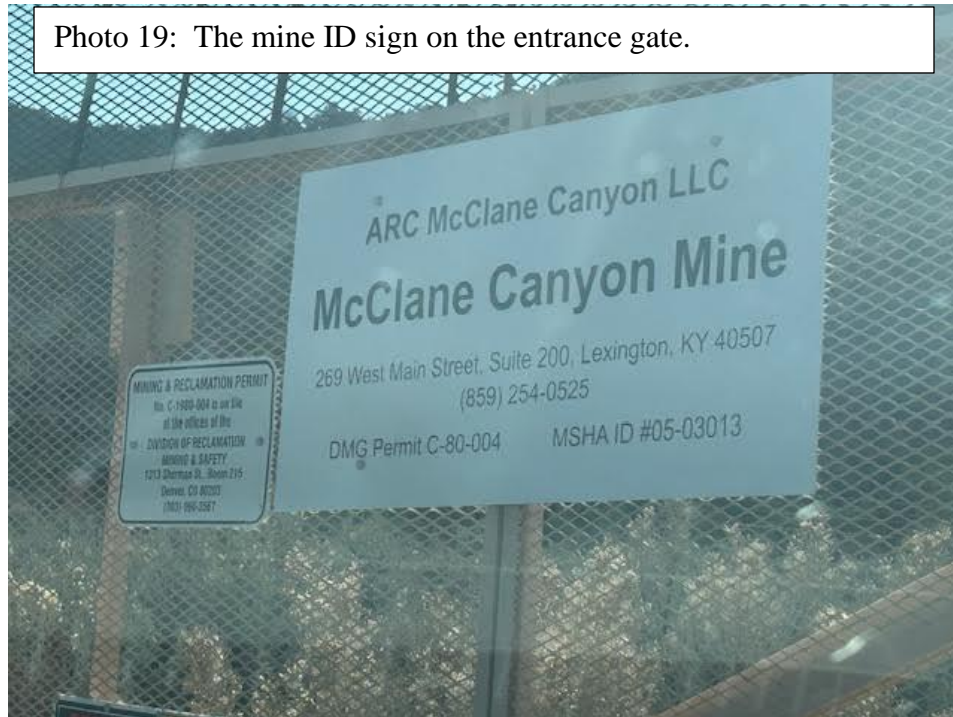
Mine identification signs were observed to be posted on the gate at the entrance over East Salt Creek (Photo 19). The signs were posted in an unobstructed location and easy to spot. The signs displayed the contact information for the permittee and the Division, along with the mine permit ID number.

Photo 19: The mine ID sign on the entrance gate.

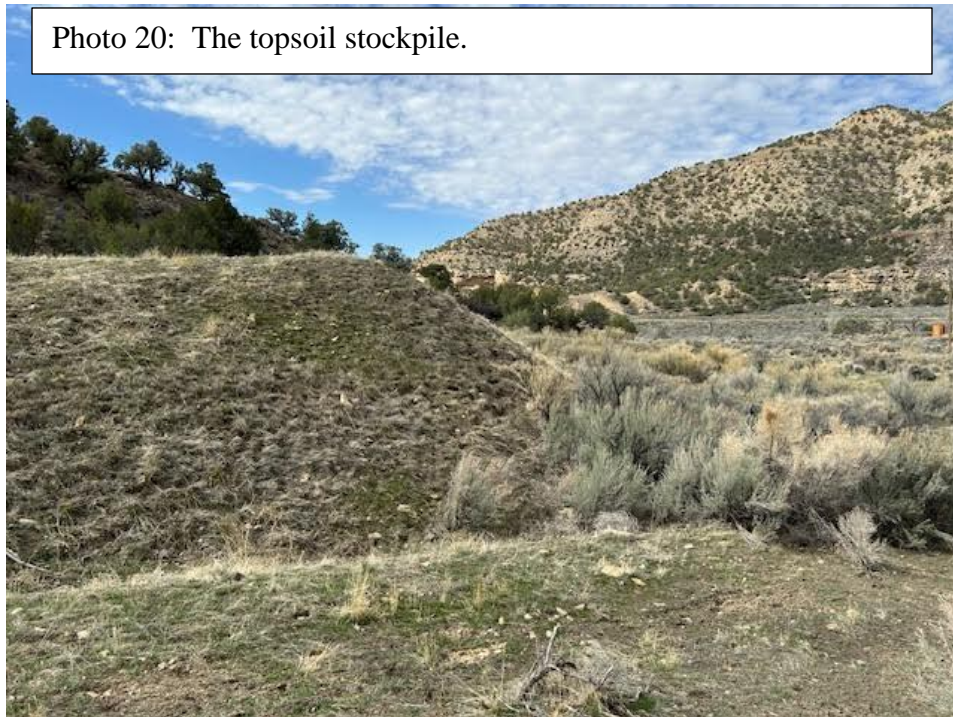
The topsoil stockpile is located on the southwest side of the sediment pond. The pile was stable with vegetative cover (Photo 20). There were no erosional features observed. The perimeter berm was vegetated and stable with no obstructions. No loss of topsoil resource was observed. The topsoil pile marker was clearly visible posted on top of the stockpile.

Photo 20: The topsoil stockpile.
