MINERALS PROGRAM INSPECTION REPORT
PHONE: (303) 866-3567

| MINE NAME: St Jude Mine | MINE/PROSPECTING ID#: M-1978-039-HR | MINERAL: Uranium and vanadium | COUNTY: San Miguel |
| INSPECTION TYPE: Multi Person Inspection | WEATHER: Clear | INSP. DATE: February 27, 2025 | INSP. TIME: 12:09 |

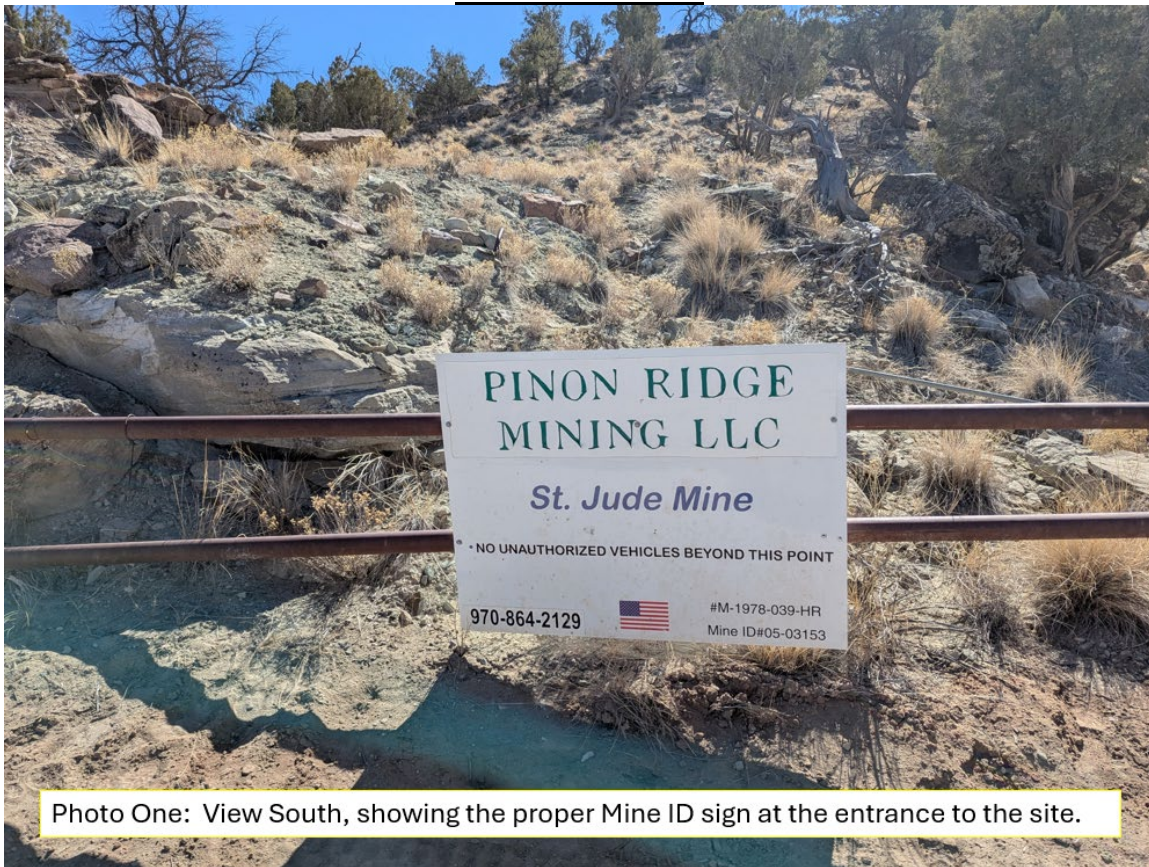
As seen in Photo One, the permit ID sign was observed at the entrance to the site. The permit boundary markers were also observed. All disturbances are contained within the permitted areas. The remote vent shaft sites were not inspected at this time. The portal was open and active at the time of the inspection. The portal and it's structure are in excellent condition, shown in Photo Two. The lined Ore Pad was observed to be in good condition. The face of the pad shows no evidence of surface stockpiling and no observable impacts from precipitation was noted. The pad can be seen in Photo Three. All work and shop facilities onsite were secured and appeared to be in good condition as seen in Photo Four. Various other items are observed on site however it was stored in an orderly fashion and was not a concern at this time. The waste rock dump storage area was observed and appears to be stable and in good condition. The out slopes show no signs of significant erosion.

Photo One: View South, showing the proper Mine ID sign at the entrance to the site.

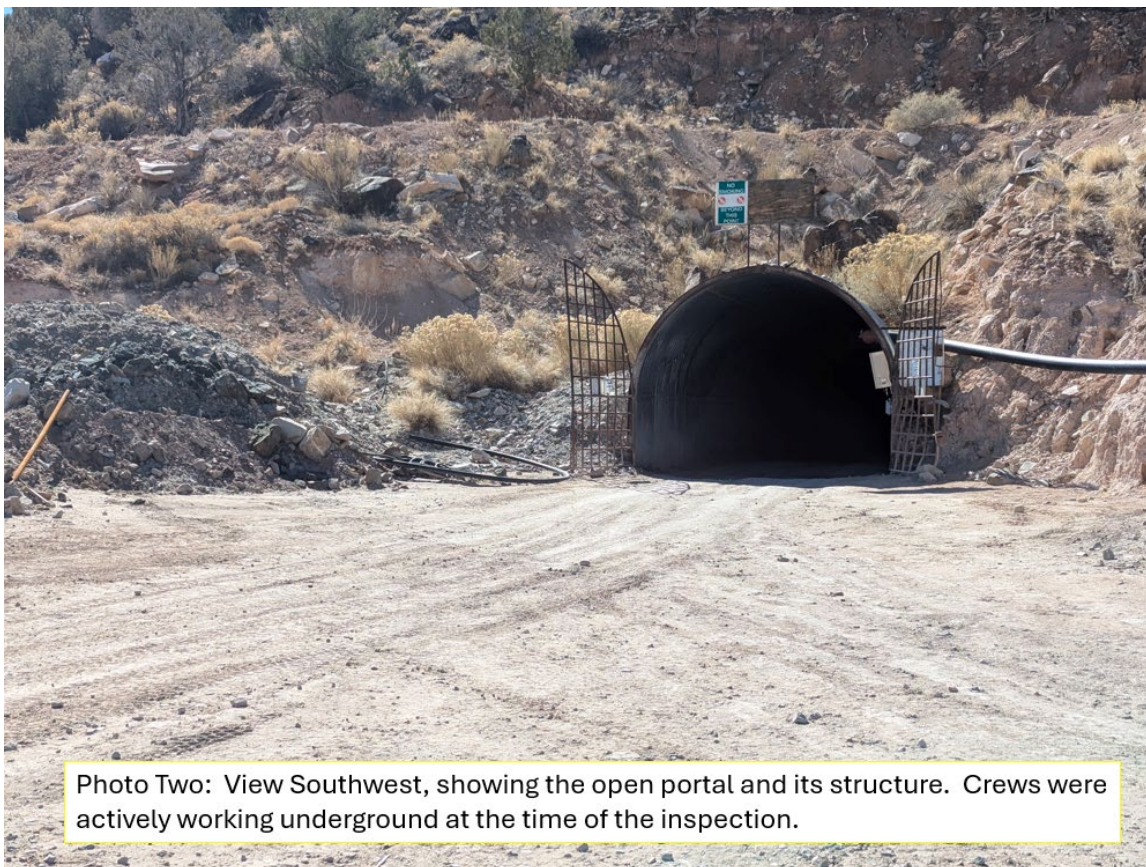
Photo Two: View Southwest, showing the open portal and its structure. Crews were actively working underground at the time of the inspection.

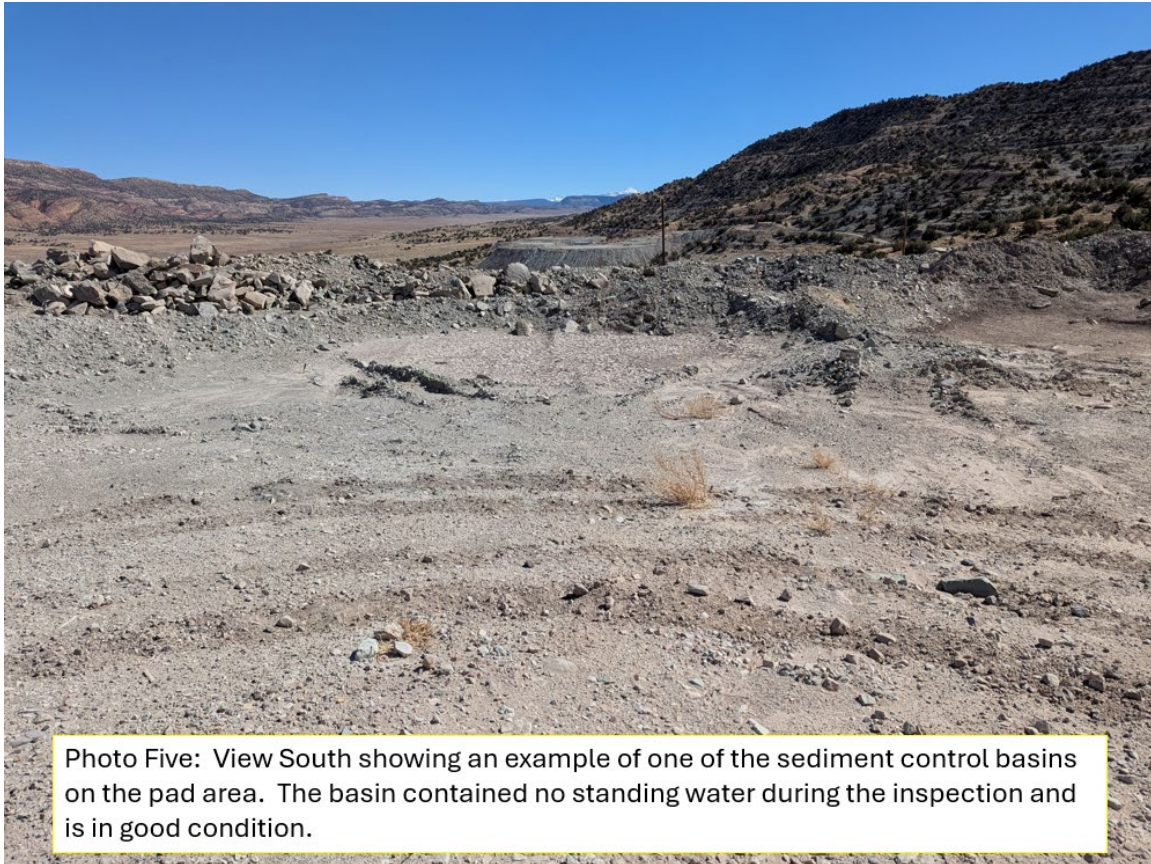
Several stormwater control structures and system are located throughout the site. At the time of the inspection none of the sediment ponds contained standing water. All observed ponds were in excellent condition and the banks appeared to be stable. An example of the various sediment basins can be seen in Photo Five. Around the toe of the waste rock dump, stormwater is routed to two sperate catchment basins using ditches, as seen in Photos Six and Seven. All observed ditches were free from obstruction and appeared to be able to function as designed. The upland diversion ditches that divert any potential run on water around the site to prevent it from becoming impacted stormwater were not observed during this inspection. On site discussions with Bruce Smith of Western Water and Land revealed that a comprehensive stormwater inspection had been conducted the day before the inspection and that all systems were in good working order.
