Permit Number: C-1981-015 Mine Name: Fruita No 1 & 2 Operator: Dorchester Coal Company Operator Address: Greg Lewicki 9054 South Forrest Drive Highlands Ranch, CO 80126	County: Mesa Operation Type: Underground Permit Status: Revoked Ownership: Private
	Operator Representative Present: NA Revoked Permit
Operator Representative Signature: (Field Issuance Only)

Inspection Start Date: March 27, 2025 Inspection Start Time: 12:00 Inspection End Date: Inspection End Time:	Inspection Type: Coal Complete Inspection Inspection Reason: Normal I&E Program Weather: Clear	
Joint Inspection Agency: None	Joint Inspection Contacts: None	
Post Inspection Agency: None	Post Inspection Contacts: None	
Inspector(s): Clayton Wein	Inspector's Signature: <i>Clayton Wein</i>	Signature Date: 4/9/2025

This report documents the Division's observations during a complete inspection of the Fruita No. 1 & 2 Mine. The inspection was conducted on March 27, 2025. The inspection was completed by Clayton Wein of the Division. The permit has been revoked; therefore, no company representative was present for the inspection. The weather was clear with a temperature of 72°F. The ground conditions were dry.

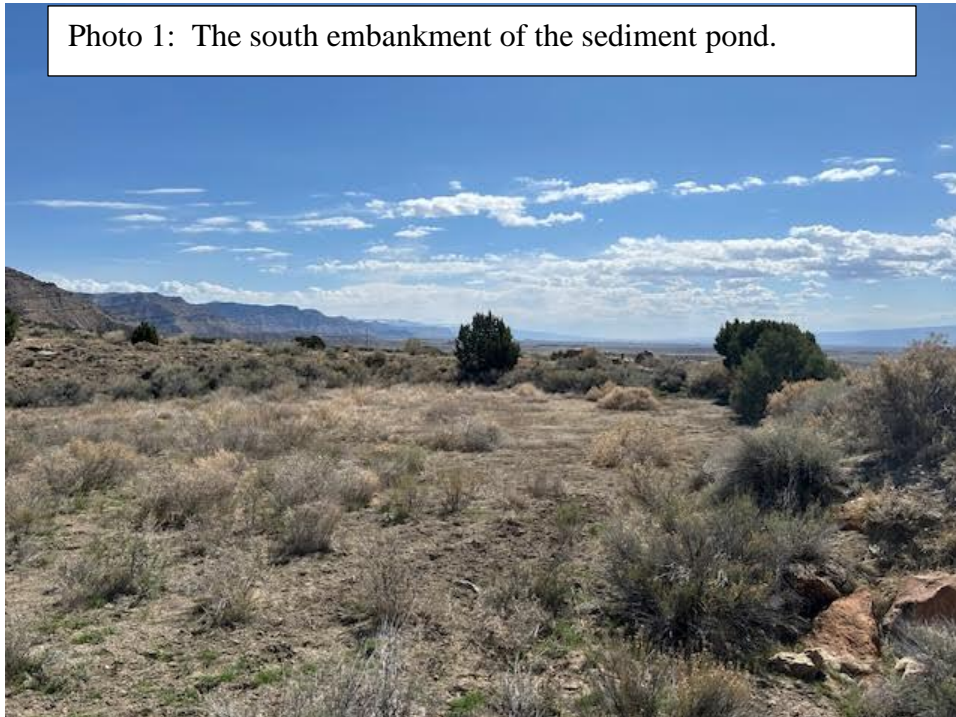
The sediment pond is located in the southern portion of the permit boundary. The pond will remain as a permanent feature. The pond was dry at the time of the inspection (Photo 1). The embankment was stable with vegetative cover. There were no erosional features or animal burrows identified. The armored outlet on the west side of the pond was clear of obstructions and in good condition.

Photo 1: The south embankment of the sediment pond.

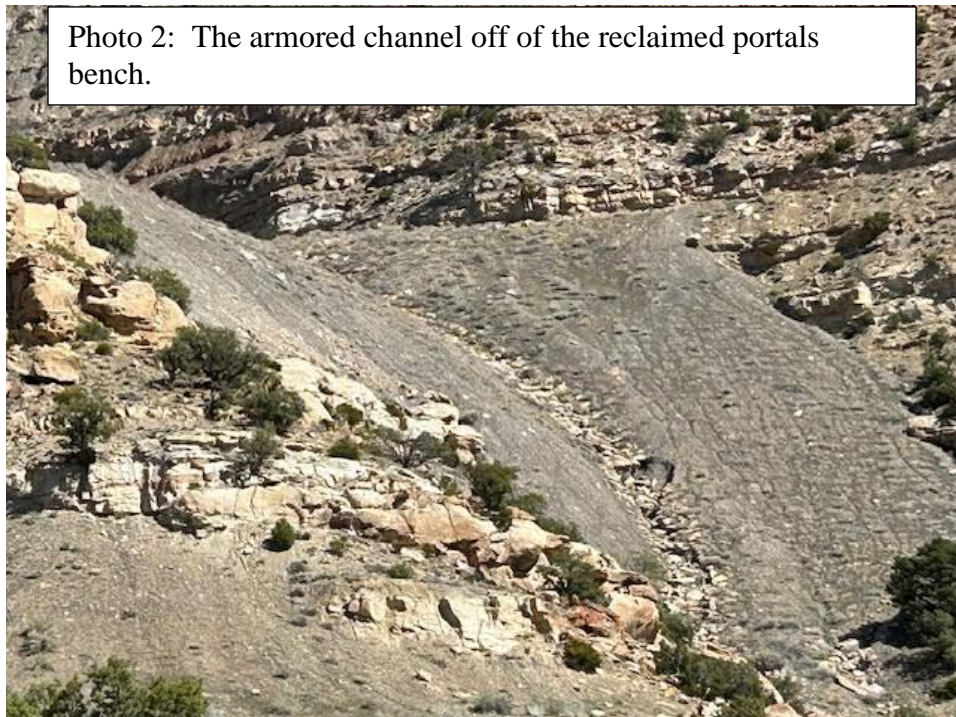
An armored channel extends down the south-facing slope of the reclaimed portals pad. The channel was stable with no blockages observed (Photo 2). There were no indications of new side cutting of the channel. The large rill has been noted for several years and seems to have self-stabilized. There was no flow through the channel during the inspection. The slope the armored channel is on faces to the south. Vegetative growth is sparse due to the southern exposure. The slope remained stable with no erosional issues.

Photo 2: The armored channel off of the reclaimed portals bench.

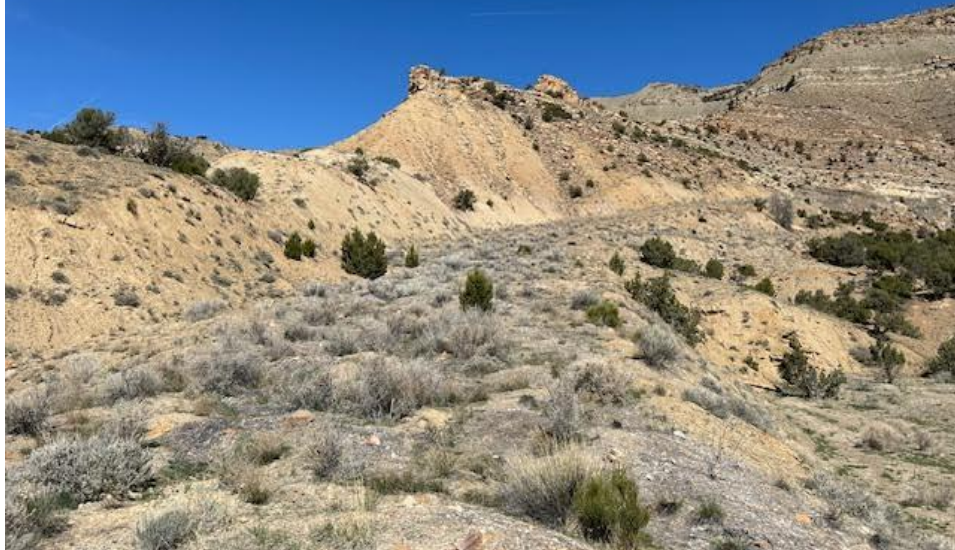
The lower portion of the reclaimed haul road was stable with vegetative cover (Photo 3 and 4). New and greening vegetation was observed at the site. The reclamation had no indications of erosional features.

Photo 3: The lower portion of the bottom of the reclaimed haul road.

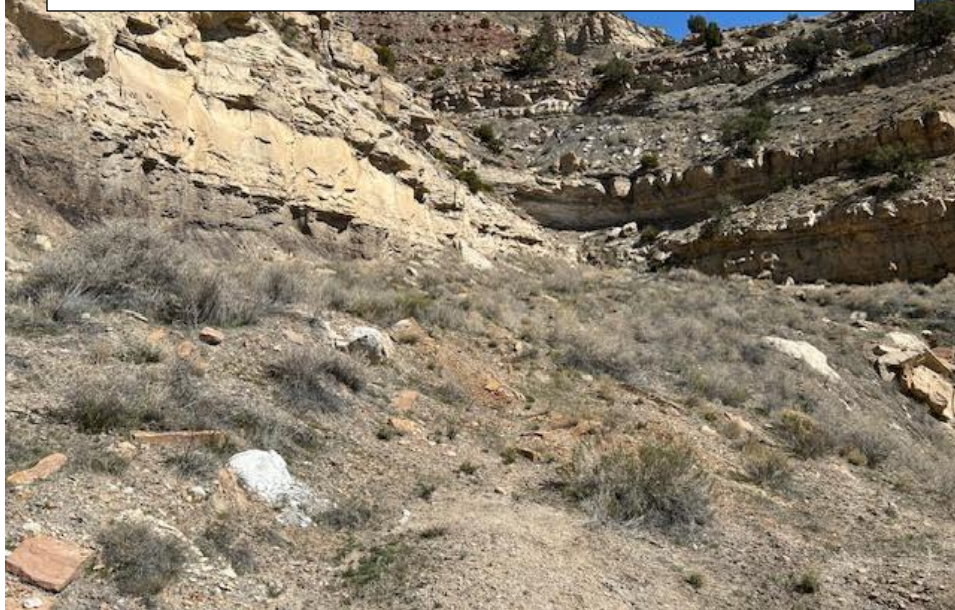
Photo 4: the upper portion of the bottom of the reclaimed haul road.

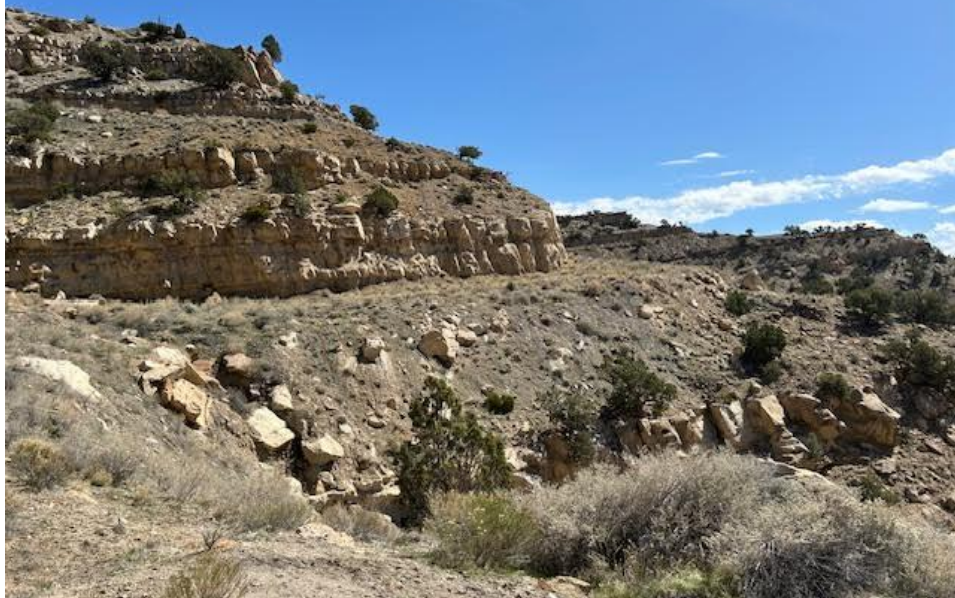
The middle portion of the reclaimed haul road was vegetated and stable (Photo 5 and 6). Vegetation on this section was noticeably denser than on the lower portion of the haul road. Vegetation was starting to grow and green for the spring. There were no erosional concerns observed.

Photo 5: The middle portion of the reclaimed haul road on the hillside.

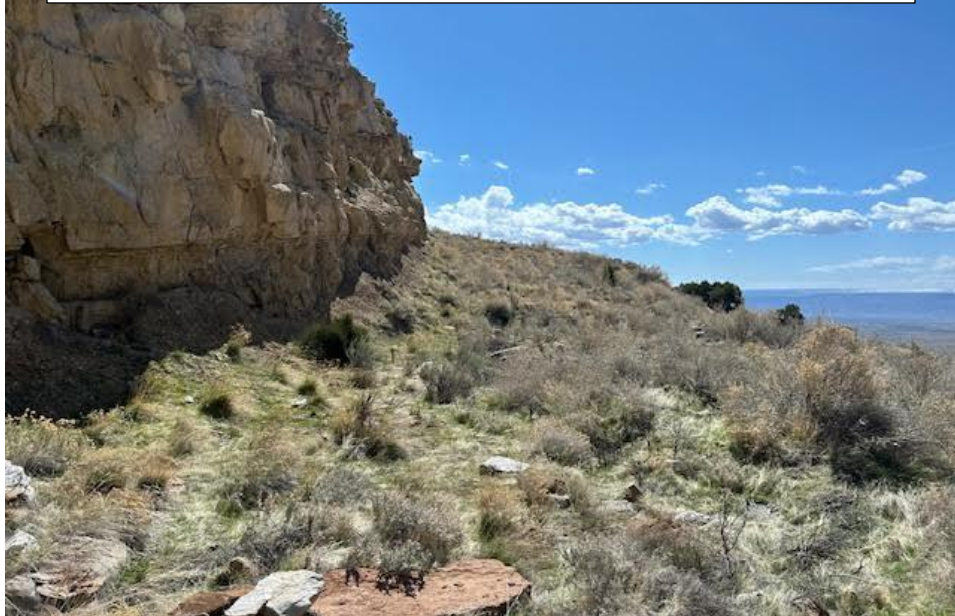
Photo 6: The vegetation on the middle portion of the reclaimed haul road.

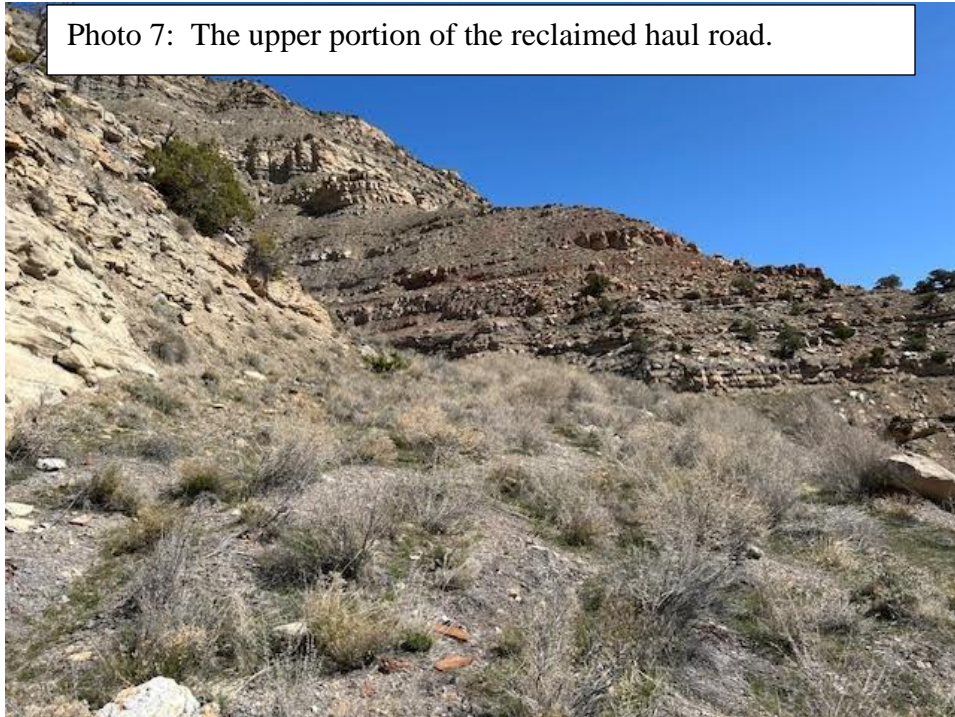
The upper portion of the haul road reclamation was also vegetated with greening and new plants. The site was stable and there were no indications of erosional features (Photo 7).

Photo 7: The upper portion of the reclaimed haul road.

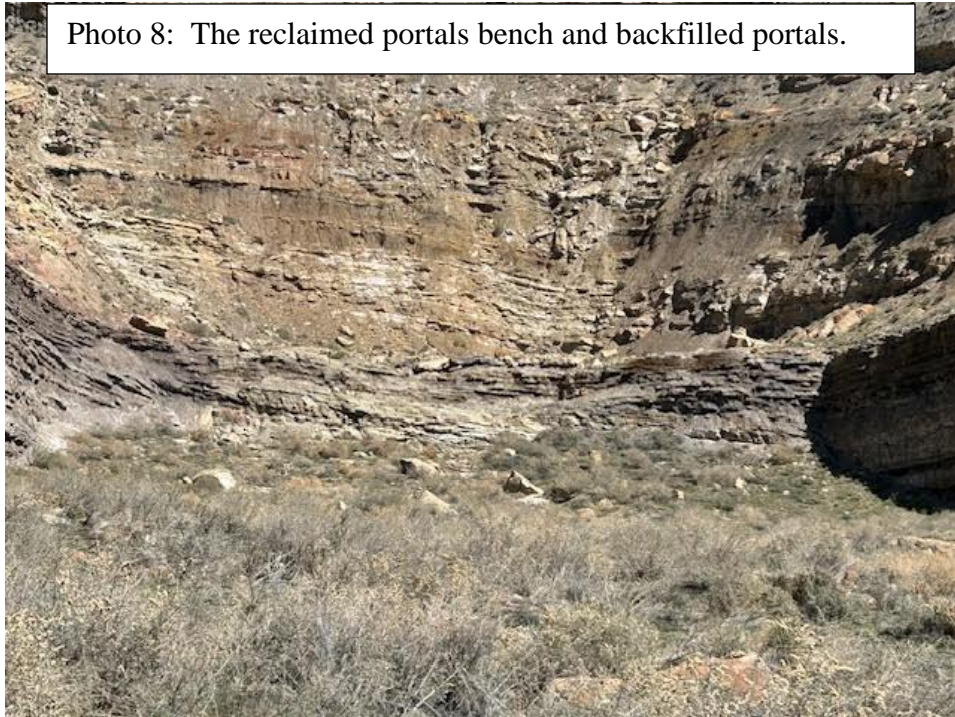
The portals bench was stable and there were no erosional concerns noted (Photo 8). Vegetation was greening up for the spring. The backfilled portals were stable with some vegetative cover. There were no erosional features observed.

Photo 8: The reclaimed portals bench and backfilled portals.
