MINERALS PROGRAM INSPECTION REPORT
PHONE: (303) 866-3567

MINE NAME: Burton Farms LLLP	MINE/PROSPECTING ID#: M-2022-012	MINERAL: Aggregate and grave	COUNTY: Rio Grande
INSPECTION TYPE: Monitoring	WEATHER: Clear	INSP. DATE: March 25, 2025	INSP. TIME: 14:00
OPERATOR: Burton Farms LLLP	OPERATOR REPRESENTATIVE: Robert Burton	TYPE OF OPERATION: 110c - Construction Limited Impact	
REASON FOR INSPECTION: Normal I&E Program	BOND CALCULATION TYPE:	BOND AMOUNT: \$42,688.00	
DATE OF COMPLAINT: NA	POST INSP. CONTACTS: None	JOINT INSP. AGENCY: None	
INSPECTOR(S): Todd Jesse	INSPECTOR'S SIGNATURE:

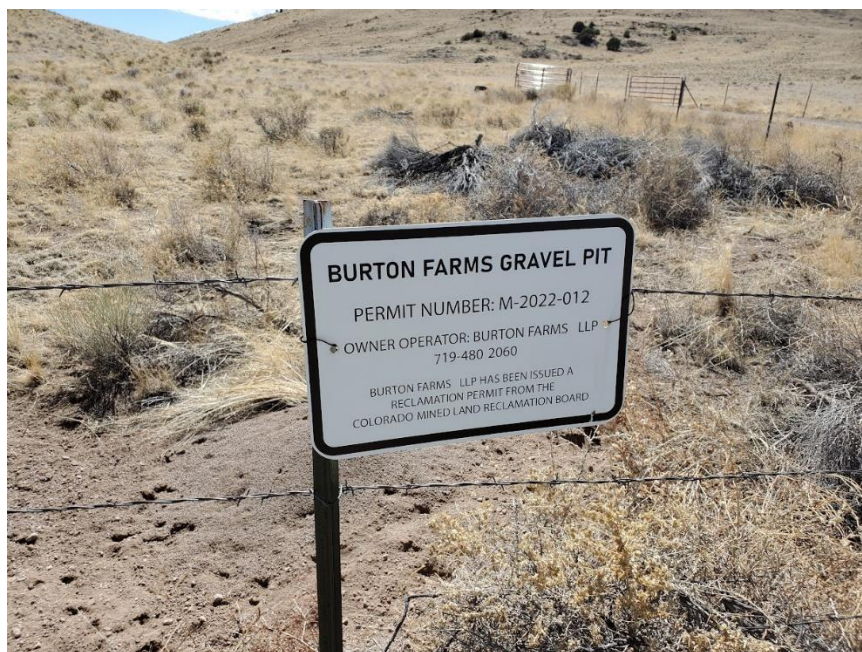
The mine identification sign and the boundary markers are in place and in compliance with Rule 3.1.12. The sign is posted by the gate off CR 15. The permit boundary is marked with fence lines and pins that are easily identifiable.

Photo 1: View to the south of proper mine ID sign at the entrance to the mine site.

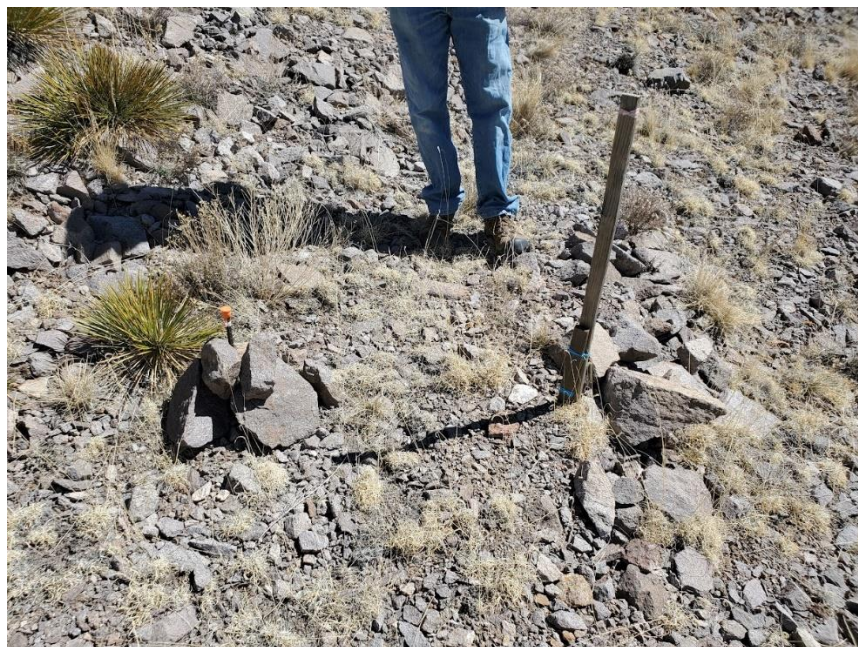
Photo 2: View to the east of pin and post along the northern boundary of the permit.

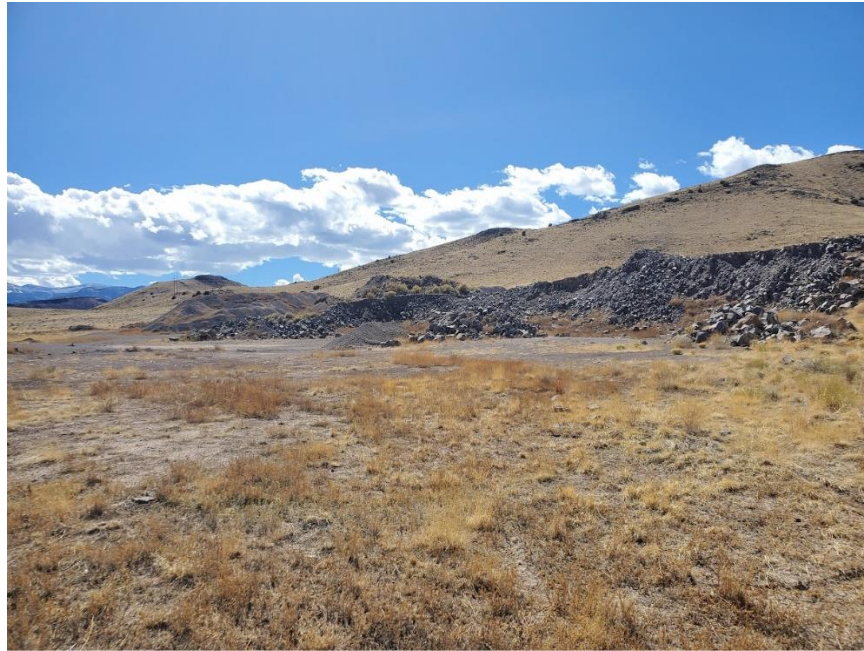
Photo 3: View to the southwest of the highwall in the mining area.

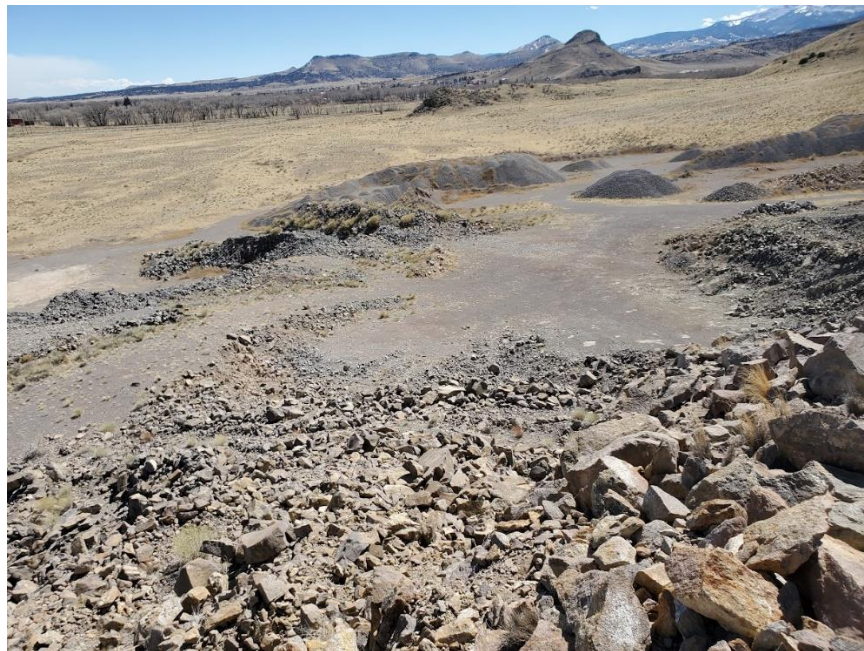
Mining is being conducted in accordance with the approved mining plan. At the time of the inspection there was no activity on site. The mining area and highwall are on the eastern portion of the permit area. Product stockpiles are located within the southern portion of the permit area.

Photo 4: View to the southeast. Overview of mining and stockpile area.
