**MINERALS PROGRAM INSPECTION REPORT**  
**PHONE: (303) 866-3567**

<b>MINE NAME:</b> Cortez Pit	<b>MINE/PROSPECTING ID#:</b> M-1976-059	<b>MINERAL:</b> Sandstone (silica, st quartzite)	<b>COUNTY:</b> Montezuma
<b>INSPECTION TYPE:</b> Monitoring	<b>WEATHER:</b> Clear	<b>INSP. DATE:</b> March 26, 2025	<b>INSP. TIME:</b> 09:00
<b>OPERATOR:</b> PEPS Transport of Colorado LLC	<b>OPERATOR REPRESENTATIVE:</b> None	<b>TYPE OF OPERATION:</b> 112c - Construction Regular Operation	
<b>REASON FOR INSPECTION:</b> Normal I&E Program	<b>BOND CALCULATION TYPE:</b>	<b>BOND AMOUNT:</b> \$2,517.00	
<b>DATE OF COMPLAINT:</b> NA	<b>POST INSP. CONTACTS:</b> None	<b>JOINT INSP. AGENCY:</b> None	
<b>INSPECTOR(S):</b> Todd Jesse	<b>INSPECTOR'S SIGNATURE:</b>

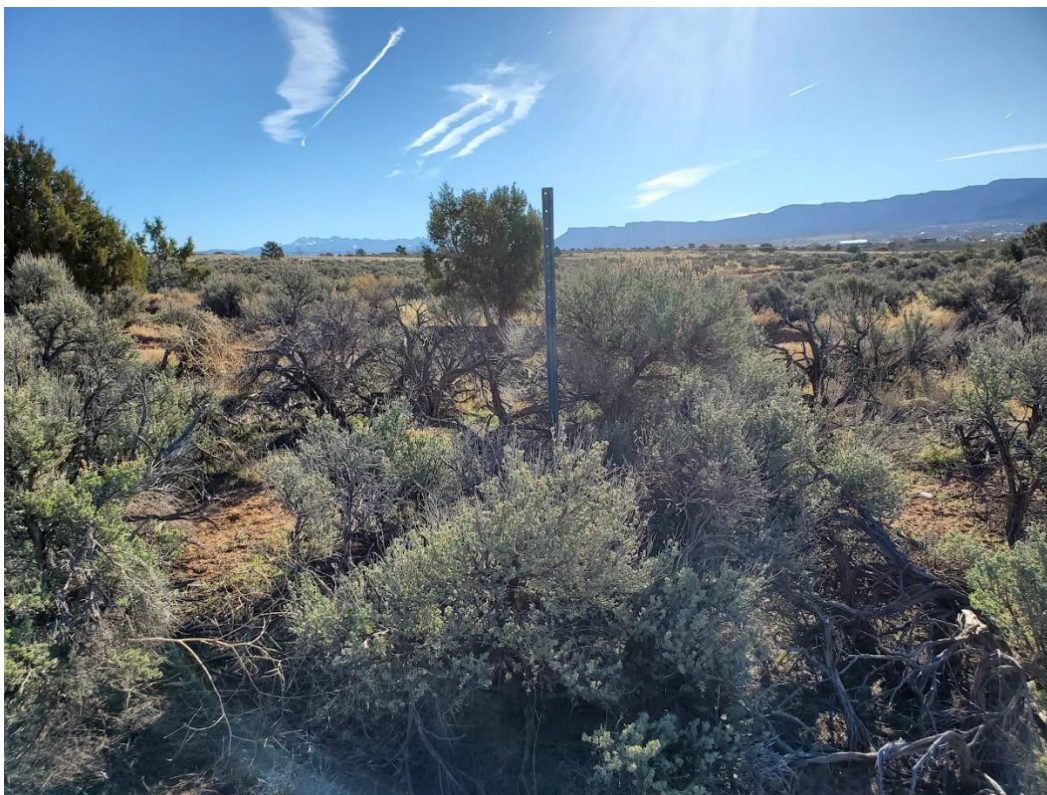
The site is on private land and is within a fenced compound owned by PEPS Transport of Colorado LLC. The permit boundary is marked by posts.

Photo 1: View to the east of boundary marker.

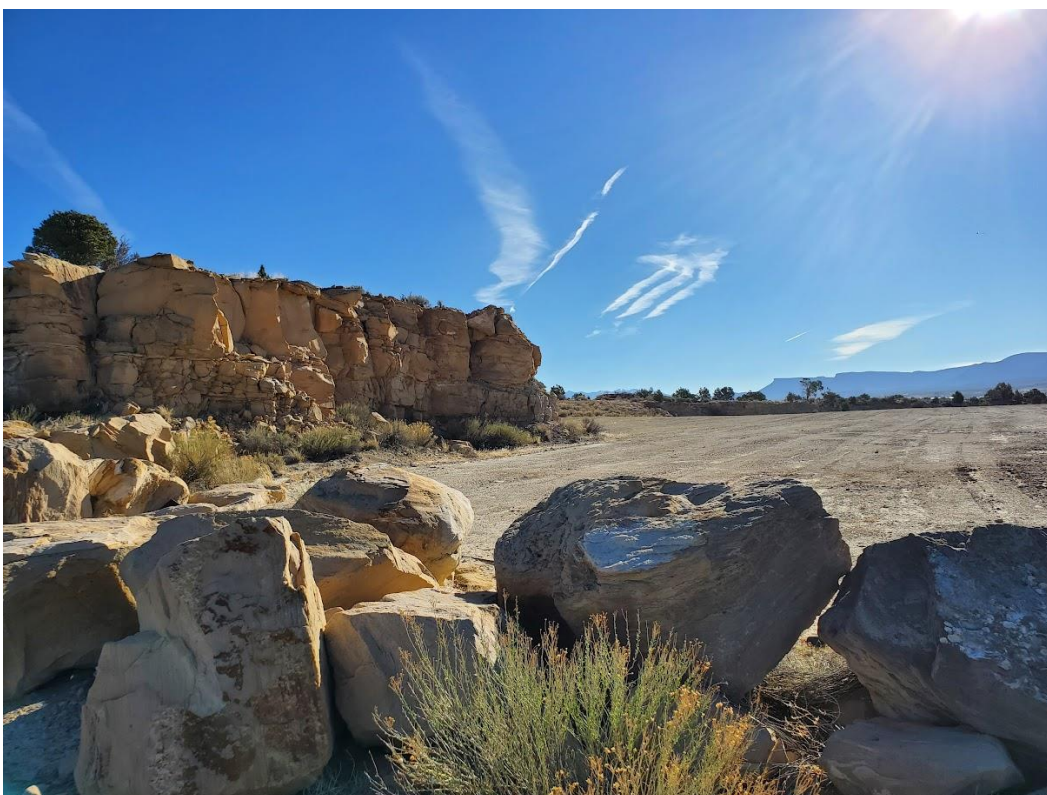
Photo 2: View to the northeast of rock outcrop on western end of the upper bench within the permit area.

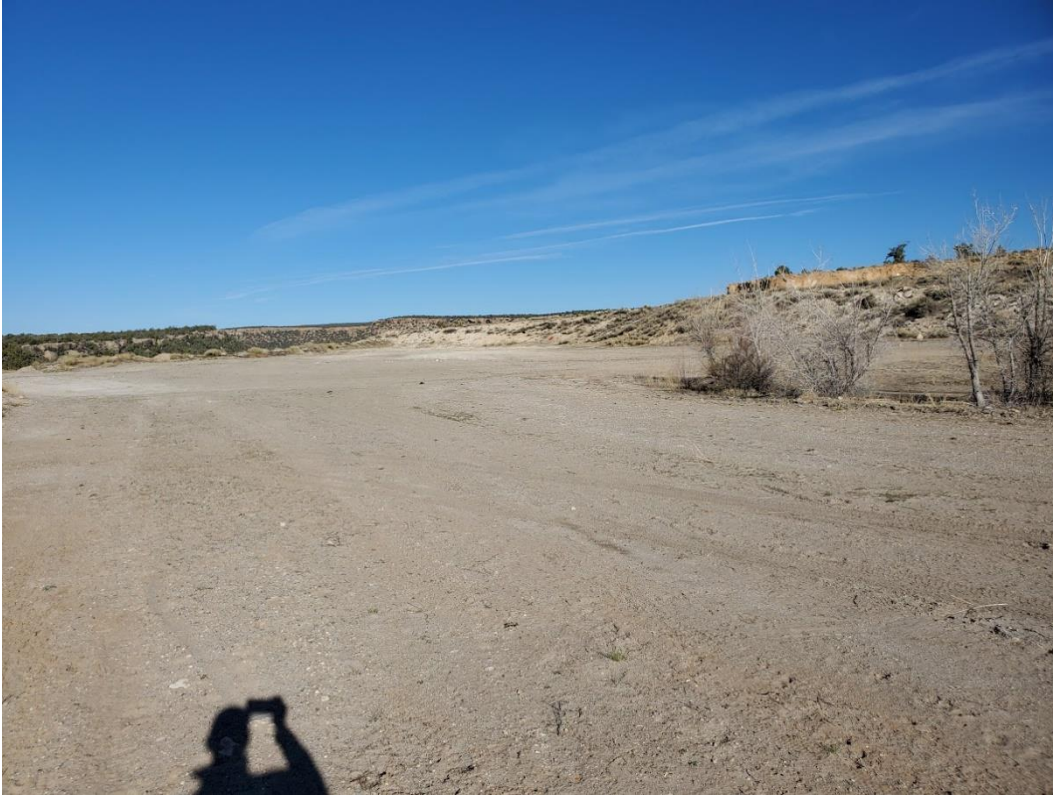
Photo 3: View to the northwest of lower bench.

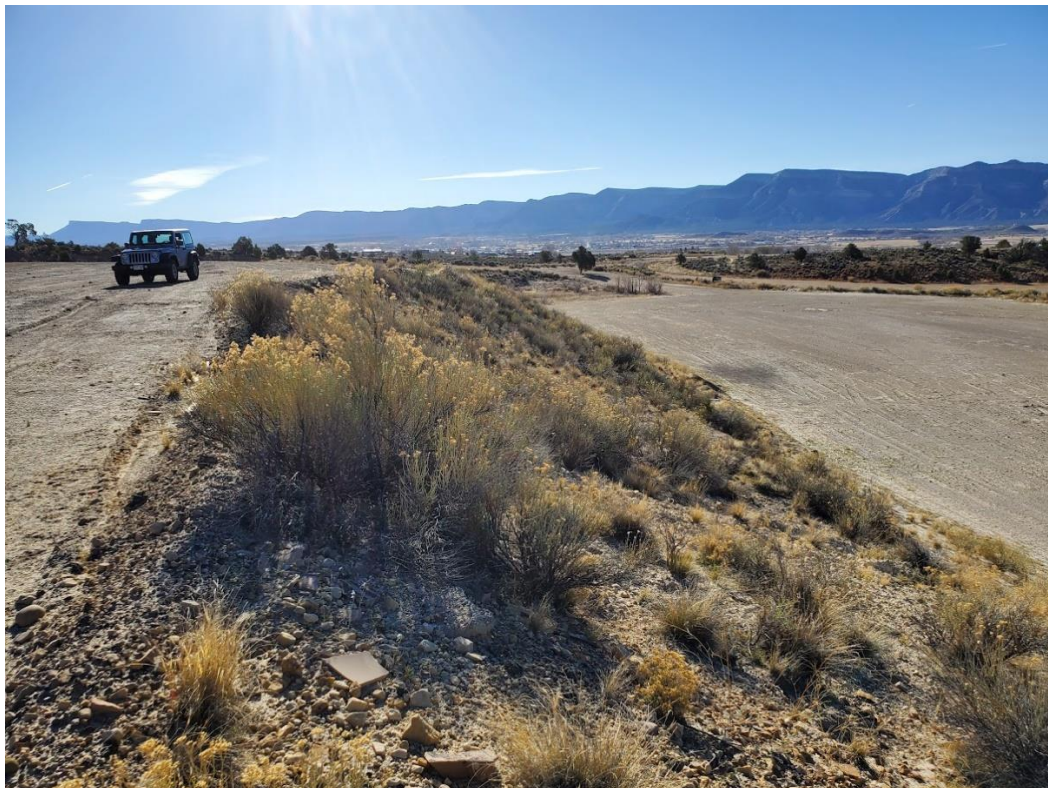
The site is at final reclamation grade. Slopes appear to be stable and well vegetated. There are no signs of excessive erosion. The only remaining reclamation task remaining is to revegetate.

Photo 4: View to the east of slope between upper and lower bench
