MINERALS PROGRAM INSPECTION REPORT
PHONE: (303) 866-3567

MINE NAME: Topaz Mine	MINE/PROSPECTING ID#: M-1980-055-HR	MINERAL: Uranium and vanadium	COUNTY: San Miguel
INSPECTION TYPE: Multi Person Inspection	WEATHER: Clear	INSP. DATE: February 27, 2025	INSP. TIME: 10:23
OPERATOR: Pinon Ridge Mining LLC	OPERATOR REPRESENTATIVE: Bruce Smith	TYPE OF OPERATION: 112d-3 - Designated Mining Operation	
REASON FOR INSPECTION: Normal I&E Program	BOND CALCULATION TYPE:	BOND AMOUNT: \$162,630.00	
DATE OF COMPLAINT: NA	POST INSP. CONTACTS: None	JOINT INSP. AGENCY: None	
INSPECTOR(S): Lucas West	INSPECTOR'S SIGNATURE:

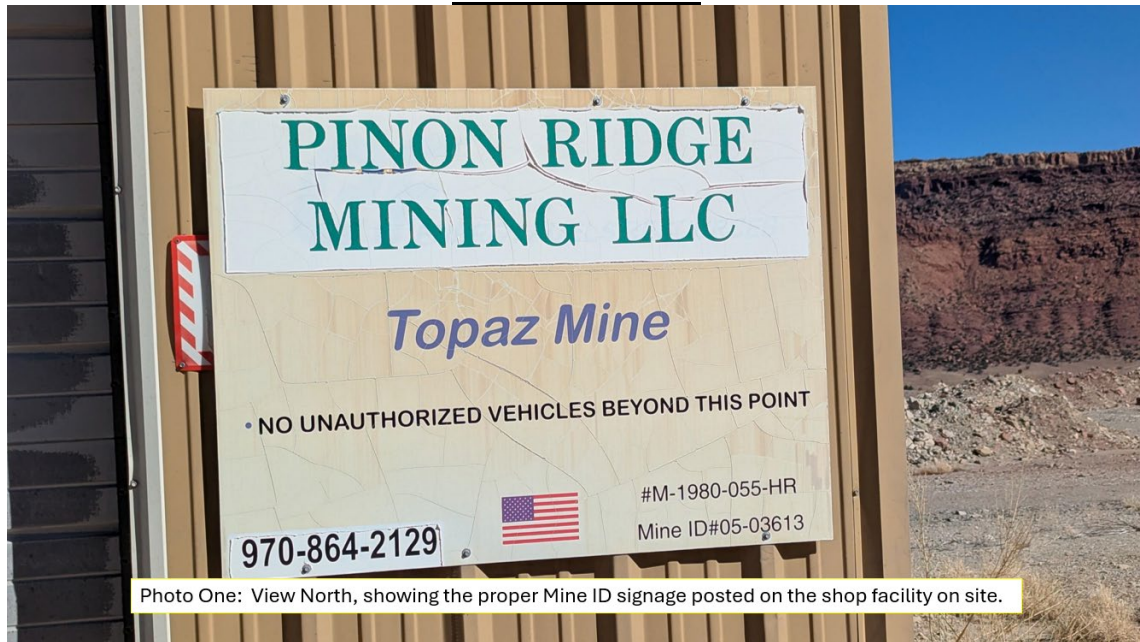
As seen in Photo One, the permit ID sign was observed posted on the shop facility near the entrance. The permit boundary markers were also observed. The shop facility located on site was observed to be secure and is in good working order. No damage or signs of vandalism was noted during the inspection. The portal located on site was also secured, it has been closed off with steel grates as well as encompassed by a small berm as seen in Photo Two. The previously stored items that had been on site for some time have been removed, and no trash or debris was noted. No fuel storage containers were observed on site.
