**MINERALS PROGRAM INSPECTION REPORT**  
**PHONE: (303) 866-3567**

<b>MINE NAME:</b> West Sunday	<b>MINE/PROSPECTING ID#:</b> M-1981-021	<b>MINERAL:</b> Uranium and vanadium	<b>COUNTY:</b> San Miguel
<b>INSPECTION TYPE:</b> Multi Person Inspection	<b>WEATHER:</b> Clear	<b>INSP. DATE:</b> February 27, 2025	<b>INSP. TIME:</b> 11:39
<b>OPERATOR:</b> Pinon Ridge Mining LLC	<b>OPERATOR REPRESENTATIVE:</b> Bruce Smith	<b>TYPE OF OPERATION:</b> 112d-3 - Designated Mining Operation	
<b>REASON FOR INSPECTION:</b> Normal I&E Program	<b>BOND CALCULATION TYPE:</b>	<b>BOND AMOUNT:</b> \$126,940.00	
<b>DATE OF COMPLAINT:</b> NA	<b>POST INSP. CONTACTS:</b> None	<b>JOINT INSP. AGENCY:</b> None	
<b>INSPECTOR(S):</b> Lucas West	<b>INSPECTOR'S SIGNATURE:</b>

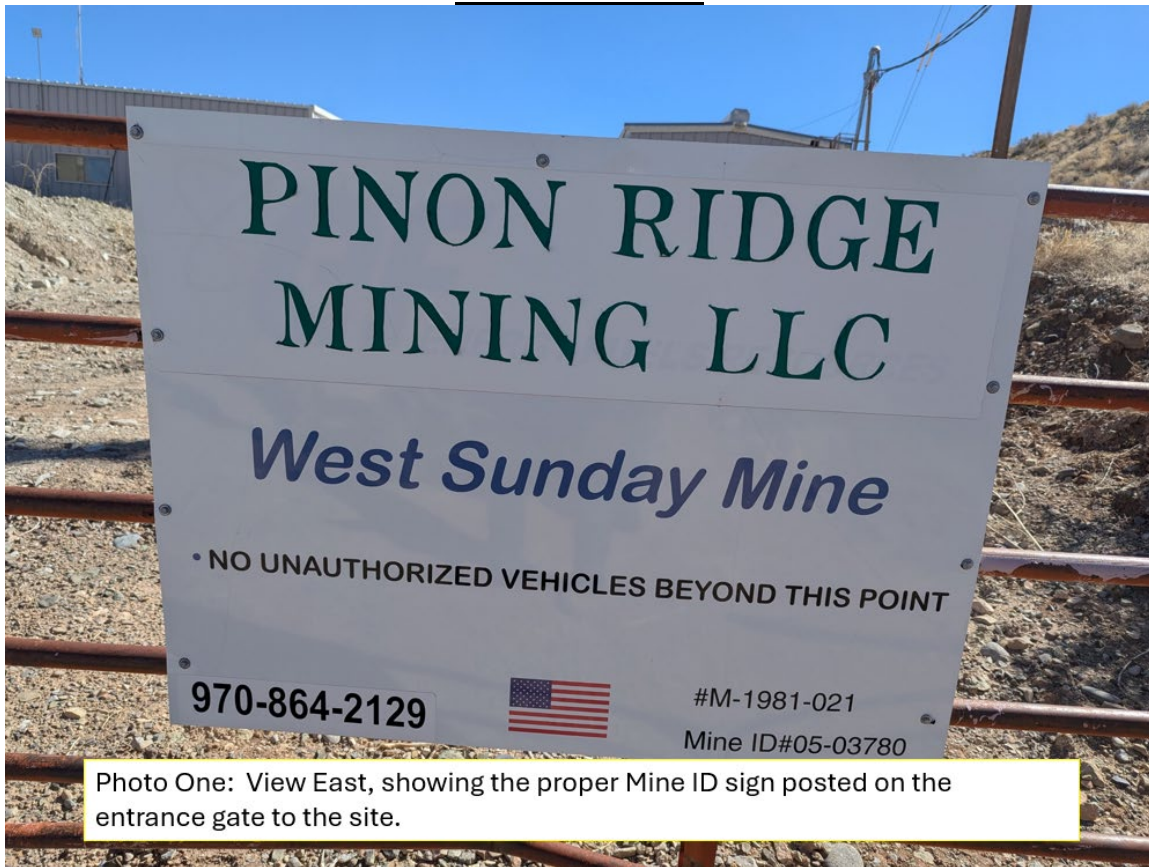
The permit ID sign was observed at the entrance to the site as seen in Photo One. The permit boundary markers were also observed. The remote vent shaft sites were not inspected at this time. Both the shop and storage facility on site were in good condition and showed no evidence of damage or vandalism. The shop can be seen in Photo Two. The portal located on site has been opened to be used as ventilation for the underground workings of the entire Sunday Complex. The portal was secure and in good condition at the time of the inspection as seen in Photo Three. The main pad and work area was in good condition, evidence of weed management during the growing season was observed. The whole site exhibits positive drainage, and no erosional issues were observed at this time. The lined Ore Pad was observed to be in good condition. The face of the pad shows no evidence of surface stockpiling and no observable impacts from precipitation was noted. The out slopes and berms of the pad appear stable. The pad can be seen in Photos Four.

Photo One: View East, showing the proper Mine ID sign posted on the entrance gate to the site.

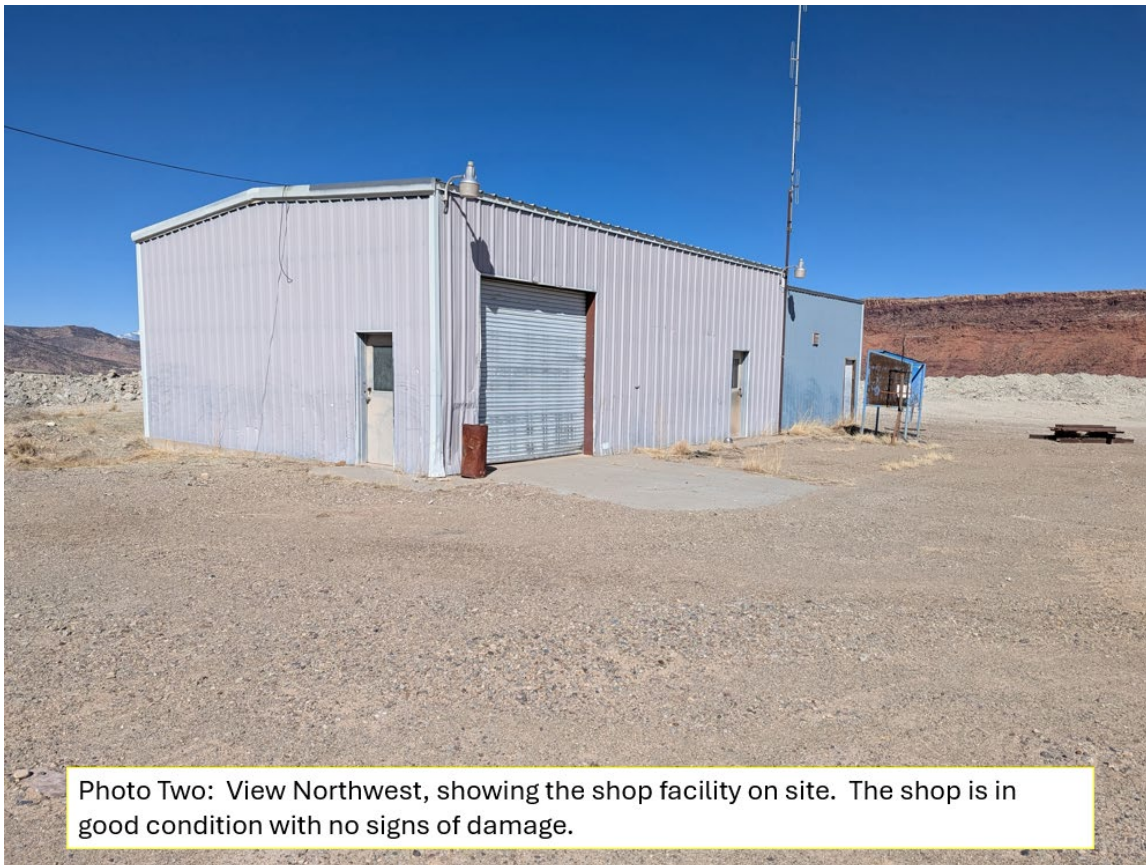
Photo Two: View Northwest, showing the shop facility on site. The shop is in good condition with no signs of damage.

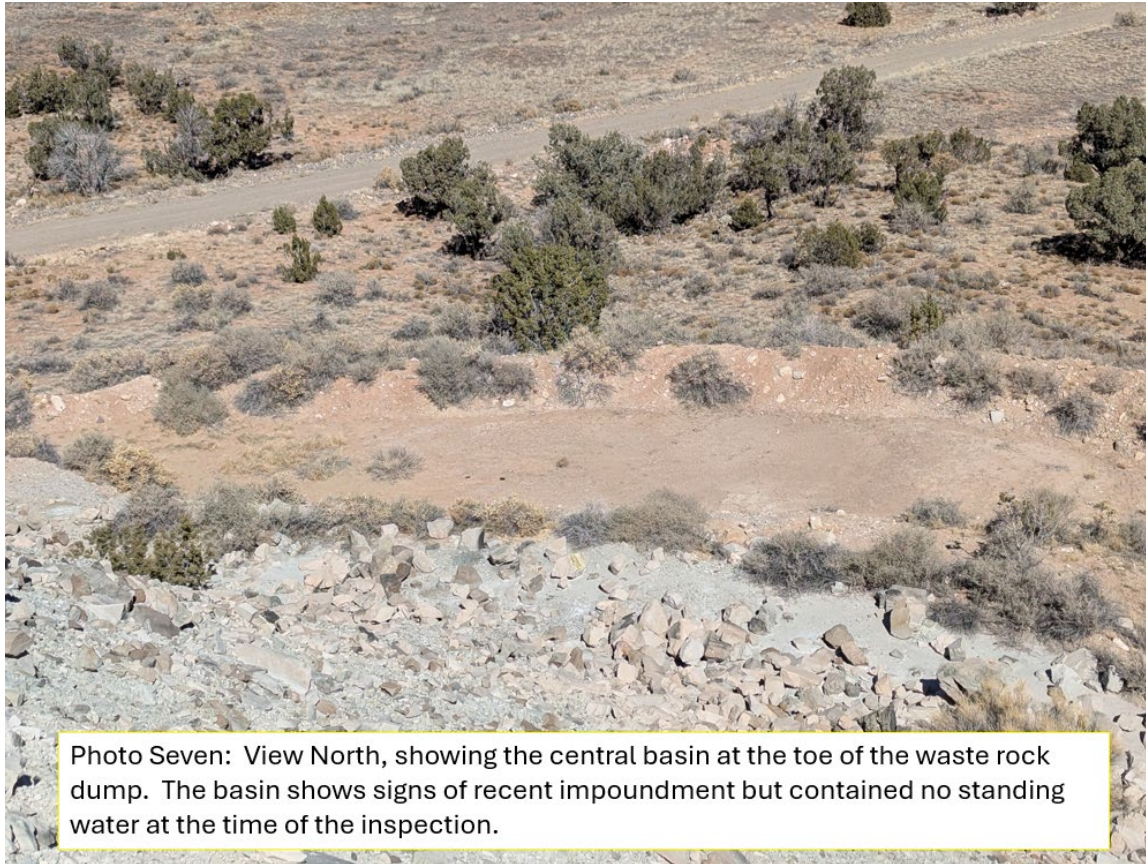
The upland diversion ditches that divert any potential run on water around the site to prevent it from becoming impacted stormwater were not observed during this inspection. On site discussions with Bruce Smith of Western Water and Land revealed that a comprehensive stormwater inspection had been conducted the day before the inspection and that all systems were in good working order. Stormwater that falls directly on the pad is directed to various control devices. None of the control devices contained standing water and an example of one such settling basin can be seen in Photo Five. Stormwater that falls on the slopes of the dump area is collected by a series of ditches leading to one centralized stormwater control basin at the toe of the waste rock dump. An example of the ditches can be seen in Photo Six, and the central basin can be seen in Photo Seven. All observed ditches were free from obstruction and appeared able to function as designed. The central basin showed evidence of recent impoundment; however no standing water was observed.

Photo Seven: View North, showing the central basin at the toe of the waste rock dump. The basin shows signs of recent impoundment but contained no standing water at the time of the inspection.
