MINERALS PROGRAM INSPECTION REPORT
PHONE: (303) 866-3567

MINE NAME: Lamar Park Grav Pit	MINE/PROSPECTING ID#: M-1987-078	MINERAL: Sand and gravel	COUNTY: Prowers
INSPECTION TYPE: Surety Release Inspection	WEATHER: Clear	INSP. DATE: April 9, 2025	INSP. TIME: 11:00
OPERATOR: City of Lamar	OPERATOR REPRESENTATIVE: Patrick Mason, Michael Machone	TYPE OF OPERATION: 110c - Construction Limited Impact	
REASON FOR INSPECTION: Surety Release Requested	BOND CALCULATION TYPE: None	BOND AMOUNT: \$0.00	
DATE OF COMPLAINT: NA	POST INSP. CONTACTS: None	JOINT INSP. AGENCY: None	
INSPECTOR(S): Ursula Armstrong	INSPECTOR'S SIGNATURE:

This was a surety release inspection of the Lamar Park Grav Pit (Permit No. M-1987-078) conducted by Ursula Armstrong of the Division of Reclamation, Mining and Safety (Division) in response to a Full Release Request (SL-1) filed with our office on March 24, 2025. The public comment period for SL-1 closed on April 8, 2025. During this period, the Division received no comments. The operator was represented by Patrick Mason and Michael Machone during the inspection. The site is located at the northern edge of Lamar, Colorado in Prowers County, directly south of a termin

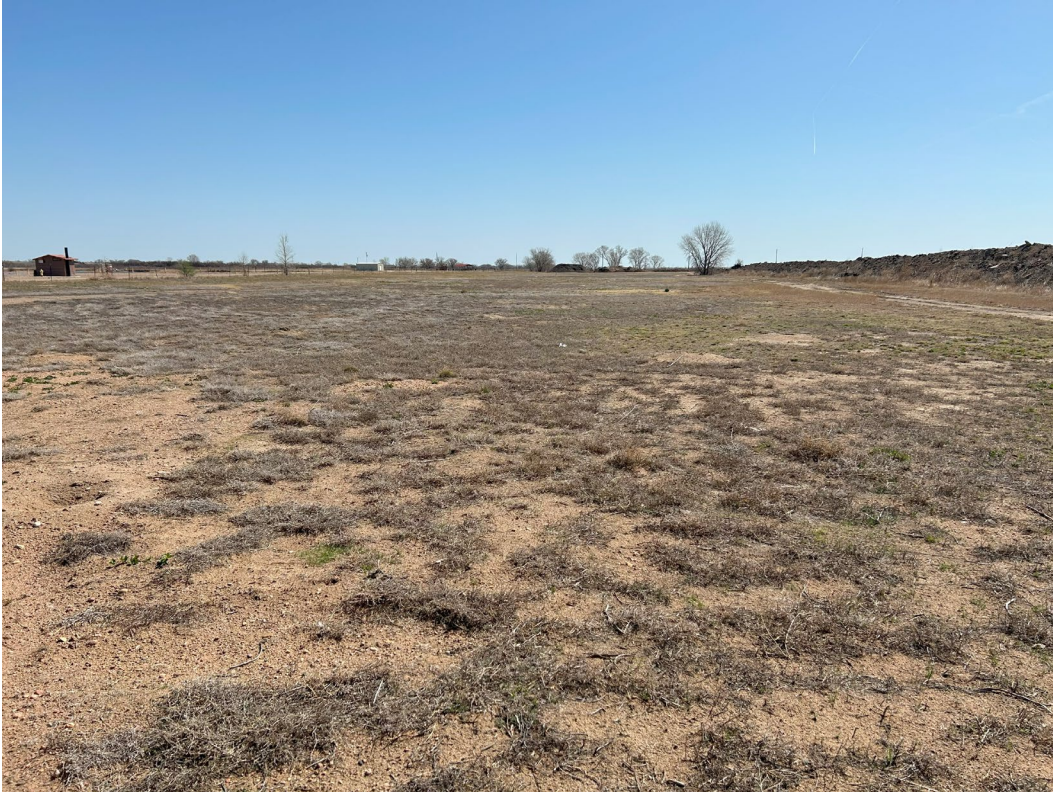
Photo 1. Looking east at the central section of the permit area.

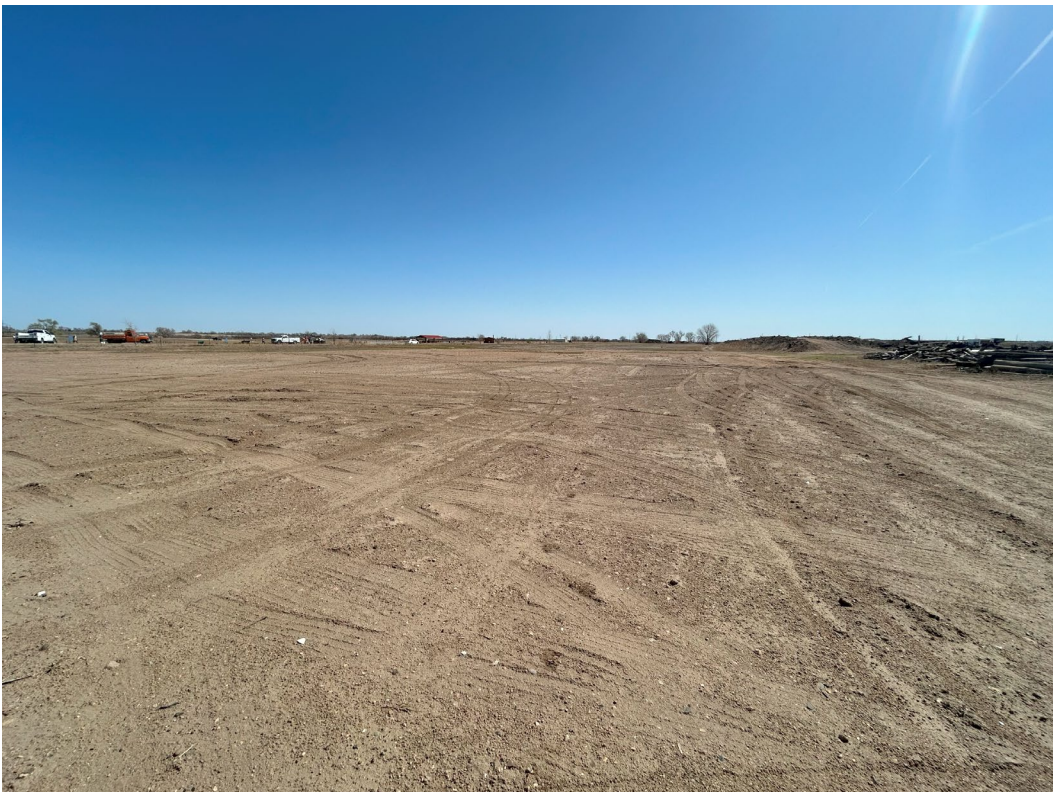
Photo 2. Looking east at the of the permit area.

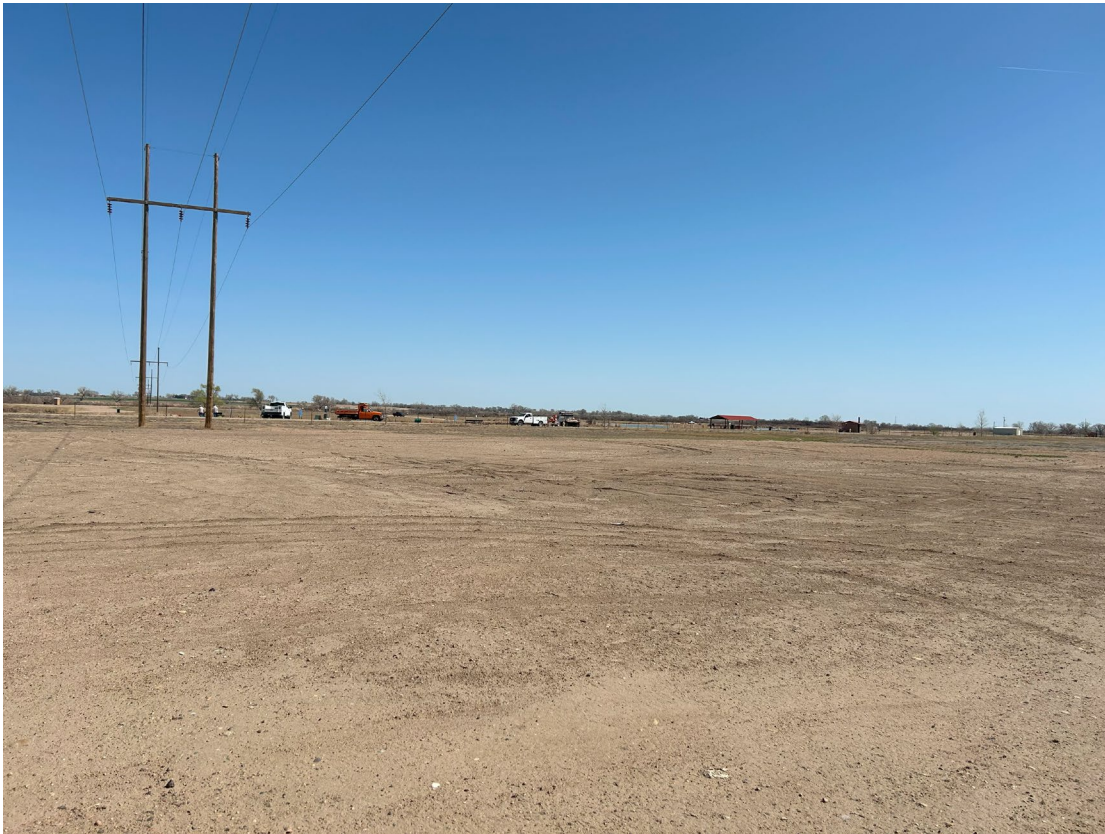
Photo 3. Looking north at the western edge of the permit area.

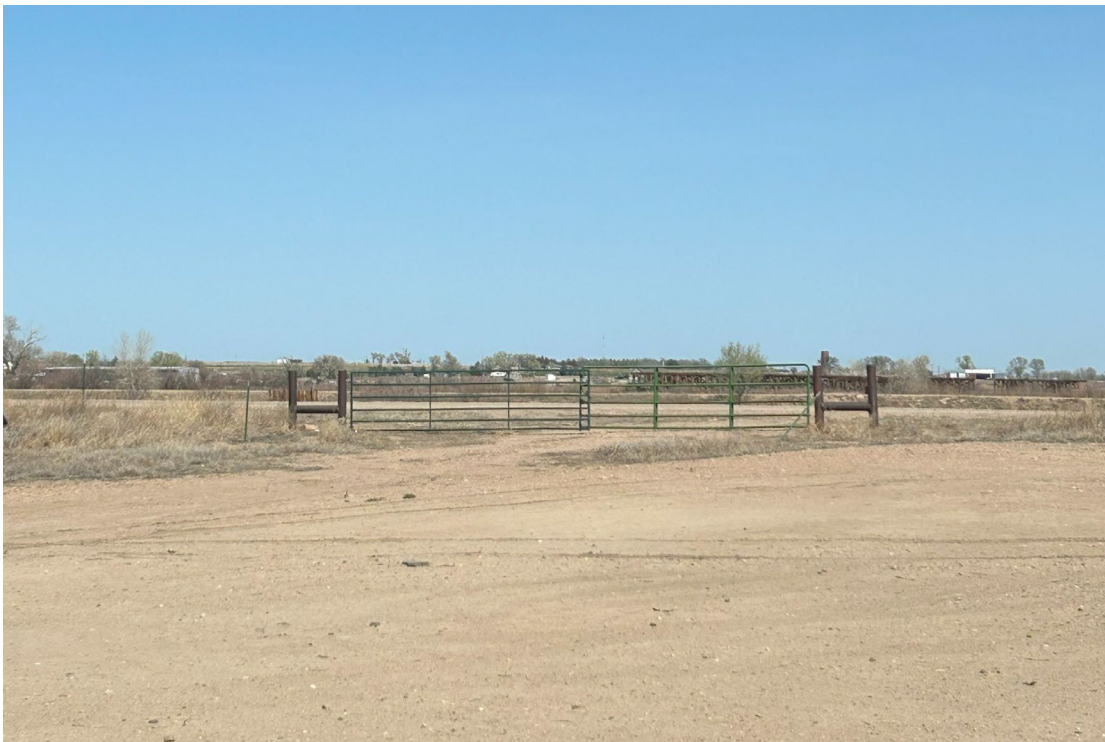
Photo 4. Looking north at the northern gate entrance to the site.

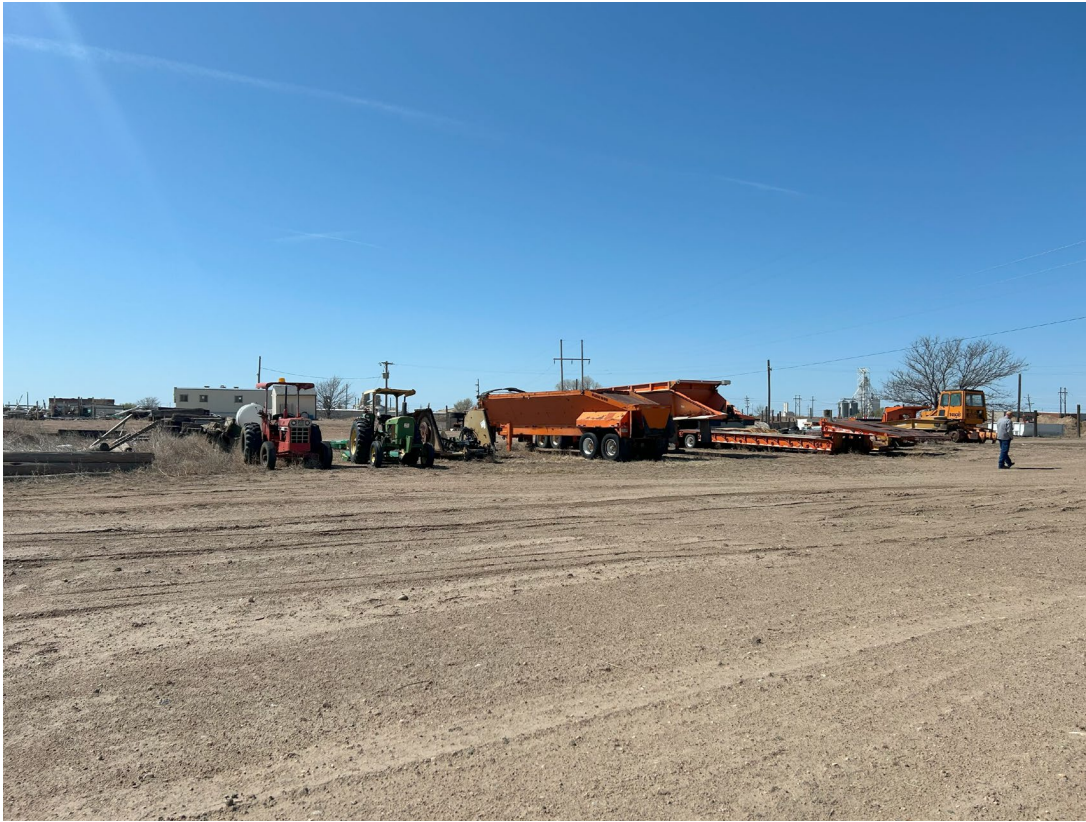
Photo 5. Looking south at the southern edge of the permit area, the equipment is outside of the permit boundary.

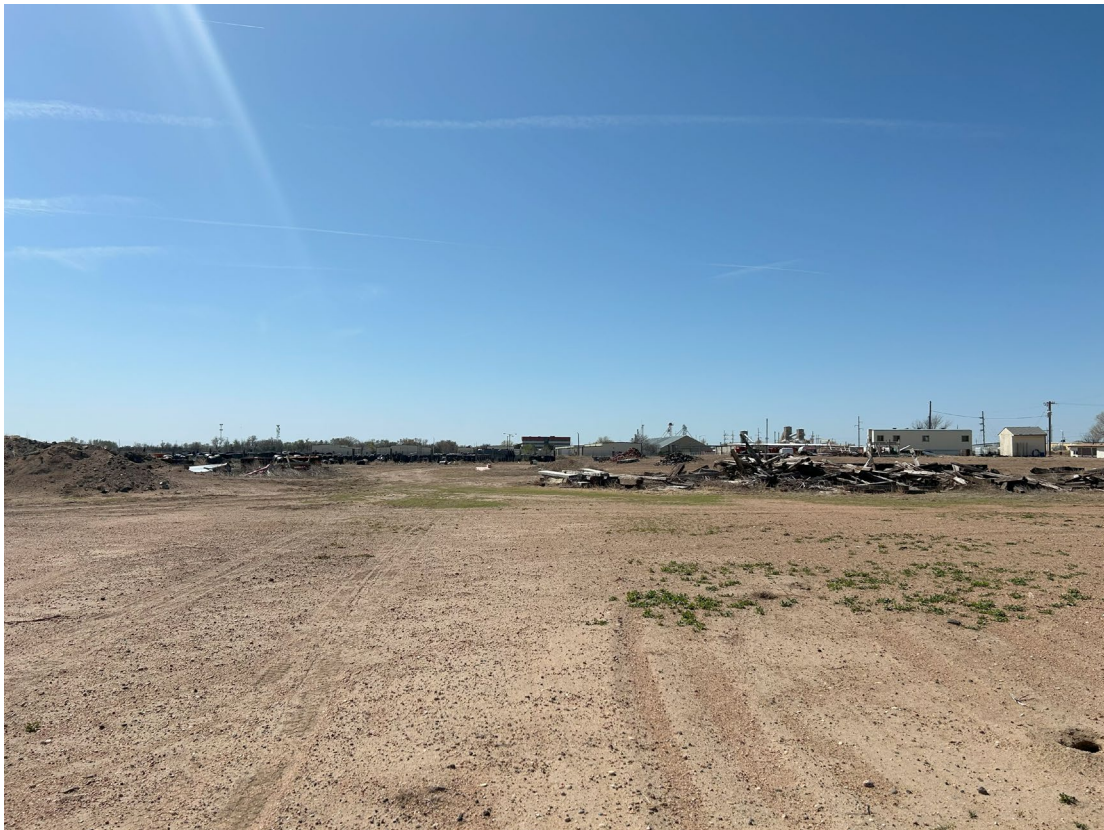
Photo 6. Looking south at the southern edge of the permit area, the storage piles are outside of the permit boundary.

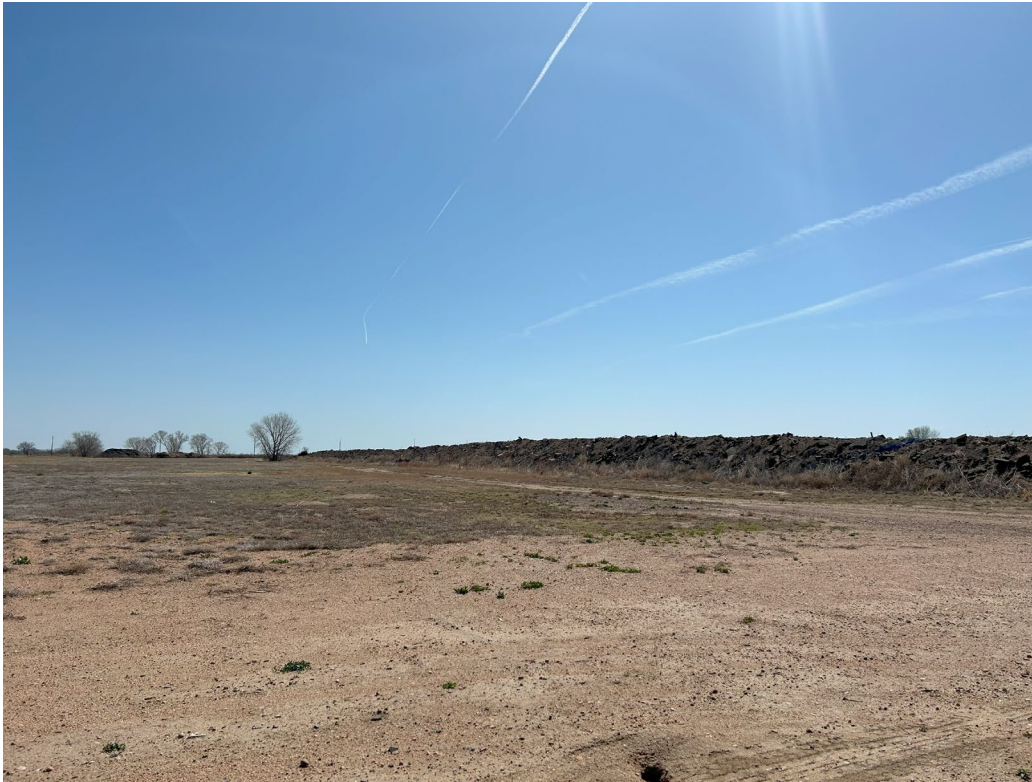
Photo 7. Looking southeast at the permit area. The material stockpile is outside of the permit boundary.

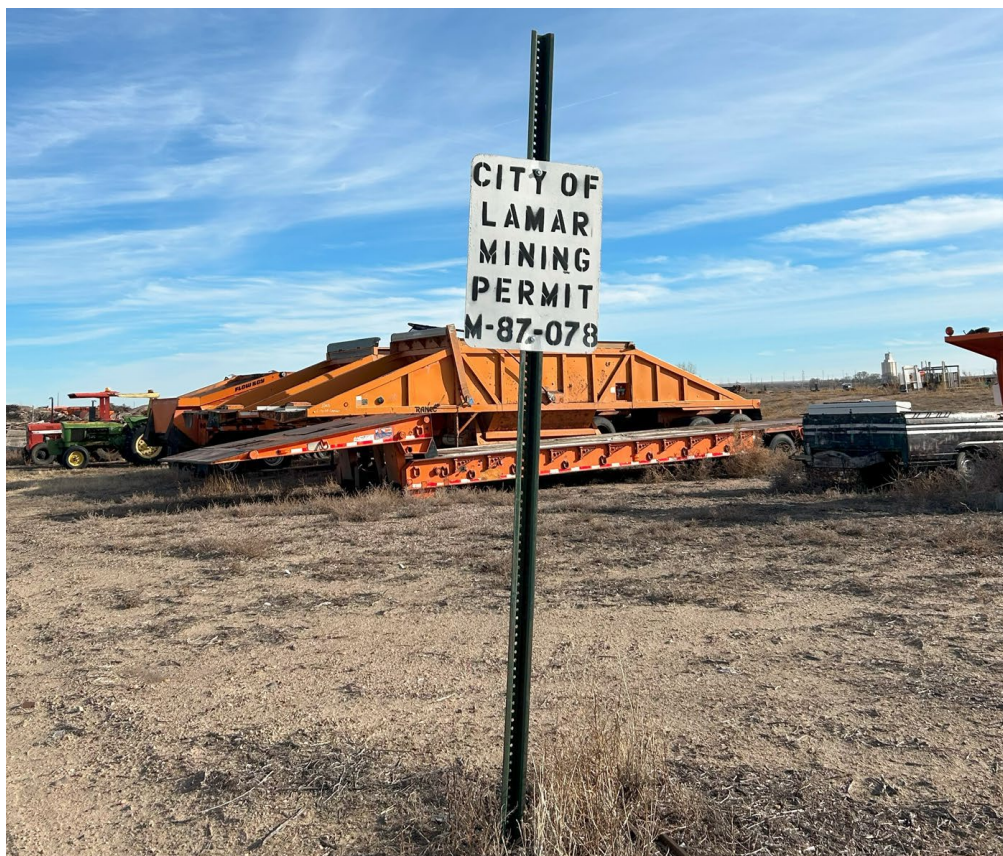
Photo 8. Looking east at the mine identification sign posted at the southwest corner of the permit boundary. The equipment in the back is directly south of the permit boundary.
