**PERMIT INFORMATION**

| <b>Permit Number:</b> C-1981-035<br><b>Mine Name:</b> King Coal Mine<br><b>Operator:</b> GCC Energy, LLC<br><b>Operator Address:</b><br>Mr. Jordan McCourt<br>6473 County Road 120<br>Hesperus, CO 81326 | <b>County:</b> La Plata<br><b>Operation Type:</b> Underground<br><b>Permit Status:</b> Active<br><b>Ownership:</b> Private |

| <b>Inspection Start Date:</b> March 26, 2025<br><b>Inspection Start Time:</b> 08:50<br><b>Inspection End Date:</b> March 26, 2025<br><b>Inspection End Time:</b> 11:45 | | <b>Inspection Type:</b> Coal Complete Inspection<br><b>Inspection Reason:</b> Normal I&E Program<br><b>Weather:</b> Clear | |

This report documents the Division's observations taken during a complete inspection of the King Mine, Permit No. C-1981-035. The inspection was completed on March 26, 2025, by Clayton Wein and Travis Marshall of the Division. The operator, GCC Energy, was represented during the inspection by Jordan McCourt. The weather was clear with a temperature starting at 45°F. The ground conditions were mostly dry with some muddy areas and small amounts of snow in the shaded north-facing slopes.

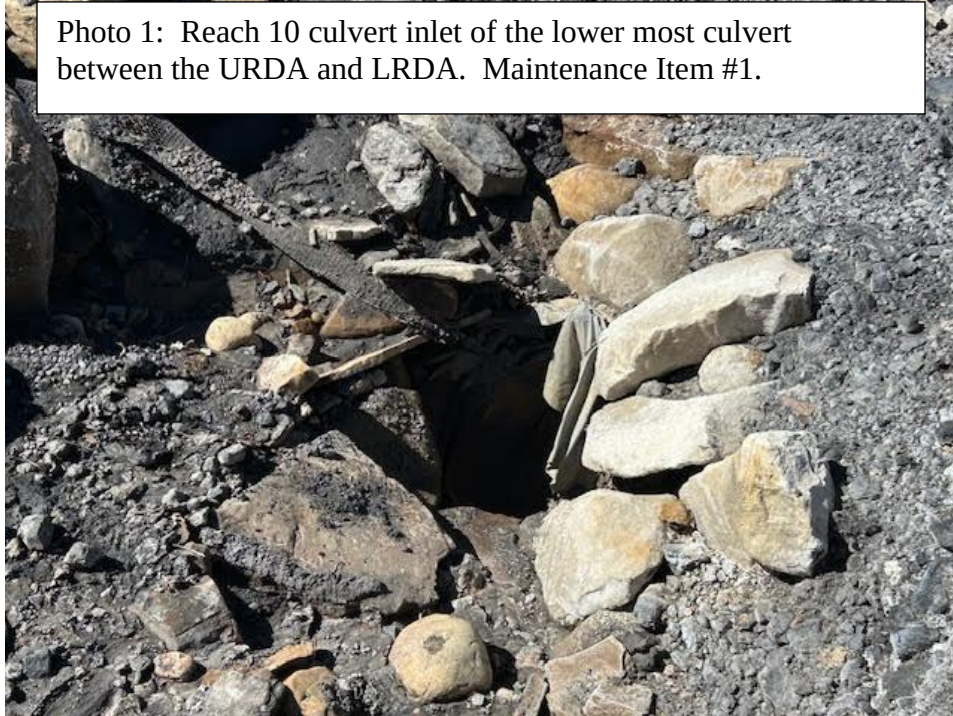
1. The culvert above the lower refuse disposal area, connected to reach 10 requires the inlet and outlet to be repaired and cleaned (Photo 1 and 2).
2. Oil barrels from a recent shipment were not in secondary containment within the hydrocarbon storage shed (Photo 2).
3. Coal dust on the southern hillside adjacent to Coal Stack #1 was identified. The west clearwater ditch for the King II area is located at the base of this hillside. GCC needs to ensure the clearwater ditches at the King II area will not be impacted by coal dust.

Photo 1: Reach 10 culvert inlet of the lower most culvert between the URDA and LRDA. Maintenance Item #1.

Maintenance Items #1 and #2 have been addressed. GCC submitted a letter on March 31, 2025, containing photos of the completed maintenance items. The March 31, 2025, letter from GCC has been attached to the end of this report.

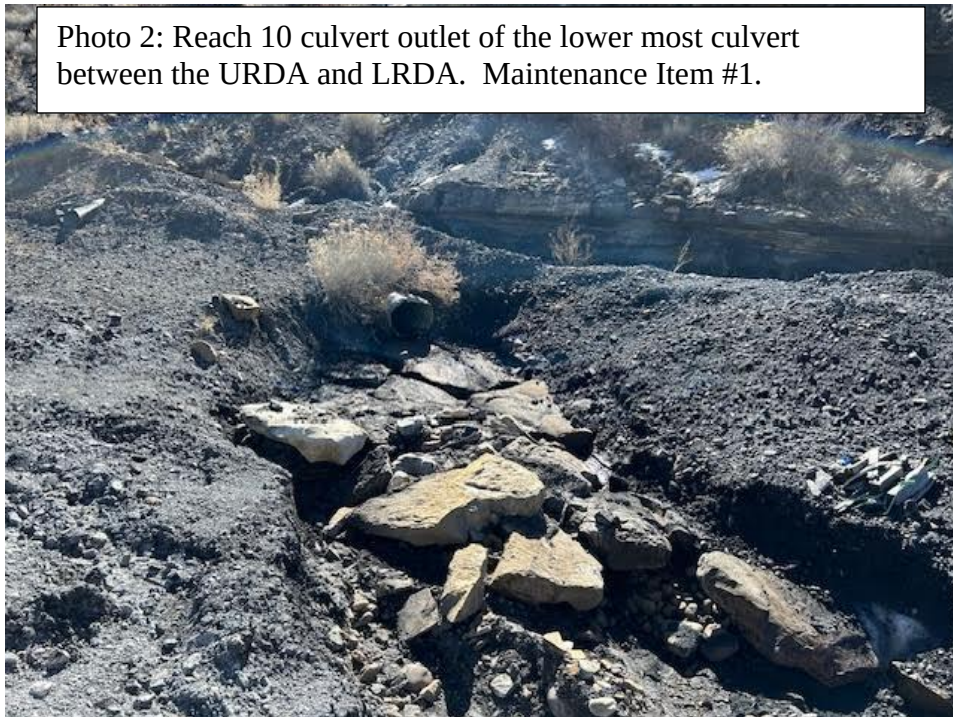
Photo 2: Reach 10 culvert outlet of the lower most culvert between the URDA and LRDA. Maintenance Item #1.

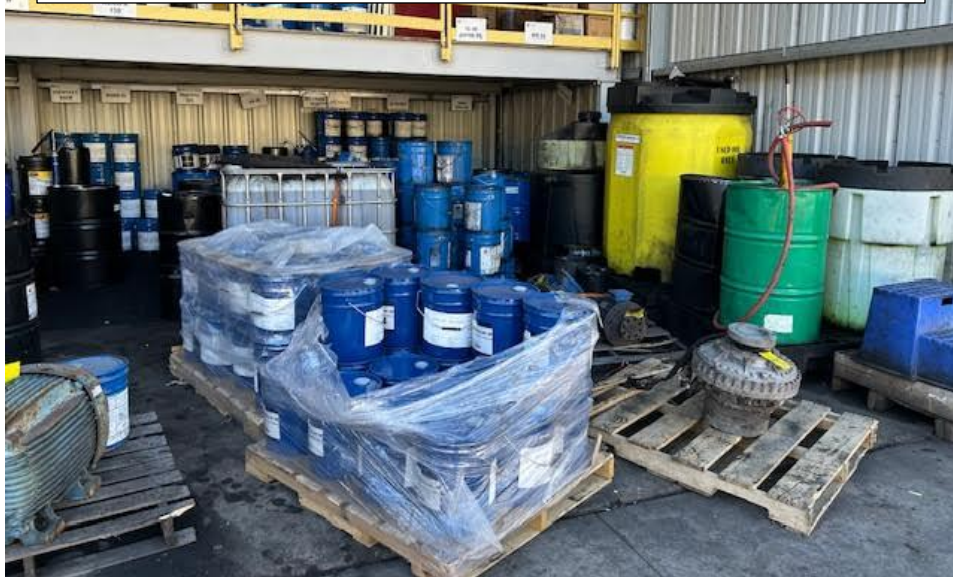
The King II facilities pad was in good condition. Materials were observed to be stored in their respective laydown area (Photo 19). Trash was kept within the receptacles (Photo 20). The hydrocarbon storage shed needed to be reorganized. A recent shipment of oil was left out of secondary containment (Photo 3). The operator moved the oil to the proper containment and provided the Division with a photo of the completed maintenance item in the attached March 31, 2025 letter. During the inspection coal dust was observed on the hillside across the access road from the Coal Stack #1. Discussions about Maintenance Item #3 following the inspection have resulted in GCC requesting 90 days to determine where the coal dust is coming from and propose a solution to keep the clearwater ditch from future potential impacts.

Photo 3: The Hydrocarbon/Fuel Storage Shed with oil that needed to be placed in secondary containment. Maintenance item #2.

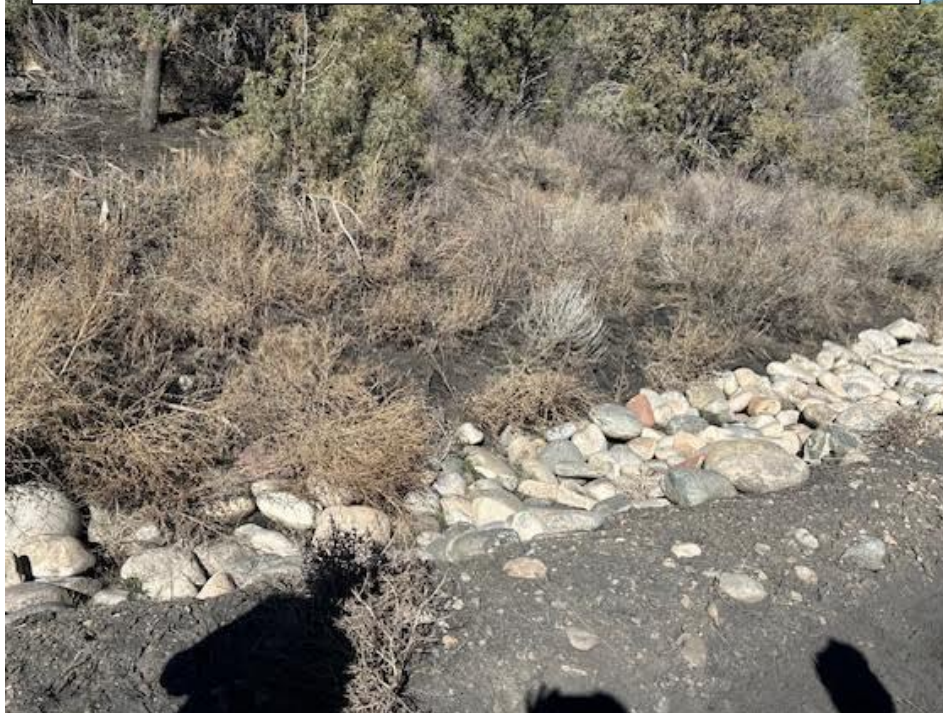
Photo 4: The hillside above the west clearwater ditch referenced in Maintenance Item #3.

Discussions about Maintenance Item #3 following the inspection have resulted in GCC requesting 90 days to determine where the coal dust is coming from and propose a solution to keep the clearwater ditch from future potential impacts. The Division has granted GCC 90 days from the date of the inspection report to complete Maintenance Item #3.

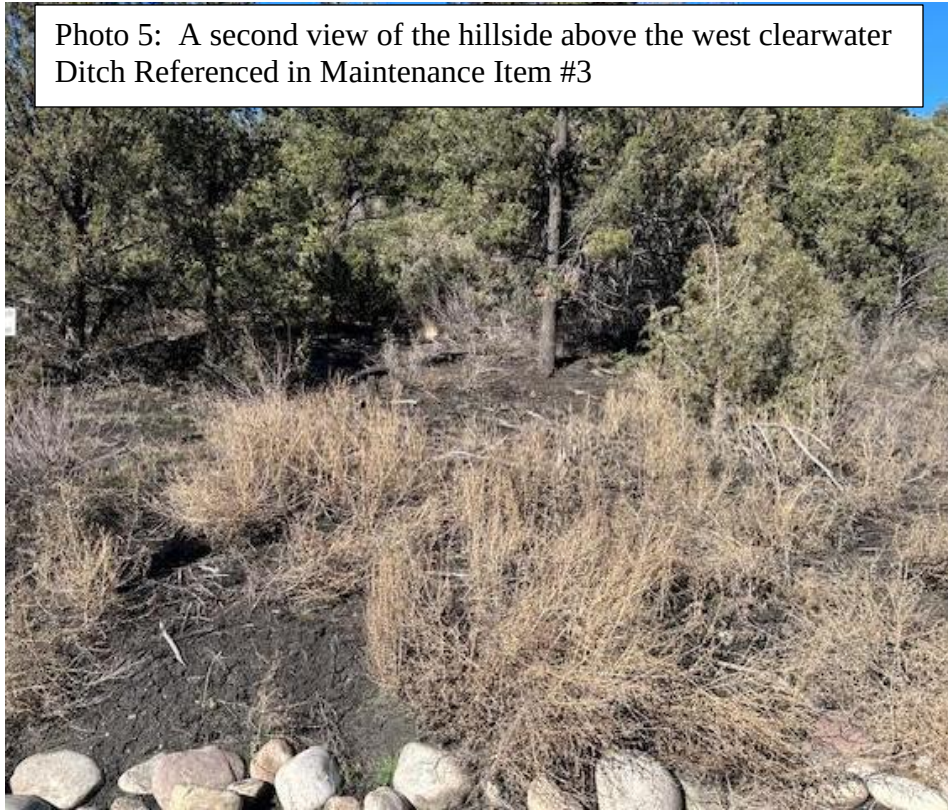
Photo 5: A second view of the hillside above the west clearwater Ditch Referenced in Maintenance Item #3

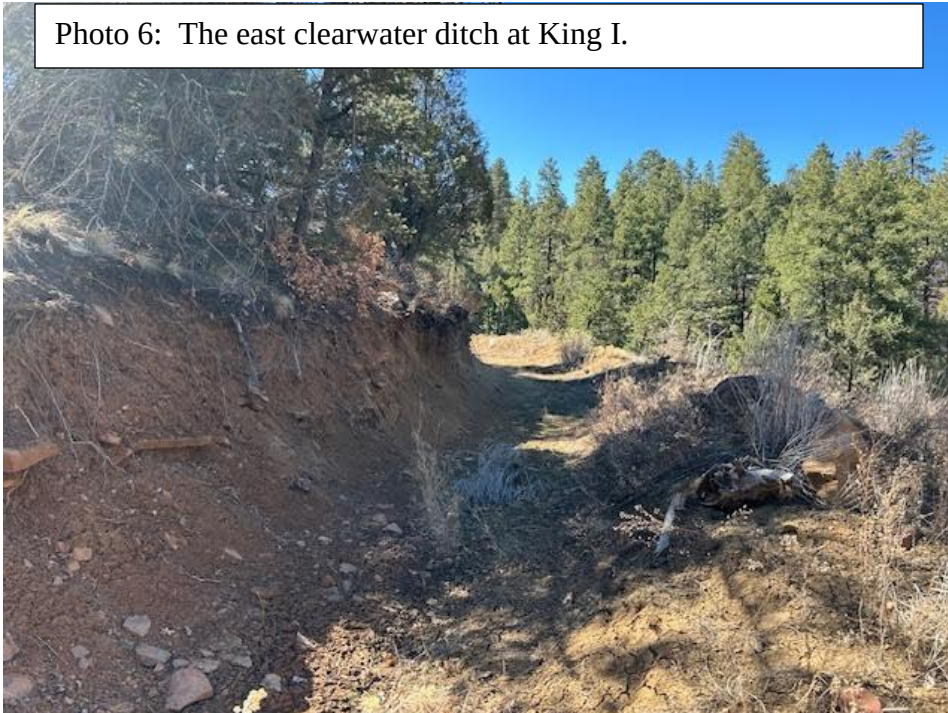
There are two clearwater diversion ditches located at the King I facilities. The east and west clearwater ditches. During the inspection the east clearwater ditch was dry (Photo 6). There were no obstructions or erosional features observed. The sediment levels within the ditch were minimal. The concrete armored portion of the ditch extends down the hill adjacent to the upper refuse disposal area (URDA) to the adjacent hillside of the lower refuse disposal area (LRDA). The concrete portion was stable and there was no undercutting observed (Photo 7). The west clearwater ditch was observed to be muddy from snowmelt (Photo 8). There were no blockages or erosional concerns identified. Sediment levels within the ditch were low.

Photo 6: The east clearwater ditch at King I.

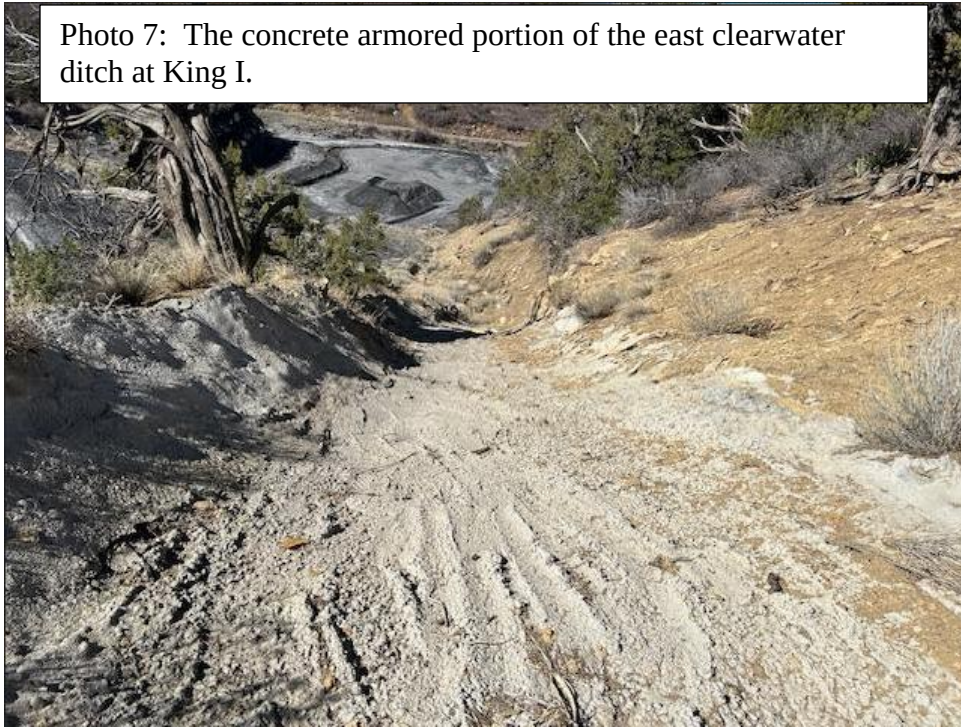
Photo 7: The concrete armored portion of the east clearwater ditch at King I.

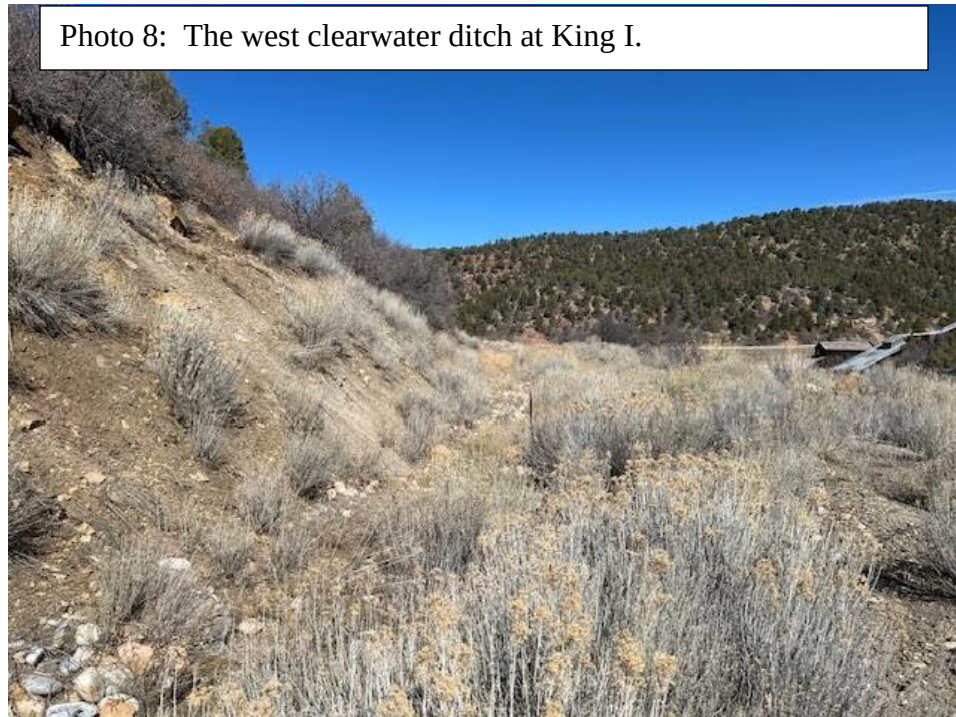
Photo 8: The west clearwater ditch at King I.

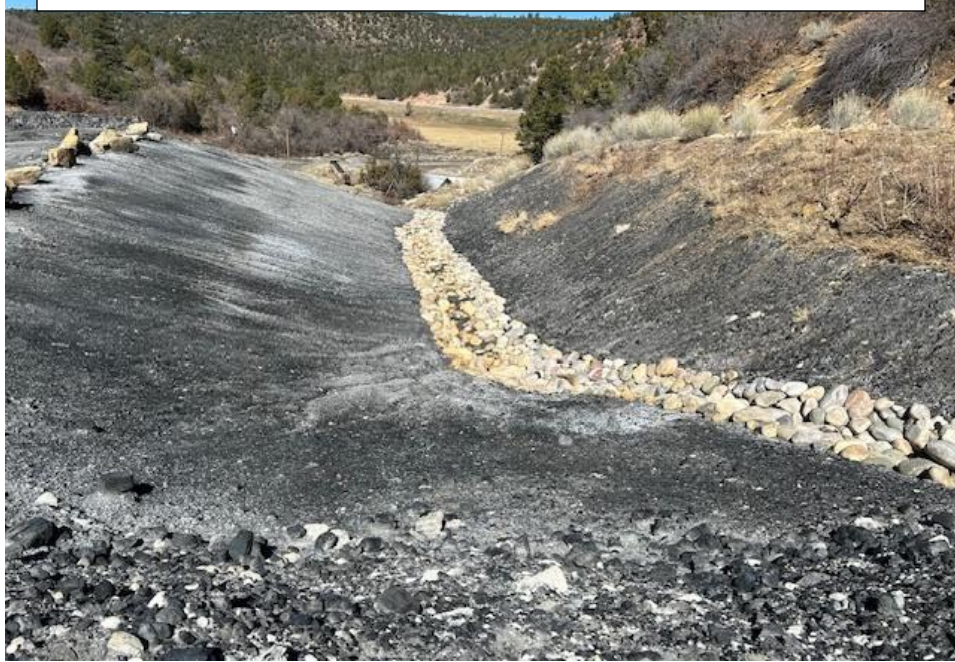
Reach 13 was also clear of blockages. There were no indications of erosional features or instability. Reach 13 was dry at the time of the inspection. The armored portion of reach 13 on the east side of the LRDA was in good condition (Photo 9). Minimal amounts of sediment were noted. The end of Reach 13 enters a culvert with a metal grate over it. The grate was unobstructed.

Photo 9: The armored portion of Reach 13.

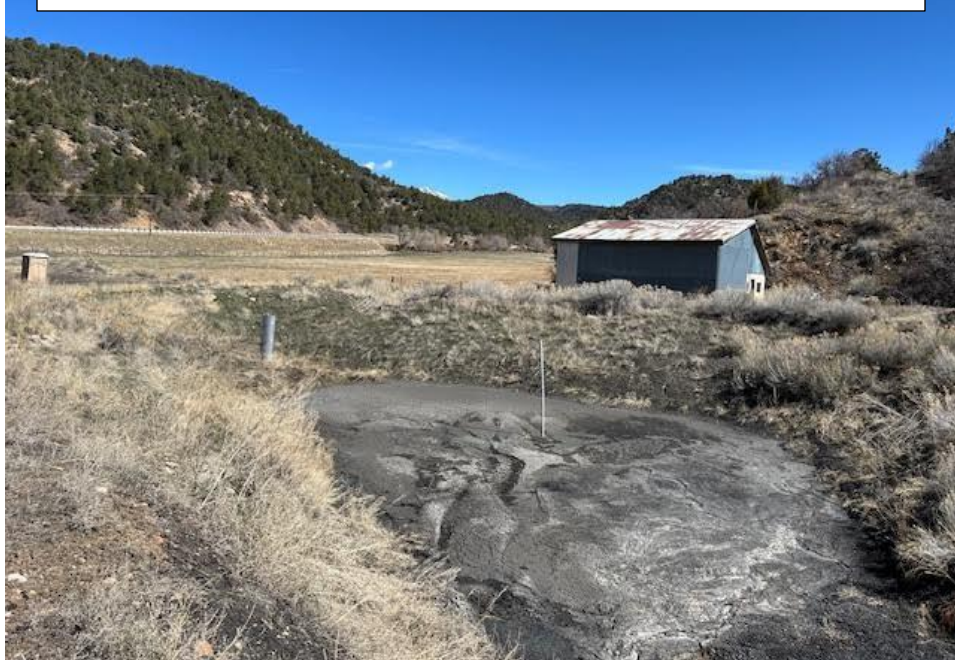
The east pond was damp in the bottom. The inlet and outlet to the pond were clear of blockages. The embankment for the pond was stable with vegetative cover (Photo 10). There were no erosional concerns noted.

Photo 10: The east sediment pond at King I.

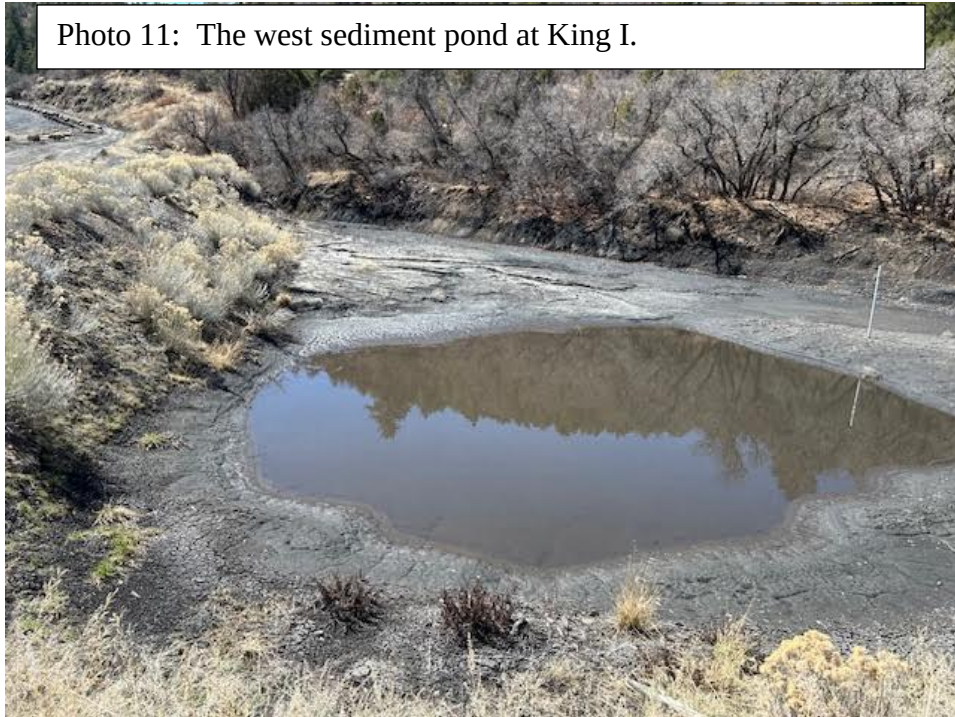
The west pond was holding a small amount of water during the inspection (Photo 11). The level of water impounded in the pond was below the discharge outlet. The inlet and outlet for the pond were unobstructed. The embankment for the pond was vegetated and stable. No erosional features were observed.

Photo 11: The west sediment pond at King I.

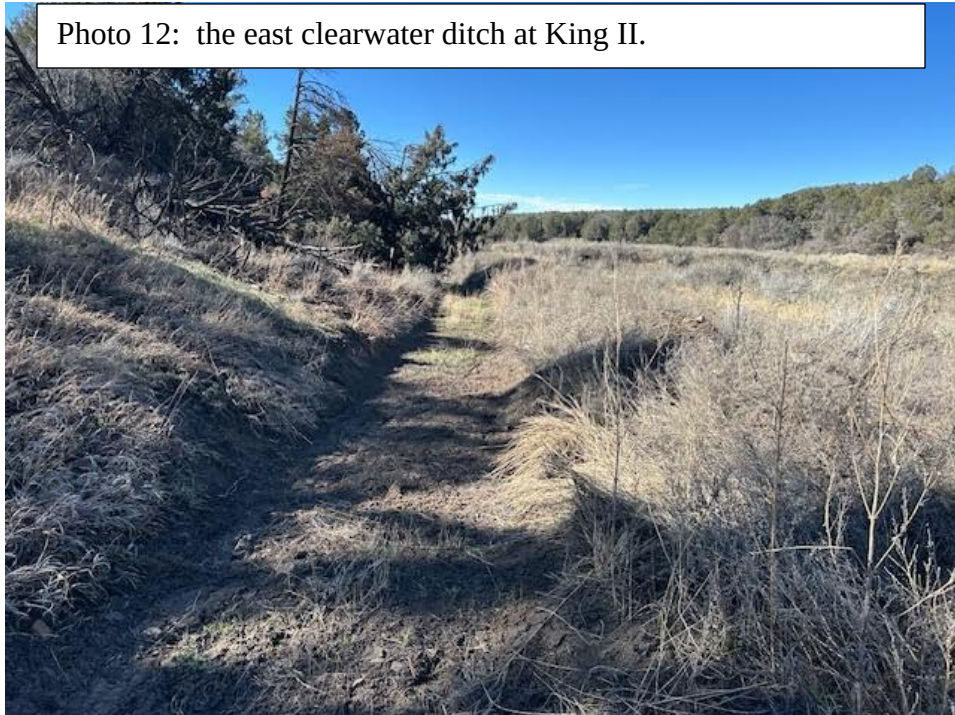
The King II facilities has two clearwater diversion ditches, the east and west clearwater ditches. The east clearwater ditch was dry during the inspection (Photo 12). The diversion was stable with no erosional features identified. Minimal amounts of sediment have deposited in the channel. The west clearwater diversion starts at the northwest corner of the King II area, turns south along the haul road and ends at the entrance to the mine site. Discharge will go through a sump with a silt fence before leaving the permit boundary. The ditch was dry with some damp spots (Photo 13). There were no obstructions or indications of erosional features. The Sump was stable with the silt fence being in good condition. There was no water in the sump.

Photo 12: the east clearwater ditch at King II.

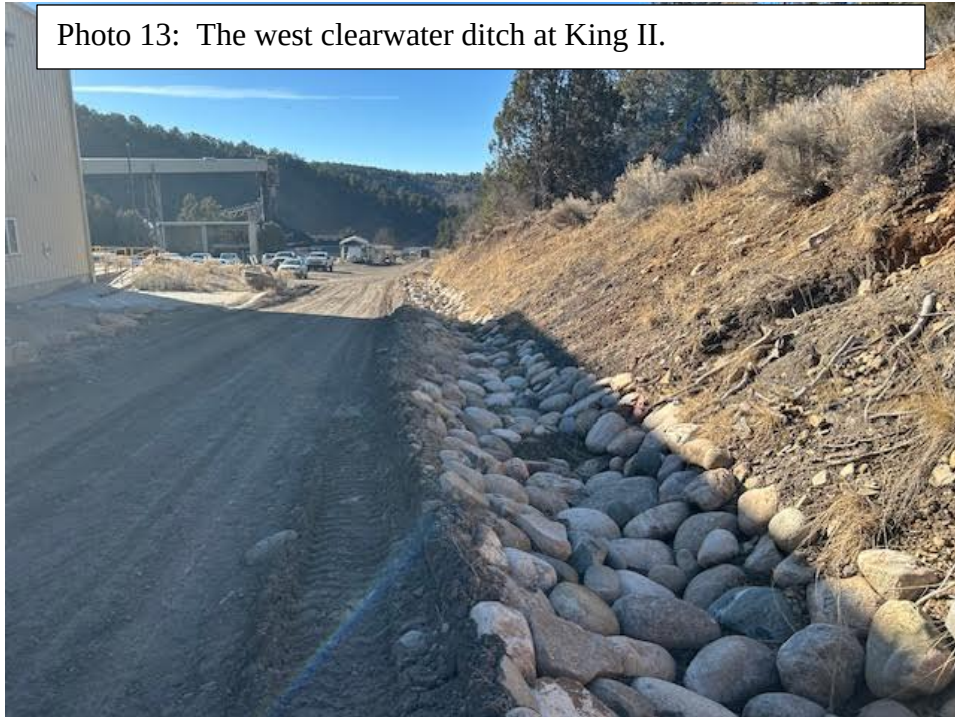
Photo 13: The west clearwater ditch at King II.

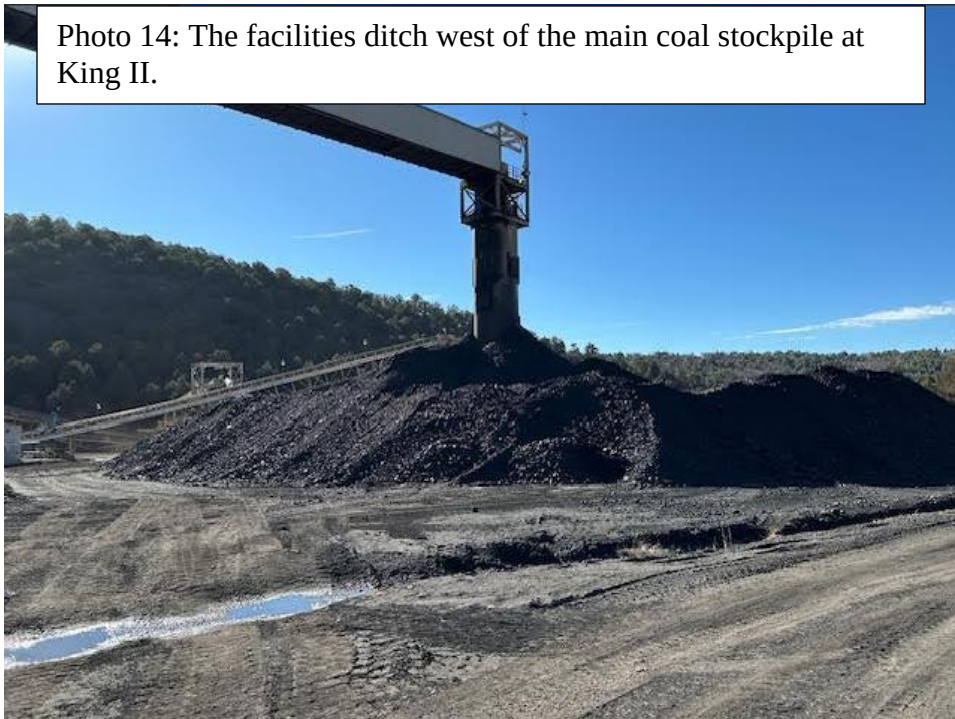
Drainage ditches and associated culverts within the King II area report to the sediment pond. The drainage ditches were conveying water during the inspection (Photo 14). The open ditches were clear of debris and functioning as designed. There were no indications or erosional features. Culverts throughout the facilities area had unobstructed inlets and outlets (Photo 15). Maintenance to remove sediment was not warranted at the time.

Photo 14: The facilities ditch west of the main coal stockpile at King II.

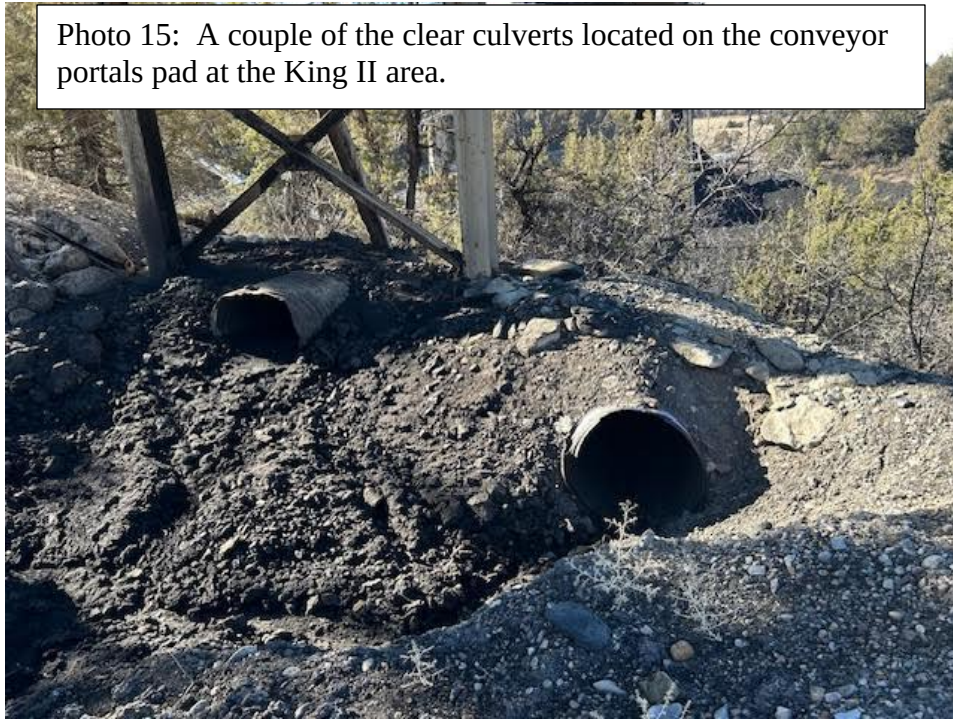
Photo 15: A couple of the clear culverts located on the conveyor portals pad at the King II area.

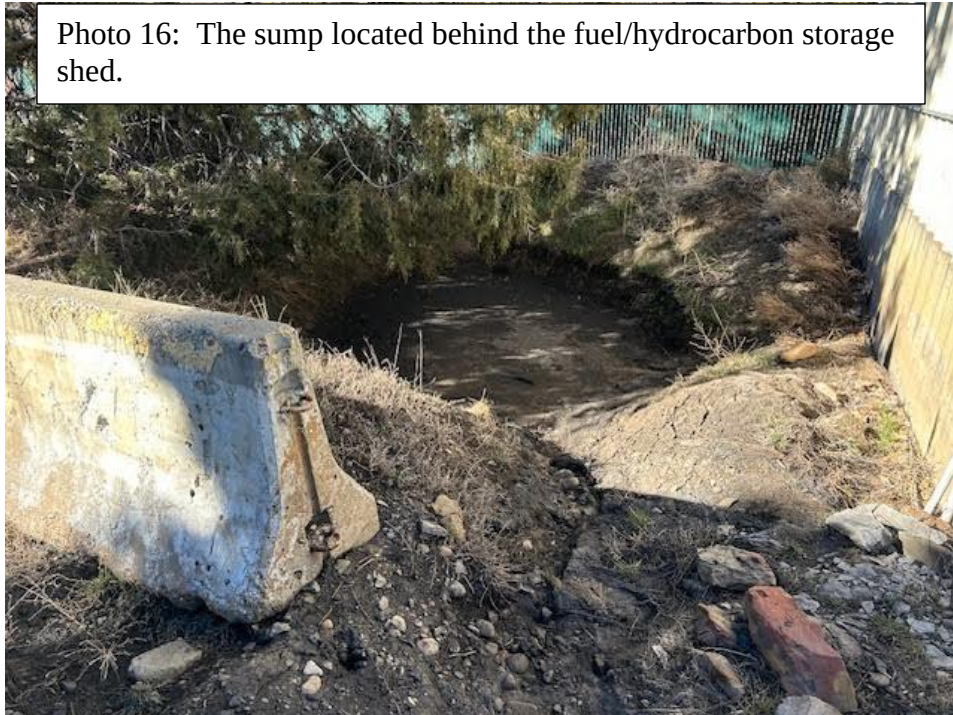
One sump is located on the east side of the hydrocarbons storage shed. The sump was muddy (Photo 16). There were no erosional concerns or indications of instability. The discharge outlet for the sump was clear of blockages.

Photo 16: The sump located behind the fuel/hydrocarbon storage shed.

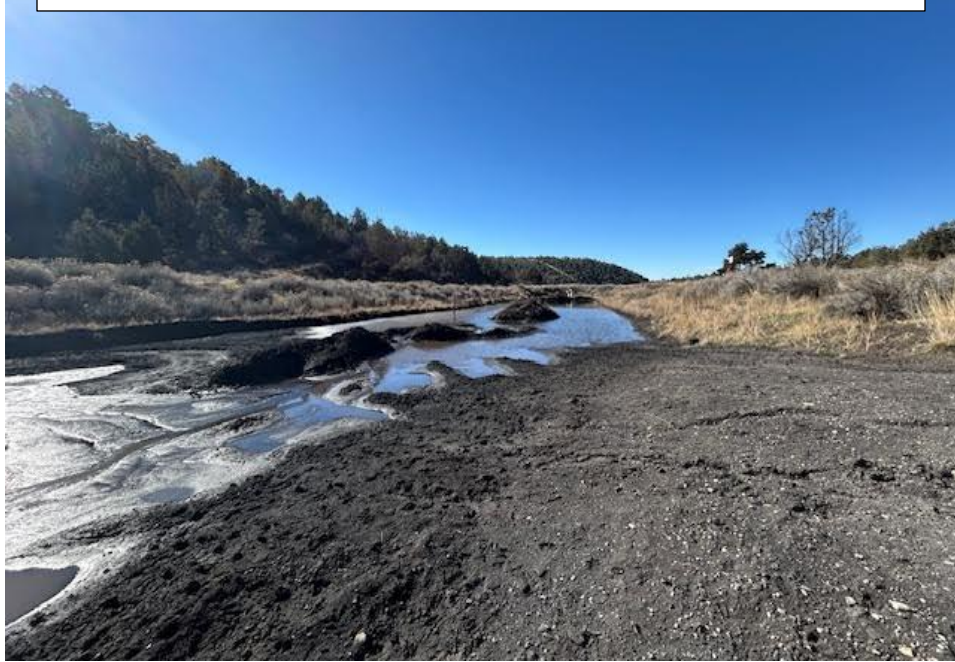
The sediment pond is located on the south end of the King II facilities. The sediment pond was holding water during the inspection (Photo 17). There was no discharge occurring. The discharge outlet was clear of debris. The embankment for the pond was stable with vegetative cover. There were no erosional concerns identified.

Photo 17: The sediment pond at the King II area.

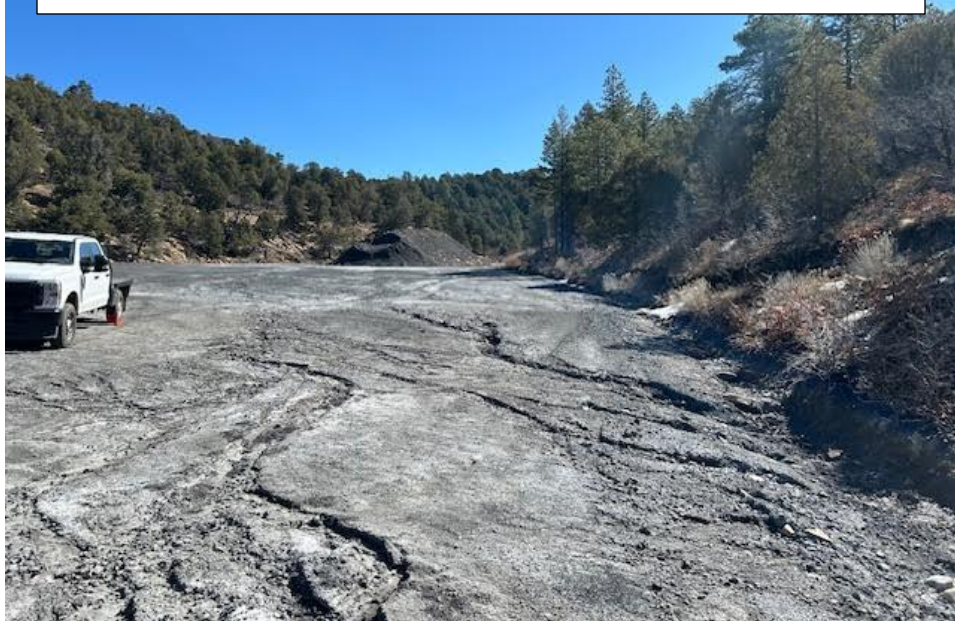
The coal waste piles are located at the King I facilities. The URDA was stable with minor rills observed on the north facing slope and top (Photo 18). These rills have been noted in previous Division inspections and do not impact the stability of the pile. The operator resurfaces the slope when the rills become too prevalent. No other erosional features were observed. A stockpile of refuse was seen on the southern end of the pile. The refuse material will be spread and compacted when springtime conditions allow. The LRDA was also stable during the

Photo 18: The top of the URDA with rills observed draining into the west drainage (Rach 10).

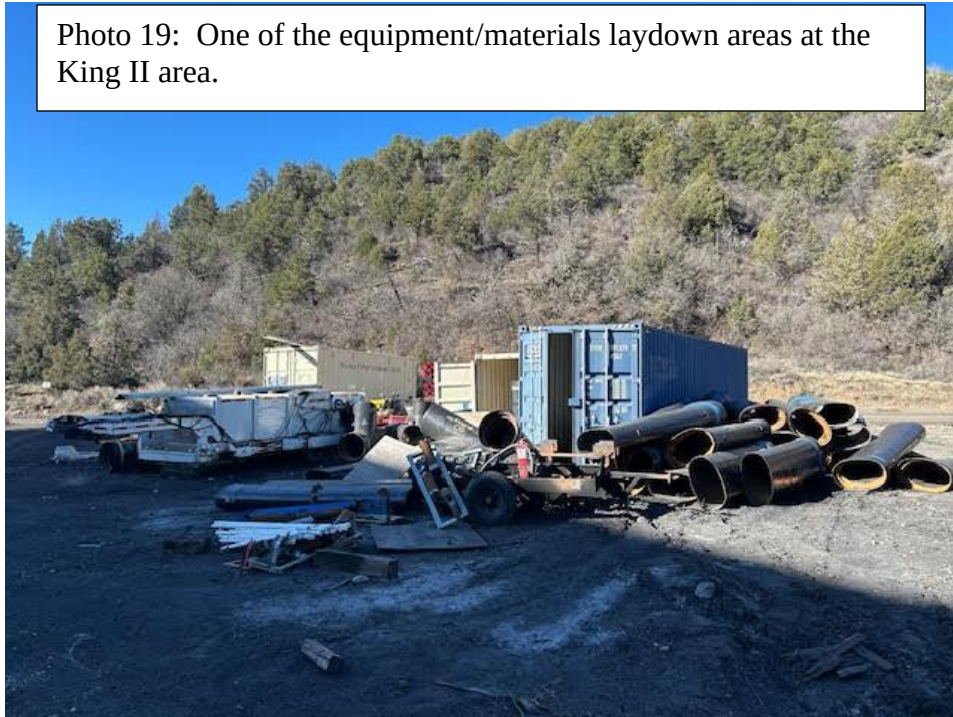
Photo 19: One of the equipment/materials laydown areas at the King II area.

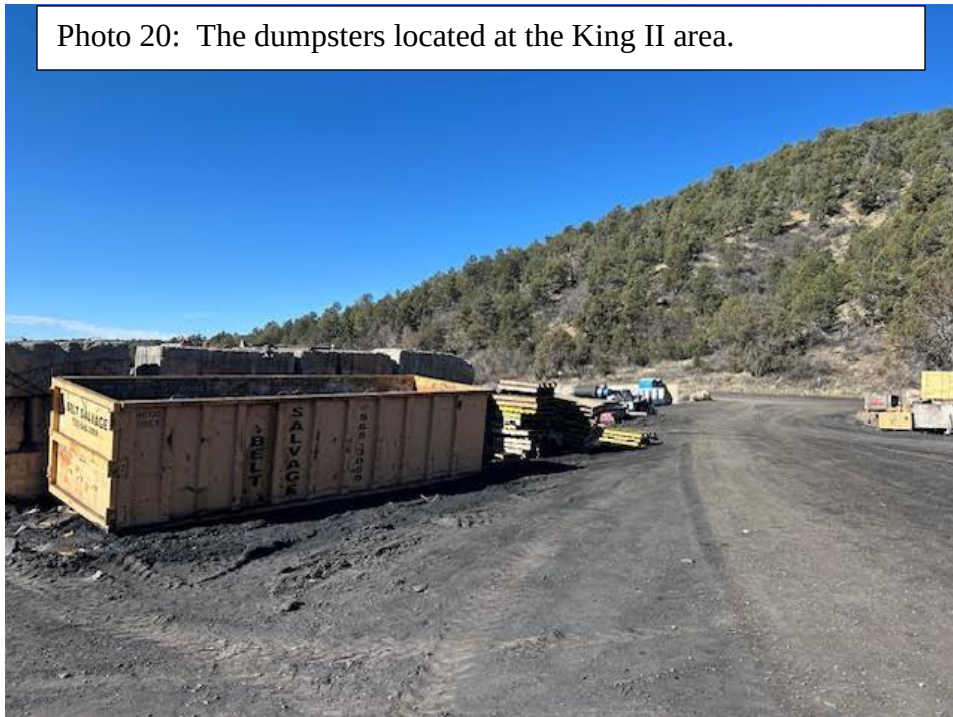
Photo 20: The dumpsters located at the King II area.

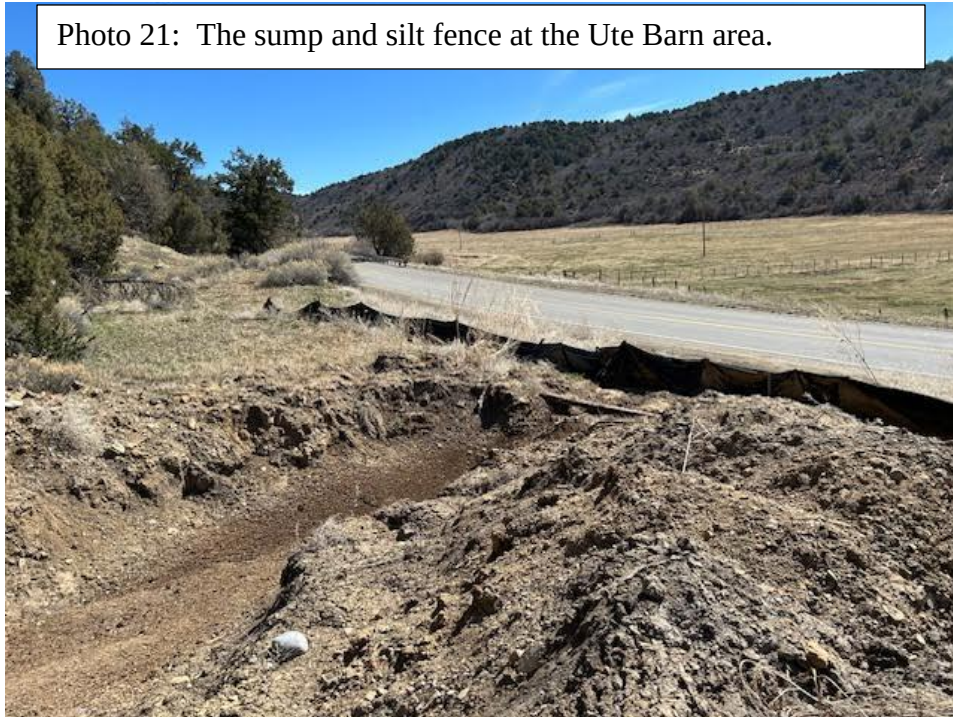
The Ute barn area was stable with no erosional concerns. The drainage ditch was clear of debris and sediment. The silt fence at the end of the sump was in good repair (Photo 21). No off-site impacts were observed.

Photo 21: The sump and silt fence at the Ute Barn area.

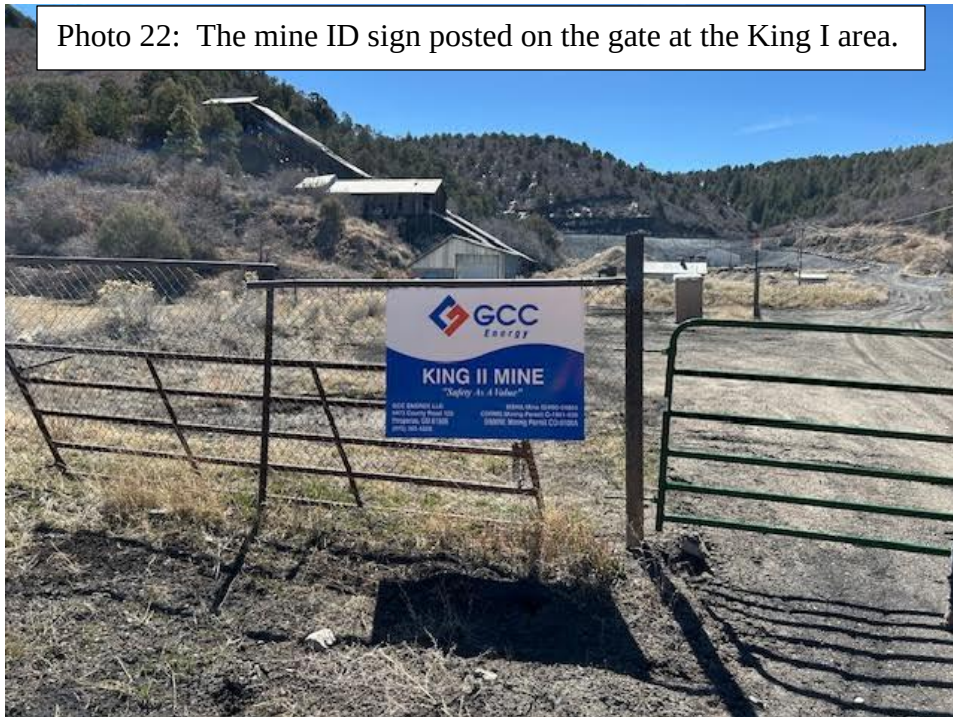
Mine identification signs were observed posted at the entrances to the King I and King II facilities from CR 120 (Photo 22). The signs displayed the permittee's name and address along with the Division's permit ID number. The signs were posted in easily identifiable locations.

Photo 22: The mine ID sign posted on the gate at the King I area.

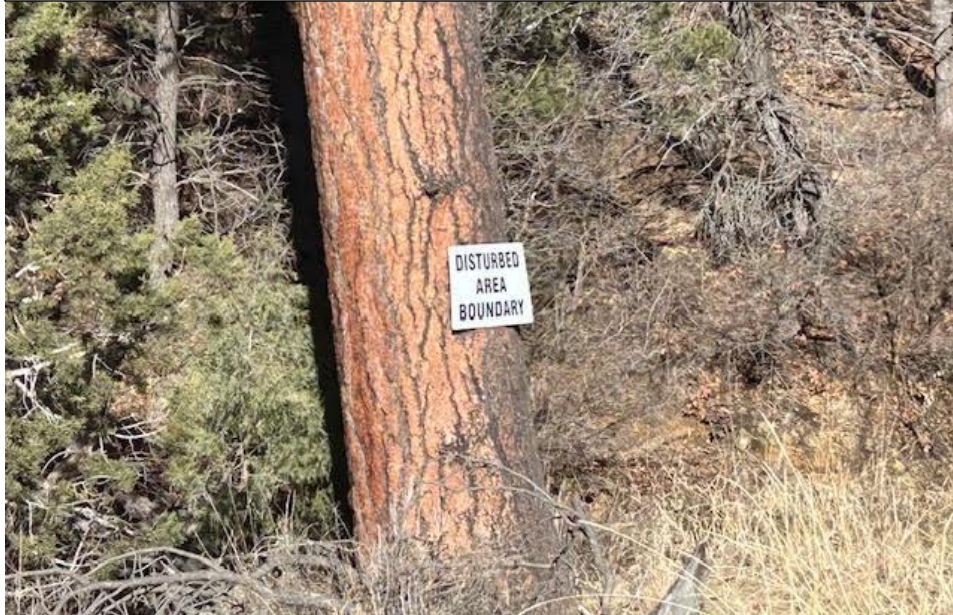
Affected/disturbed boundary markers were also observed to be posted (Photo 23). The signs were placed in locations easy to spot.

Photo 23: One of the disturbed boundary markers observed at the King II area.

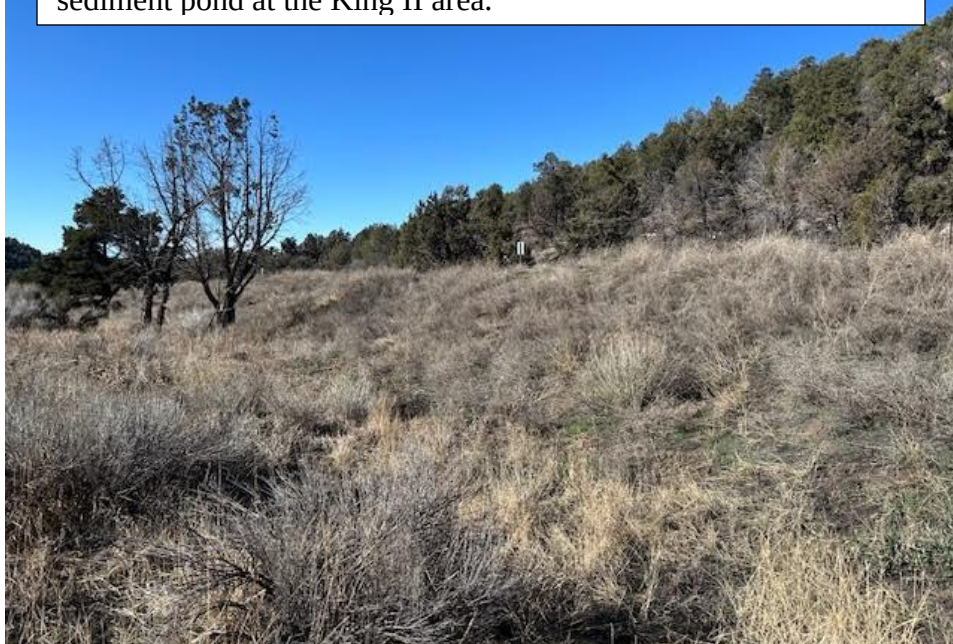
Topsoil stockpiles at the King II facilities were also found to be covered with vegetation. The piles were stable with no erosion identified (Photo 24). There was no loss of topsoil resource.

Photo 24. The topsoil stockpile located on the west side of the sediment pond at the King II area.
