MINERALS PROGRAM INSPECTION REPORT
PHONE: (303) 866-3567

MINE NAME: Climax Mine	MINE/PROSPECTING ID#: M-1977-493	MINERAL: Molybdenum	COUNTY: Lake, Summit
INSPECTION TYPE: Aerial Inspection	INSPECTOR(S): Dustin Czapl / Hunter Ridley	INSP. DATE: March 26, 2025	INSP. TIME: 10:00
OPERATOR: Climax Molybdenum Company	OPERATOR REPRESENTATIVE: NA	TYPE OF OPERATION: 112d-3 - Designated Mining Operation	
REASON FOR INSPECTION: Normal I&E Program	BOND CALCULATION TYPE: None	BOND AMOUNT: \$284,783,656.00	
DATE OF COMPLAINT: NA	POST INSP. CONTACTS: None	JOINT INSP. AGENCY: None	
WEATHER: Clear	INSPECTOR'S SIGNATURE:

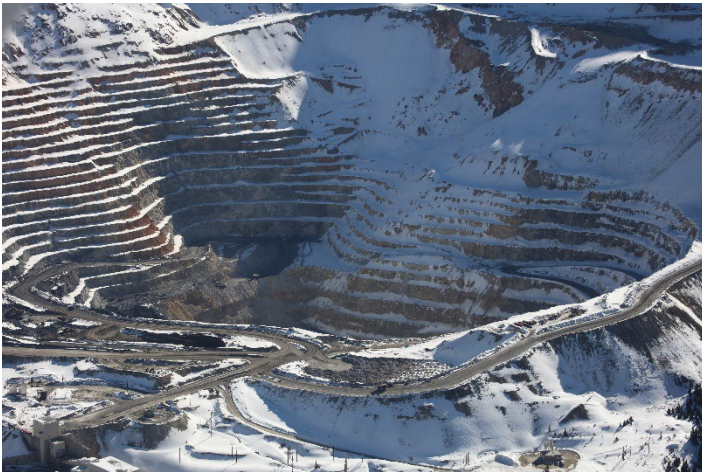
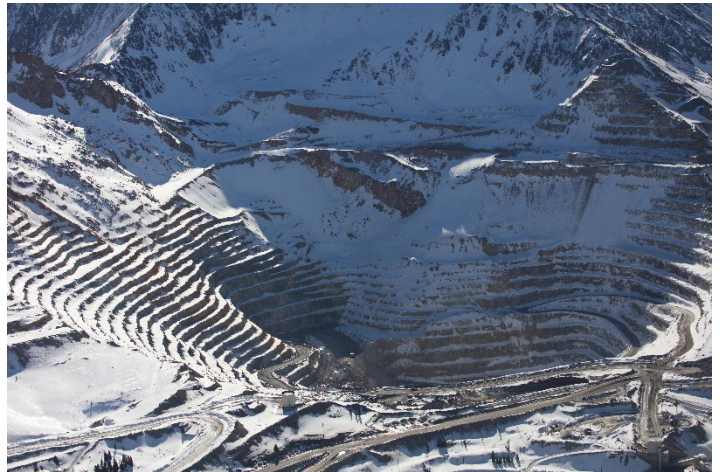
The Pit area was observed. Operations appear to be occurring according to approved plans. No problems were noted.

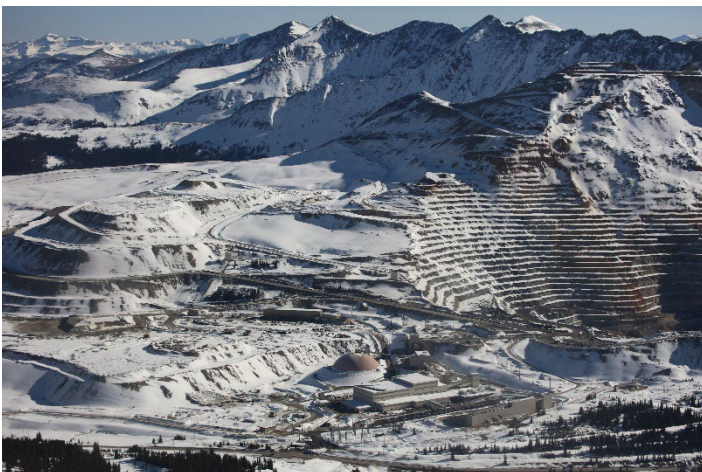
North 40 and McNulty OSF

The North 40 and McNulty OSF's were observed. No abnormal conditions were noted. OSF's appear to be functioning within the established design criteria.

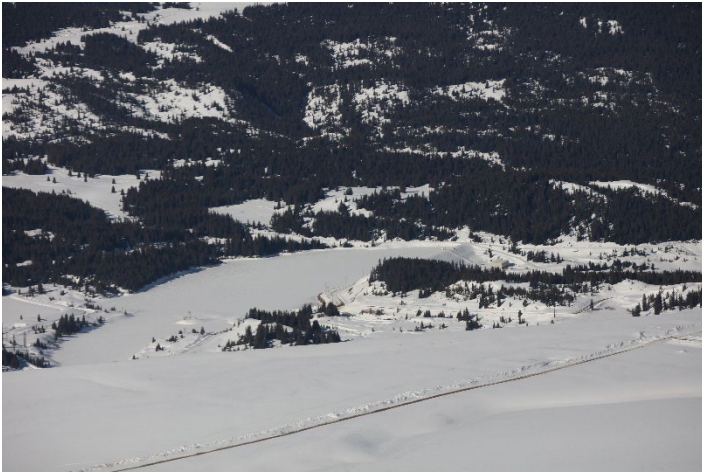
Robinson Lake/1 Dam

The Mayflower TSF and 5 Dam, Tenmile TSF and 3 Dam, Robinson TSF and 1 and 2 Dams, Robinson Lake, Eagle Park Reservoir and 4 Dam were observed. No abnormal conditions were noted. TSF's appear to be functioning within the established design criteria.
