MINERALS PROGRAM INSPECTION REPORT
PHONE: (303) 866-3567

MINE NAME: Colona Gravel Pit	MINE/PROSPECTING ID#: M-1994-005	MINERAL: Sand and gravel	COUNTY: Montrose
INSPECTION TYPE: Monitoring	WEATHER: Clear	INSP. DATE: April 2, 2025	INSP. TIME: 10:30
OPERATOR: Oldcastle SW Group, Inc. dba United Companies of Mesa County	OPERATOR REPRESENTATIVE:	TYPE OF OPERATION: 112c - Construction Regular Operation	
REASON FOR INSPECTION: Normal I&E Program	BOND CALCULATION TYPE: Complete Bond	BOND AMOUNT: \$165,351.00	
DATE OF COMPLAINT: NA	POST INSP. CONTACTS: None	JOINT INSP. AGENCY: None	
INSPECTOR(S): Dustin Czapla	INSPECTOR'S SIGNATURE:

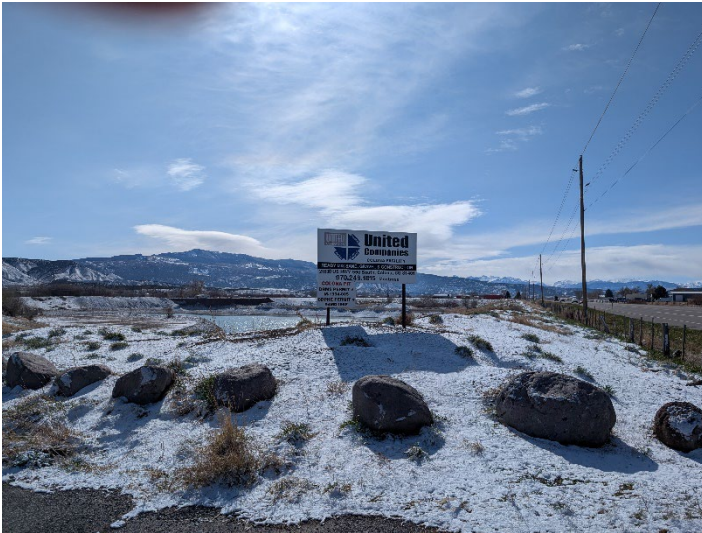
Adequate mine identification signage was noted at the entrance to the site.

Mine id at site entrance

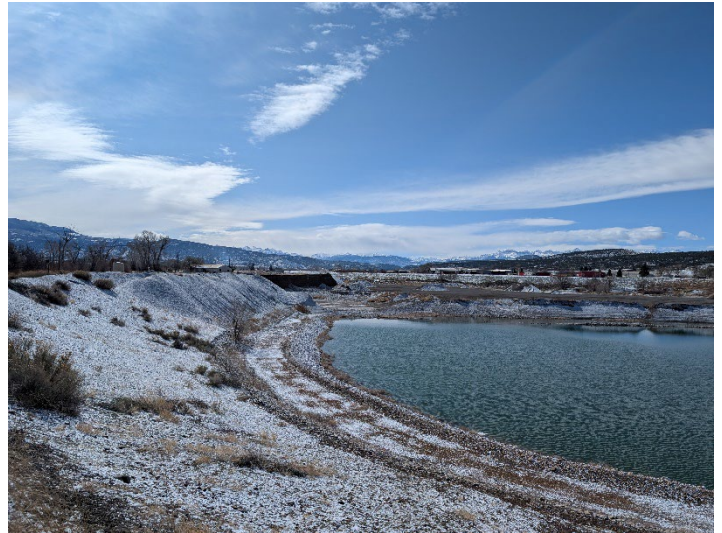
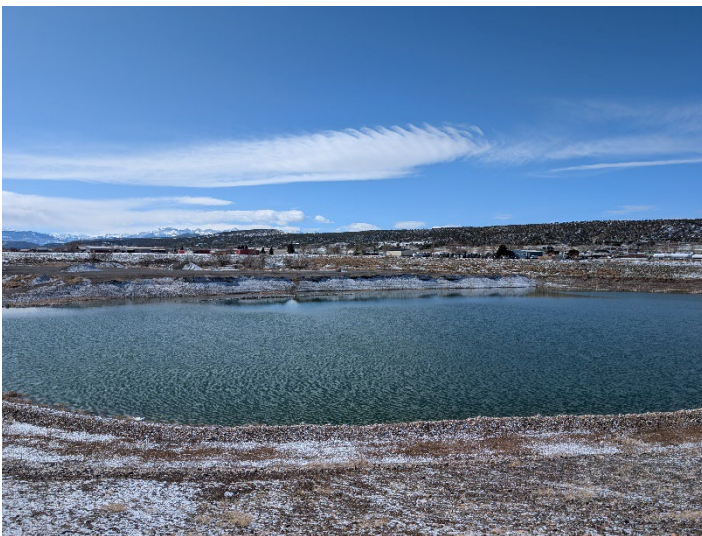
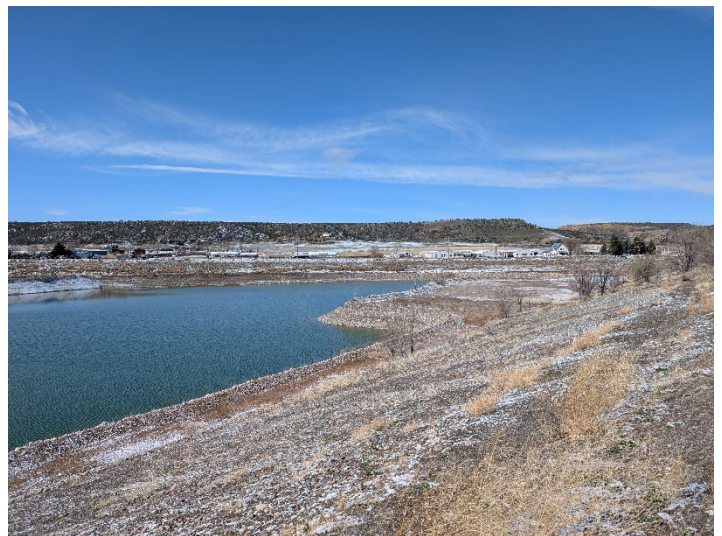
View from northeast side of pit

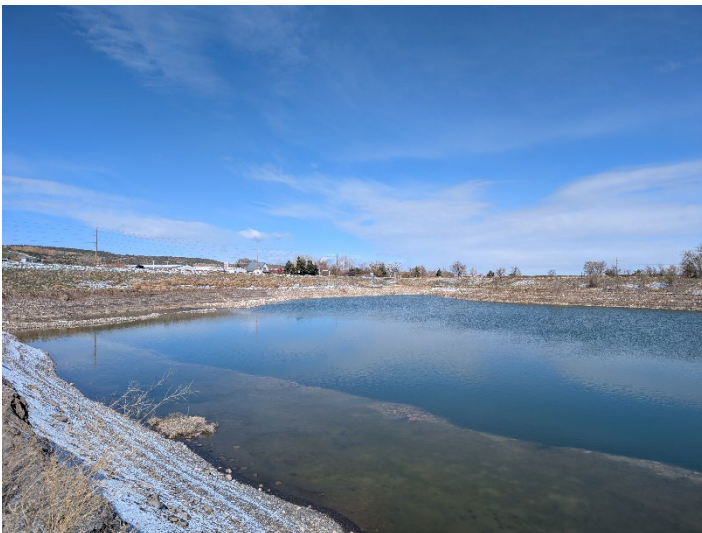
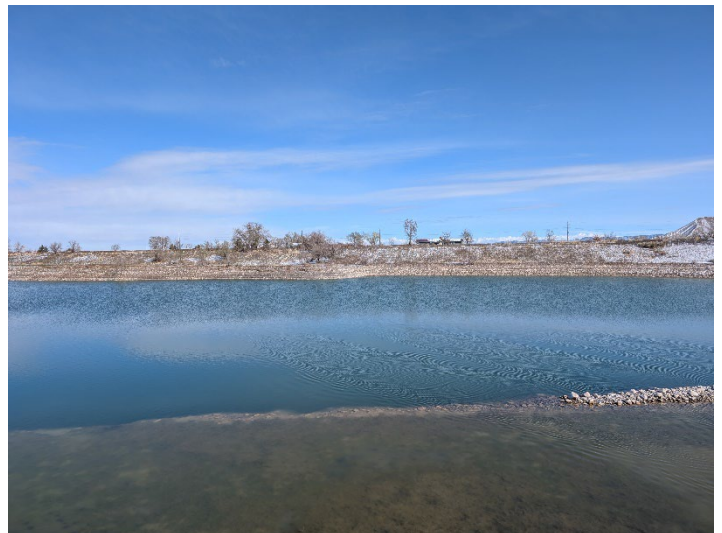
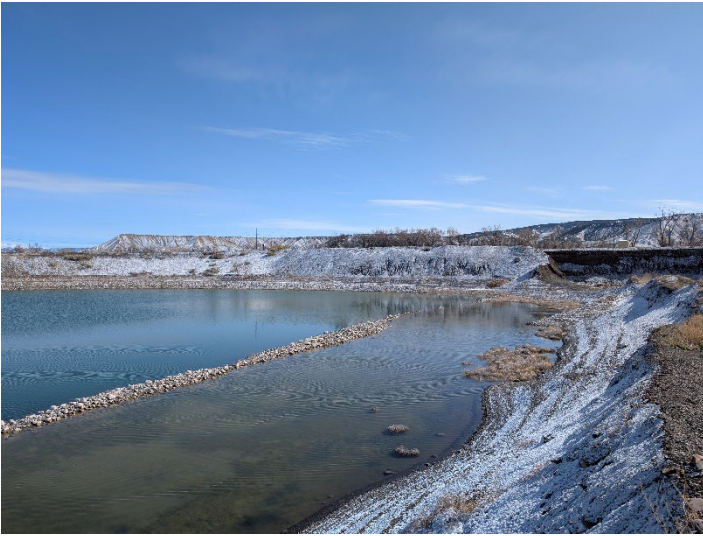
View from south side of pit

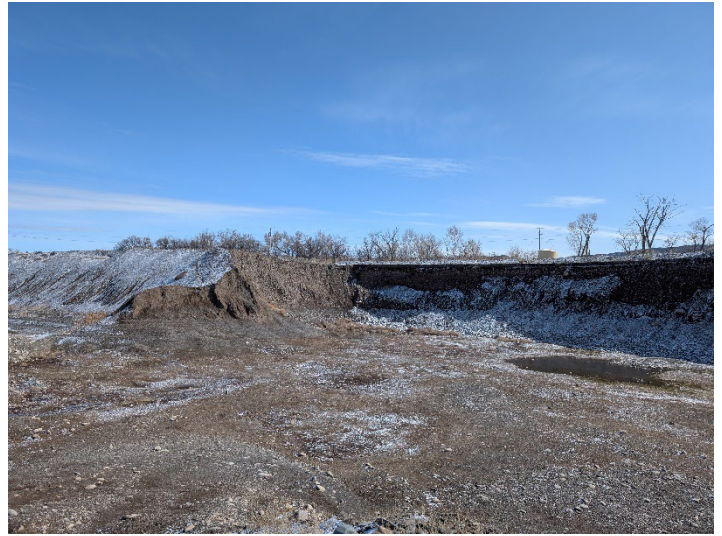
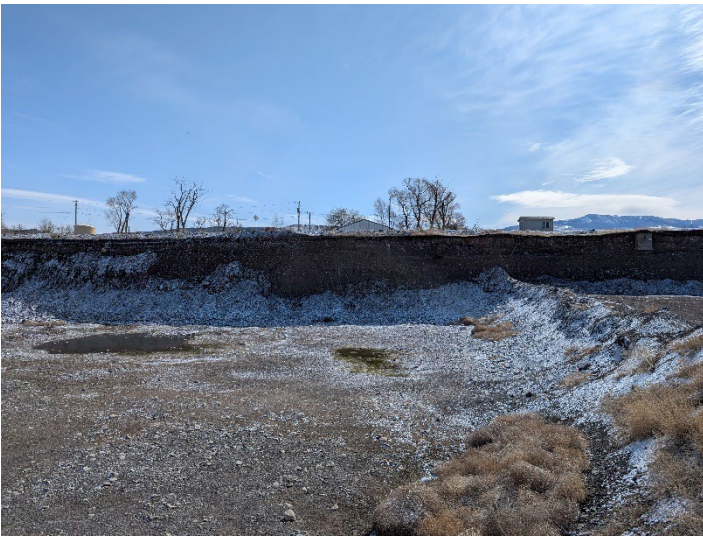
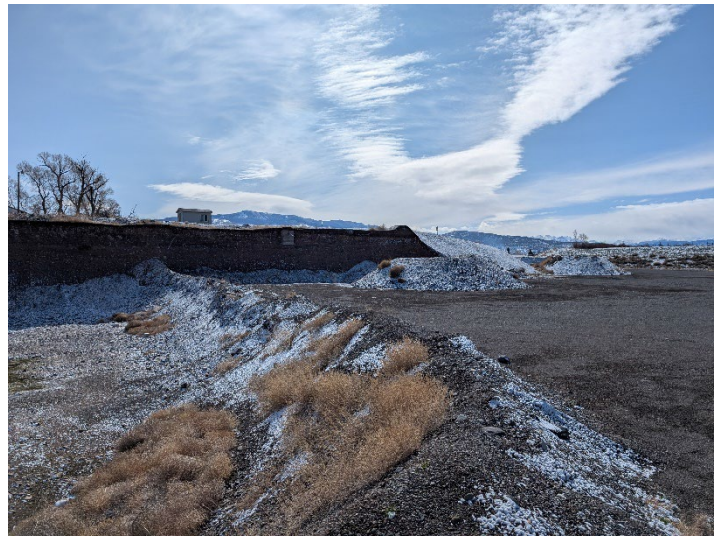
Mining is occurring in the Phase 2 and 3 areas. There is a pond in the Phase 2 area which covers approximately 7.5 acres. The Phase 3 pit area is still above ground water level. Slopes on the west and north sides of the pit have been graded to 3H:1V and are well vegetated. A near vertical highwall exists in the current mining area on the east side of the Phase 3 pit.

Current mining area in east side of Phase 3

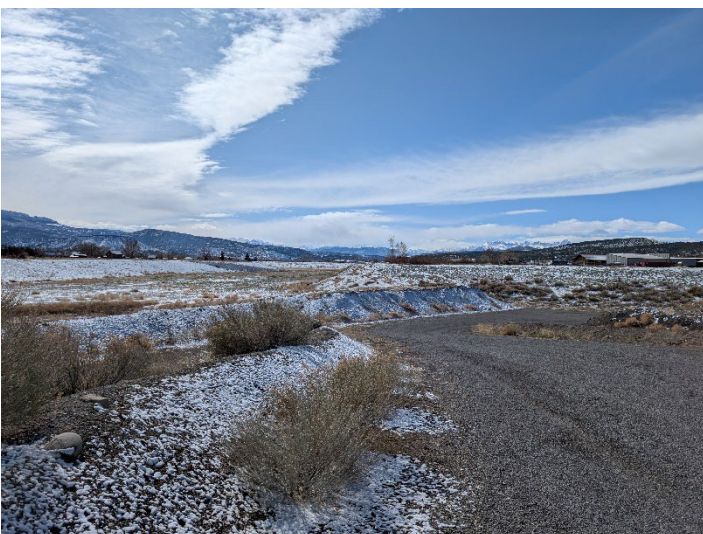
Topsoil stockpiled along southern permit boundary

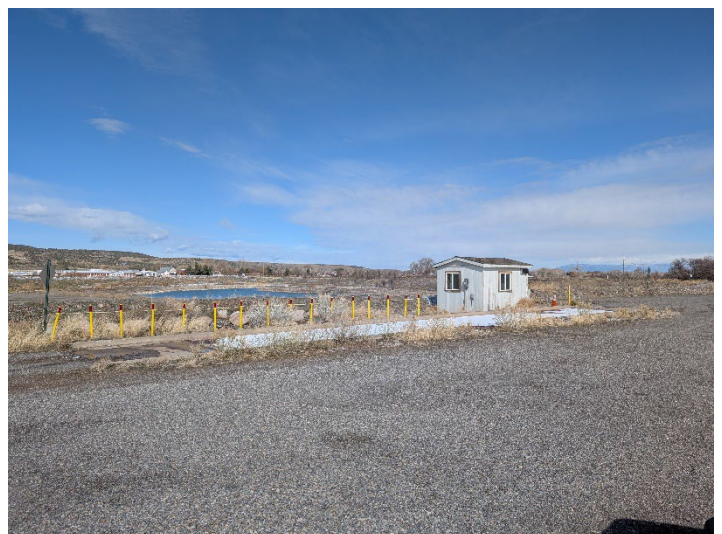
Scale on east side of pit
