**MINERALS PROGRAM INSPECTION REPORT**  
**PHONE: (303) 866-3567**

<b>MINE NAME:</b> Gray Pit #2	<b>MINE/PROSPECTING ID#:</b> M-2005-012	<b>MINERAL:</b> Sand and gravel	<b>COUNTY:</b> Montrose
<b>INSPECTION TYPE:</b> Monitoring	<b>WEATHER:</b> Clear	<b>INSP. DATE:</b> April 2, 2025	<b>INSP. TIME:</b> 12:30
<b>OPERATOR:</b> Lewis Energy Lands, L.L.C.	<b>OPERATOR REPRESENTATIVE:</b> Aaron Brack	<b>TYPE OF OPERATION:</b> 112c - Construction Regular Operation	
<b>REASON FOR INSPECTION:</b> Normal I&E Program	<b>BOND CALCULATION TYPE:</b> None	<b>BOND AMOUNT:</b> \$29,770.00	
<b>DATE OF COMPLAINT:</b> NA	<b>POST INSP. CONTACTS:</b> None	<b>JOINT INSP. AGENCY:</b> None	
<b>INSPECTOR(S):</b> Dustin Czapla	<b>INSPECTOR'S SIGNATURE:</b>

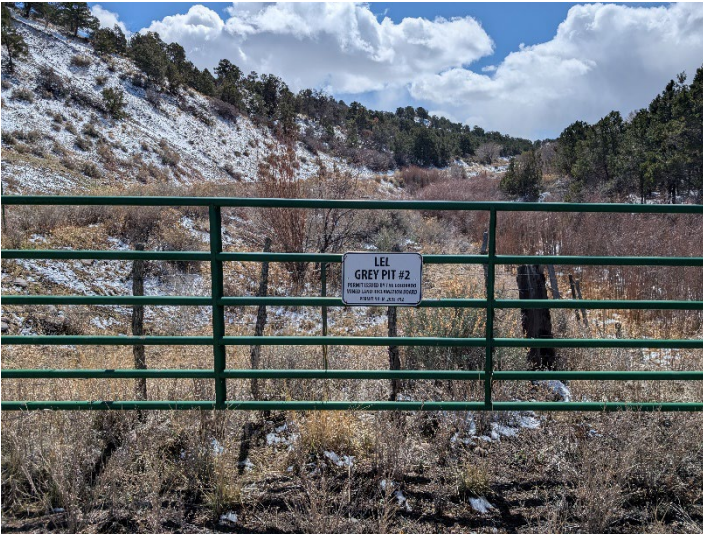
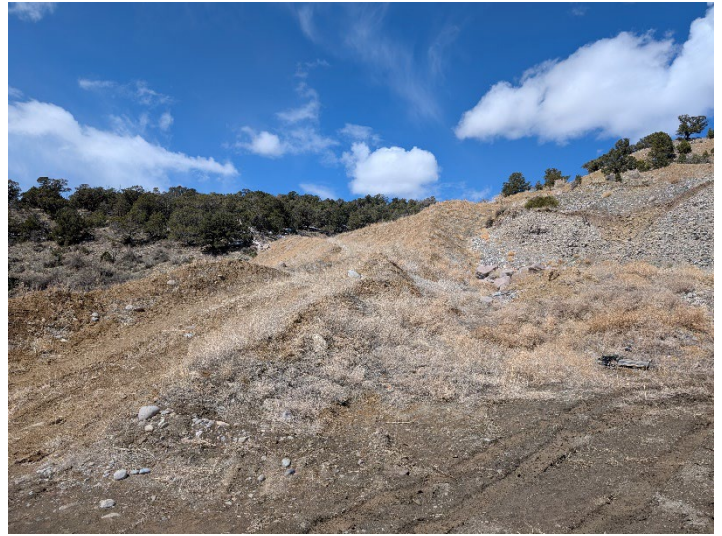
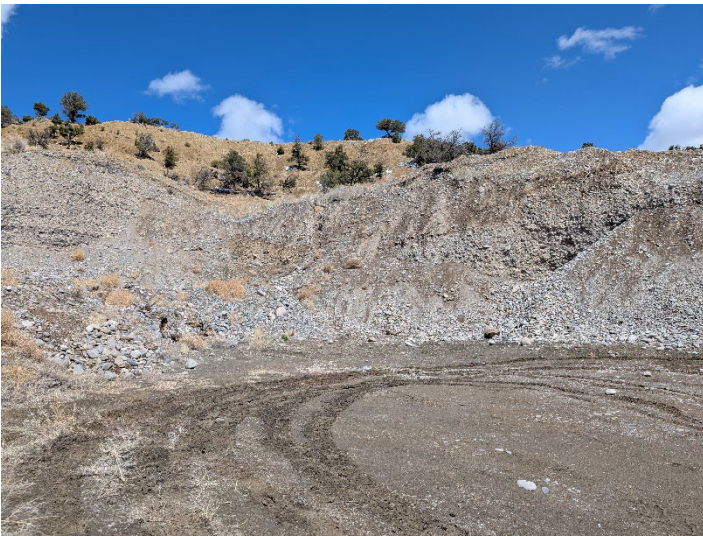
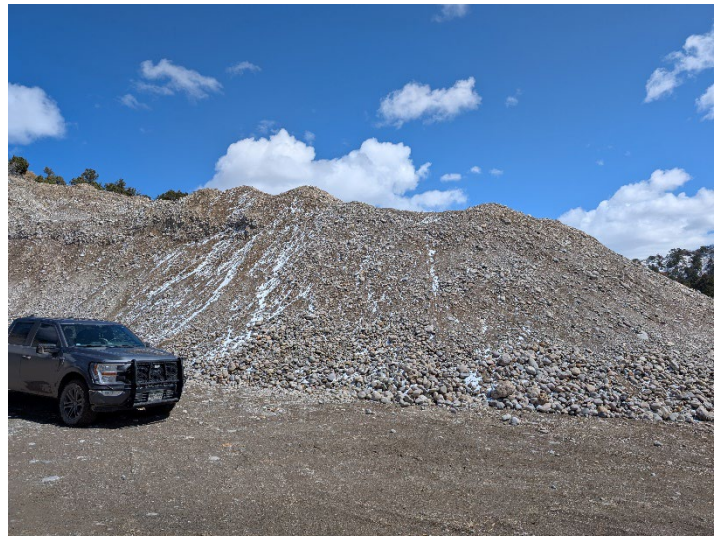
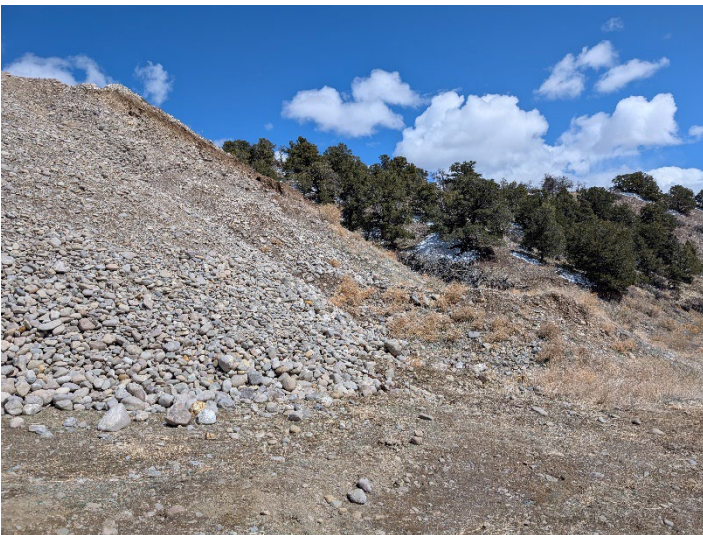
Mining was not active during this inspection. No evidence of recent mining activity was noted. The current mining area covers approximately two acres. A near vertical highwall approximately 20 feet high and spanning approximately 200 feet has been created. No stability issues were noted. No stormwater or erosion control issues were noted. Limited overburden and topsoil have been pushed to the south side above the current mining area. No materials stockpiles were observed. There was no mining equipment on site.
