### MINERALS PROGRAM INSPECTION REPORT

<b>MINE NAME:</b> South D-20 Pit	<b>MINE/PROSPECTING ID#:</b> M-1992-102	<b>MINERAL:</b> Sand and gravel	<b>COUNTY:</b> Montrose
<b>INSPECTION TYPE:</b> Monitoring	<b>WEATHER:</b> Clear	<b>INSP. DATE:</b> April 2, 2025	<b>INSP. TIME:</b> 11:00
<b>OPERATOR:</b> The Uncompahgre Valley Water Users Association	<b>OPERATOR REPRESENTATIVE:</b> Steve Pope	<b>TYPE OF OPERATION:</b> 112c - Construction Regular Operation

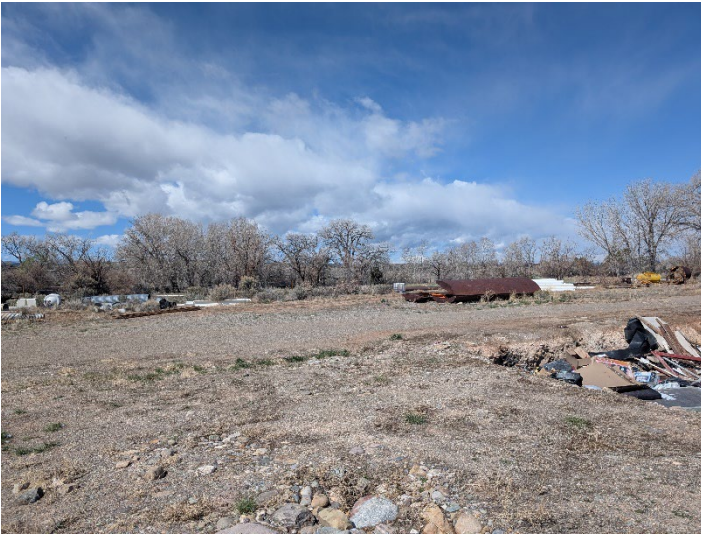
**PROBLEM/POSSIBLE VIOLATION:** Problem: The mine identification sign was not posted at the entrance of the mine site. This is a problem for failure to post a mine identification sign as required by Section 3.1.12(1) of the rule. The Operator shall, at the entrance of the mine site post a sign, which shall be clearly visible from the access road, with a minimum size equaling one hundred and eighty-seven (187) square inches, such as eleven (11) inches in height and seventeen (17) inches in width, with appropriate font size, with the following: the name of the Operator, a statement that a reclamation permit for the operation has been issued by the Colorado Mined Land Reclamation Board; and the permit number.

Adequate mine identification signage was not noted at the entrance to the site. This was noted as a problem on Page 1 of this report.

**CORRECTIVE ACTIONS:** The operator shall, at the entrance of the mine site, post a sign which shall be clearly visible from the access road with the following: the name of the operator, a statement that a reclamation permit for the operation has been issued by the Colorado Mined Land Reclamation Board; and the permit number. The operator shall submit photo documentation that a proper sign has been posted by the corrective action date.
