Western Water & Land, Inc.

April 8, 2025

RE: Notice of Reclamation Completion: Van 4 Mine Permit No. M-1997-032

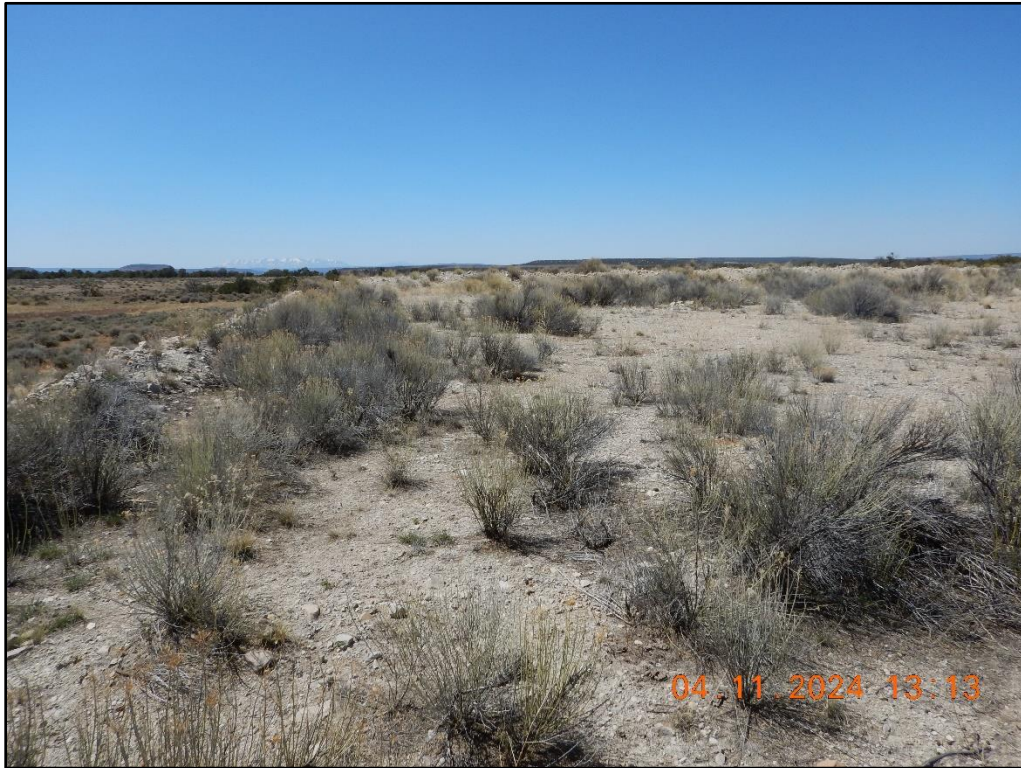
Photo 1. Prereclamation top of waste rock area with natural vegetation.

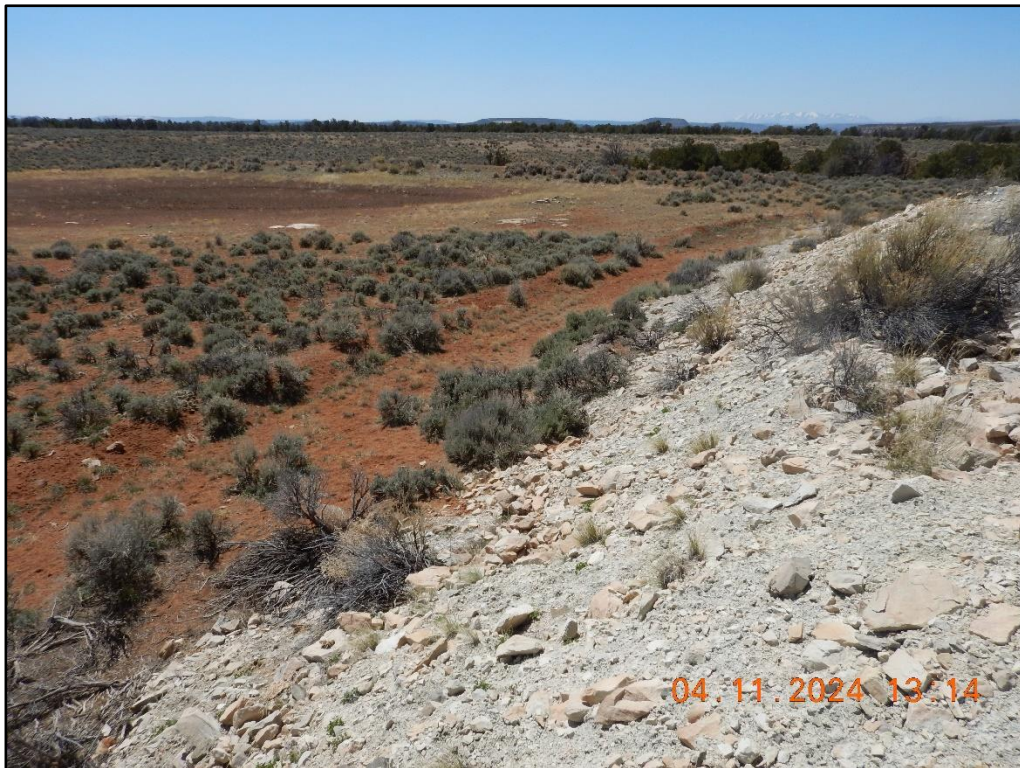
Photo 2. Prereclamation terminal slope of waste rock area with runoff swale at toe.

Regrading of the waste rock area also began on January 13th. Regrading of the affected land initially focused on the waste rock area where terminal slopes were regraded to slopes equal to or gentler than three feet horizontal to one-foot vertical (3 to 1). The reclamation plan specified that the historical shallow runoff swale at the west and south toe of the waste rock area remain in place.

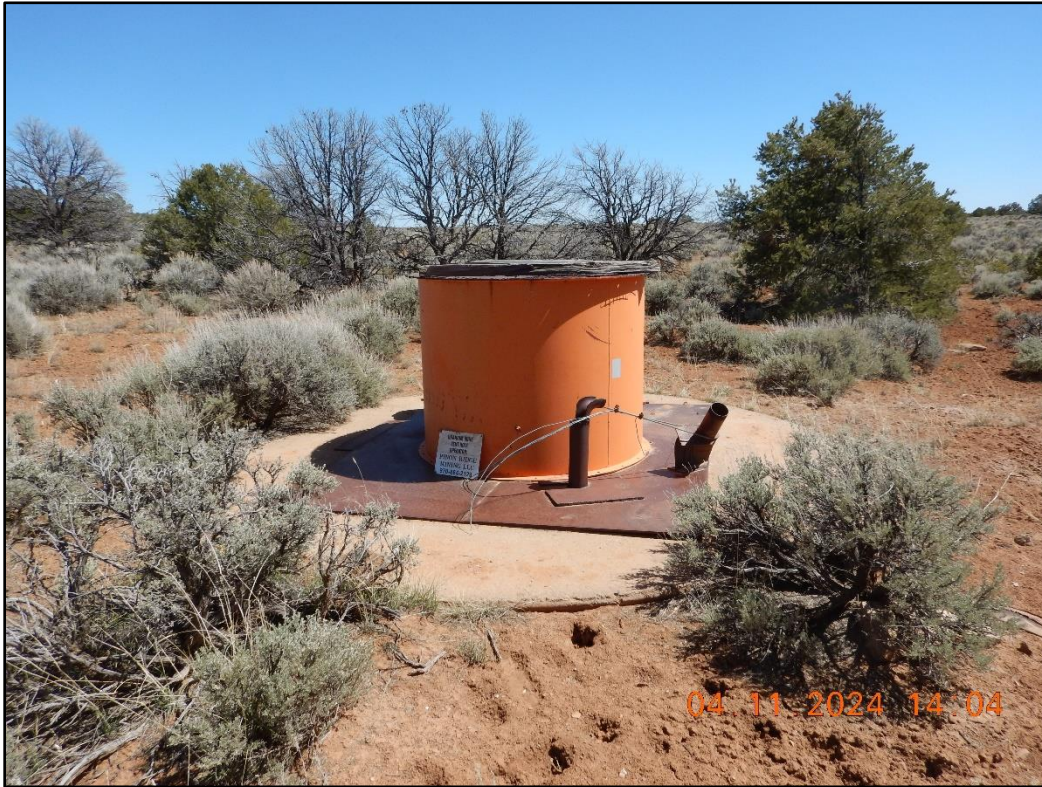
Photo 3. Prereclamation Vent Shaft.

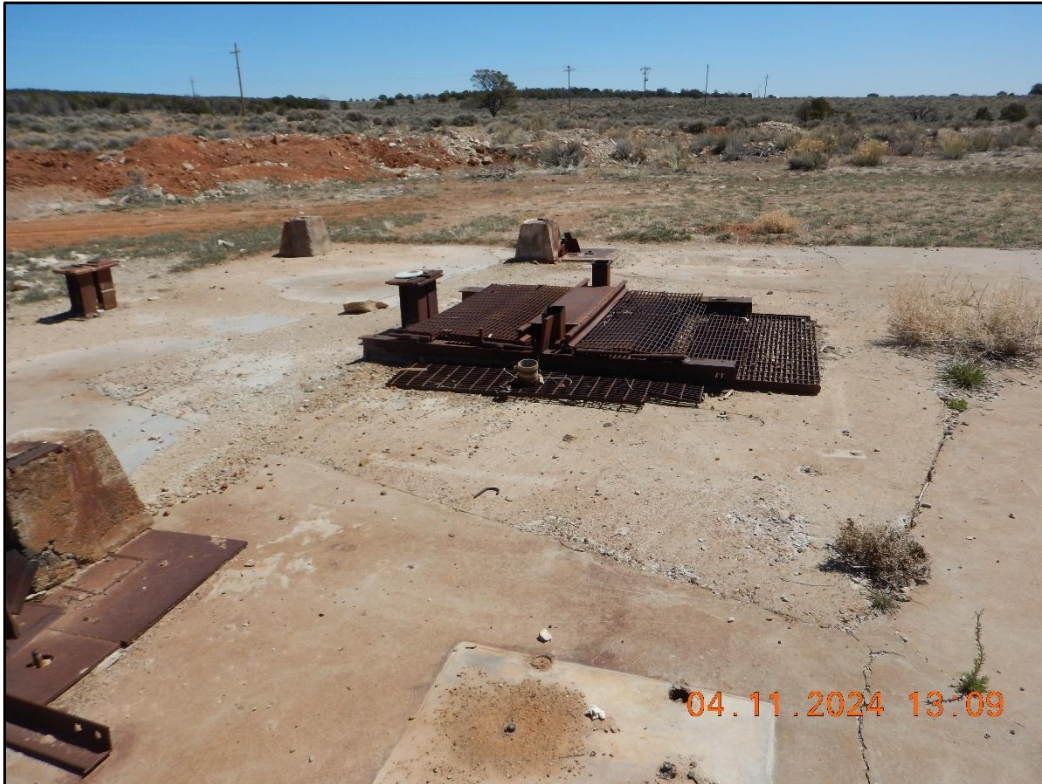
Photo 4. Prereclamation Production Shaft and pad.

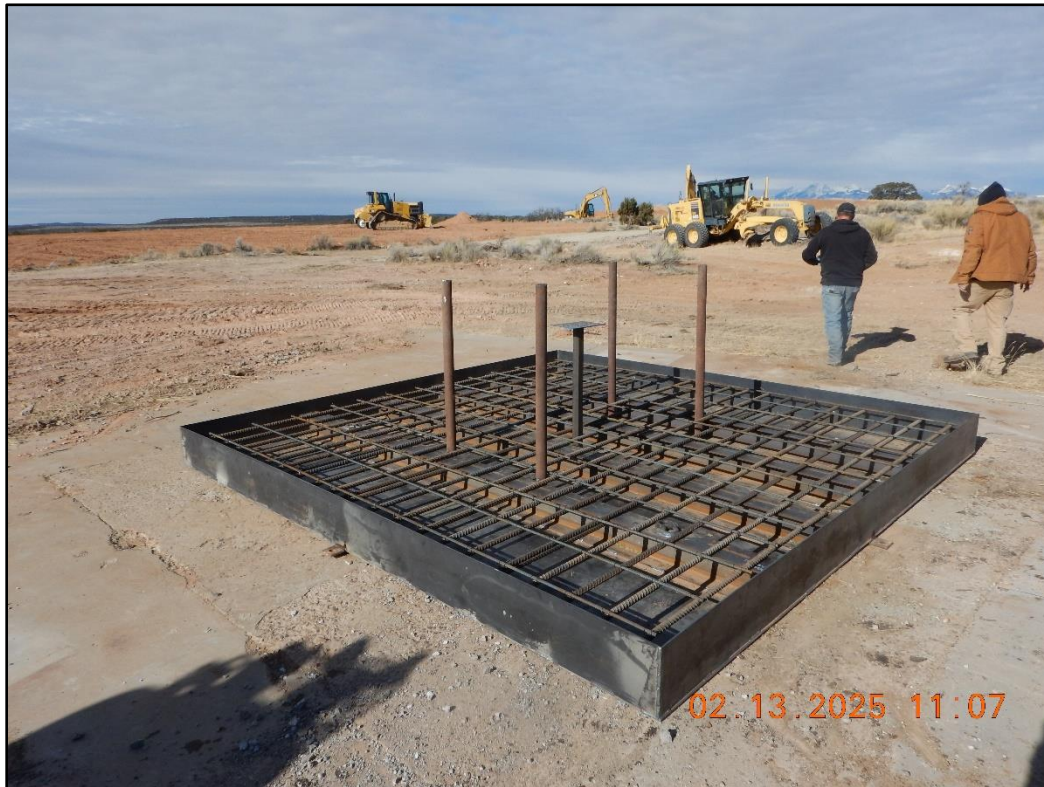
Photo 5. Steel beam structural cap and form at Production Shaft.

Shaft cap closure was conducted on February 13th, 2025. Both the Production Shaft and Vent Shaft locations were sealed as specified in the closure design presented in TR No. 1. The design allowed in-place cap construction directly on top of the concrete shaft collars which were measured to be least 2-feet thick. Shaft cap construction specifications followed DRMS-approved Standard Drawing No. 3 – Concrete Shaft Closure. Topsoil cover at the shaft locations was constructed to be a minimum of four-feet thick.

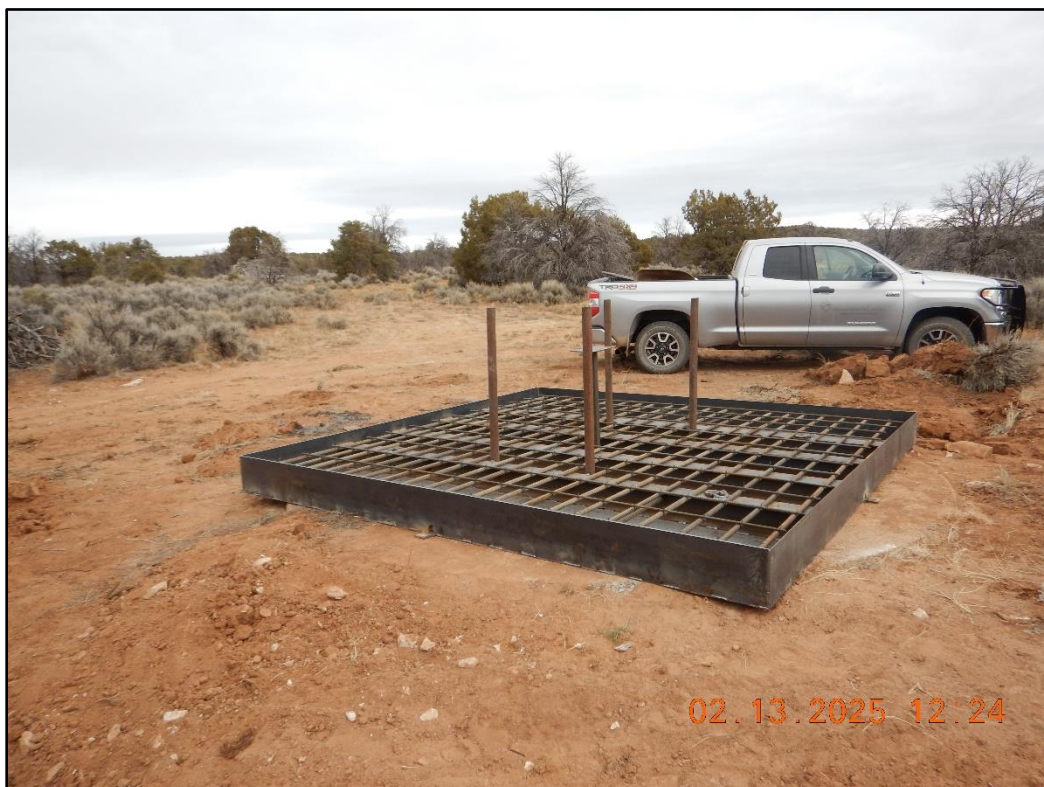
Photo 6. Steel beam structural cap and form at Vent Shaft.

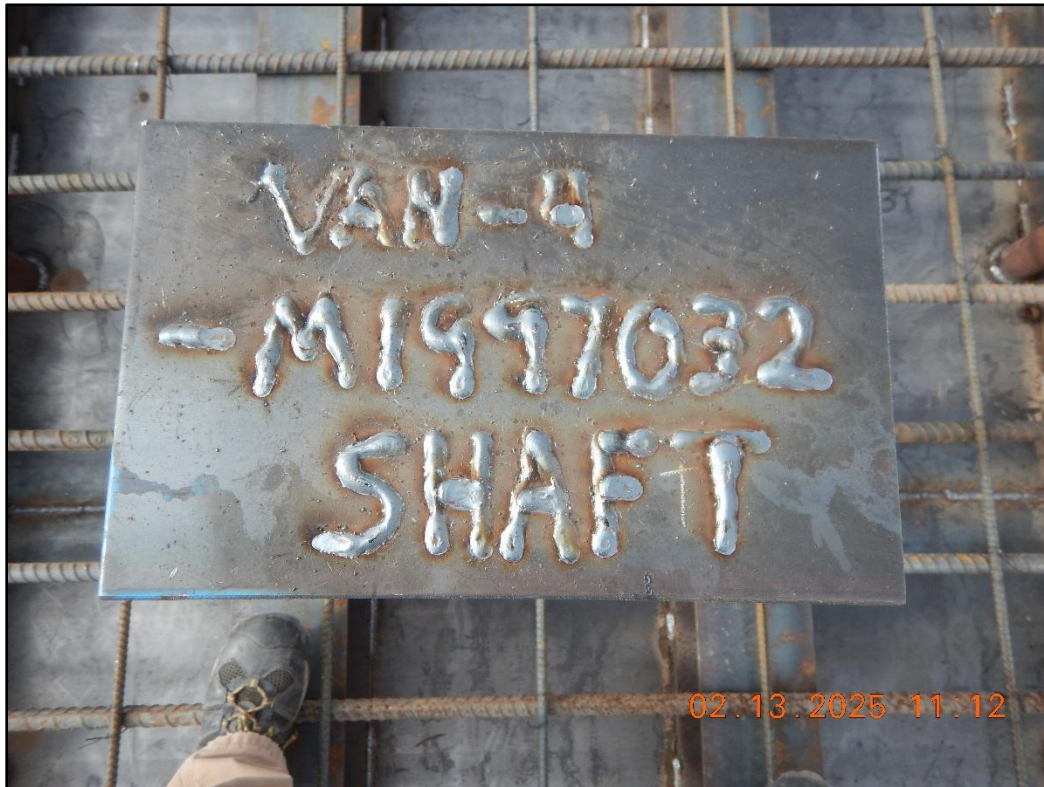
Photo 7. Production Shaft identification plate on cap cover.

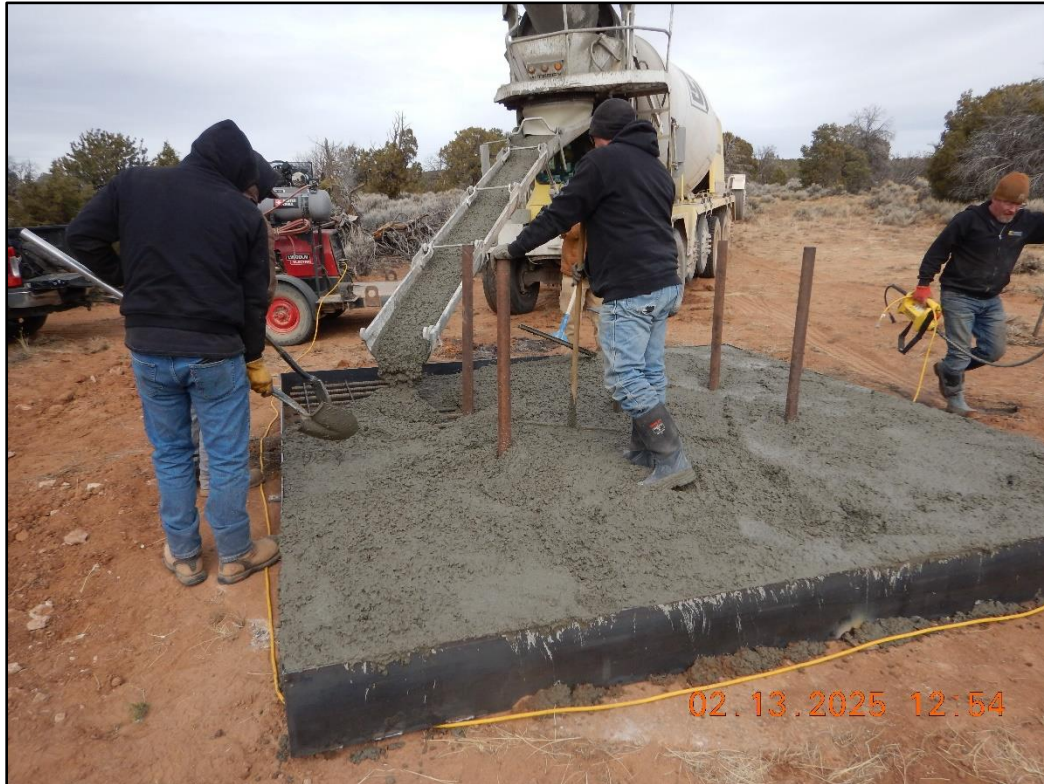
Photo 8. Cement pour at Vent Shaft cap cover.

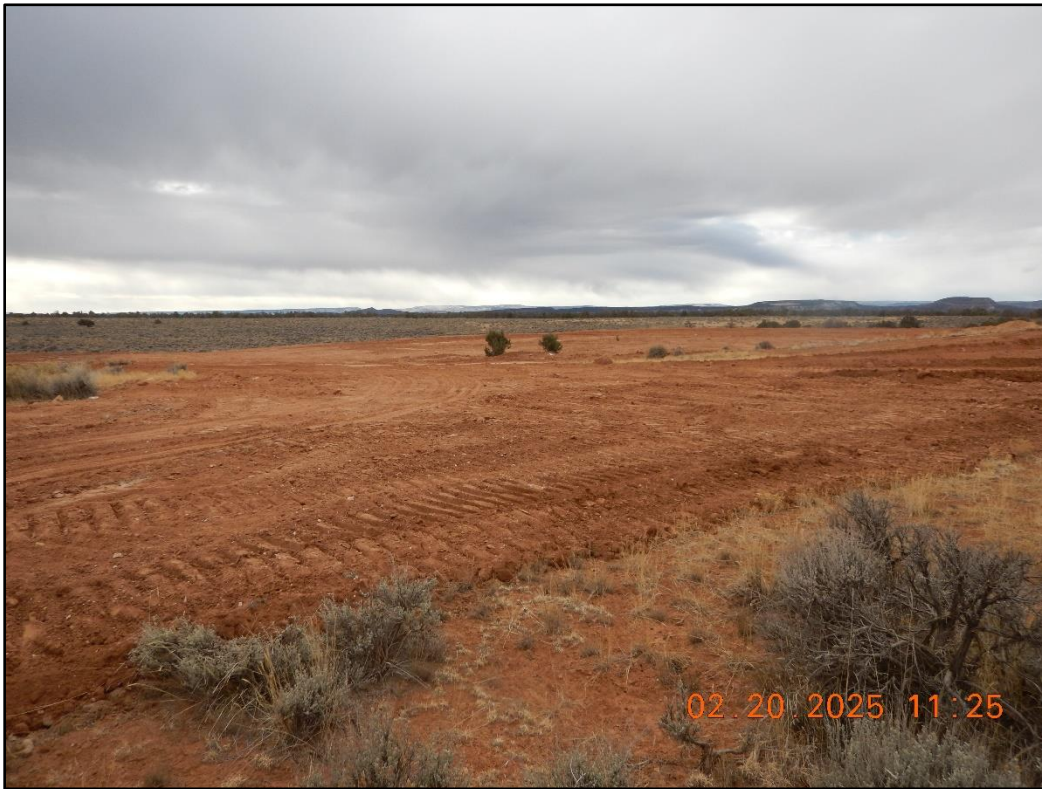
Photo 11. Topsoil cover at waste rock area.

By early February, most regrading work was completed and topsoil placement was underway. Topsoil was burrowed from the large onsite topsoil storage area and spread over the affected area at minimum depths of 6-inches. The topsoil storage area contained an adequate volume of material to cover all affected acreage.

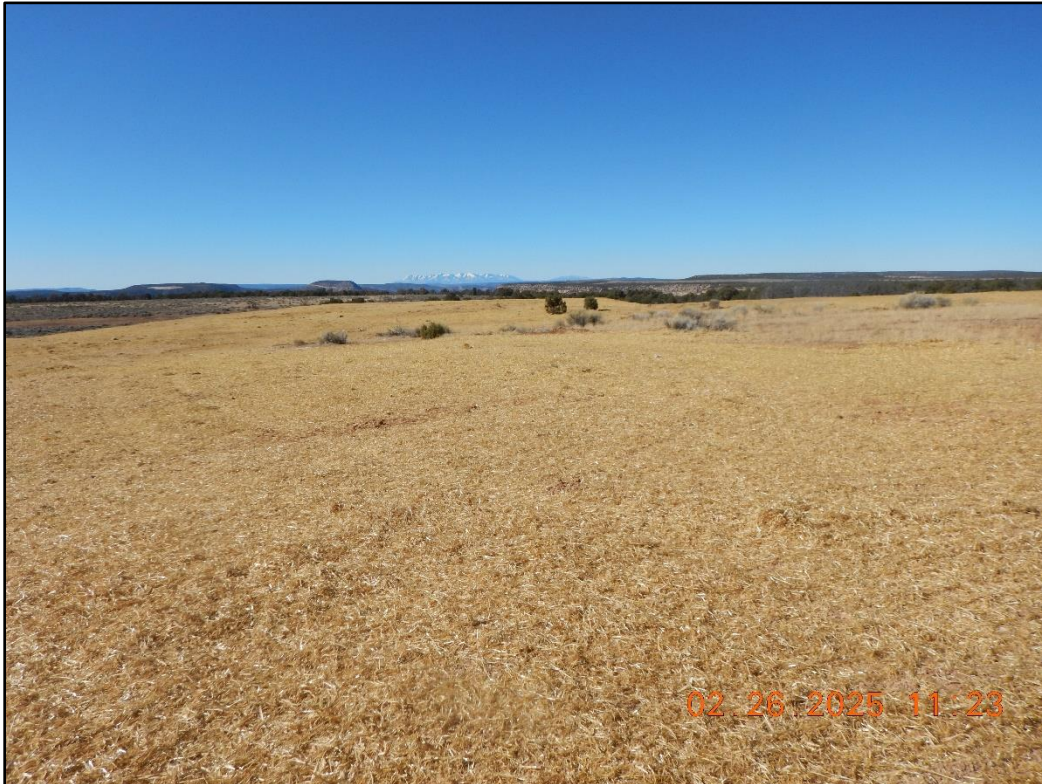
Photo 12. Crimped certified weed-free straw at waste rock area.

Revegetation work began on February 24 and was completed on February 26th. Revegetation work was conducted by Horizon Environmental, based in Durango, Colorado. A high percentage of the seeding work was conducted using a drill seeding method. Broadcast seeding method was used at the shaft areas and few other small areas. Certified weed-free straw was applied with a power mulch spreader at a rate of 2,000 pounds per acre. A crimping implement was used to crimp the straw into the topsoil. Please see TR No. 1 for the reclamation seed mix as specified by the U.S. BLM.
