MINERALS PROGRAM INSPECTION REPORT
PHONE: (303) 866-3567

| MINE NAME: Midwestern Farms | MINE/PROSPECTING ID#: M-1993-059 | MINERAL: Sand and gravel | COUNTY: Prowers |
| INSPECTION TYPE: Surety Release Inspection | WEATHER: Clear | INSP. DATE: April 9, 2025 | INSP. TIME: 12:40 |

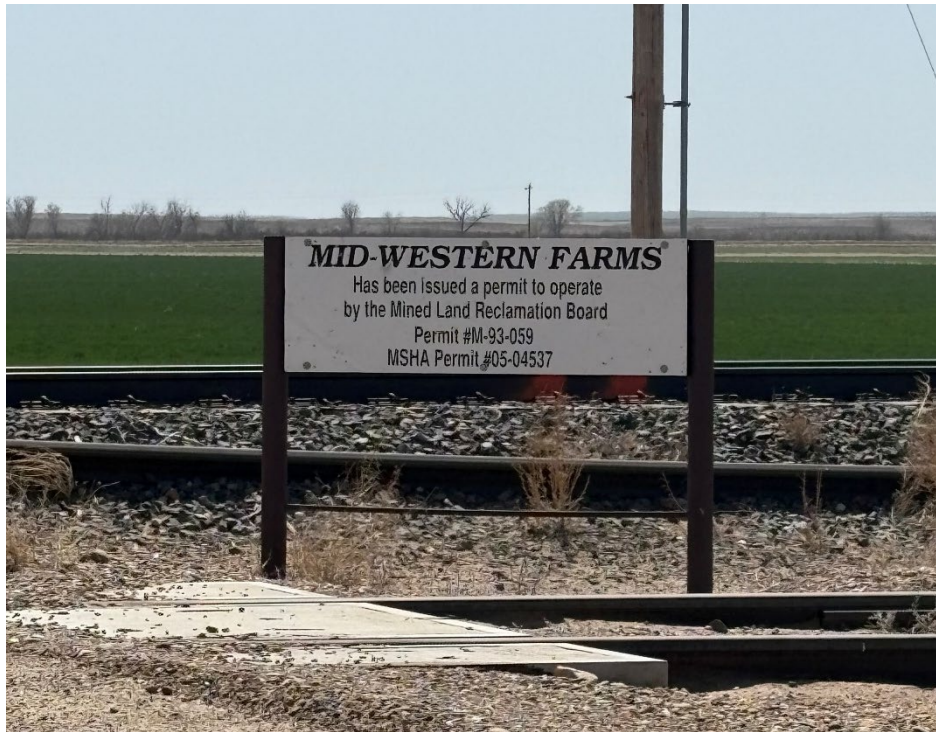
Photo 1. Mine identification entrance sign, facing south.

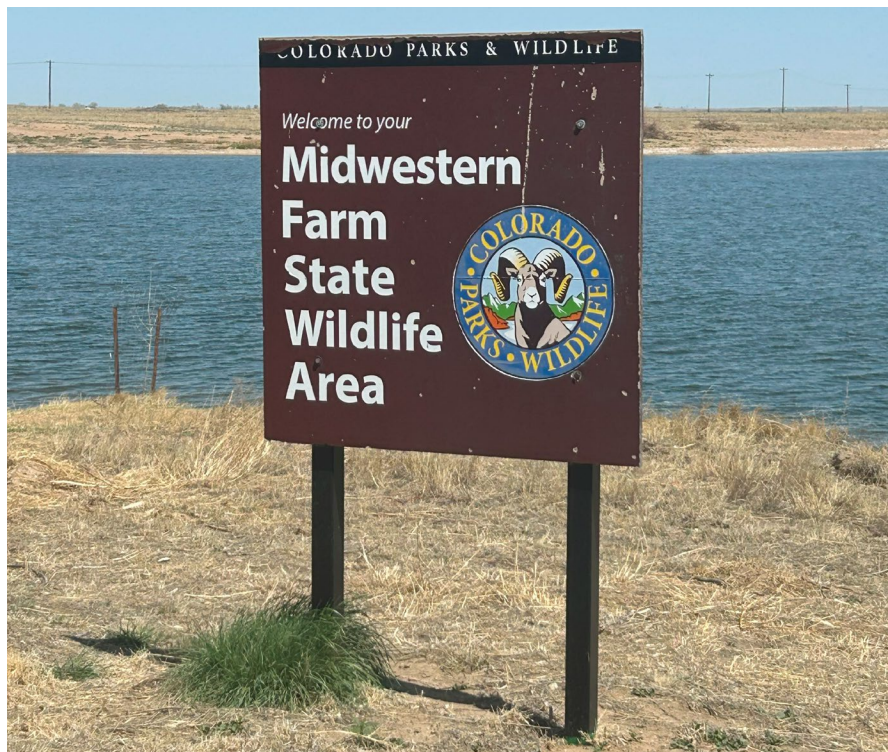
Photo 2. CPW Wildlife Area sign, facing east.

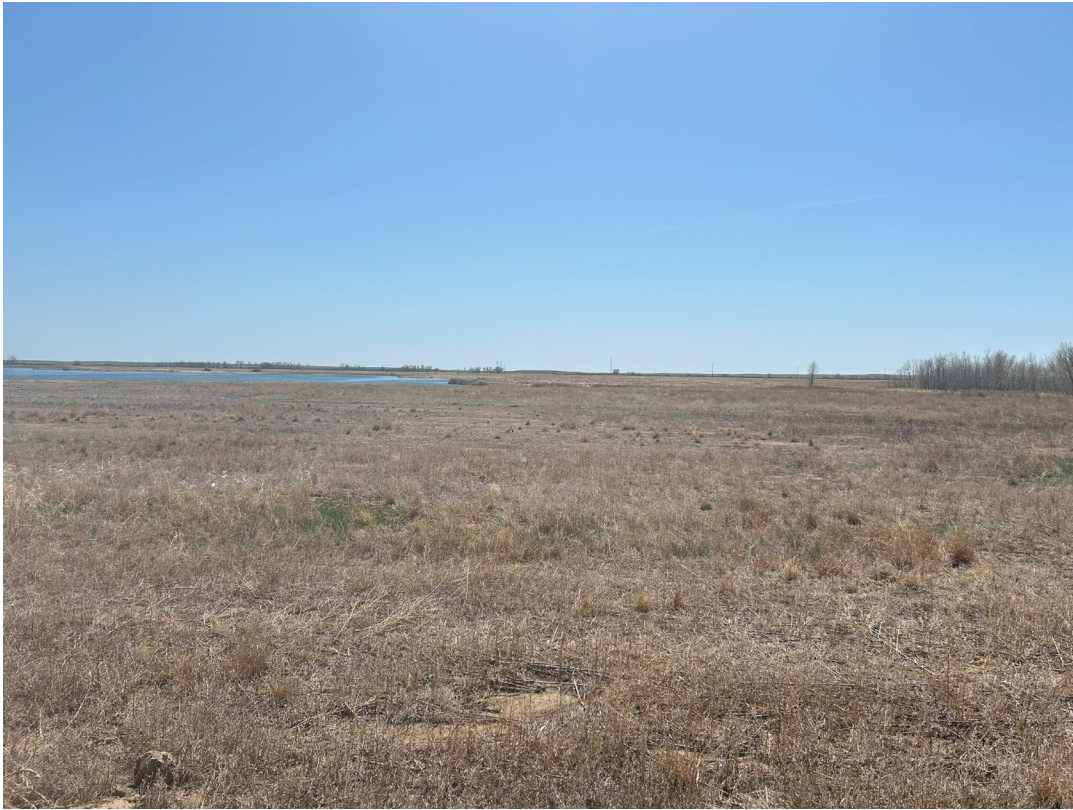
At the time of the inspection, the weather was warm and sunny. Mr. Marriott (CPW) discussed how the site was reseeded with a native seed mixture appropriate for the local area, and that CPW was very satisfied with the regrowth at the site. Vegetation throughout the site was well established, particularly in the northwestern area of the site where the 2024 inspection noted large bare ground areas.

Photo 3. Facing south, revegetation in the northern portion of the site.

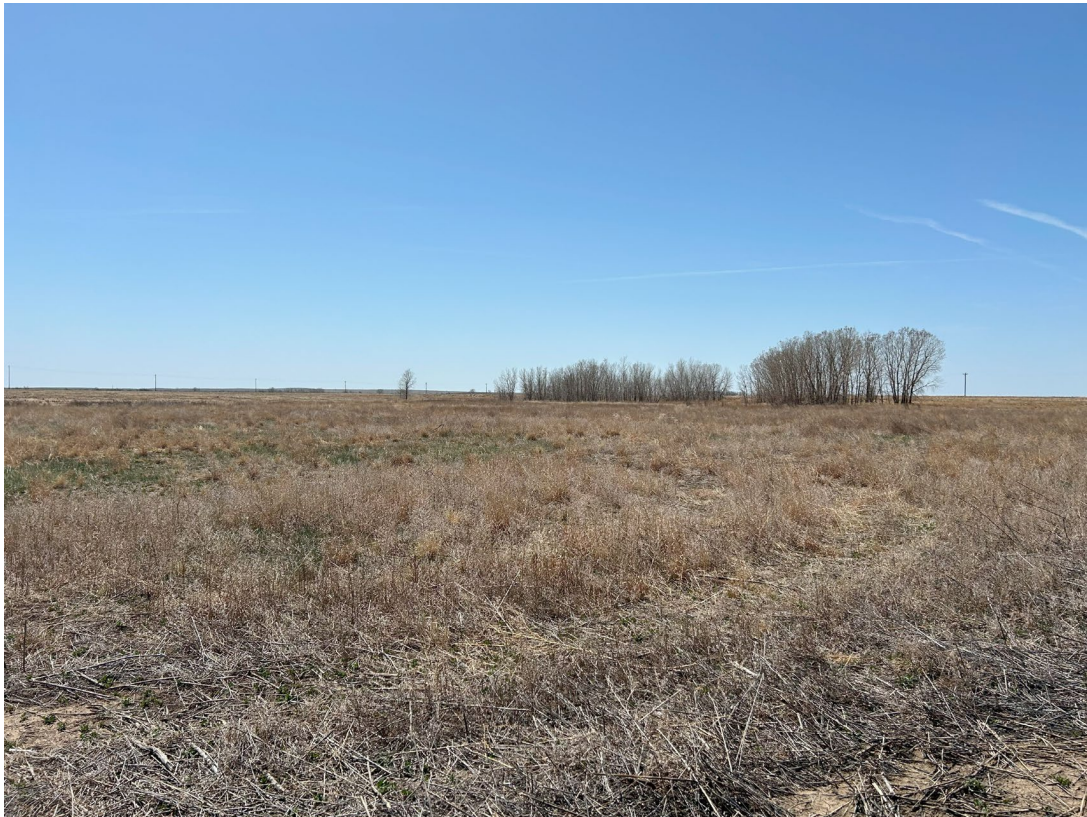
Photo 4. Revegetation in the northern portion of the site, facing southwest.

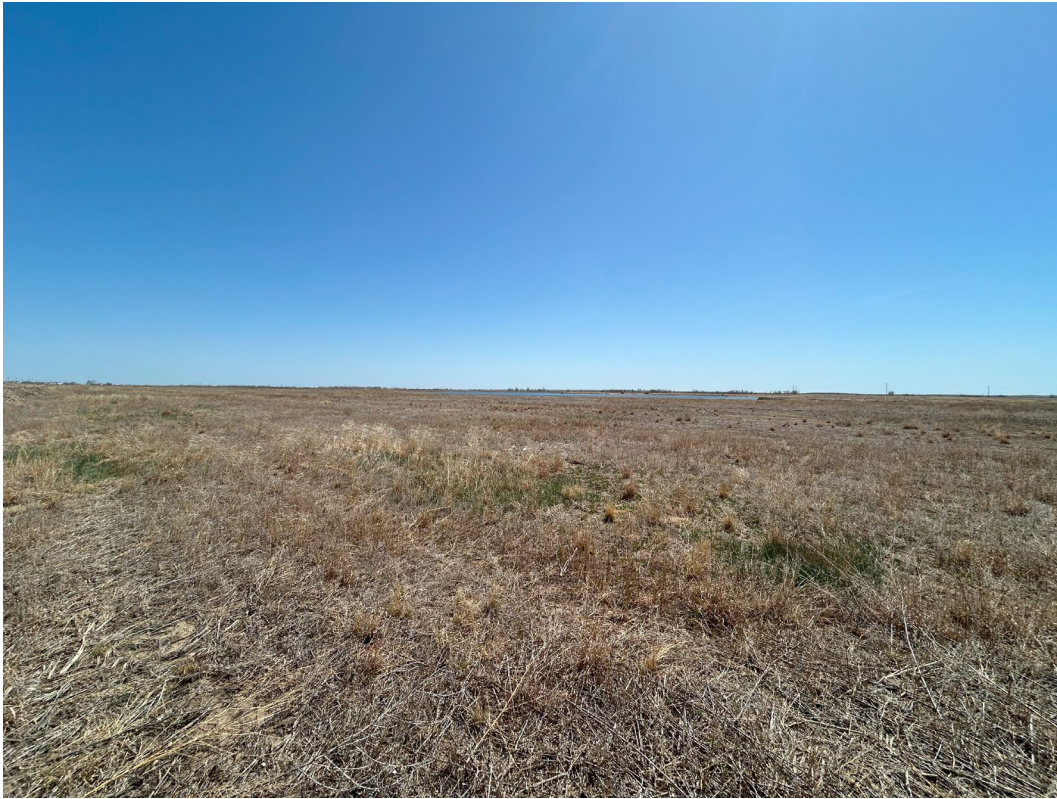
Photo 5. Revegetation in a central portion of the site, facing southeast.

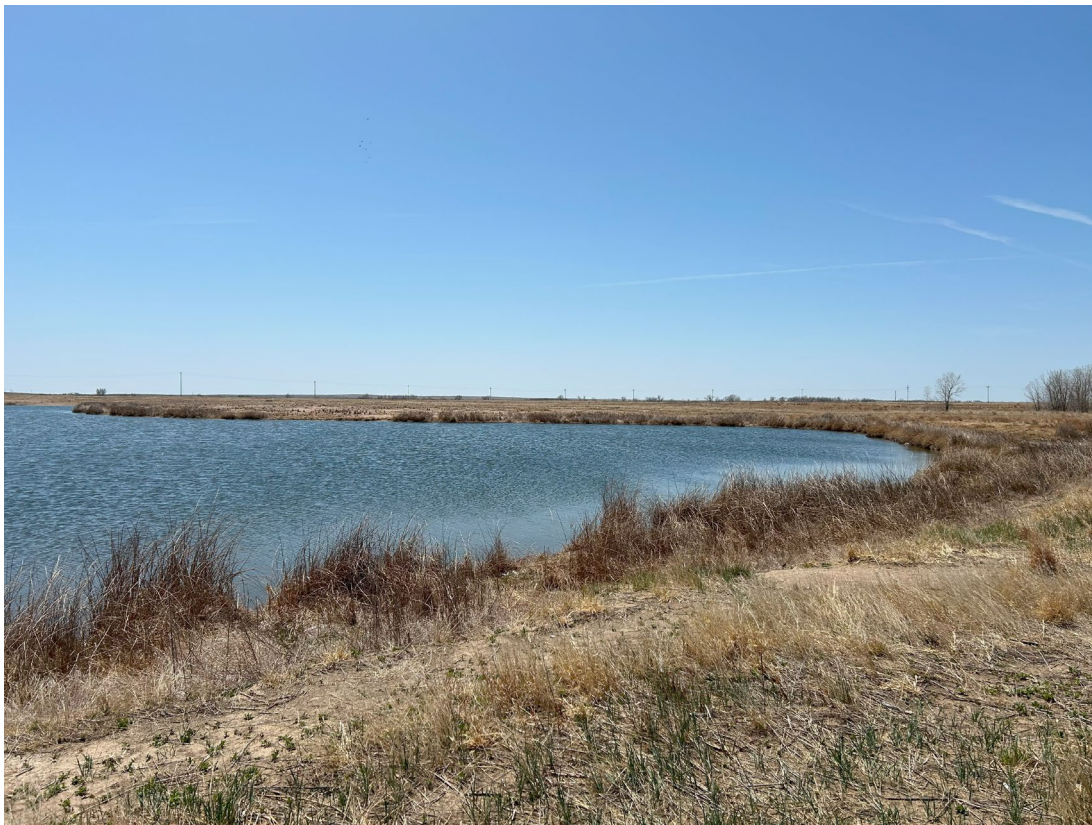
No noxious weeds were observed during the inspection. All the Tamarisk was removed following the 2024 inspection, and there was no regrowth observed. A portion of the removed Tamarisk is still on site in slash piles, but these piles will eventually be hauled off site. A problem with erosion along the shorelines was cited in the Division's September 26, 2019 inspection report. To address that issue, rip-rap was placed to stabilize the bank and the rip-rap seems to be effective, as the banks appeared to be stable during this inspection. No major erosional features were observed along the shorelines of the pond or at other portions of the site.

Photo 6. Northernmost shoreline, facing west.

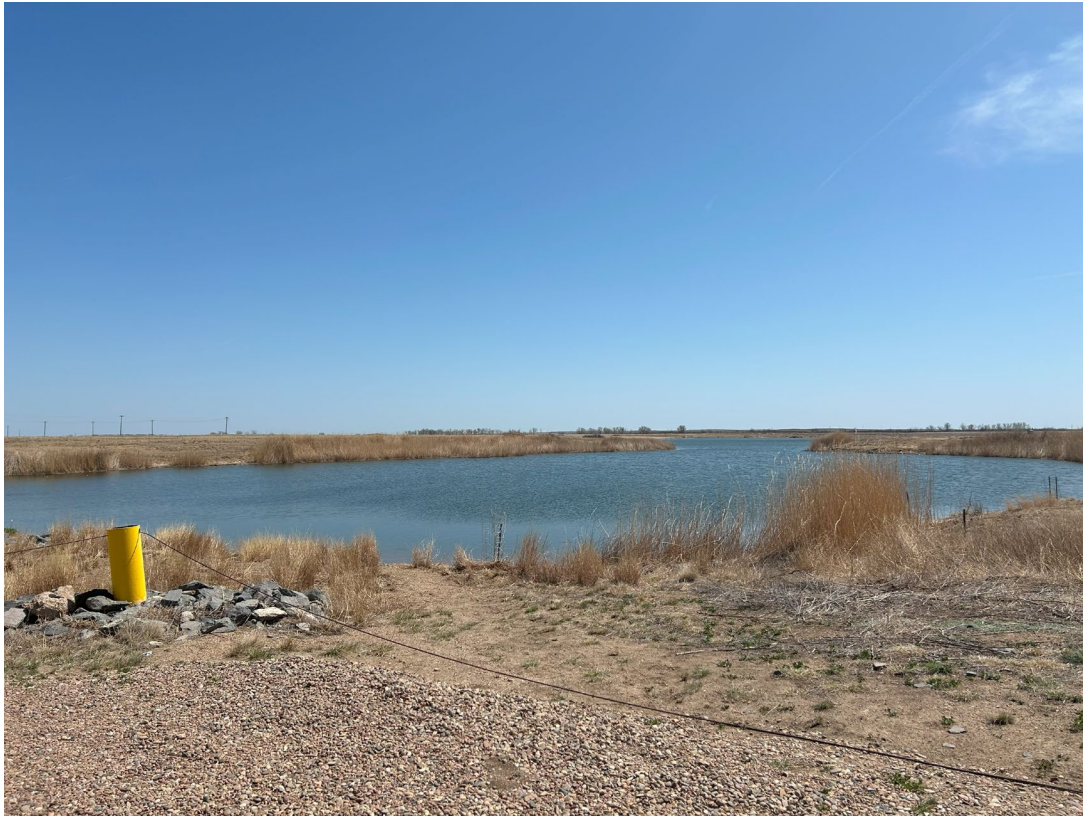
Photo 7. Standing at the CPW fishing pond parking area in the western portion of the site, facing southeast.

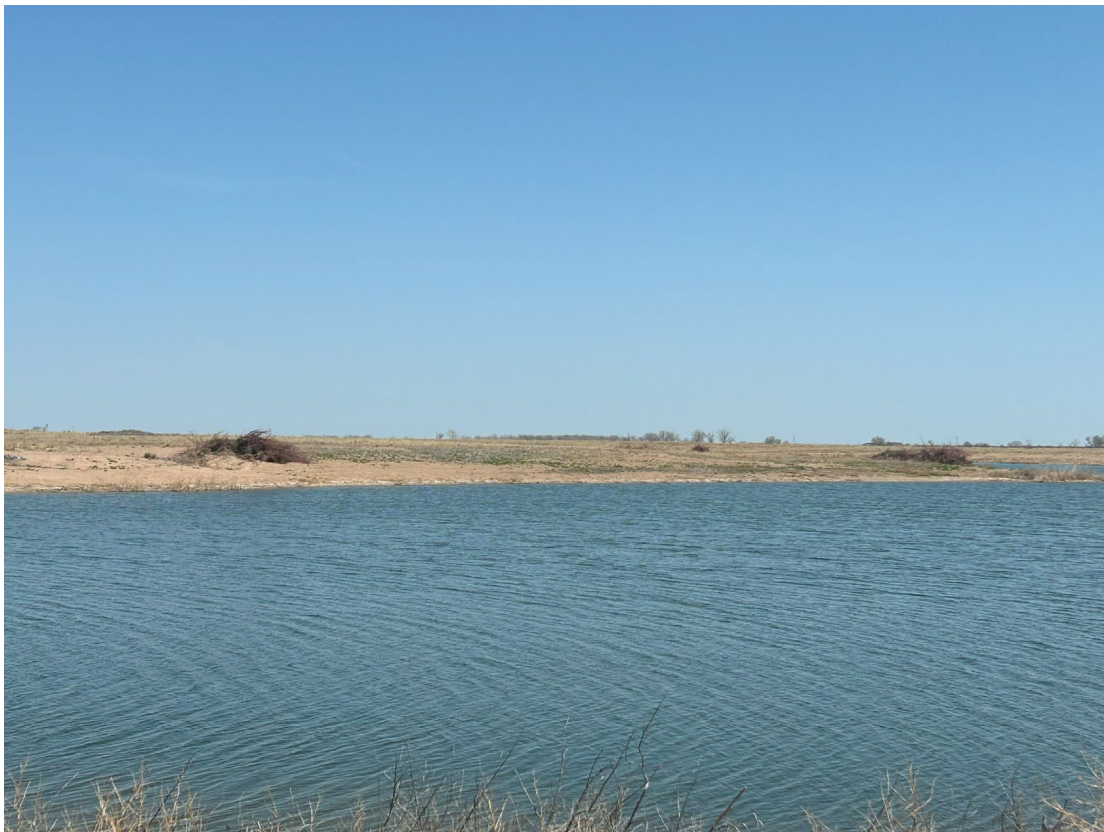
Photo 8. Two piles of removed Tamarisk seen across the CPW fishing pond, facing east.
