MINERALS PROGRAM INSPECTION REPORT

MINE NAME: The Broyles Pit	MINE/PROSPECTING ID#: M-2004-028	MINERAL: Gravel	COUNTY: Las Animas
INSPECTION TYPE: Monitoring	WEATHER: Clear	INSP. DATE: March 26, 2025	INSP. TIME: 08:31
OPERATOR: Michele M and Frederick V Eichler IV	OPERATOR REPRESENTATIVE: Seth Crummer	TYPE OF OPERATION: 112c - Construction Regular Operation

The Broyles Pit was inspected by Amber Gibson with the Division of Reclamation, Mining and Safety (Division/DRMS). The inspection was completed as part of the Division's routine monitoring inspection program. The site was previously inspected by the Division on November 3, 2020 as a routine monitoring inspection. Seth Crummer (representing the Operator/Permittee), accompanied me during the inspection. The sky was clear, and the weather was warm.

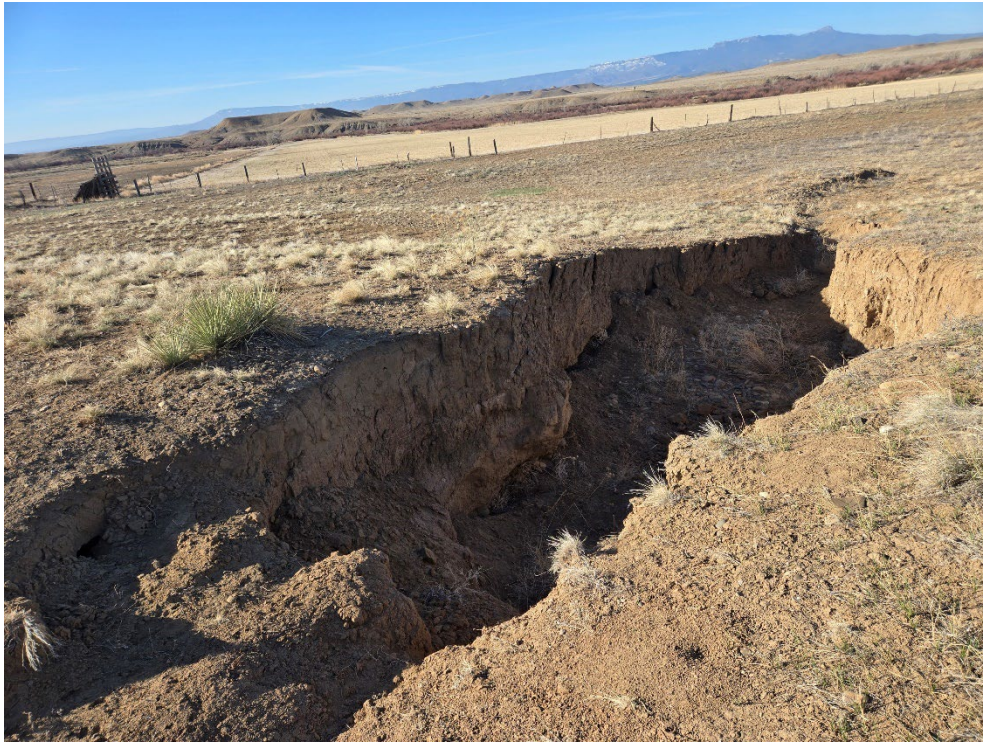
The northeast side of the pit has a large erosion gully beginning above the permit boundary along the side of County Road 40.2 and extending to the toe of the pit (Photo 1 and Maps 1-2). The top of the East Pit slope has also sloughed down, and smaller ruts and gullies are observed along the extent of the slope (Photos 2-3). There is another deeper erosion gully on the northwest corner of the East Pit as well (Photo 4). The erosion in the East Pit **has been cited as a problem above**. The Operator shall stabilize the erosion and send a photo to the Division by the corrective action date. The Operator will also need to re-seed the slopes to ensure a vegetative cover establishes in the area.

Photo 1: Erosion gully in northeast corner of the East Pit.

CORRECTIVE ACTIONS: The Operator shall provide photo documentation to the Division verifying erosion gullies and ruts have been repaired, and that the site has have been reconstructed and stabilized to prevent erosion damage by the corrective action date.

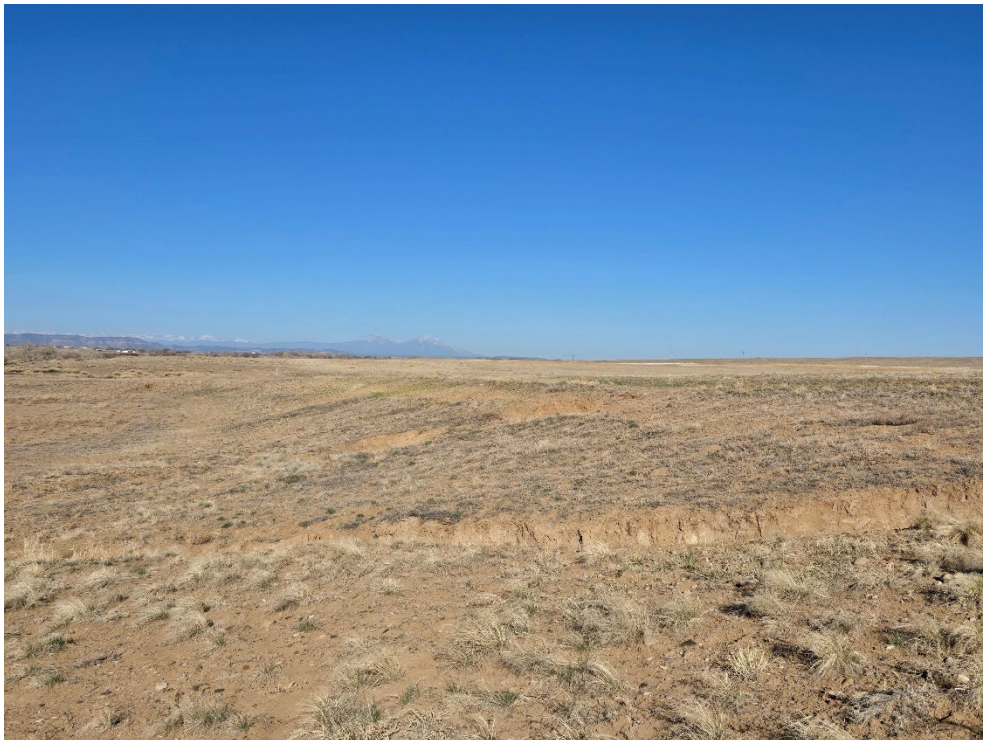
Photo 2: Looking west across the top of the sloughed off slope in the East Pit.

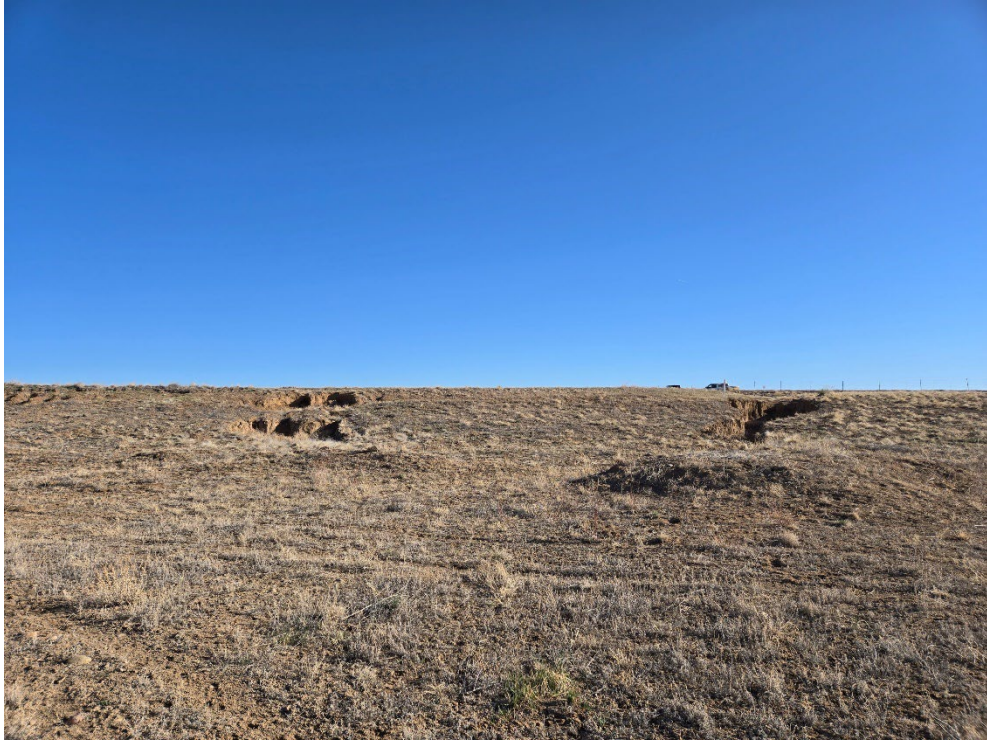
Photo 3: Looking north at the erosion on the East Pit slope.

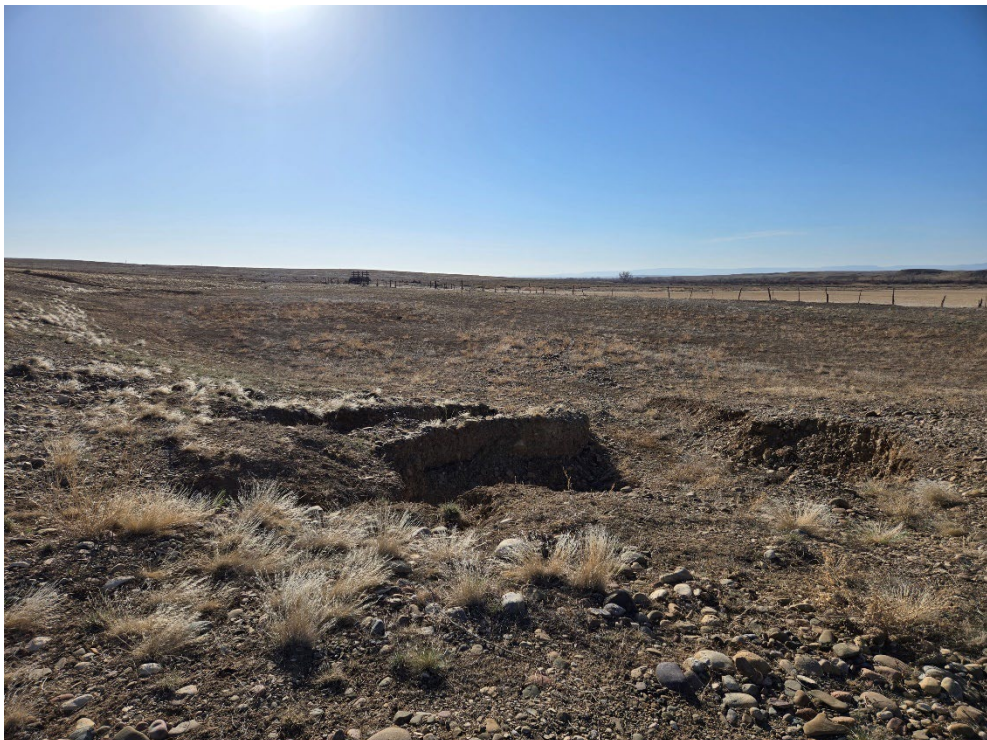
Photo 4: Looking east at the erosion gully in the northwest side of the East Pit.

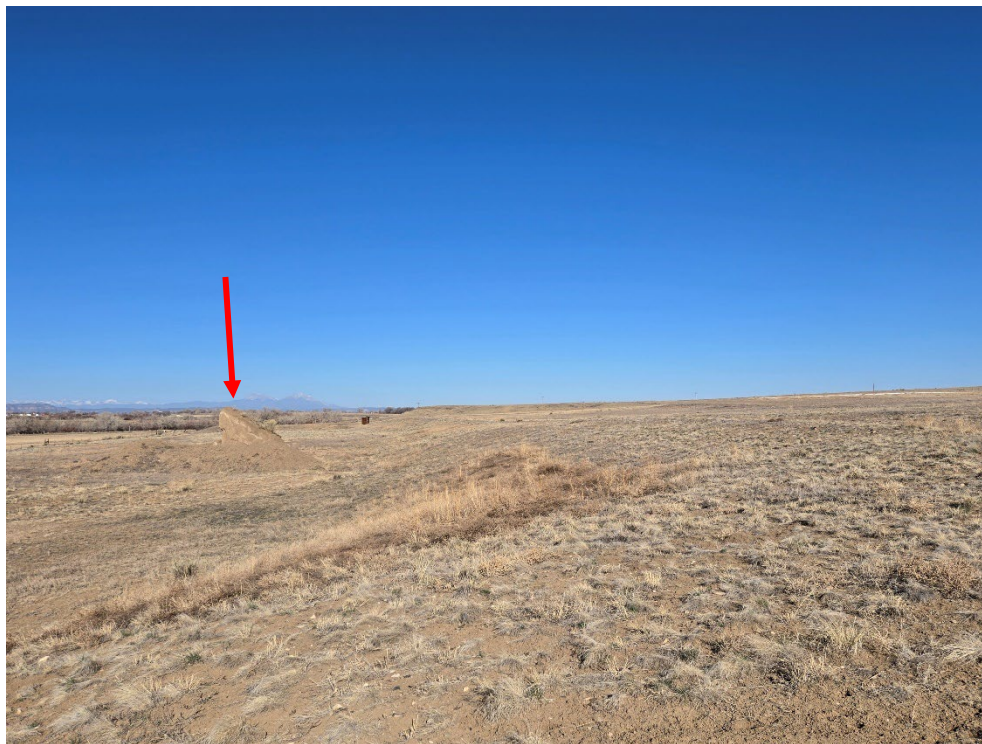
Photo 5: Looking west across part of the graded slope in the West Pit. The arrow points to some stockpiled material that remains within the pit area.

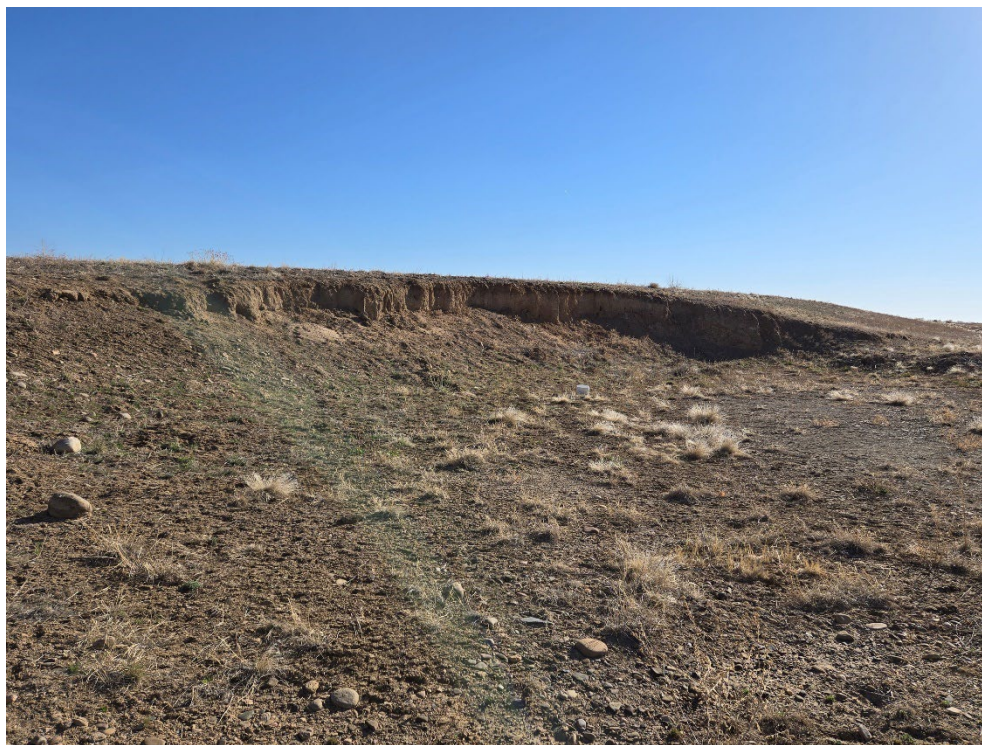
Backfilling and grading had also occurred in the West Pit (Photo 5) however, there is still a portion of highwall remaining along the south side of the access road (Photos 6-7: Map 3). There is an approximately 113' x 8' section of highwall in the West Pit, just south of the access road. The Operator was advised to push the excess material still stockpiled in the west pit up against the highwall to backfill, because it is extremely close to the edge of the permit boundary and the cut-fill method would create off-site damage. As a reminder, the Reclamation Plan states that the Operator will grade the slopes to a 4H:1V slope. Additionally, there are some areas south of the access road, on the West Pit slope where erosion rills have begun to form (Map 3).

Photo 6: Looking north at the highwall remaining in the West Pit.

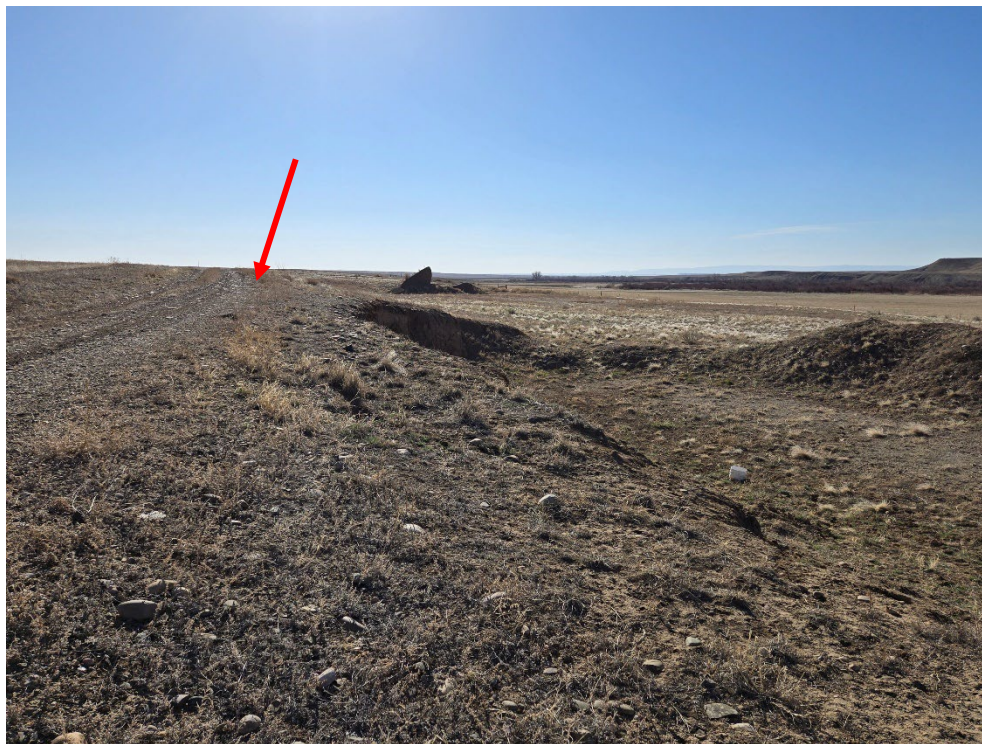
Photo 7: Looking east across the top of the highwall in the West Pit. The haul road (arrow) is outside of the permit boundary in this section.

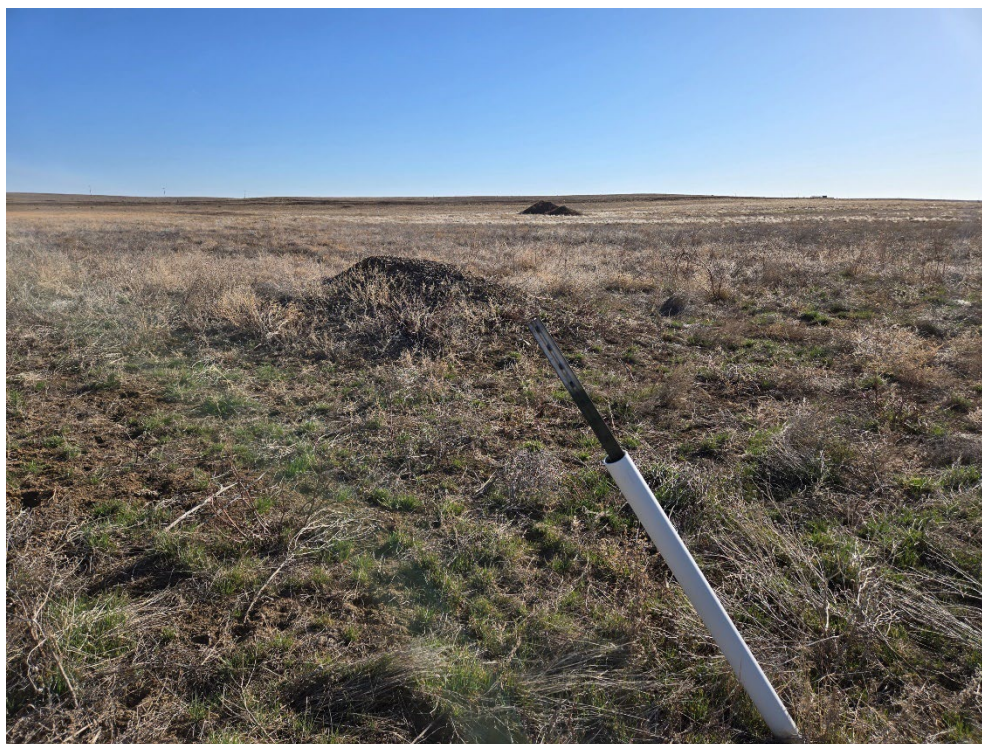
The Stockpile Area is located northwest of the East Pit. There are a couple of small piles remaining in this area (Photo 8). The piles are required to be removed and the area is to be plowed and seeded upon reclamation.

Photo 8: Looking northeast at the small stockpiles remaining in the Stockpile Area.

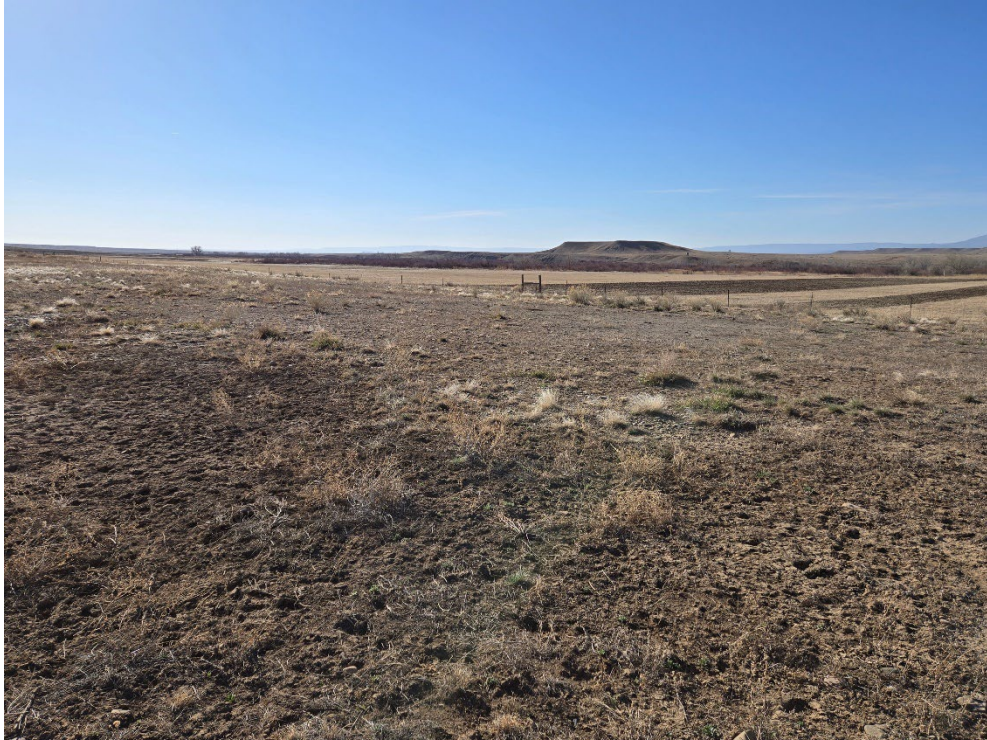
Photo 9: Looking southeast at the low lying area in the West Pit that needs to be revegetated.

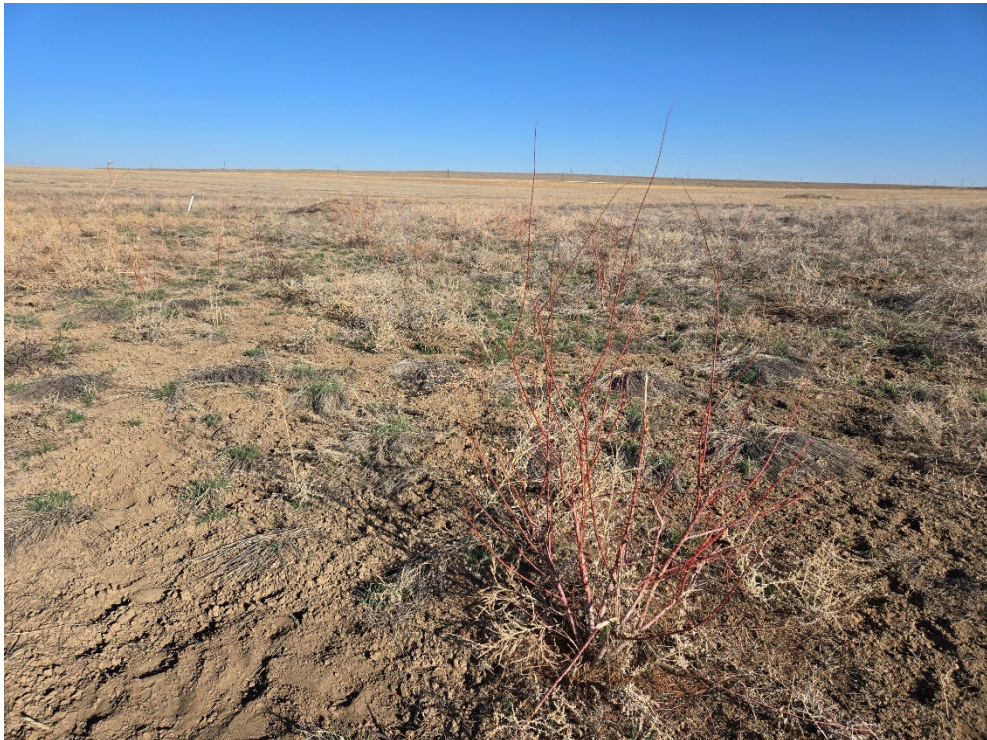
PROBLEM: Tamarisk (salt cedar) trees are present within or have volunteered into the permit area and are becoming established. This is a problem for failure to employ weed control methods for a state listed noxious weed species within the permitted area, and to reduce the spread of weeds to nearby areas as required by Section 3.1.10 (6) of the rule.

The state listed noxious weed Tamarisk (salt cedar) was observed within the Stockpile Area (Photo 10). **This has been cited as a problem above**. The Operator shall remove the Tamarisk and send evidence to the Division by the corrective action date. An informational sheet for treating Tamarisk is attached to this report.

Photo 10: Looking east at some small Tamarisk trees establishing in the Stockpile Area.

CORRECTIVE ACTIONS: The Operator shall either implement the existing weed control plan, or develop a weed control and management plan in accordance with Section 3.1.10 (6) of the Rule. This plan should be developed in consultation with the county extension agency, or weed control district office and should include specific control measures to be applied, a schedule for when control measures will be applied and a post-treatment monitoring plan. The Operator shall provide the Division with evidence that the weeds have been eradicated by the corrective action date.

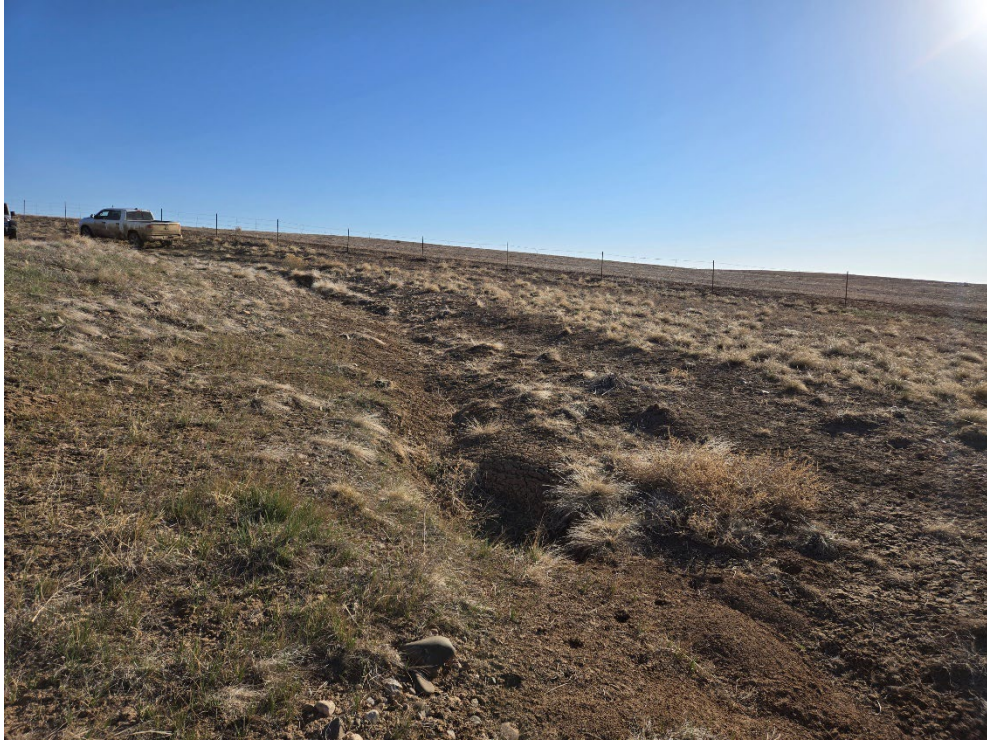
As mentioned in the Backfilling and Grading section above, large erosion ruts and gullies were observed in the East Pit, and small erosion rills have formed on the slope in the West Pit. Also, the horizontal length of the east slope has begun to slough off. The road outside of the permit area to the northeast of the East Pit slopes down towards the pit and the runoff from the road appears to have caused or exacerbated the erosion experienced in the East Pit (Photo 11). No excess sediment was observed outside of the permit area.

Photo 11: Looking northeast at the erosion caused by runoff from the road above the East Pit.

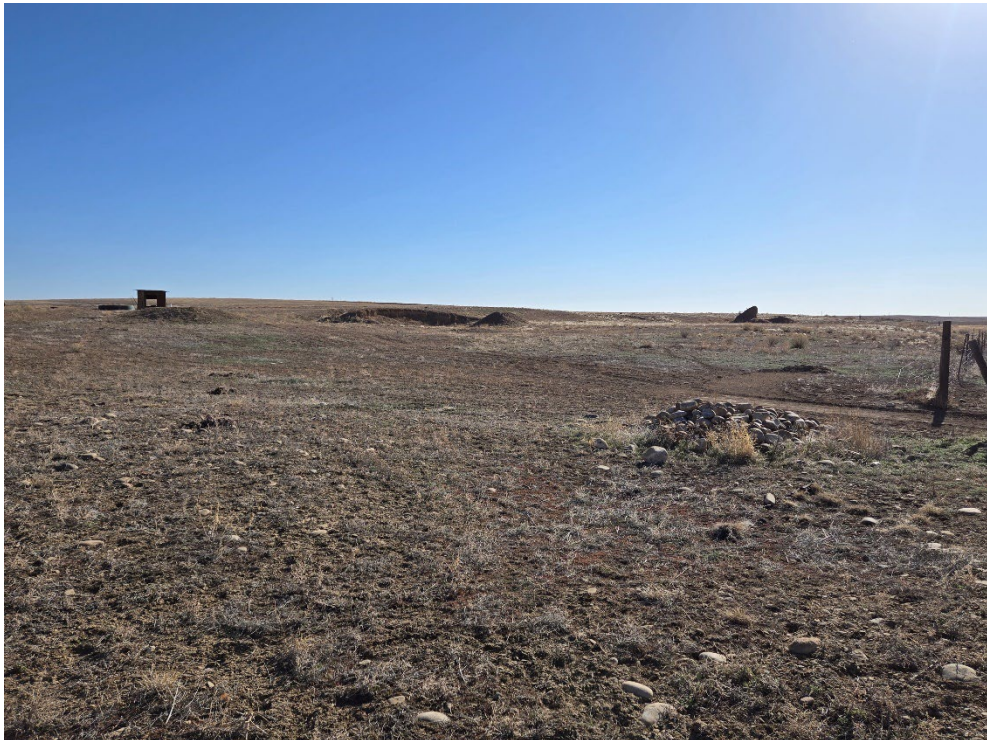
Photo 12: Looking east across the West Pit area from the southwest corner.

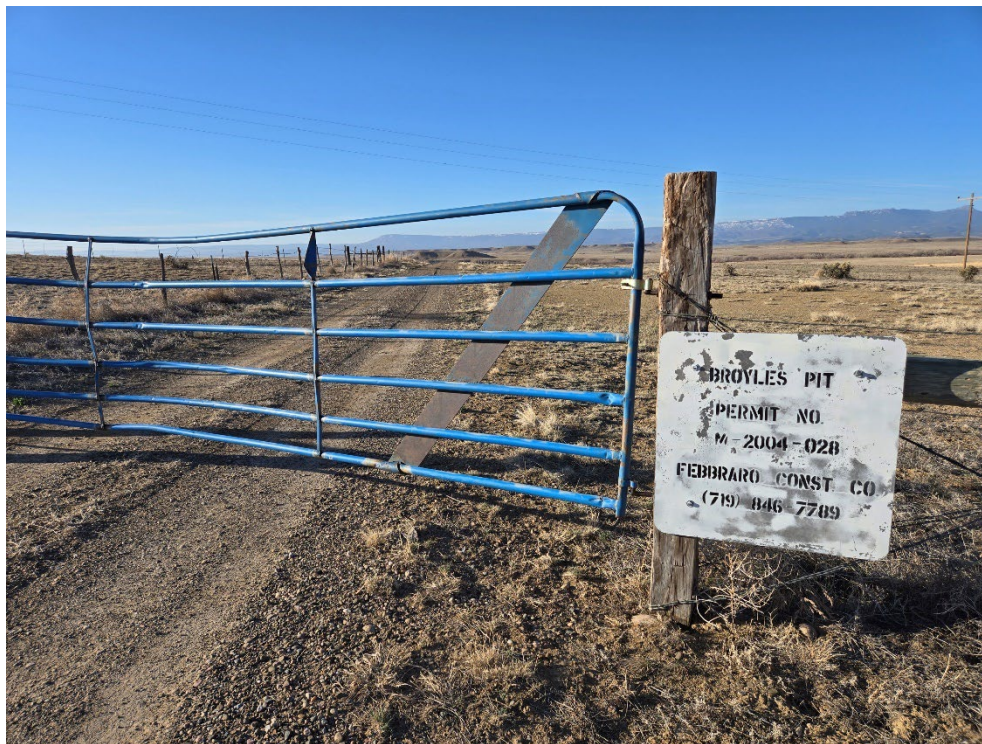
PROBLEM: The mine identification sign contains incorrect information regarding the Permittee.

A mine sign was posted at the entrance to the site but has the previous Permittee's information on it (Photo 13). **This has been cited as a problem above**. The Permittee shall revise or replace the sign and send a photo to the Division by the corrective action date. Field markers were collected using the Esri Field Maps application

Photo 13: Mine sign posted at the gated entrance. The Permittee information needs to be updated.

CORRECTIVE ACTIONS: The Operator shall, at the entrance of the mine site, post a sign which shall be clearly visible from the access road with the following: the name of the operator, a statement that a reclamation permit for the operation has been issued by the Colorado Mined Land Reclamation Board; and the permit number. The Operator shall submit photo documentation that a proper sign has been posted by the corrective action date.

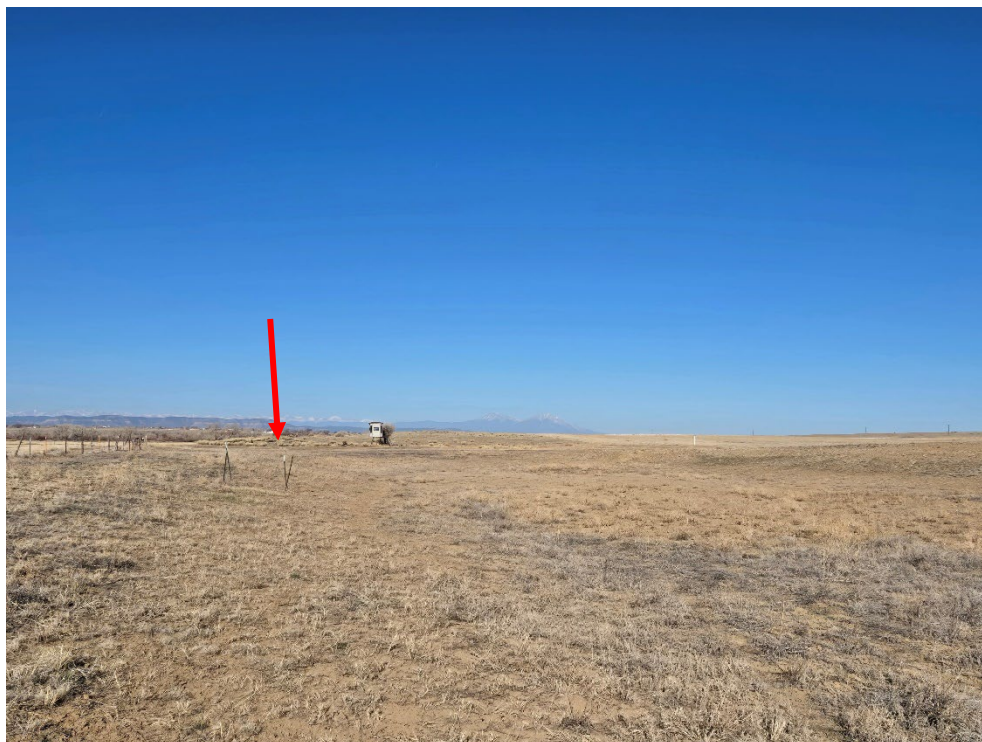
Photo 14: Looking west across the toe of the East Pit. The arrows point to t-posts marking the permit boundary.

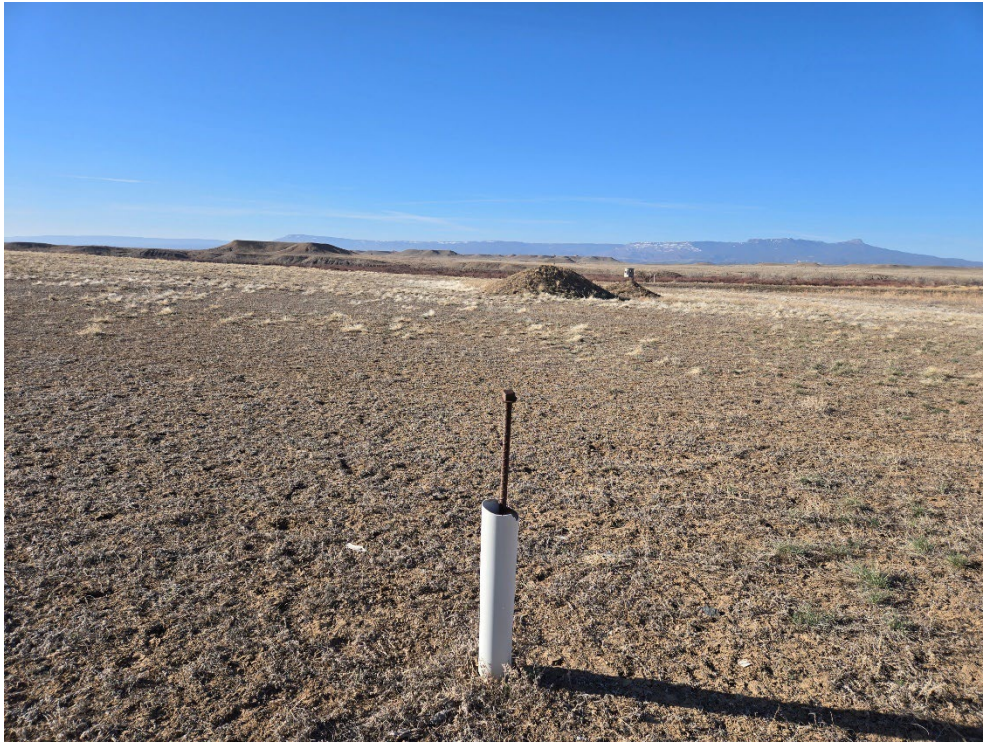
Photo 15: Looking south at some of the stockpiles in the Stockpile Area. The PVC covered rebars serve as the permit boundary marker in this area.

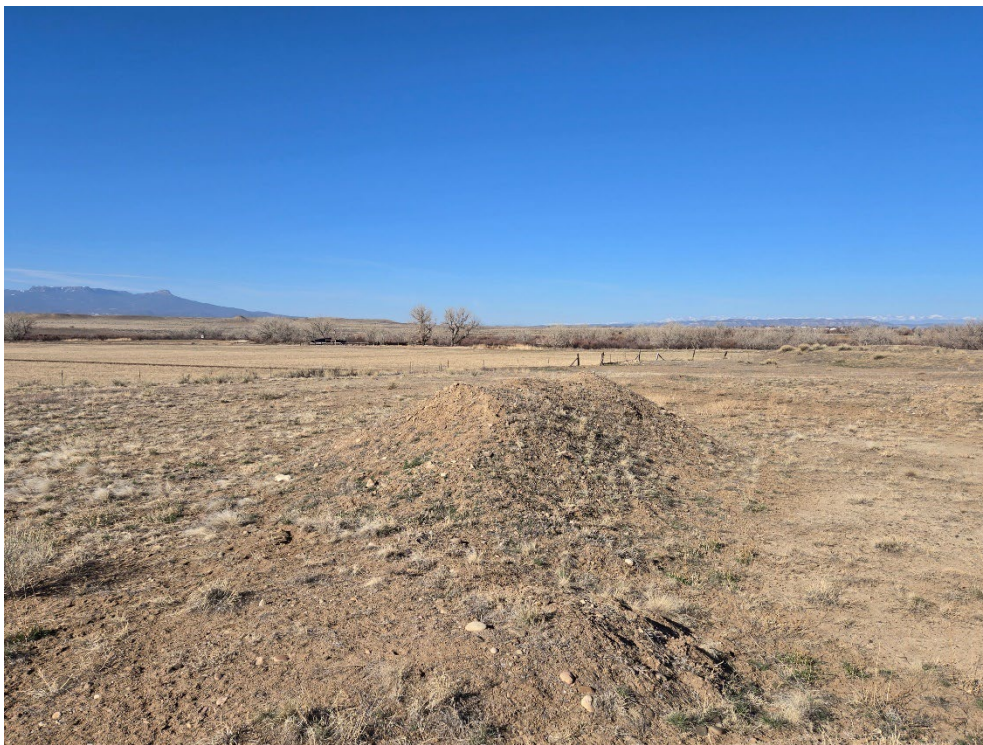
Photo 16: Looking southwest at some topsoil material in the West Pit.

There appears to be some topsoil piled in the West Pit (Photo 16). The Operator shall use this material to topsoil the highwall in the West Pit once it has been backfilled and graded.

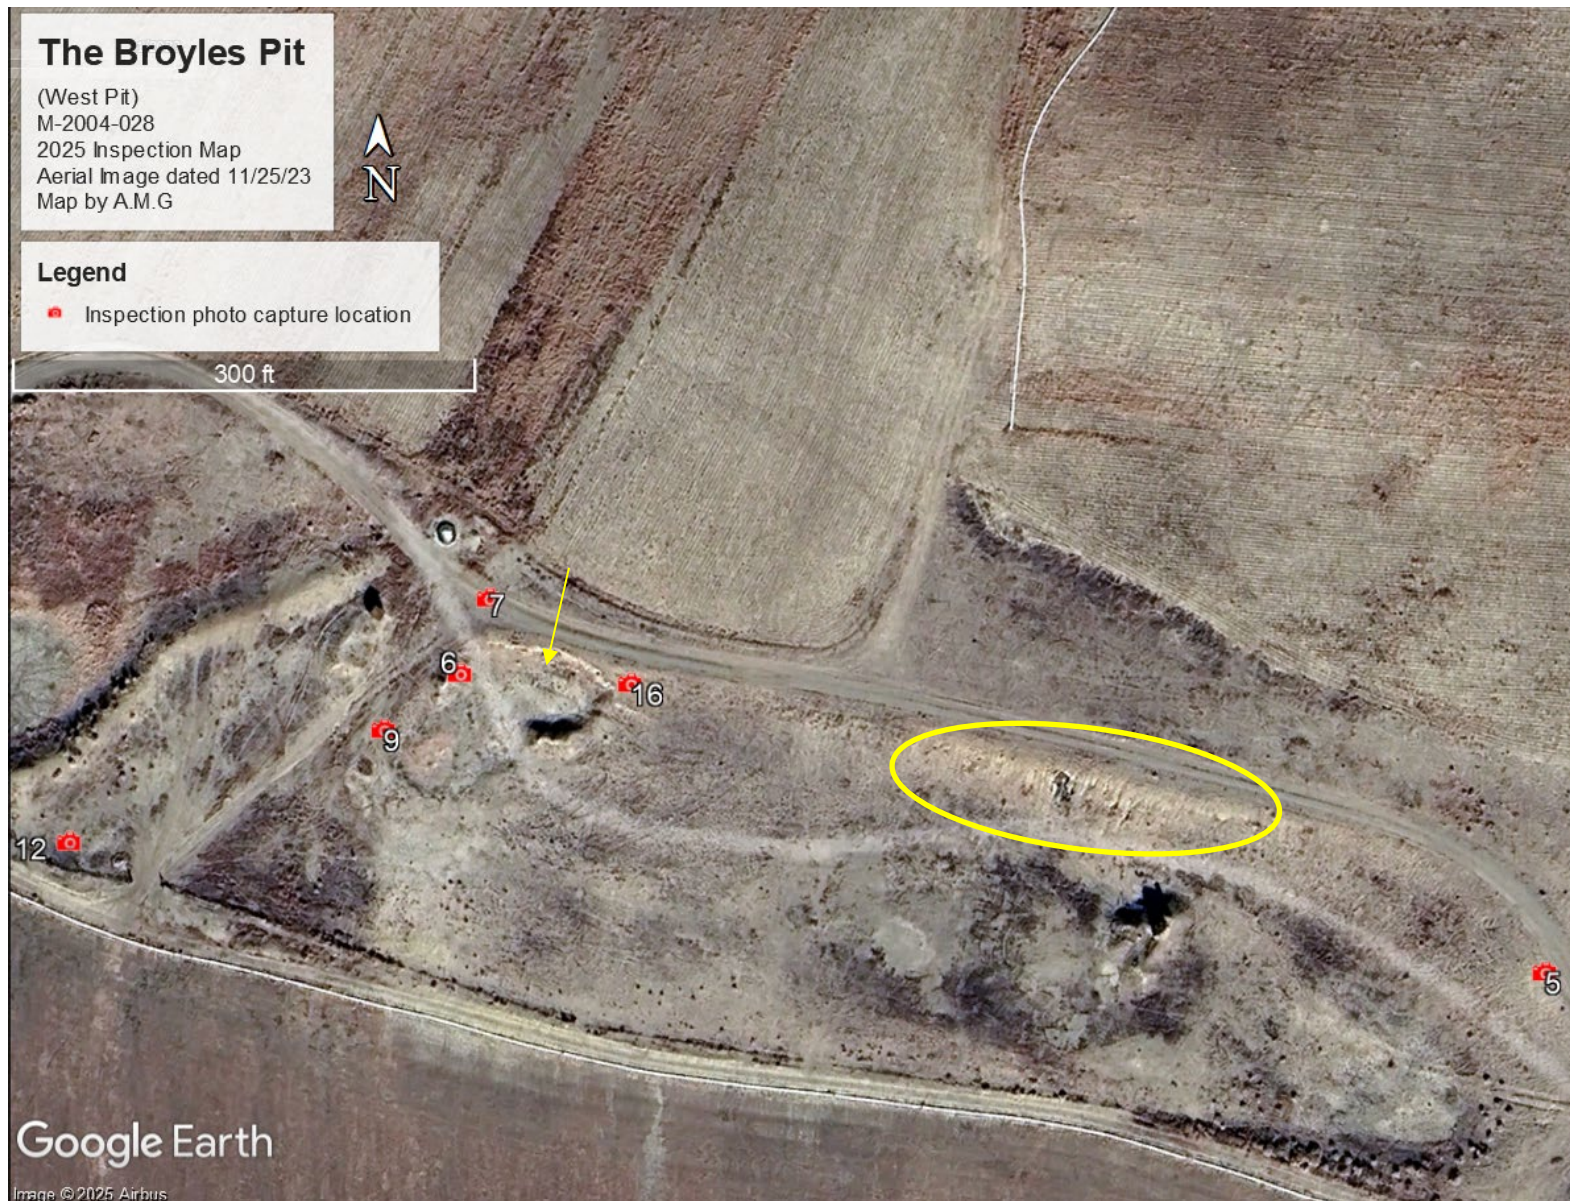
Map 3: Zoomed in map of the West Pit. The yellow arrow points to the highwall that needs to be backfilled, graded, topsoiled, and revegetated. Circled in yellow is an area where some erosion rills have begun to form on the slope.
