**MINERALS PROGRAM INSPECTION REPORT**  
**PHONE: (303) 866-3567**

<b>MINE NAME:</b> Hindmarsh Sandstone	<b>MINE/PROSPECTING ID#:</b> M-2006-009	<b>MINERAL:</b> Sandstone (silica, st quartzite)	<b>COUNTY:</b> Montezuma
<b>INSPECTION TYPE:</b> Monitoring	<b>WEATHER:</b> Clear	<b>INSP. DATE:</b> March 26, 2025	<b>INSP. TIME:</b> 08:00
<b>OPERATOR:</b> Mesa Sandstone, LLC	<b>OPERATOR REPRESENTATIVE:</b> William Goode	<b>TYPE OF OPERATION:</b> 112c - Construction Regular Operation	
<b>REASON FOR INSPECTION:</b> Normal I&E Program	<b>BOND CALCULATION TYPE:</b>	<b>BOND AMOUNT:</b> \$20,000.00	
<b>DATE OF COMPLAINT:</b> NA	<b>POST INSP. CONTACTS:</b> None	<b>JOINT INSP. AGENCY:</b> None	
<b>INSPECTOR(S):</b> Todd Jesse	<b>INSPECTOR'S SIGNATURE:</b>

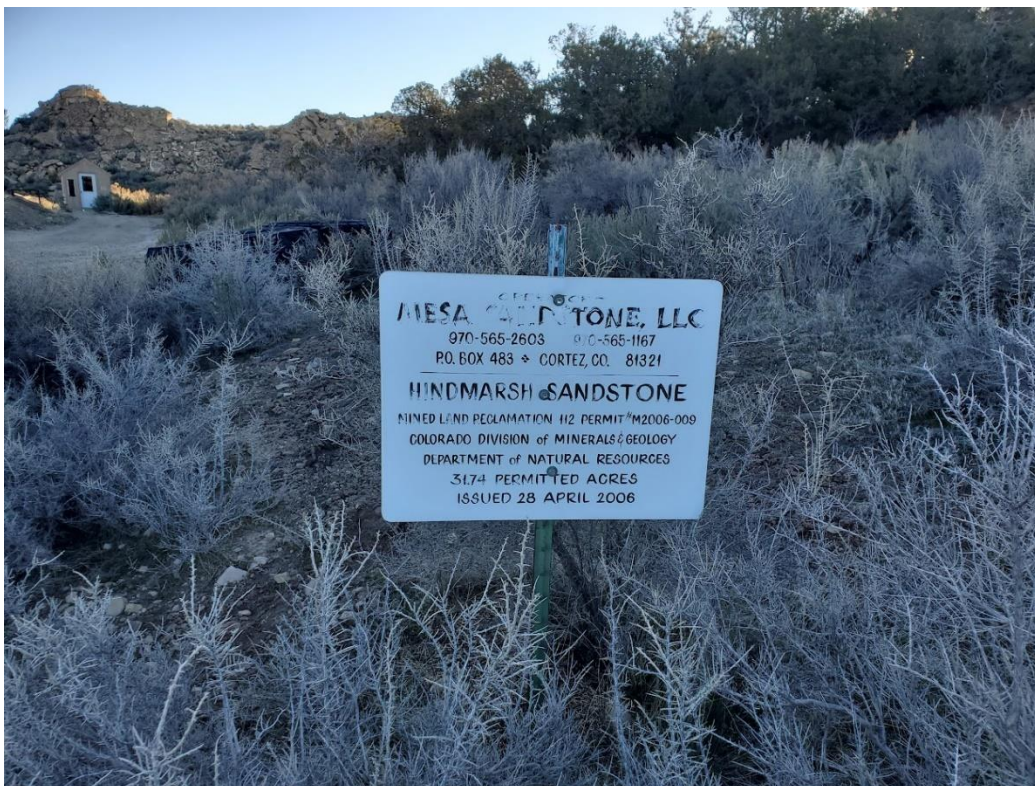
The mine identification sign and the affected area boundary markers are in place and in compliance with Rule 3.1.12. The mine ID sign is posted at the entrance to the permit area. The boundary is marked with berms and signs that are easily identifiable.

Photo 1 – to the northeast of mine identification sign.

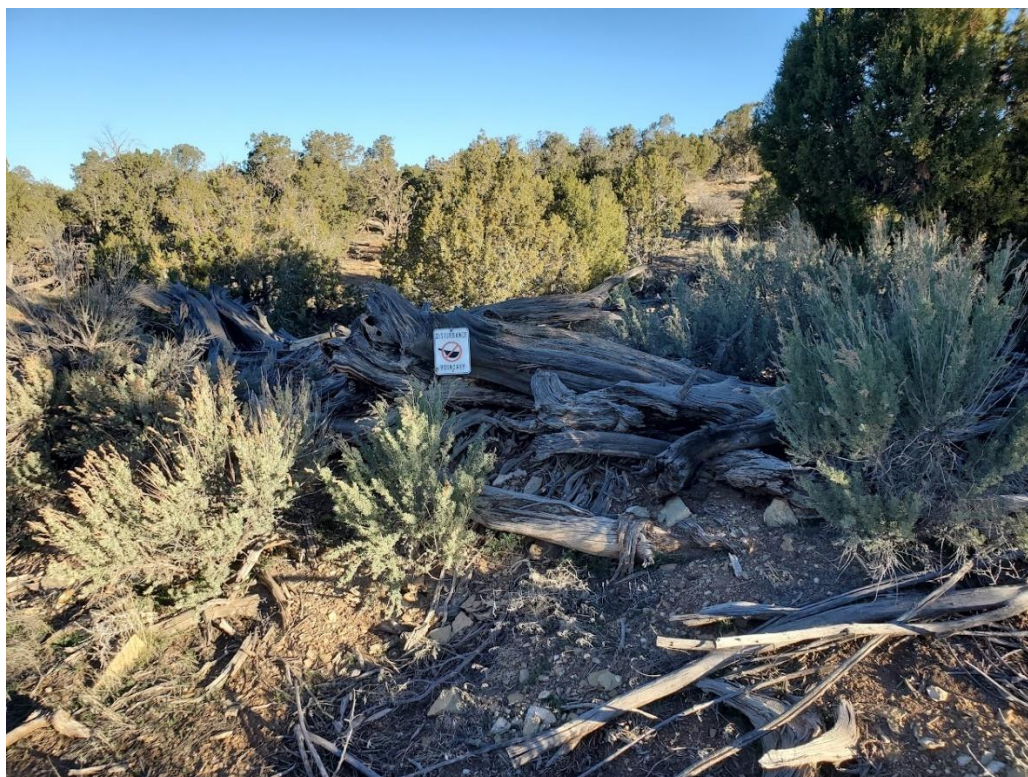
Photo 2 – to the north of boundary marker.

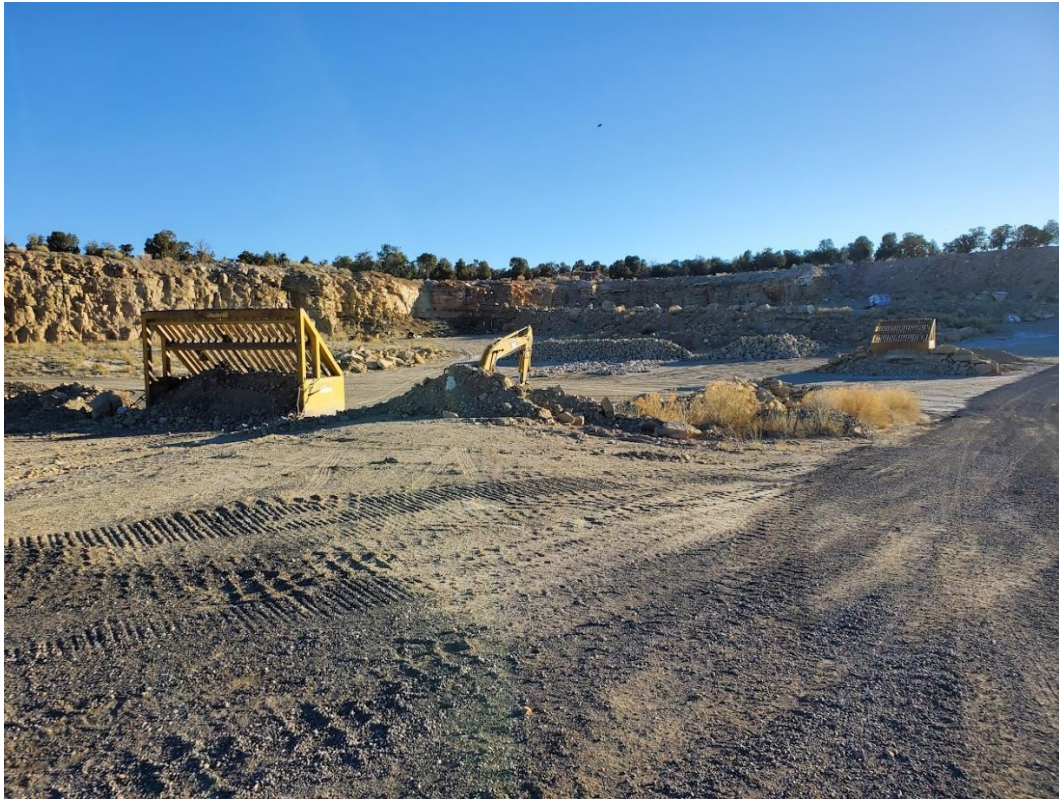
Minimal activity was occurring on the site at the time of the inspection. Product is being sold out of stockpiles, but no mining activity was occurring at the time of the inspection. The mining area is in the northern portion of the permit area and product stockpiles are located in the south near the entrance to the site. There is a 15-foot high and approximately 200 foot long highwall in the mining area. The operator blasts in order to generate material in this area. There is also a 15 foot highwall that is roughly 500 feet long at the northern portion of the permit area that has been reclaimed. The highwall appears stable and no displacement was noted. A scale and small office building are located near the entrance to the site. A loader, excavator, and two grizzly screens were located in the processing area.

Photo 3 – to the northeast of processing area.

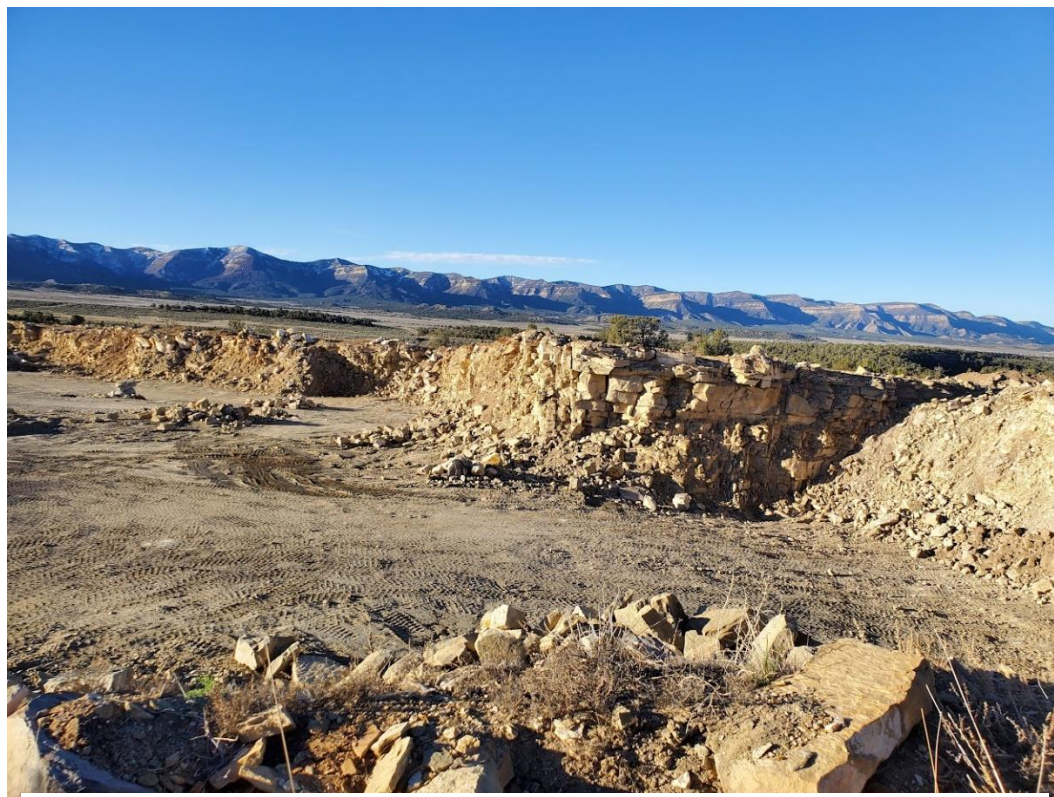
Photo 4 – to the south of mining area.

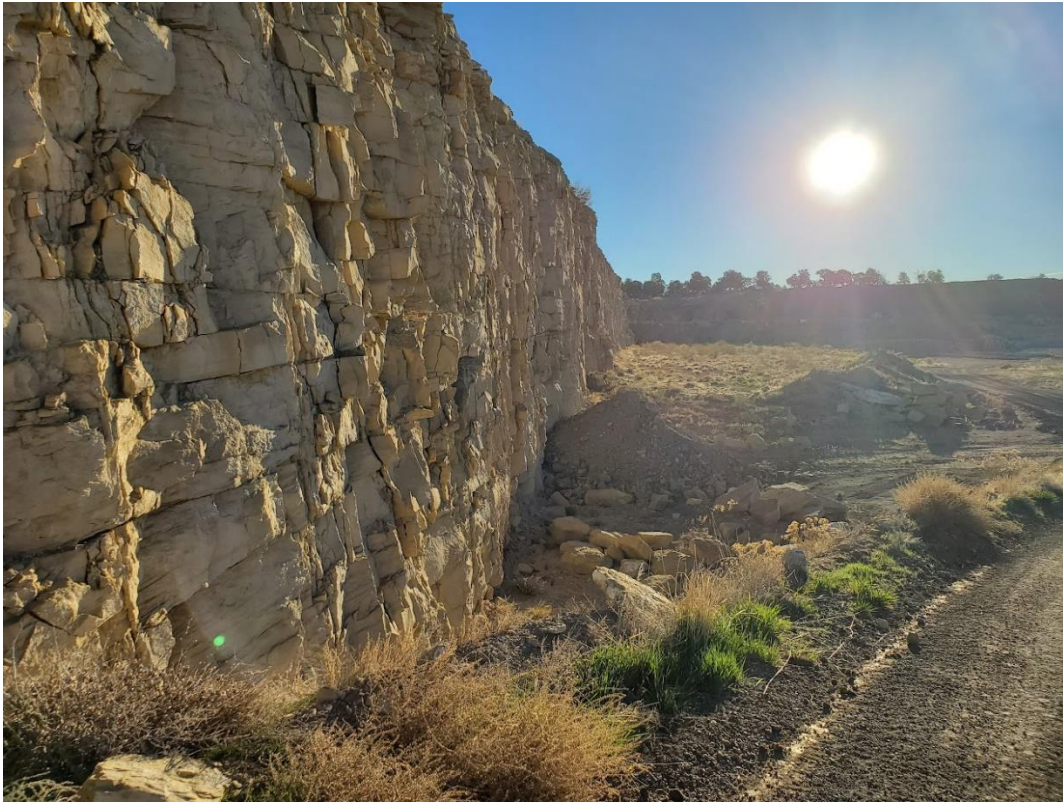
Photo 5 – to the east of reclaimed highwall.

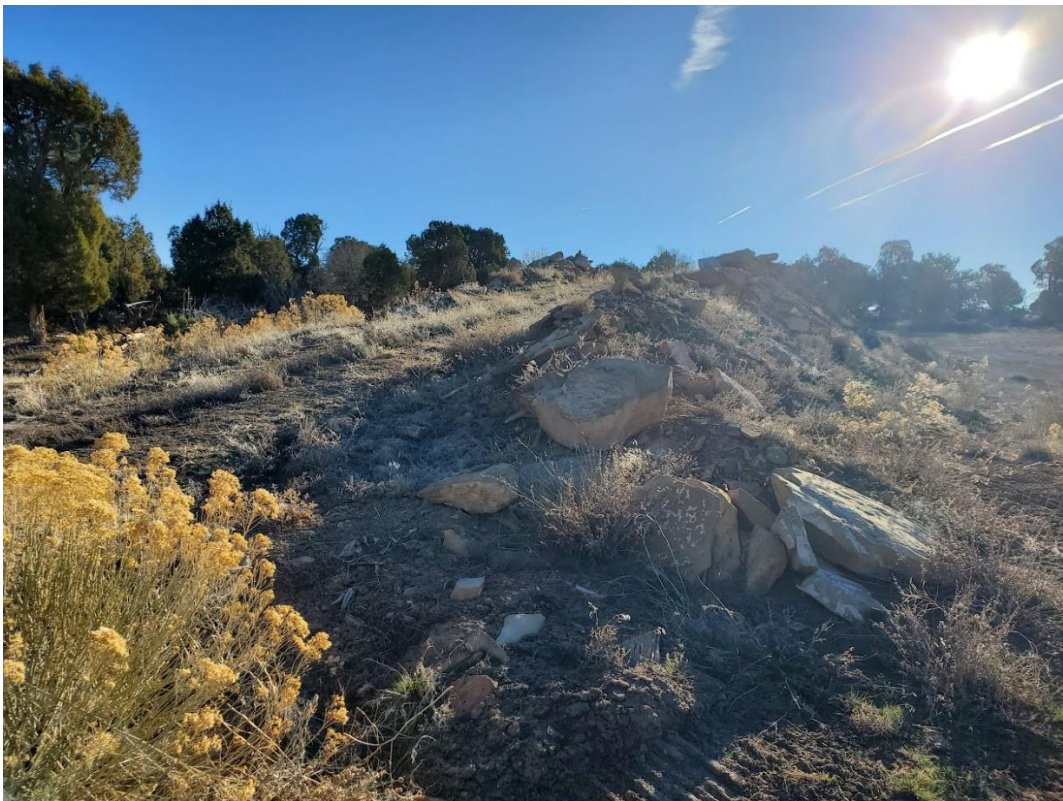
Topsoil is being stockpiled along the northern permit boundary. The topsoil stockpiles are protected by vegetation. No signs of erosion or slumping were observed on the topsoil piles. There appears to be sufficient topsoil to complete reclamation.

Photo 6 – to the east of a topsoil stockpile.
