2025 April Inspection Reports Yoast and Seneca IIW

COLORADO
Division of Reclamation,
Mining and Safety
Department of Natural Resources

Permit Number: C-1994-082 Mine Name: Yeast Mine Operator Address: Seneca Property LLC Ms. Miranda Kawcak 29515 Routt County Road No. 27 Oak Creek, CO 80467	County: Routt Operation Type: Surface Permit Status: Permanent Cessation Ownership: Private Operator Representative Present: Miranda Kawcak
Operator Representative Signature: (Field Issuance Only) This report was issued electronically from the Divisions' Denver Office.

INSPECTION

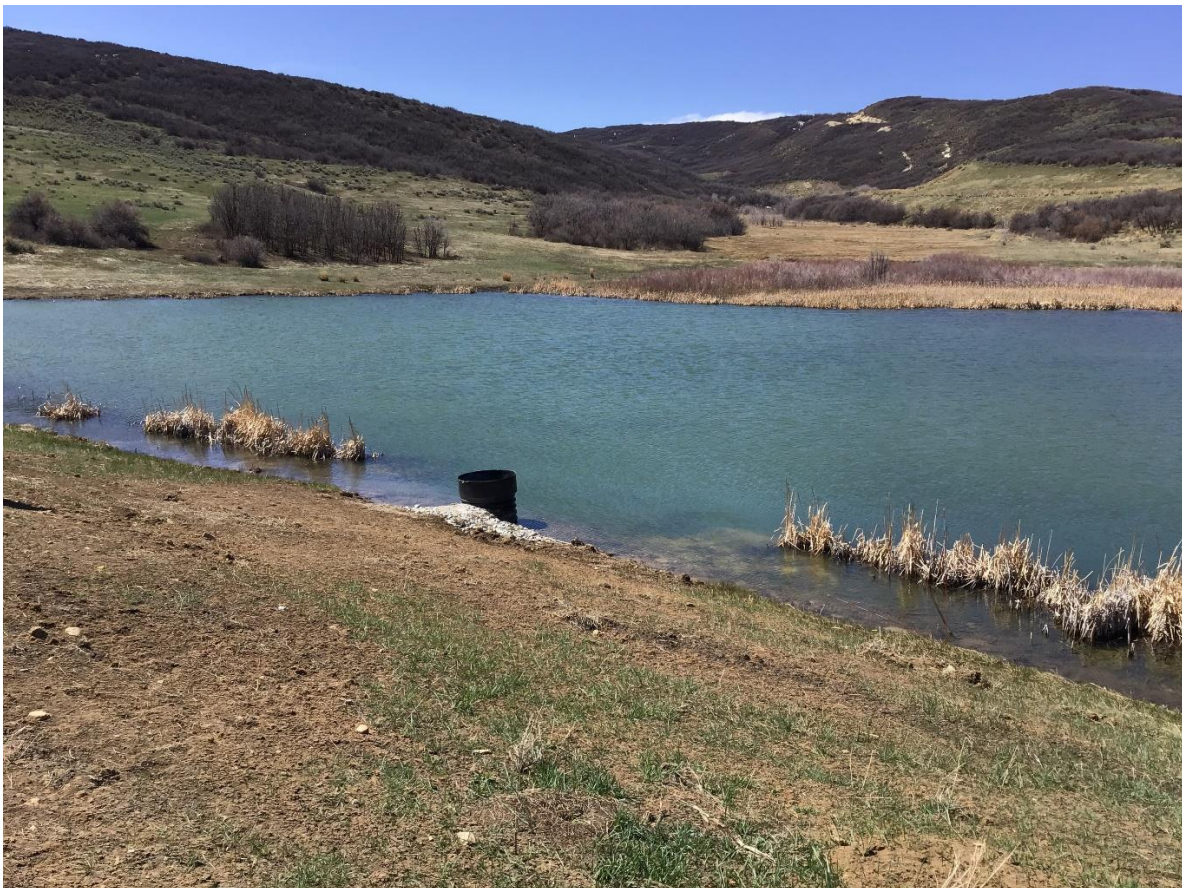
- New decant structure and culvert through dam were functioning adequately, discharging clear water.
- Pond 12 viewed from above was holding water at the time of inspection.

Photo 1: Pond 10, new decant structure discharging clear water.

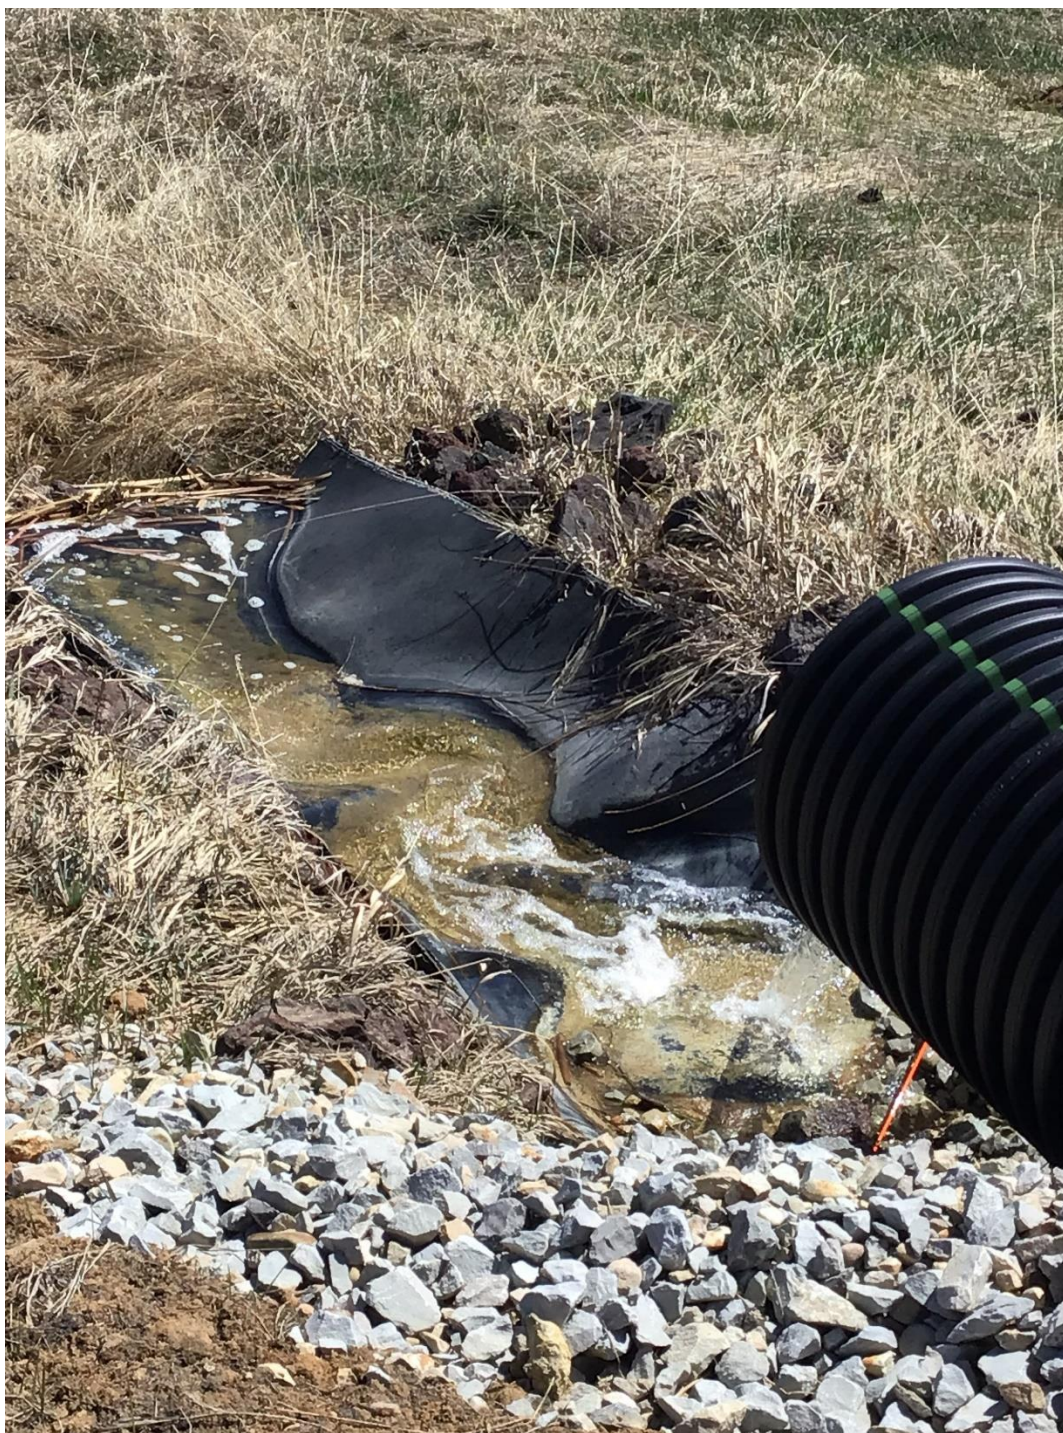
- Pond banks at Pond 10 and dam appeared stable, with no signs of seepage.

Photo 2: Pond 10, new culvert through dam discharging clear water to flume.

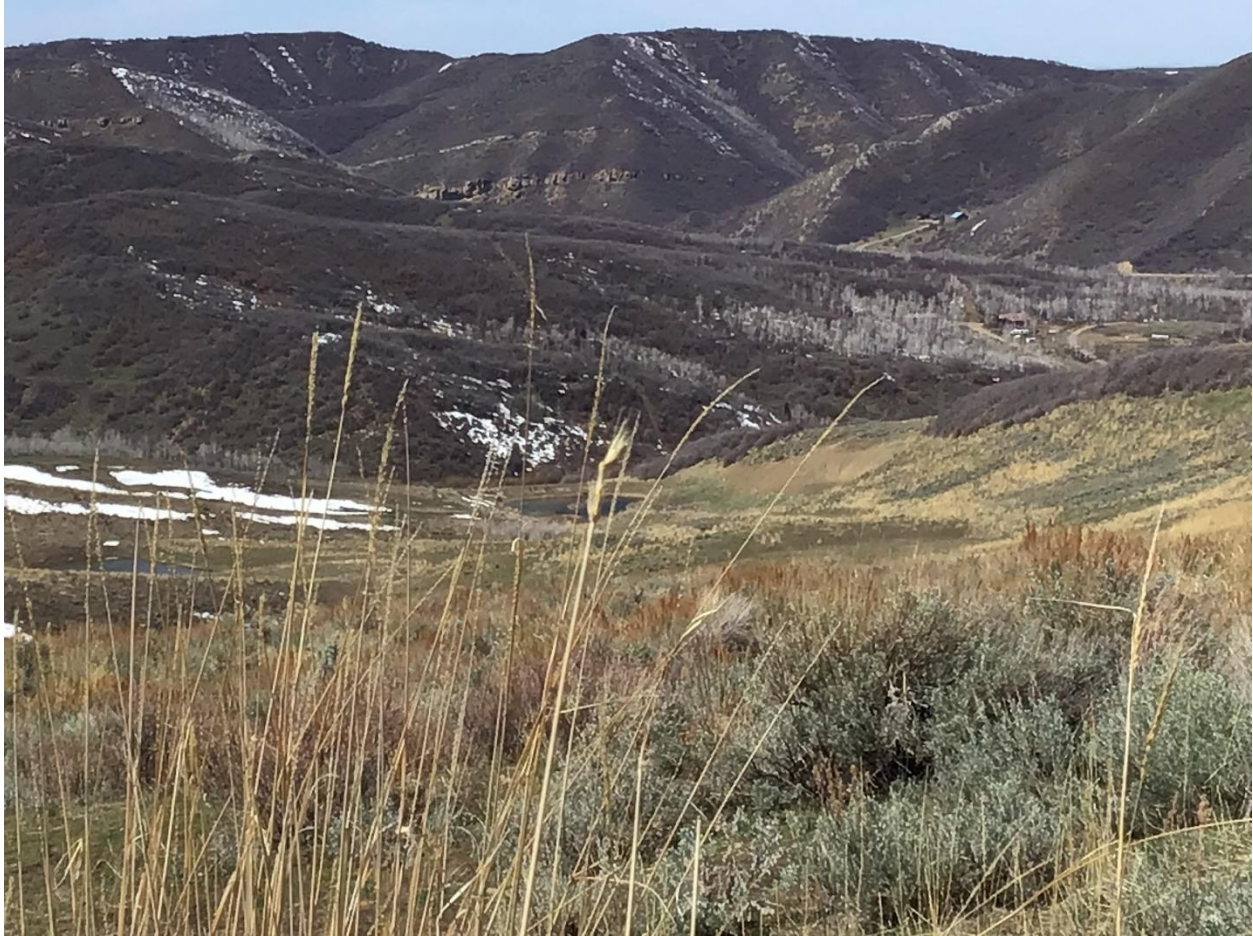
Photo 3: Yoast Pond 12, viewed from above, holding water.
