2025 April Inspection Reports Yoast and Seneca IIW

Division of Reclamation,
Mining and Safety

Permit Number: C-1982-057 Mine Name: Seneca IIW Mine Operator: Seneca Property LLC Operator Address: Ms. Miranda Kawcak 29515 Routt County Road 27 Oak Creek, CO 80467	County: Routt Operation Type: Surface Permit Status: Permanent Cessation Ownership: Private
	Operator Representative Present: Miranda Kawcak
Operator Representative Signature: (Field Issuance Only) This report was issued electronically from the Divisions' Denver Office.

Inspection Start Date: 15 April 2025 Inspection Start Time: 13:30 p.m. Inspection End Date: 15 April 2025 Inspection End Time: 15:30 p.m.		Inspection Type: Coal Partial Inspection Inspection Reason: Normal I&E Program Weather: Clear	
Joint Inspection Agency: None		Joint Inspection Contacts:	
Post Inspection Agency: None		Post Inspection Contacts:	
Inspector(s): Robin Reilley, M.S. GISP	Inspector's Signature:

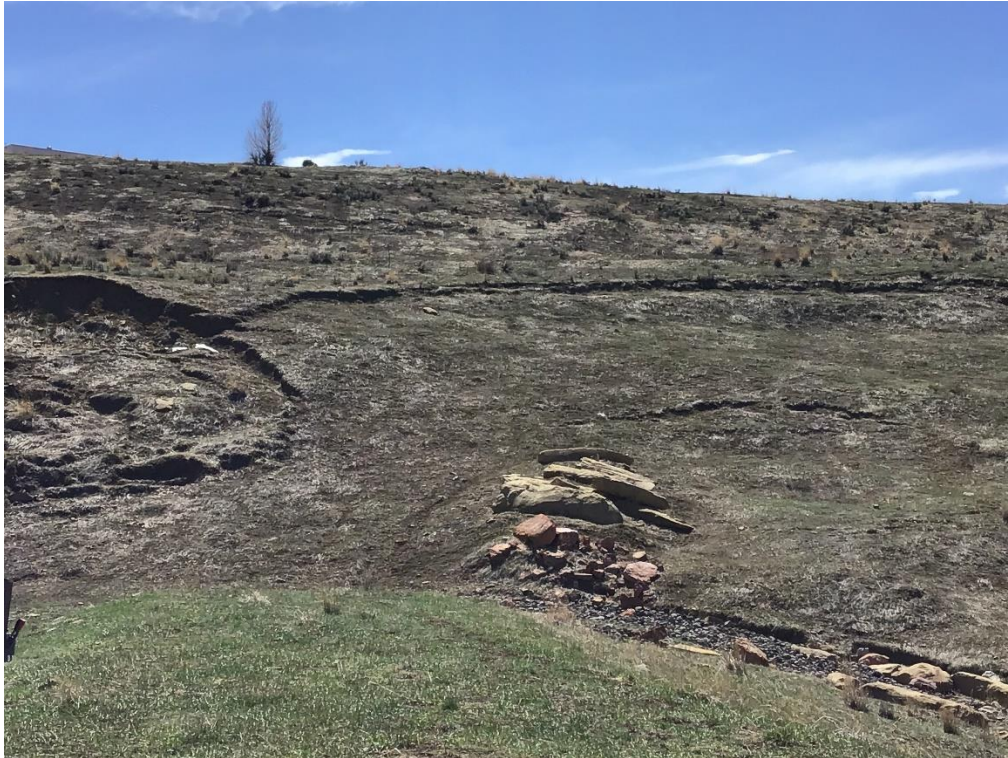
- The two slumps and associated crack between them at Pond 6 were documented.
- No new movement was noted at the time of inspection.

Photo 1: Old Pond 6 slump with crack going across the slope.

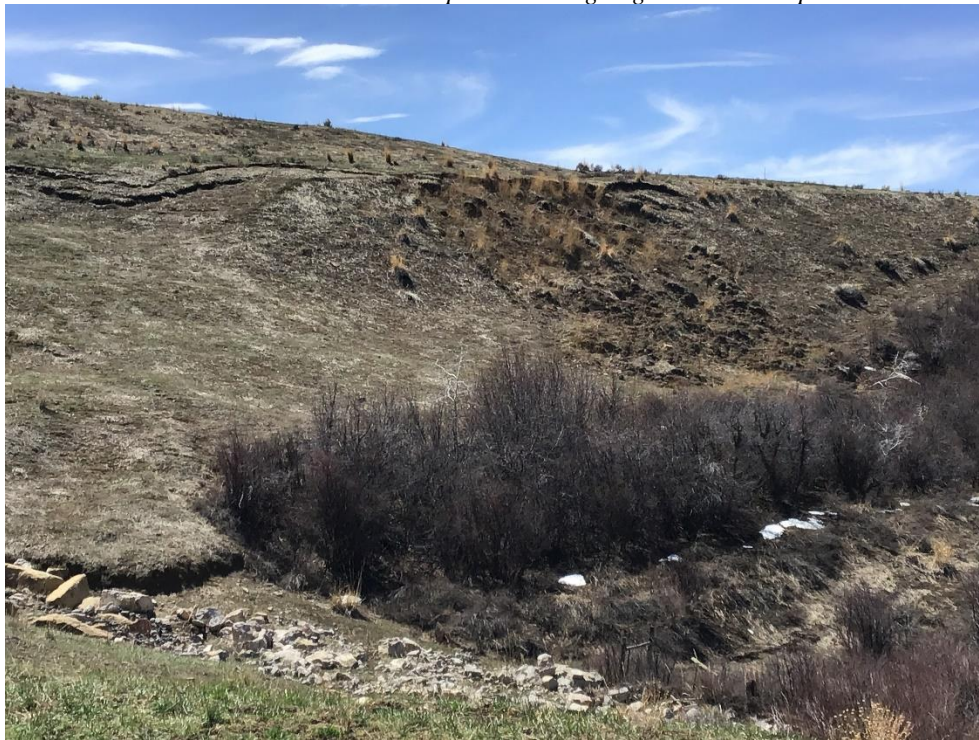
Photo 2: Pond 6 slump of 2023 at the right in the photo and slope fissures.

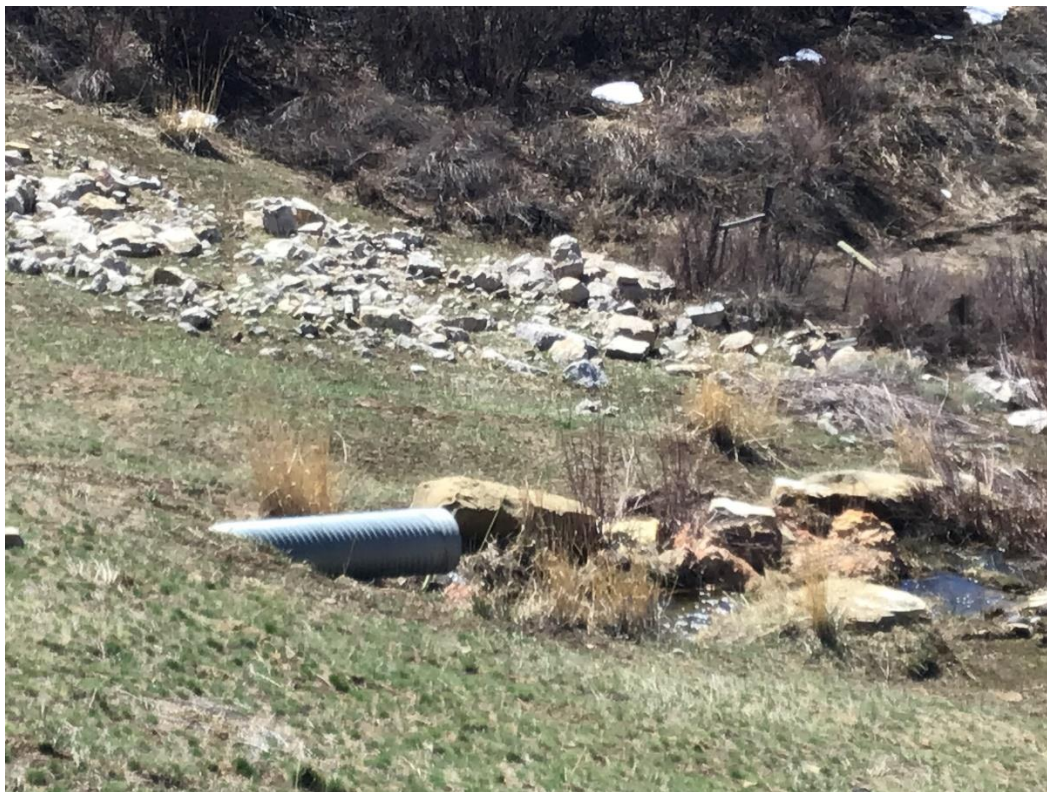
Photo 3: Pond 6 discharging clear water.

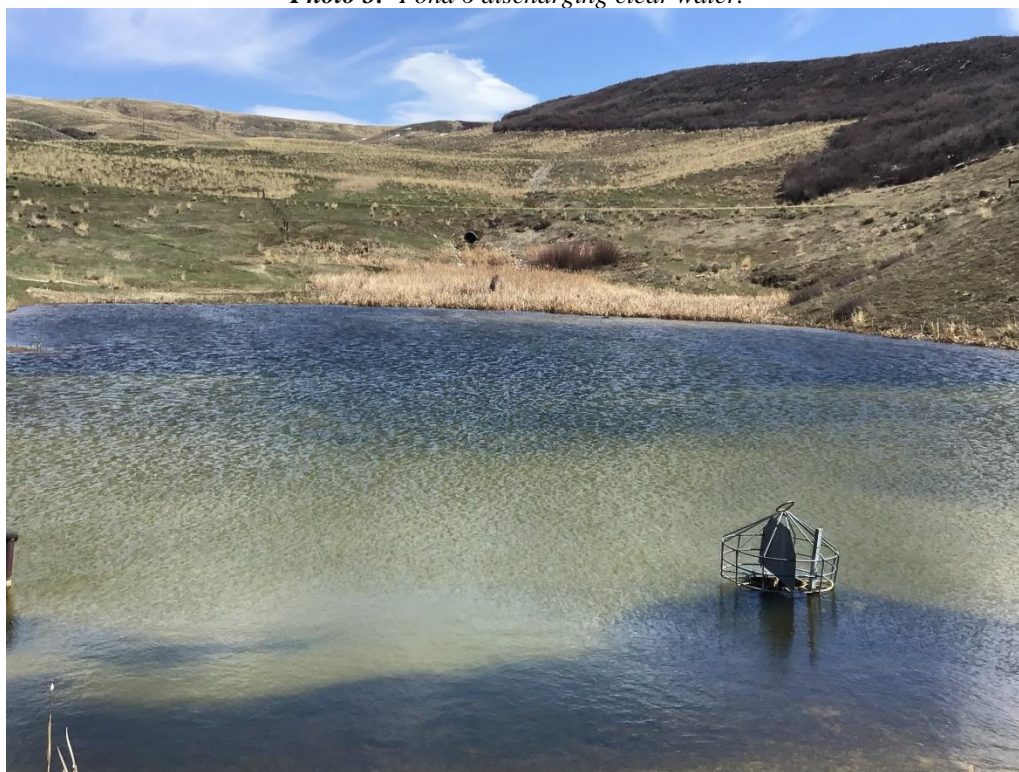
Photo 3: Pond 6 and decant structure.

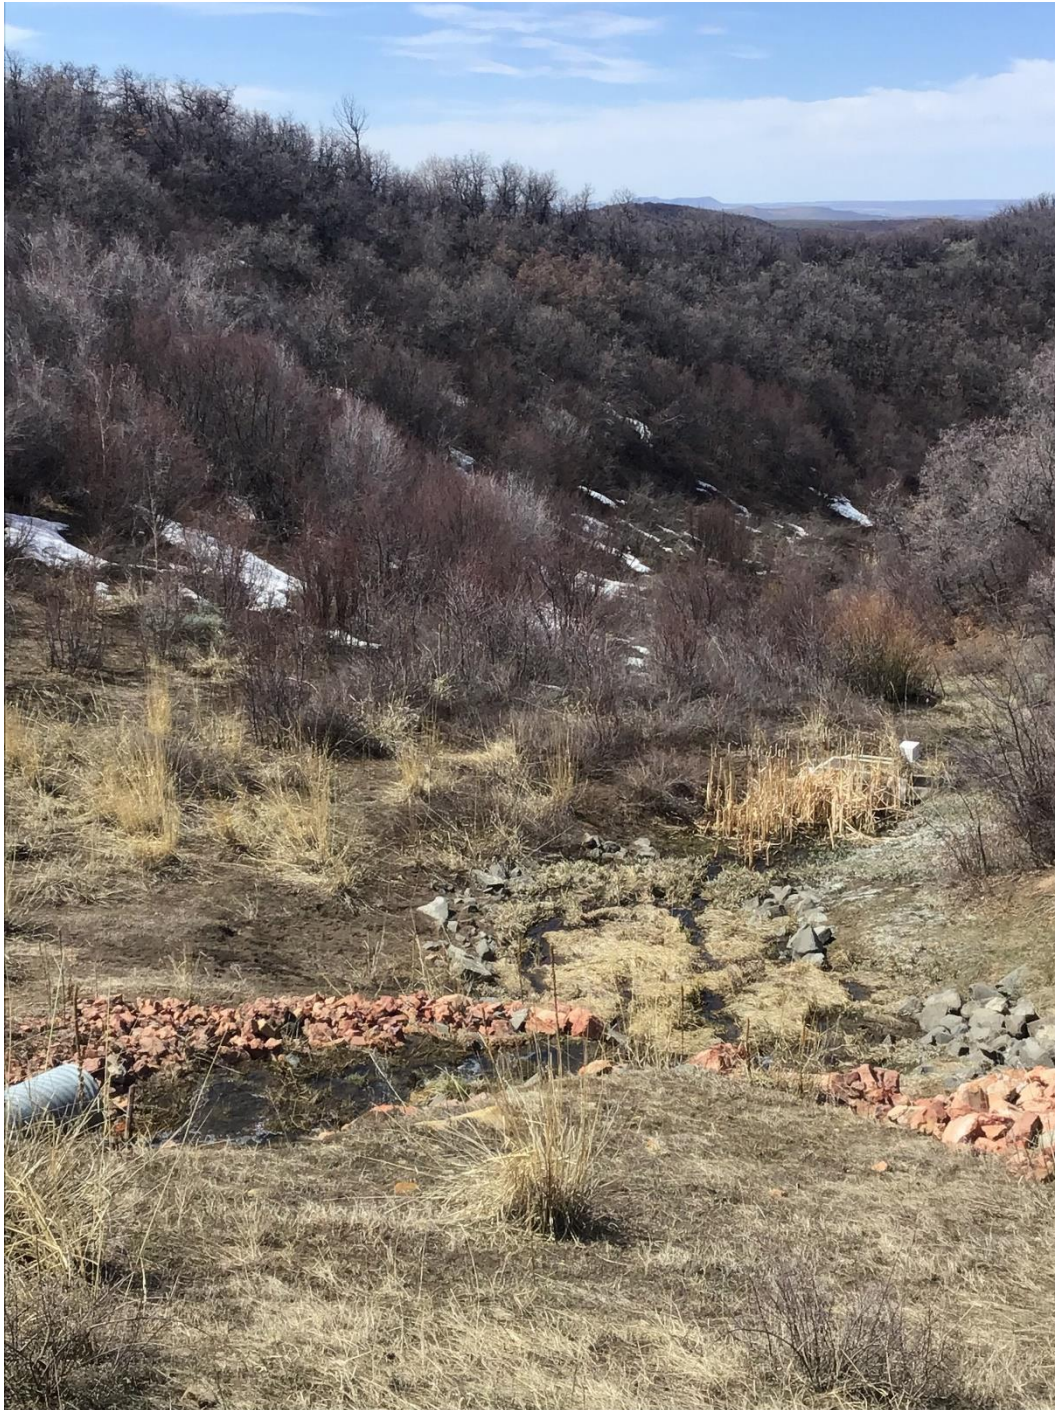
Photo 4: Pond 16 discharging through culvert to drainageway.

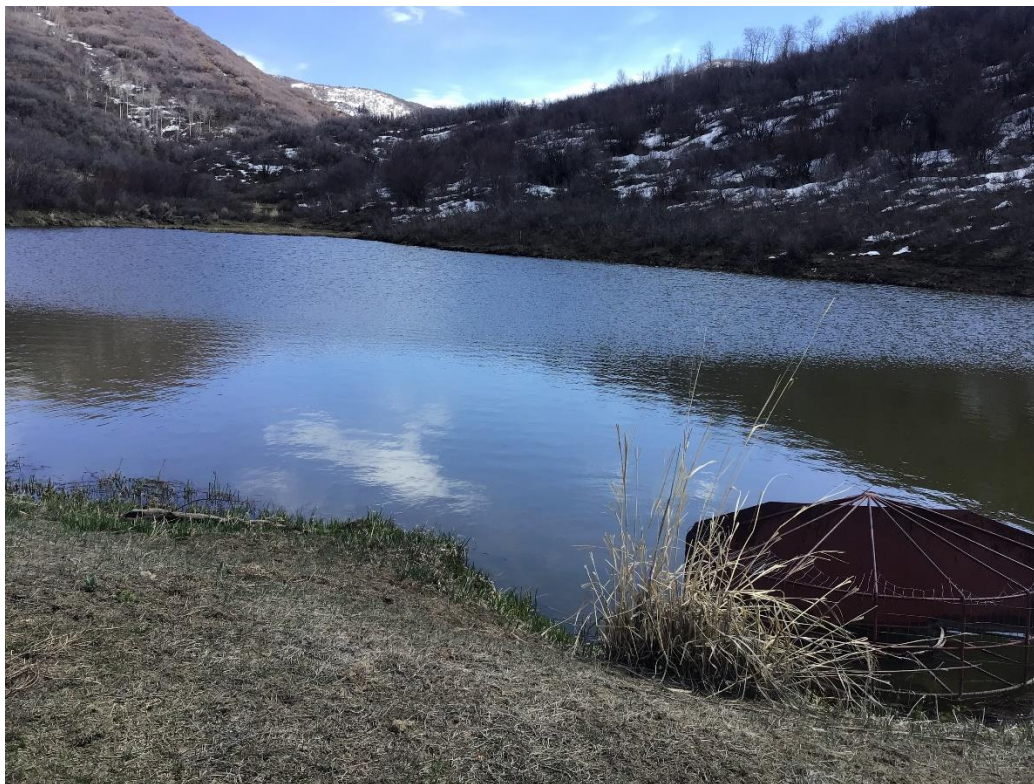
Photo 5: Pond 16 and decant structure.

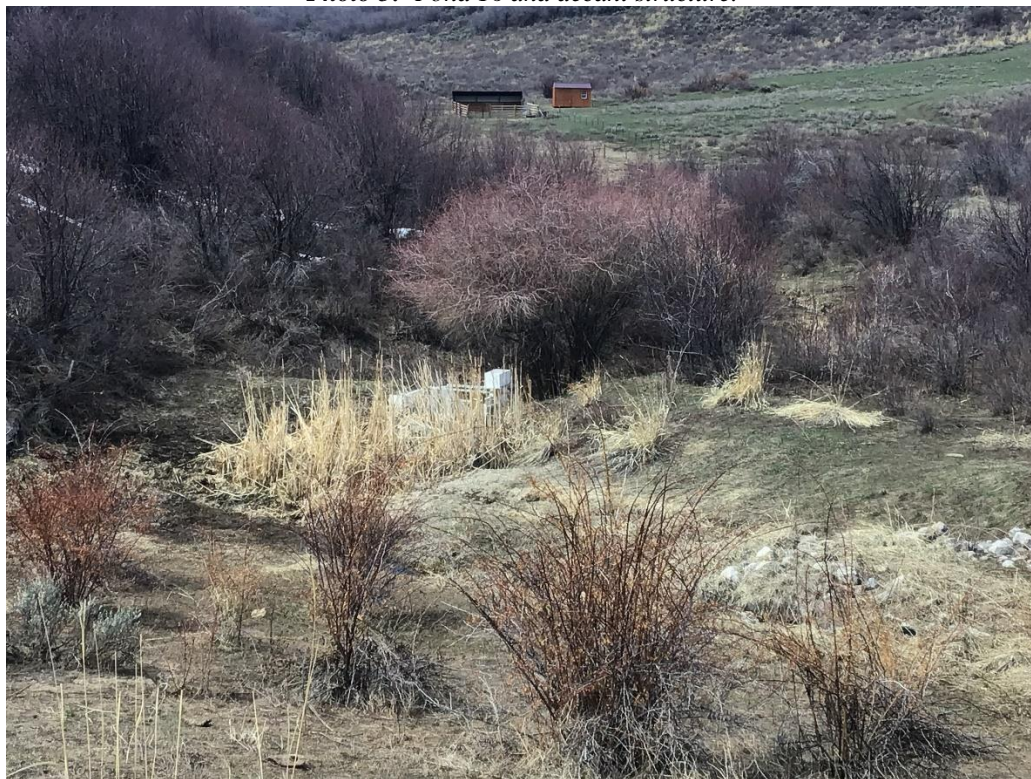
- Pond 6 was discharging clear water. The flume, and the emergency spillway were in good repair and functioning adequately.
- Pond 16 held water that appeared turbid at the time of inspection. The pond was discharging. Cattails growing at the entrance to the flume do not seem to be impeding the flow of water through the flume.
- Pond 17 was discharging clear water. Water was flowing under the flume rather than the flume. This requires attention, possibly some bentonite or concrete to stabilize the flume.
- Stock ponds were full and water appeared turbid at the time of inspection

Photo 6: Pond 16 flume, cattails were not impeding flow getting to the flume.
